LICENSEE EVENT REPORT

Browns Ferry Nuclear Plant Unit 2
Recirculation Manifold Indications
Assessment and Action Plan

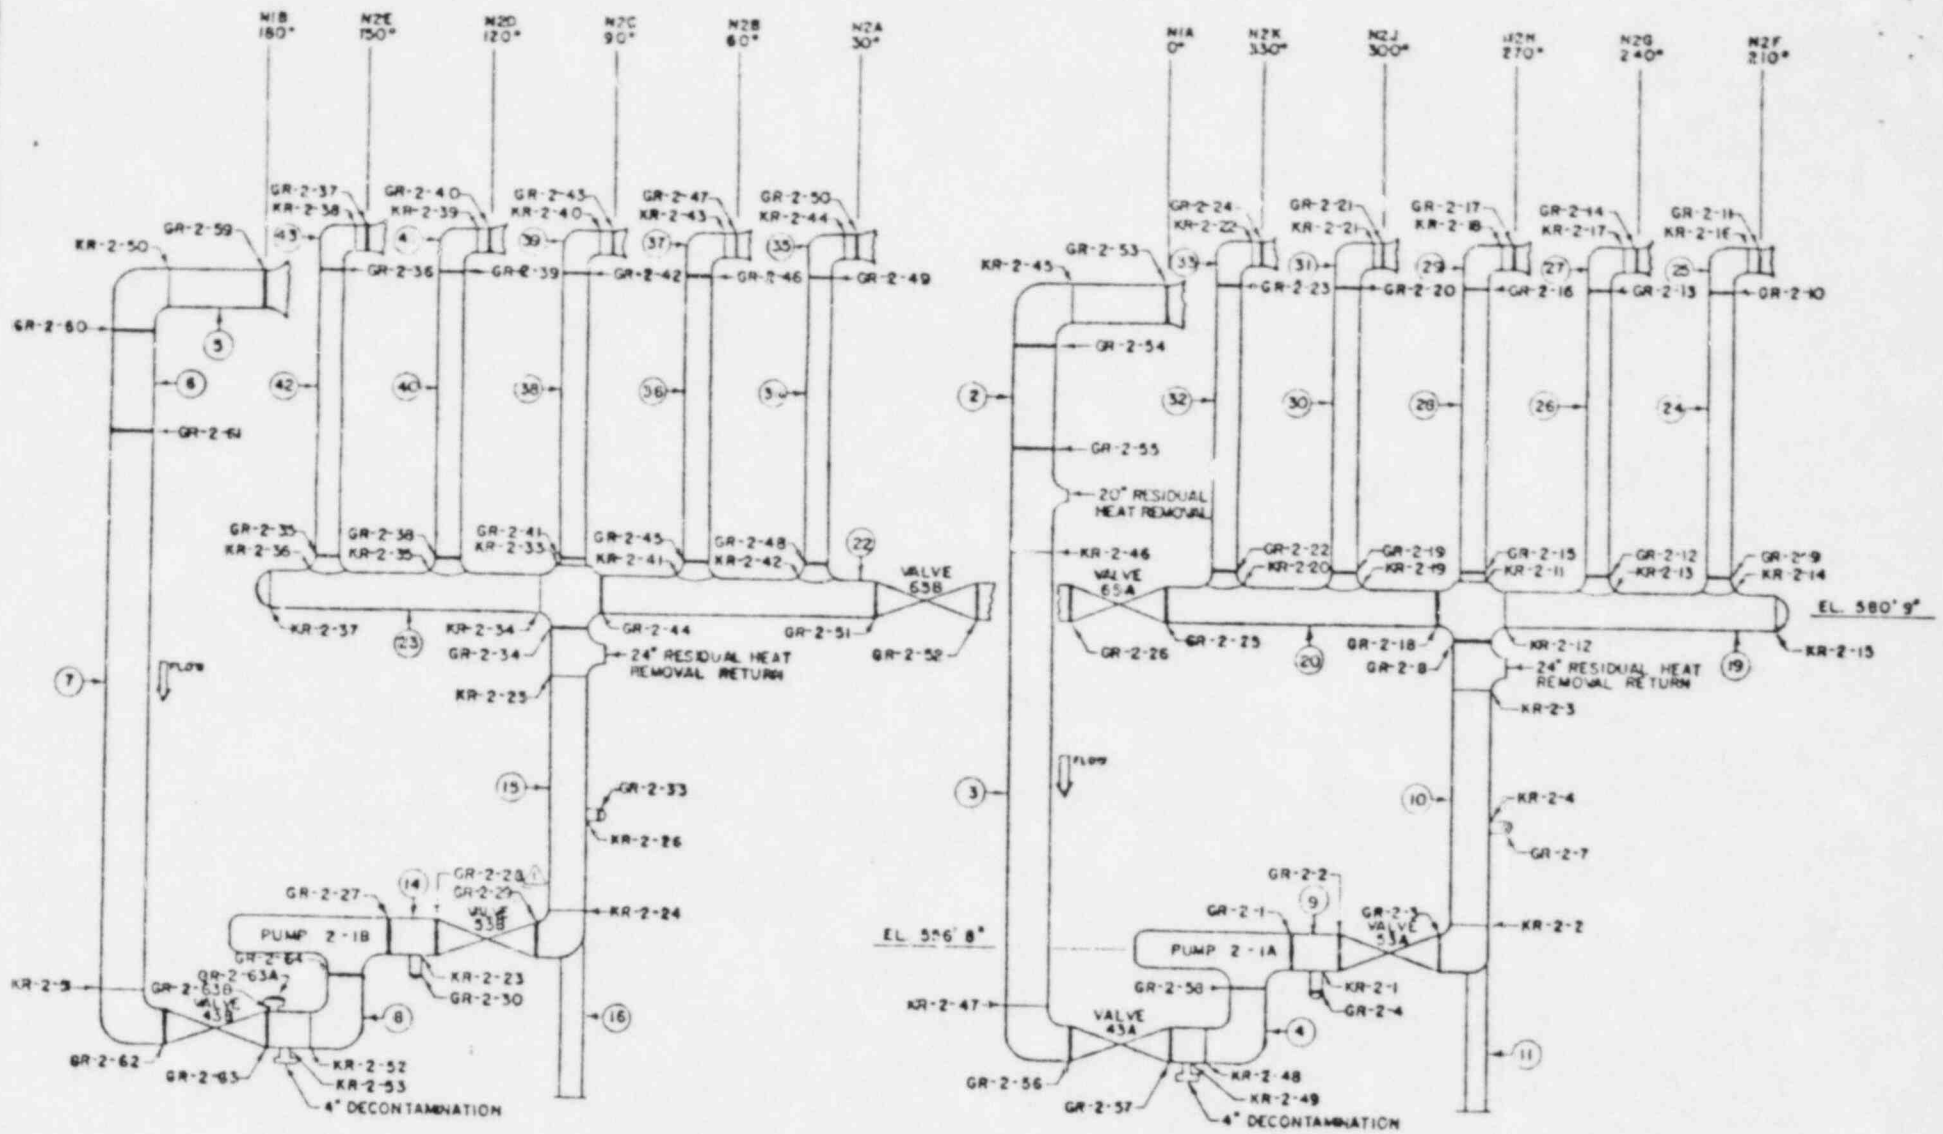
NO. DATE		REVISIONS
TENNESSEE VALLEY AUTHORITY DIVISION OF POWER PRODUCTION		
BROWN'S FERRY NUCLEAR PLANT UNIT 2 RECIRCULATION SYSTEM WELD IDENTIFICATION		
DATE	BY	CHKD.
12-5-71	J. J. GIBB	C. M. DICKERSON

As a result of indications that were found in a sweepolet at Hatch unit 2, NRC region II inspectors requested that TVA examine a sweepolet-to-manifold joint nearest the manifold end cap. TVA proceeded to perform a preliminary examination on sweepolet-to-manifold weld KR-2-36 in loop B (see attachment) and found unacceptable indications. LMT was then called back to Browns Ferry to examine the sweepolet-to-manifold weld KR-2-36 and three additional sweepolet-to-manifold welds. LMT found three unacceptable indications in weld KR-2-36 and one unacceptable indication in the loop A sweepolet-to-manifold weld joint nearest the end cap (KR-2-14). As a result of the unacceptable indication in KR-2-14, the four remaining sweepolet-to-manifold welds were examined. No additional unacceptable indications were found.

The unacceptable indications which were found in the loop B sweepolet-to-manifold joint nearest the end cap (KR-2-36) were determined to be in the heat-affected zone (HAZ) of the manifold, and their orientations looking down toward the sweepolet were approximately 1:30, 4:00, and 5:00 o'clock positions--assuming a 12:00 o'clock reference position in the direction toward the manifold end cap. The indication which was found in the loop A sweepolet-manifold joint nearest the end cap (KR-2-14) was also determined to be in the HAZ of the manifold, and its orientation looking down toward the sweepolet was approximately at the 1:30 o'clock position--assuming a 12:00 o'clock reference position in the direction toward the manifold end cap. All of the indications were interpreted by LMT to be cracks and were determined to be approximately 1-1/4 inches in length and 20-percent wall thickness in depth. A detailed report summarizing the ultrasonic inspections has been prepared by LMT and submitted to TVA.¹

Based on the ultrasonic examinations performed by LMT and the radiography performed by Industrial Laboratories, it is TVA's position that three small cracks exist in sweepolet-to-manifold weld KR-2-36 and one small crack exists in sweepolet-to-manifold weld KR-2-14. Because the original shop X-rays and the ASME Section XI preservice examinations did not reveal any similar indications in these areas, TVA believes that these cracks are service induced.

TVA believes that the indications were fatigue induced for the following reasons. There have been concerns in the past about audible noises in the general area of the unit 2 recirculation manifolds; and TVA, therefore, believes that there is a strong possibility that this noise was caused by vibrations in this piping system. If fatigue is the real cause, TVA believes that the two sweepolet-to-manifold joints with unacceptable indications would be the most likely locations to experience fatigue problems because the amplitude of vibration is expected to be greater near the free ends (capped ends) of the 22-inch recirculation manifold. This greater amplitude would then result in higher cyclic stress levels in the suspect sweepolet joints. Also, the locations and orientations of the indications in the manifold HAZ is where one would expect fatigue cracking caused by vibration-induced bending moments on the sweepolets because the stress levels in the area of the indications are higher. This has been documented by past research conducted by Battelle Memorial Institute relative to fatigue in sweepolet branch connections (see attached report).² TVA determined that the audible noise was due to a resonant frequency that was generated by the recirc pumps when they were operating at approximately 80-percent capacity. TVA has eliminated this noise problem by operating the pumps at different speeds during startup and operation. If fatigue cracks were initiated as a result of these vibrations, TVA believes that the driving force may have been eliminated.

Because of the many problems associated with any type of weld repair, it is TVA's decision to provide justification for continued operation in the "as is" condition. This justification will consist of (1) performing LEFM analysis to show that the indications will not grow to unacceptable sizes during the current fuel cycle, (2) installing instrumentation (accelerometers, etc.) near both suspect welds to assess the vibrations, (3) installing moisture-sensitive tape near the suspect joints to monitor for leakage at these joints, and (4) reinspecting the suspect welds at the next refueling outage and determining if any crack growth has occurred.
