SUBJECT: Arkansas Nuclear One - Unit 2
 Docket No. 50-368
 License No. NPF-6
 Evaluation of HPSI
 Operability Without Service
 Water Cooling
 (File: 2-0510.5)

ANO-2 EVALUATION OF HPSI PUMP OPERABILITY
WITHOUT SERVICE WATER COOLING

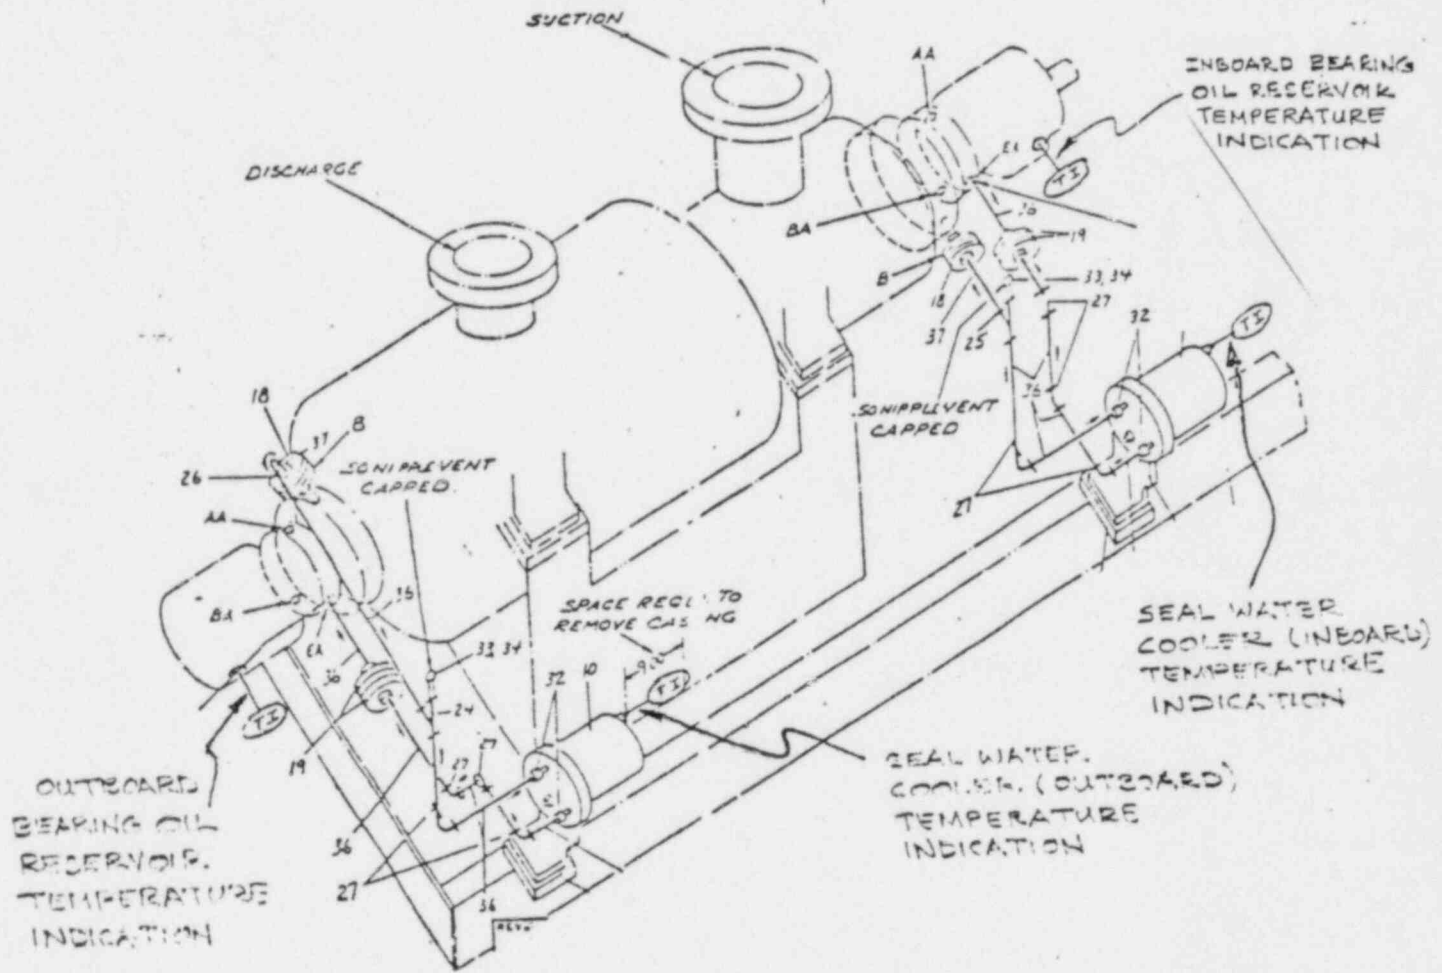
FIGURE 1

HPSI PUMP TEMPERATURE MONITORING

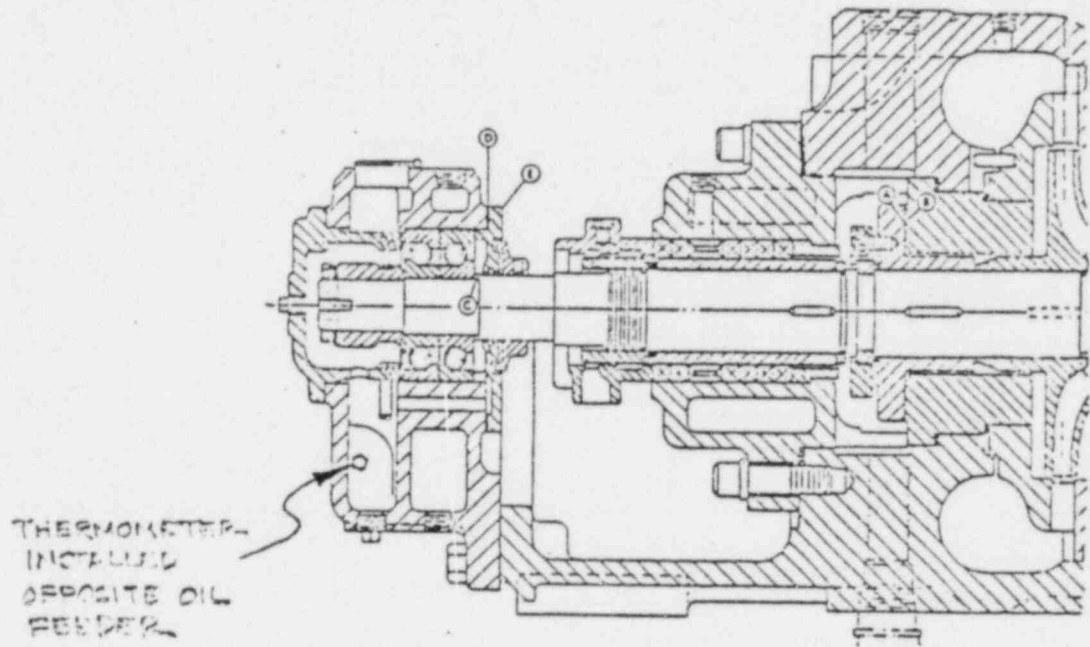
FIGURE 2

HPSI PUMP BEARING DETAIL

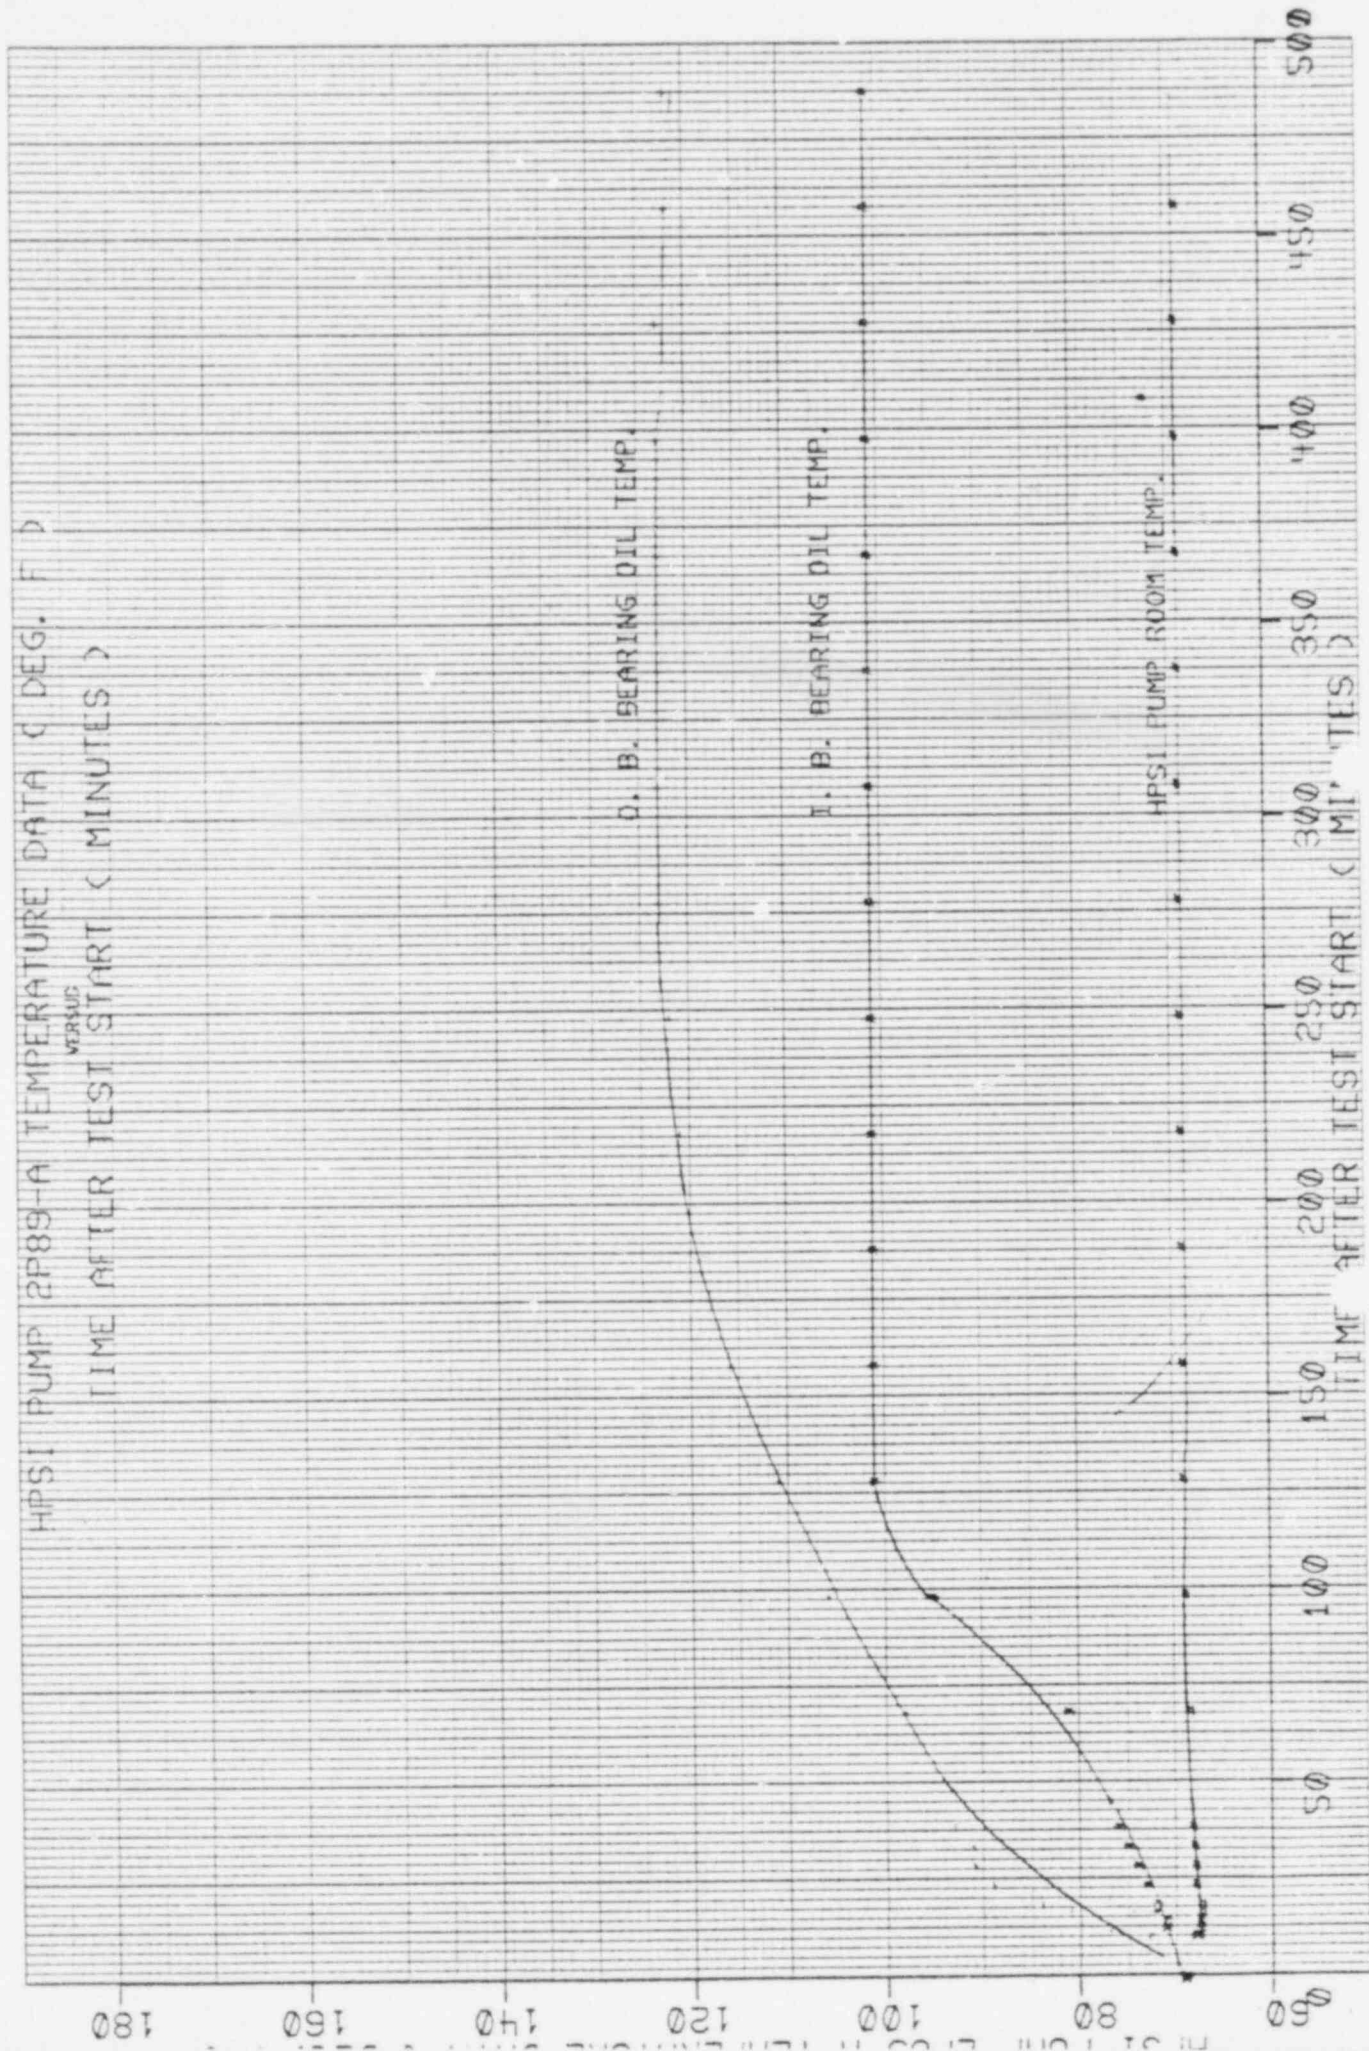
FIGURE 3

HPSI PUMP 2F89-A TEMPERATURE DATA (DEG. F)
VERSUS
TIME AFTER TEST START (MINUTES)

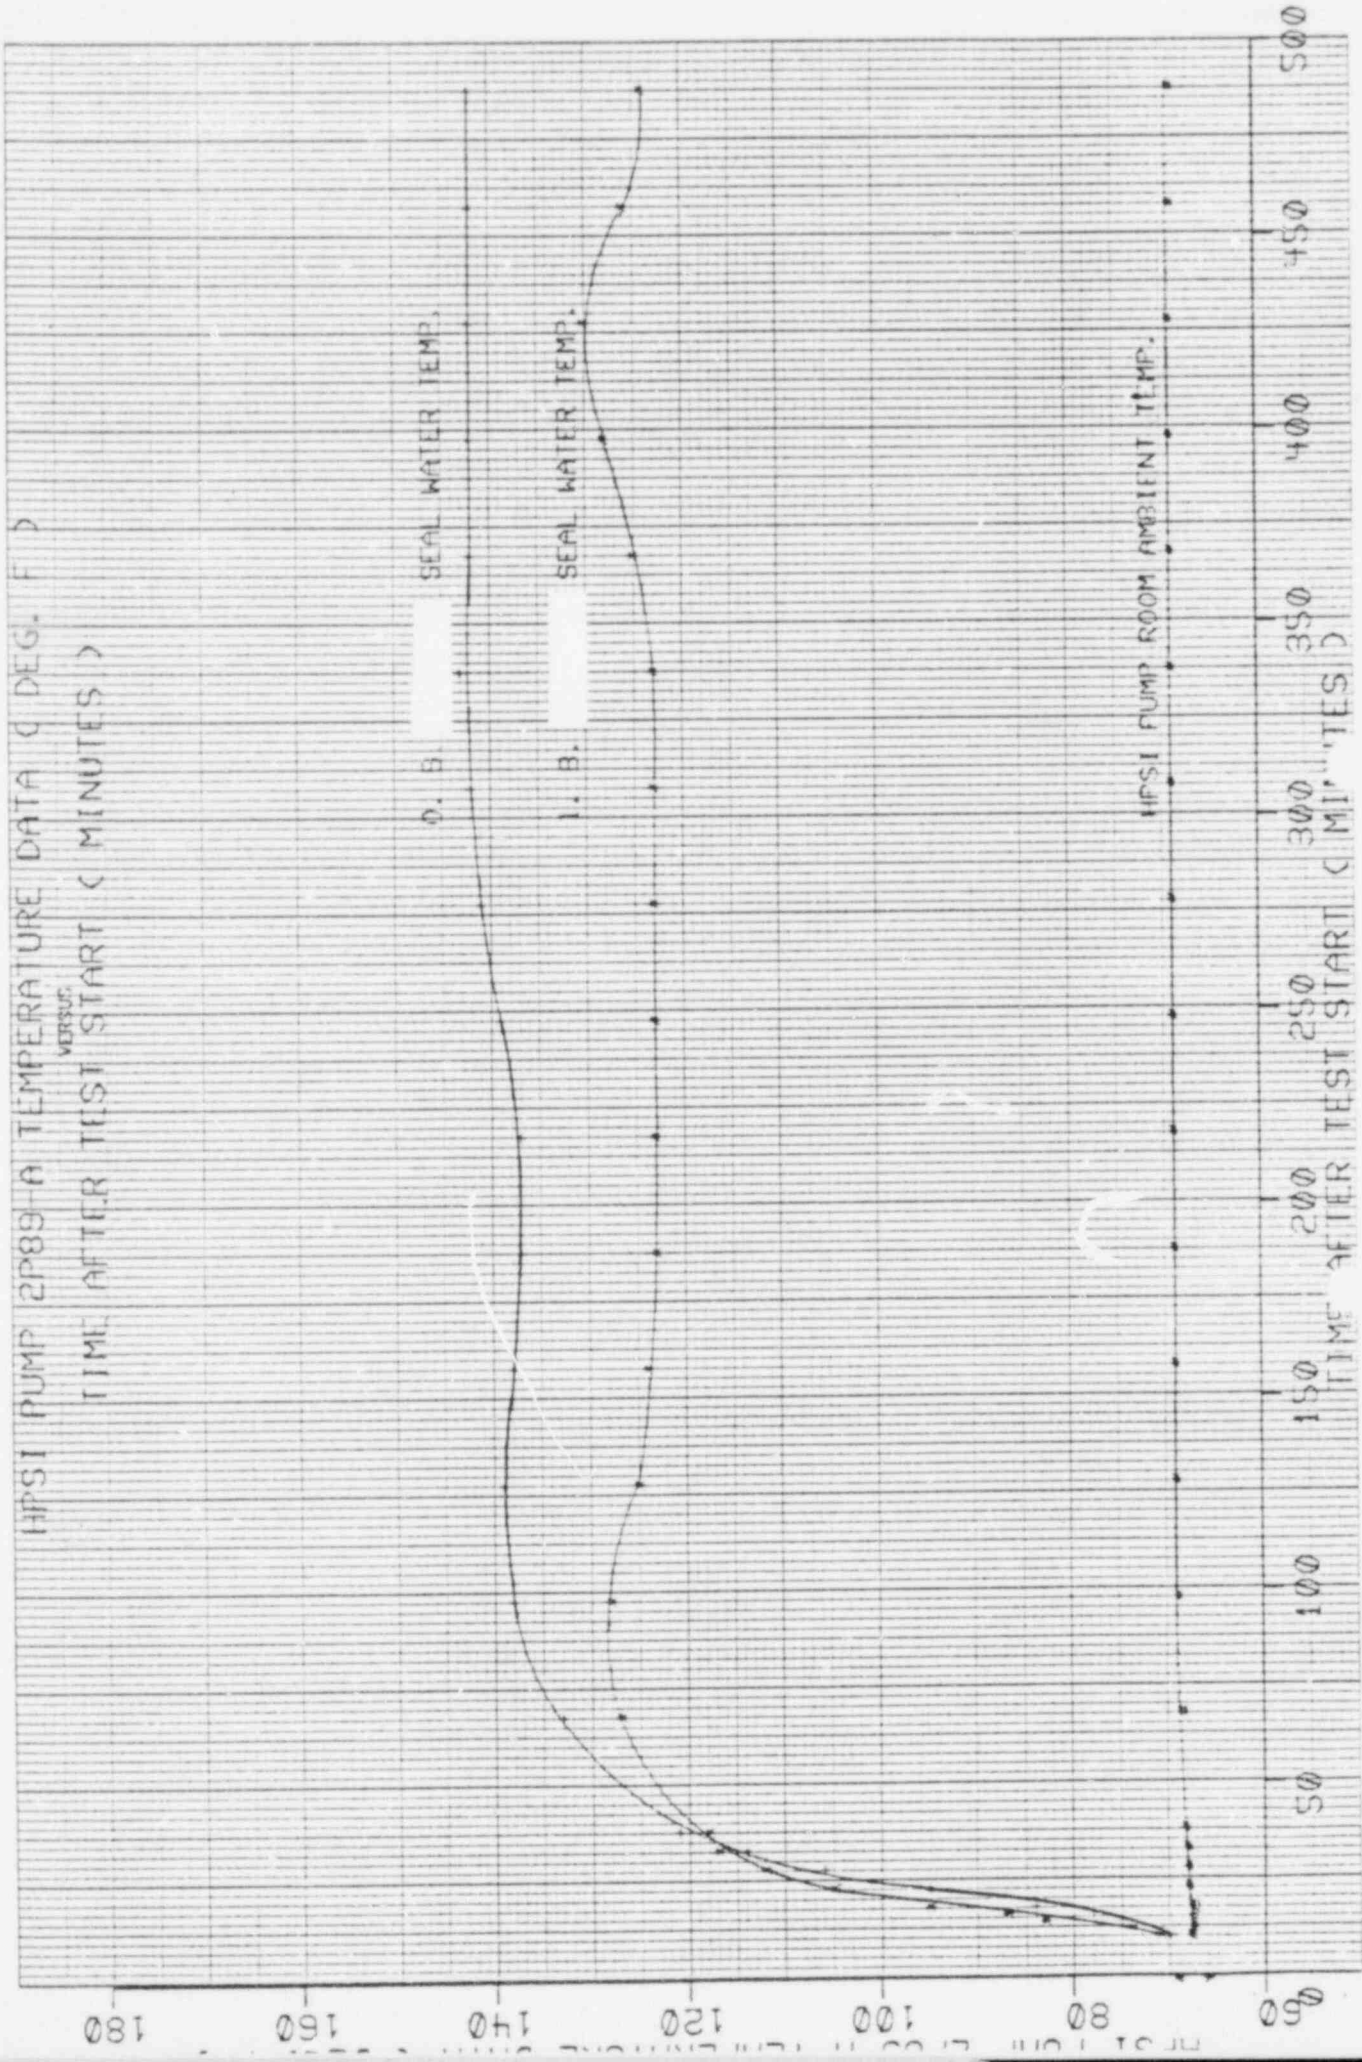
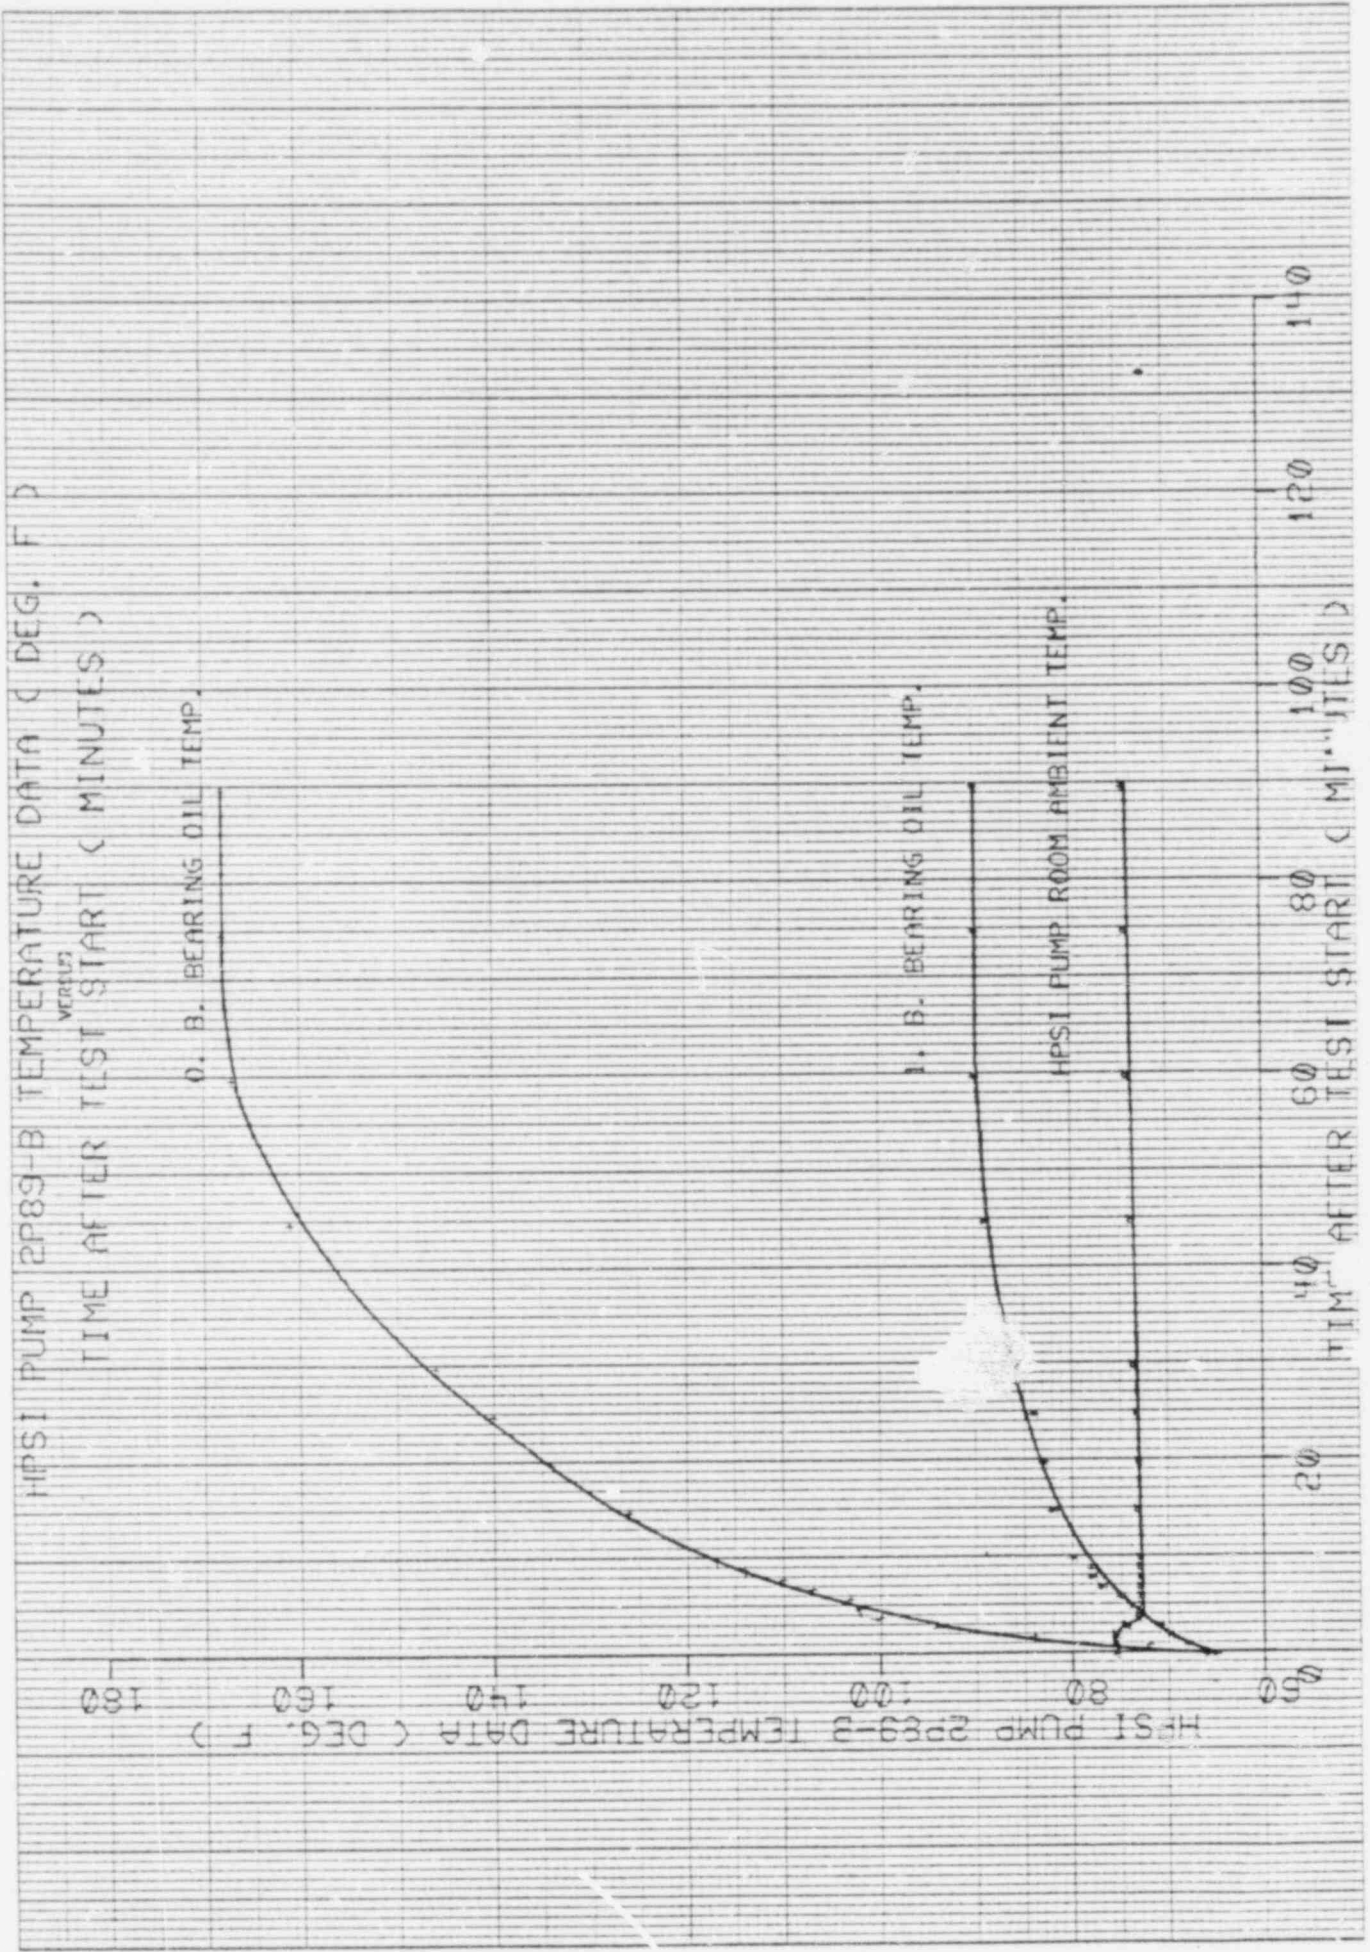
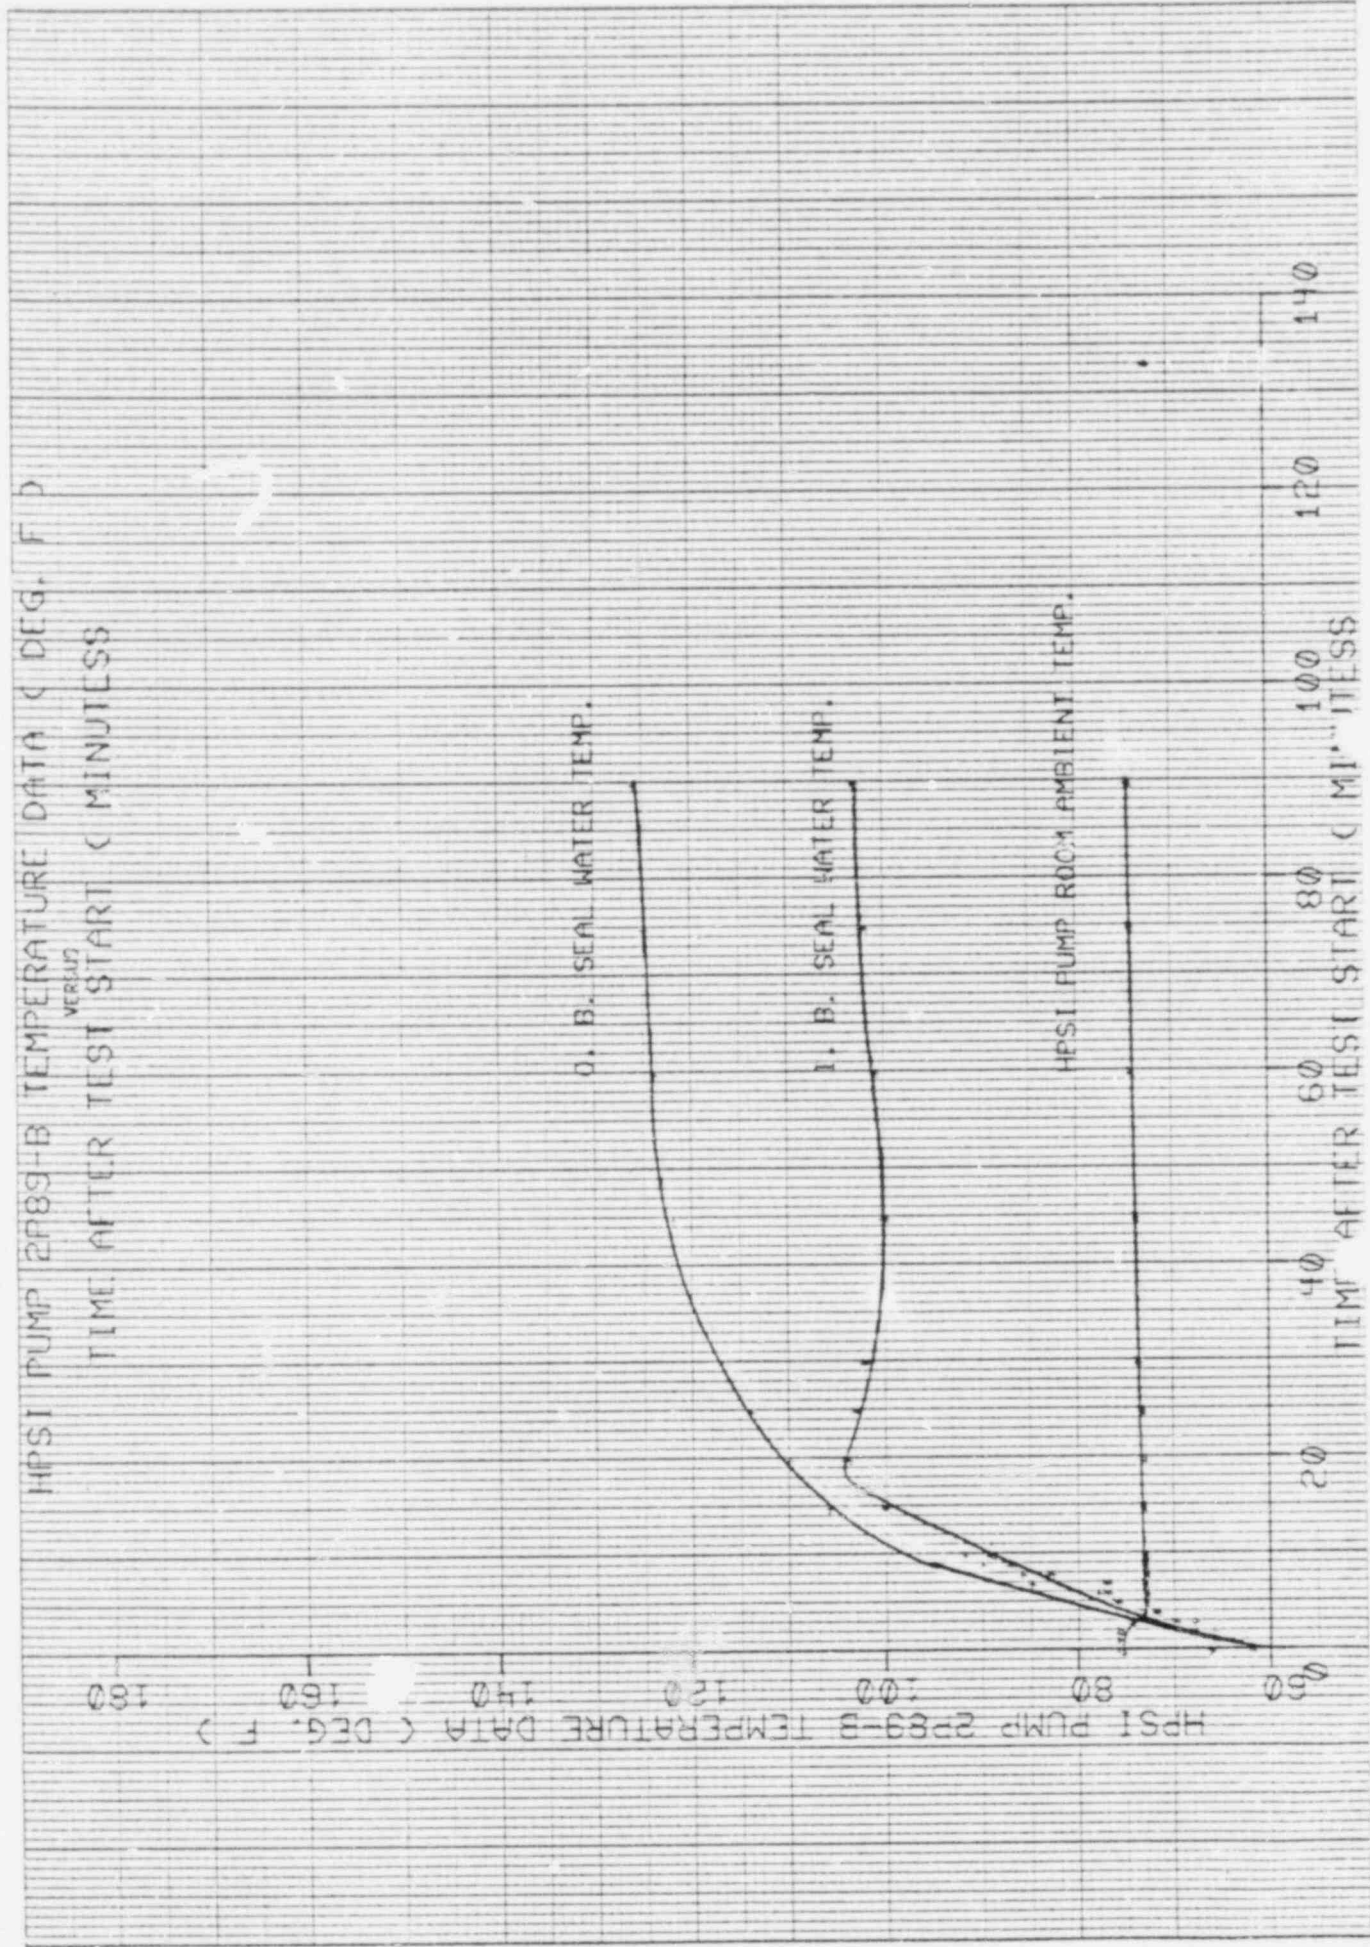
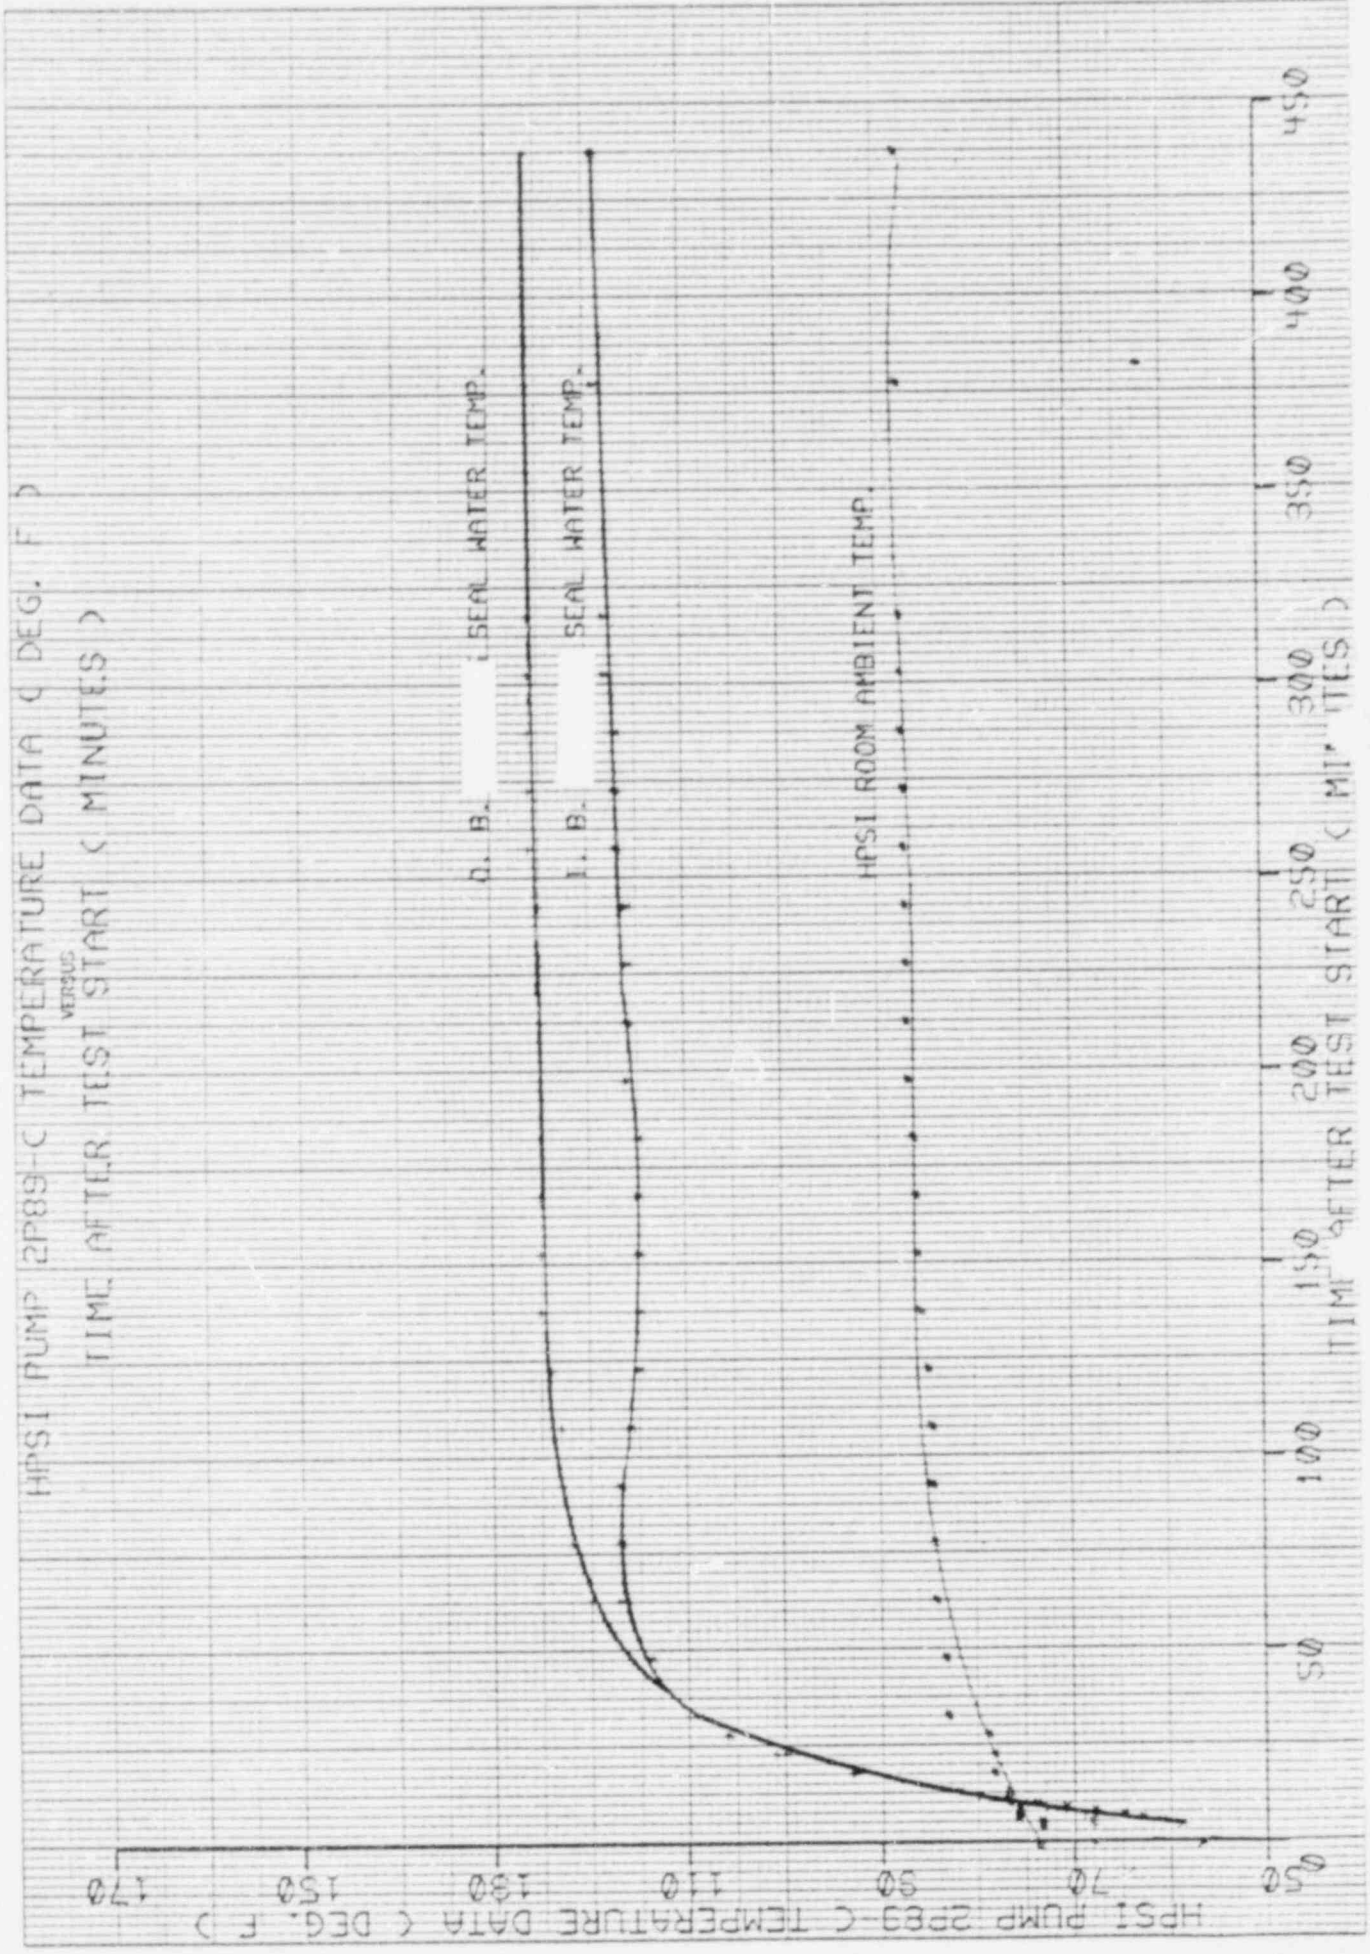
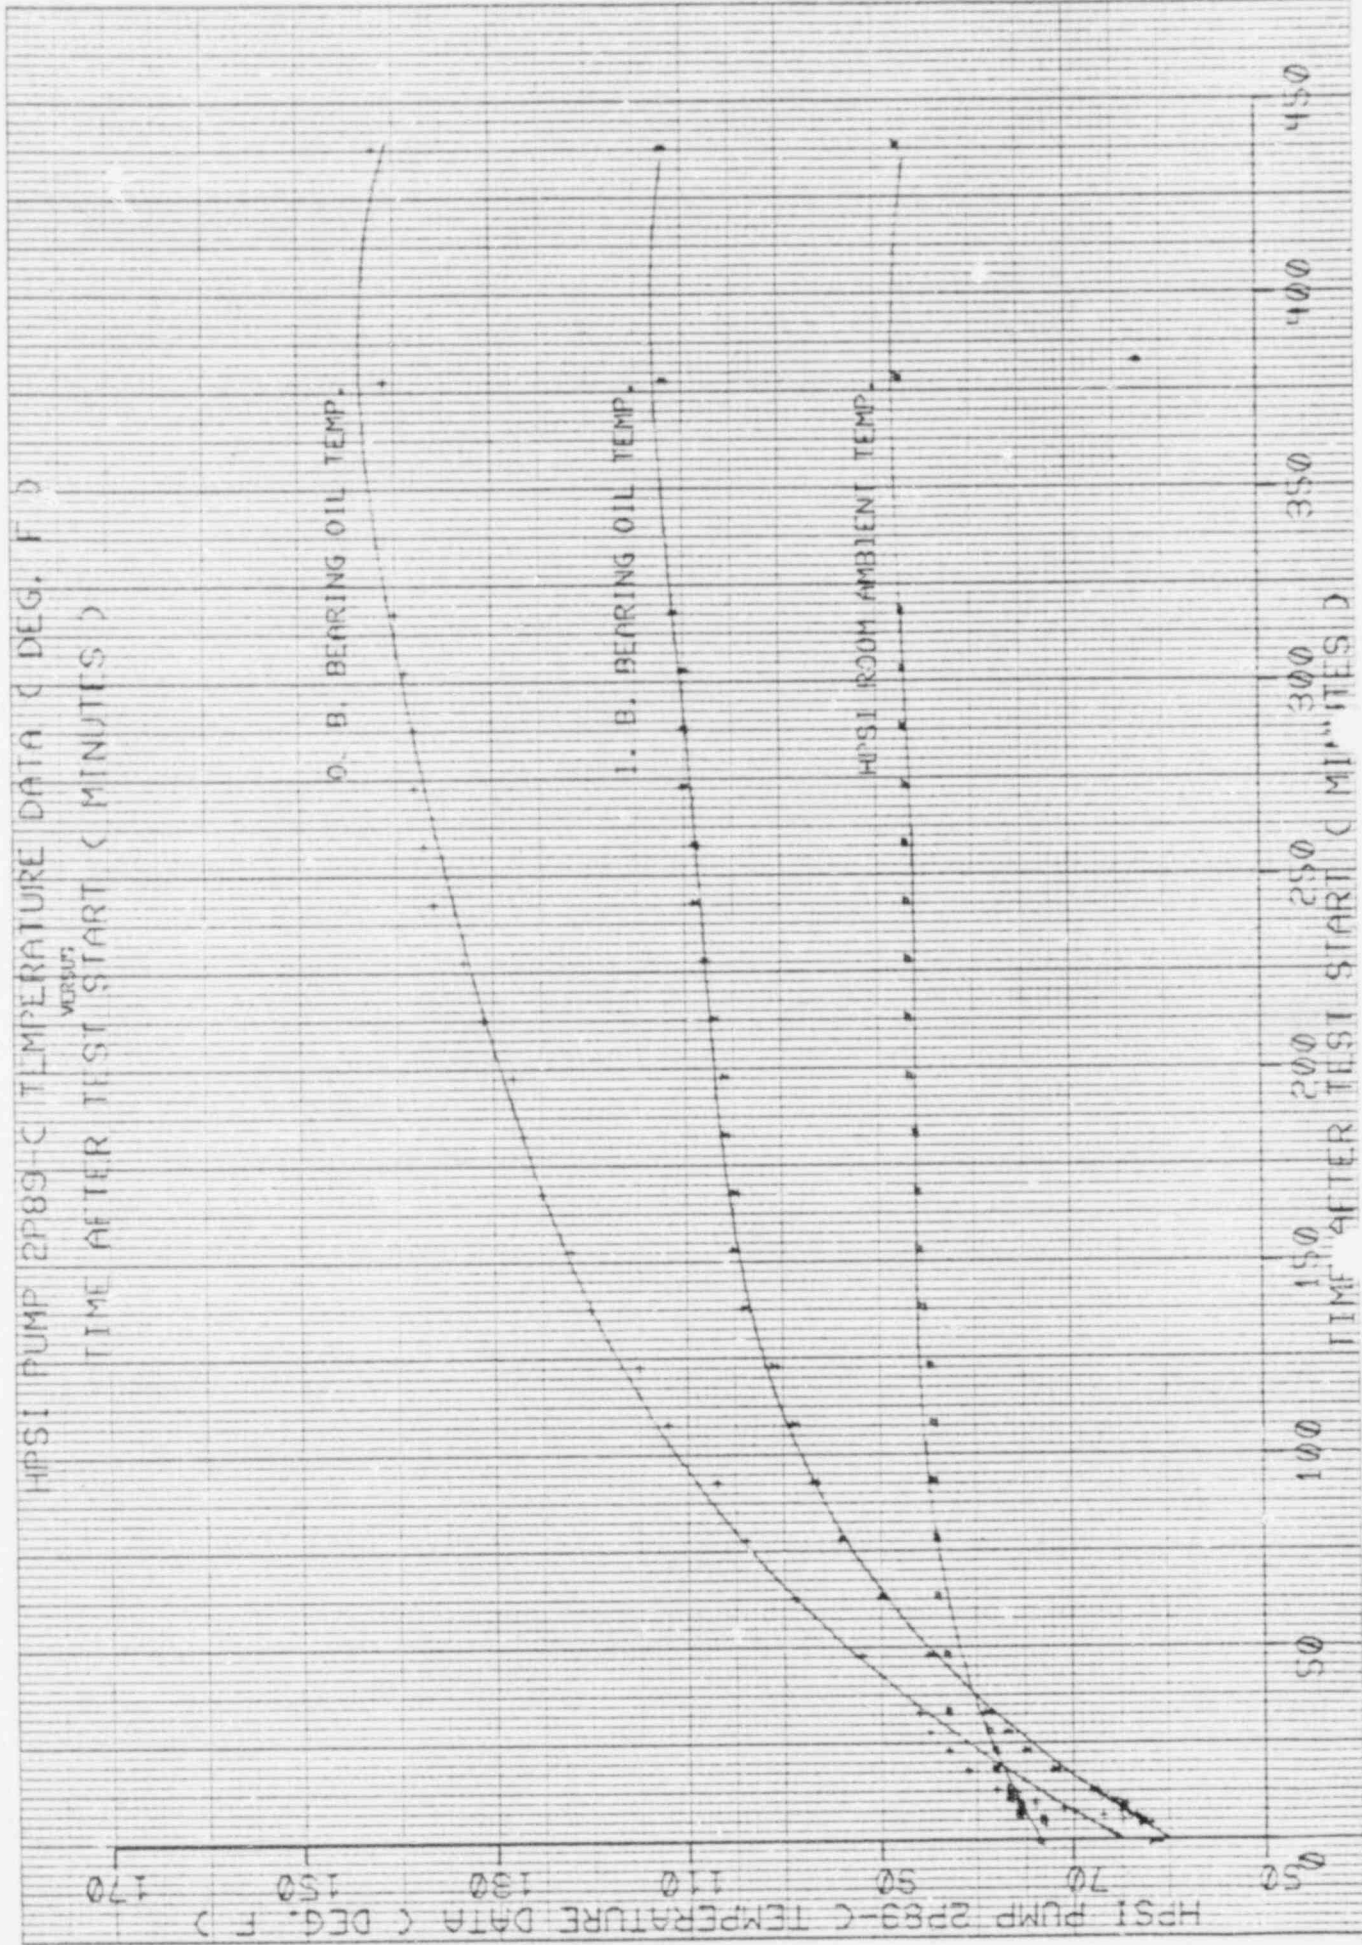
Bearing race temperature measurements indicated 4°F to 6°F higher than bearing oil temperatures. See also plots of temperatures versus time (Figures 3-8).

A large deviation in temperature between the outboard and inboard bearings for 2P89B was observed during these tests. (The difference was 78°F versus 21°F for 2P89A and 30°F for 2P89C.) The testing on 2P89B was performed immediately following maintenance on its motor and the data indicated that the pump and motor may not have been adjusted optimally causing a greater than necessary thrust loading. For this reason further maintenance on 2P89B is planned in the future, and these test results were not used for assessing operability.
