STATE of NEBRASKA

**BECTON  
DICKINSON**

- EMERGENCY SERVICE REPORT -  
AECL-CP TYPE IR 96 CATEGORY IV IRRADIATOR  
BECTON DICKINSON, BROKEN BOW, NEBRASKA

REPORT ON SOURCE JAM ATB-D, BROKEN BOW

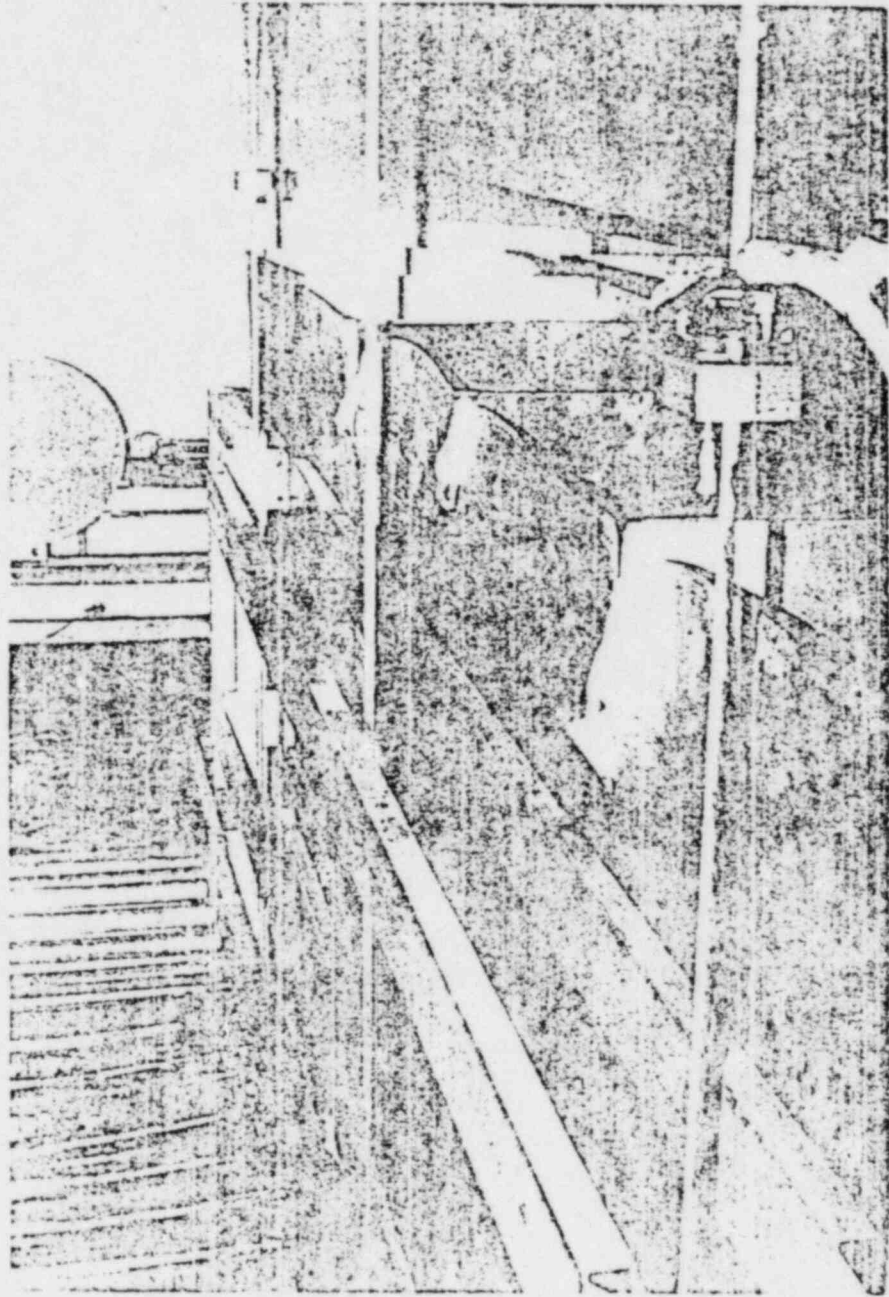
FIGURE 1

Most of the totes on the machine had splits in the corners. The splits ran from the open top down the corner between four and six inches in length. The sides on some of these totes had been peeled open as shown in the attached photographs so that the corner could protrude into the central space occupied by the source rack. The source rack had been held by three totes on an inside pass on the upper level (Figures 1 and 2) and by one on an inside pass on the lower level (Figure 3). The marks left by the rack could be seen on the flaps on all four totes.

The flaps presumably had got peeled open during a cross transfer at the end of a pass where one box slides against another.

We advised the customer that under no circumstances could he run the plant with split totes and that as a temporary measure, he could cut the top six inches off each tote and as long as there were no splits remaining, he could run with cut-down totes. They were advised to replace the totes with new totes of minimum 12 gauge (.081 inch) aluminum 5052-H34.
