NUCLEAR REGULATORY COMMISSION WASHINGTON, D. C. 20555

AEOD/E108

SUBJECT:

HATCH UNITS 1 and 2 - ALTERNATE OFFSITE SOURCE INTERLOCK WITH

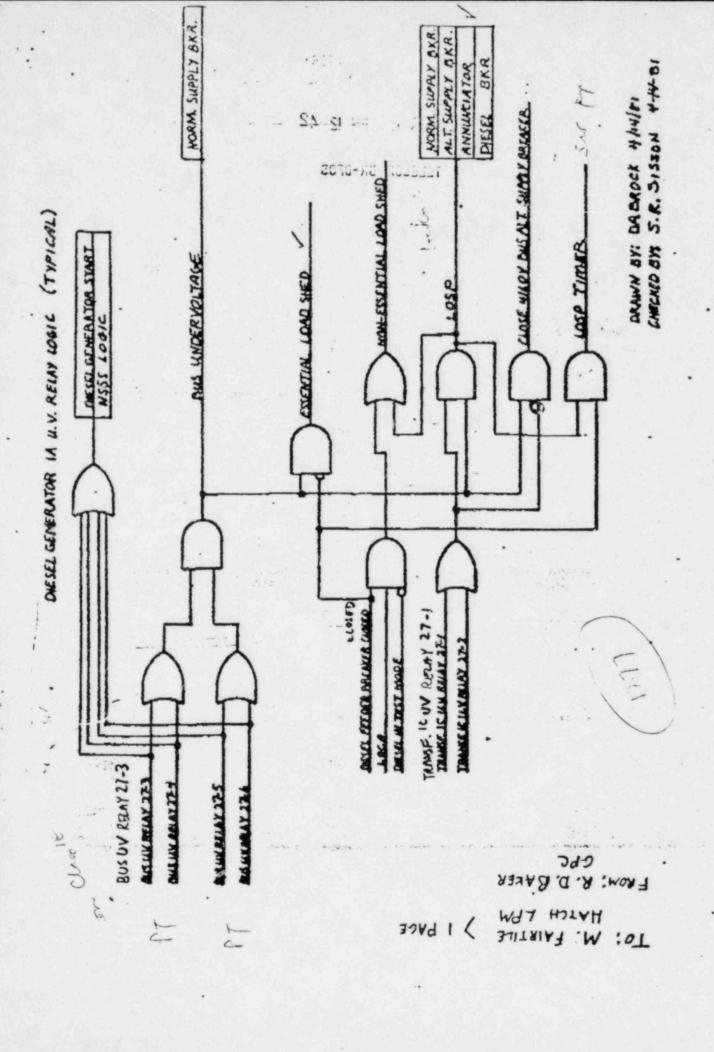
The licensee, while performing a relay trip procedure at Hatch 1, identified that the undervoltage relays of the second offsite source would not operate. The relays are designated "Transformer 1C UV relays 27-1 and 27-2." (see attached logic diagram). Transformer 1C is the alternate offsite source to the safety-related buses.

The design of the station safety-related electrical system is such that on loss of the primary offsite source (monitored by UV relays 27-3, 27-4, 27-5, and 27-6 on each safety bus) the diesel generators are started and the safety buses seek the alternate offsite source -- transformer IC. If this offsite source is unavailable (as seen by the operation of UV relays 27-1 and 27-2), then the DG breakers are closed to energize the safety buses.

The UV relays 27-3 through 27-6 that monitor the voltage of each safety bus are designated as Class IE equipment -- a set of four is provided for each bus. The UV relays 27-1 and 27-2, however, are not designated Class IE and only one pair is provided for all the safety buses. On April 6, 1981 during the trip procedure, relays 27-1 and 27-2 did not operate, thus preventing the closure of all the DG breakers on Unit 1. The design is the same for Unit 2.

The licensee will be proposing a design modification to correct the problem of the non-Class IE interlock that prevents the automatic operation of safety systems. ORAB/NRR is presently pursuing this matter. Other than keeping ourselves informed of the resolution of the design problem, we do not anticipate any further AEOD action.
