February 3, 1983
Fort St. Vrain
Unit No. 1
P-83046

REPORTABLE OCCURRENCE 83-003

FORT ST. VRAIN NUCLEAR GENERATING STATION
PUBLIC SERVICE COMPANY OF COLORADO
16805 WELD COUNTY ROAD 19 1/2
PLATTEVILLE, COLORADO 80651-9298

REPORT NO. 50-267/83-003/03-L-0

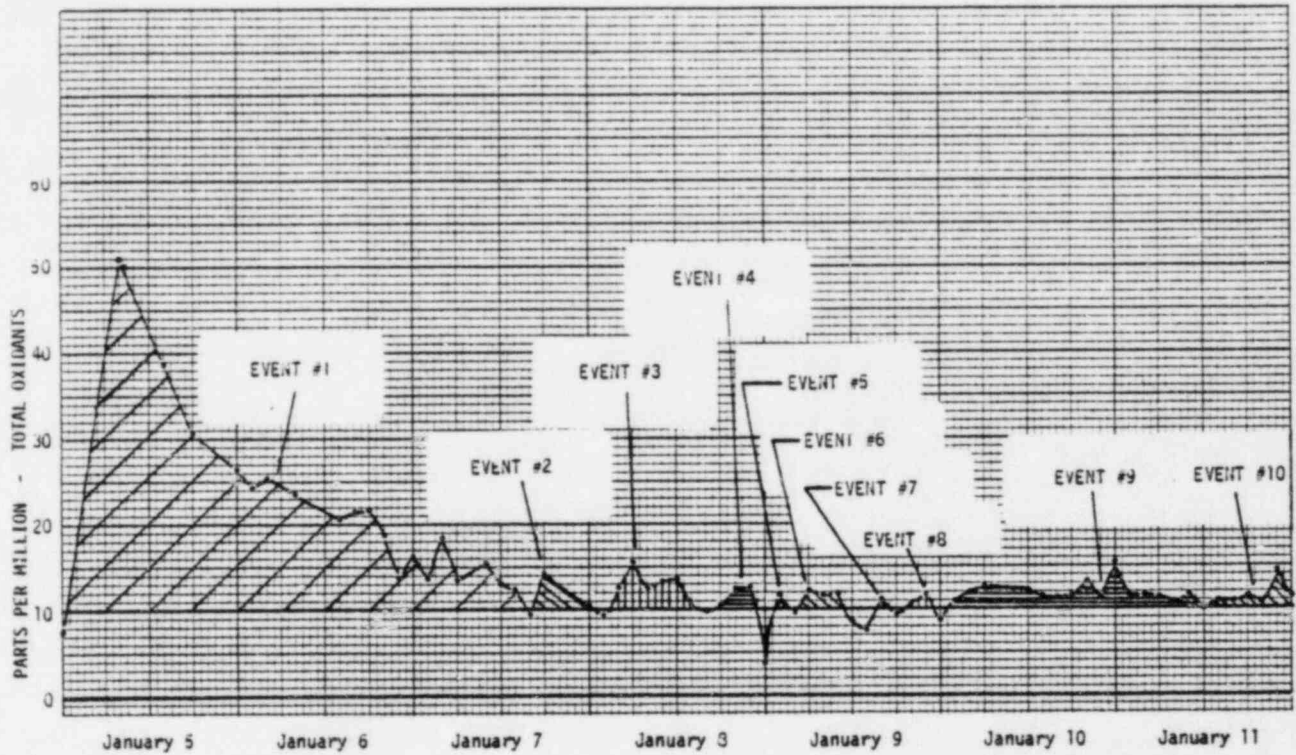
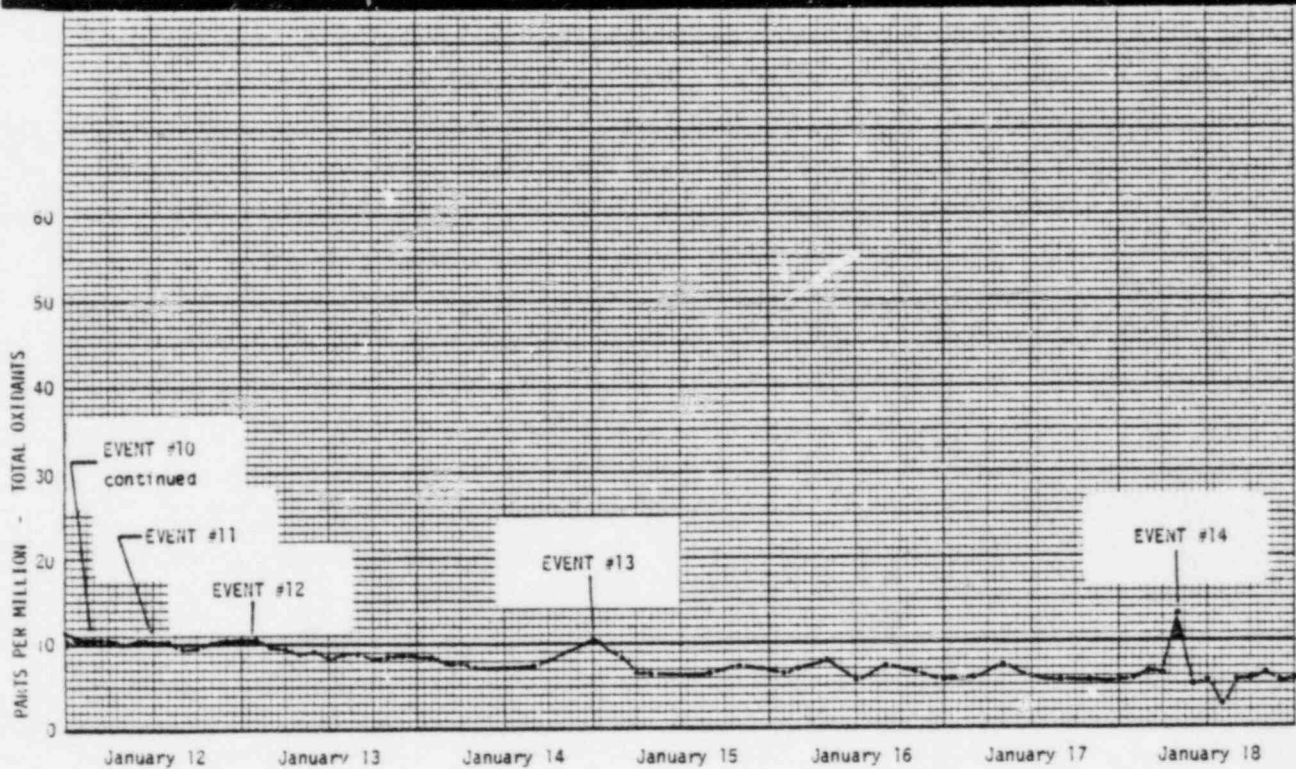
At approximately 0030 hours on January 5, 1983, the concentration of total primary coolant oxidants (sum of water, carbon monoxide, and carbon dioxide) exceeded 10 parts per million (ppm) by volume. This impurity concentration increase occurred during a rise in power following a normal startup with the average core outlet temperature greater than 1200 degrees fahrenheit. The concentration of total primary coolant oxidants returned to less than the 10 ppm limit of LCO 4.2.10 on January 7, 1983, at 0345 hours as a result of primary coolant cleanup through the helium purification system, but continued to fluctuate about 10 ppm until 0900 hours on January 18, 1983.

A total of 14 events occurred in which the 10 ppm limit was exceeded. Each event is described in Table 1 and illustrated in Figure 1.

As the core temperature was increased, the retained moisture was released from the reactor vessel internal components and chemically reacted with the core graphite. This process caused the total oxidant concentration to fluctuate about 10 ppm until all moisture had been removed.

In all 14 events, the total oxidant concentration was reduced below the LCO 4.2.10 limit by utilization of the helium purification system.
