LICENSEE: Northern States Power Company
 FACILITY: Monticello Nuclear Generating Plant
 SUBJECT: MEETING SUMMARY OF FEBRUARY 2, 1994

Meeting with Monticello Personnel to Discuss

Repair of the Core Spray Header Crack

**Monticello Core Spray Repair
and Improvement Plan**

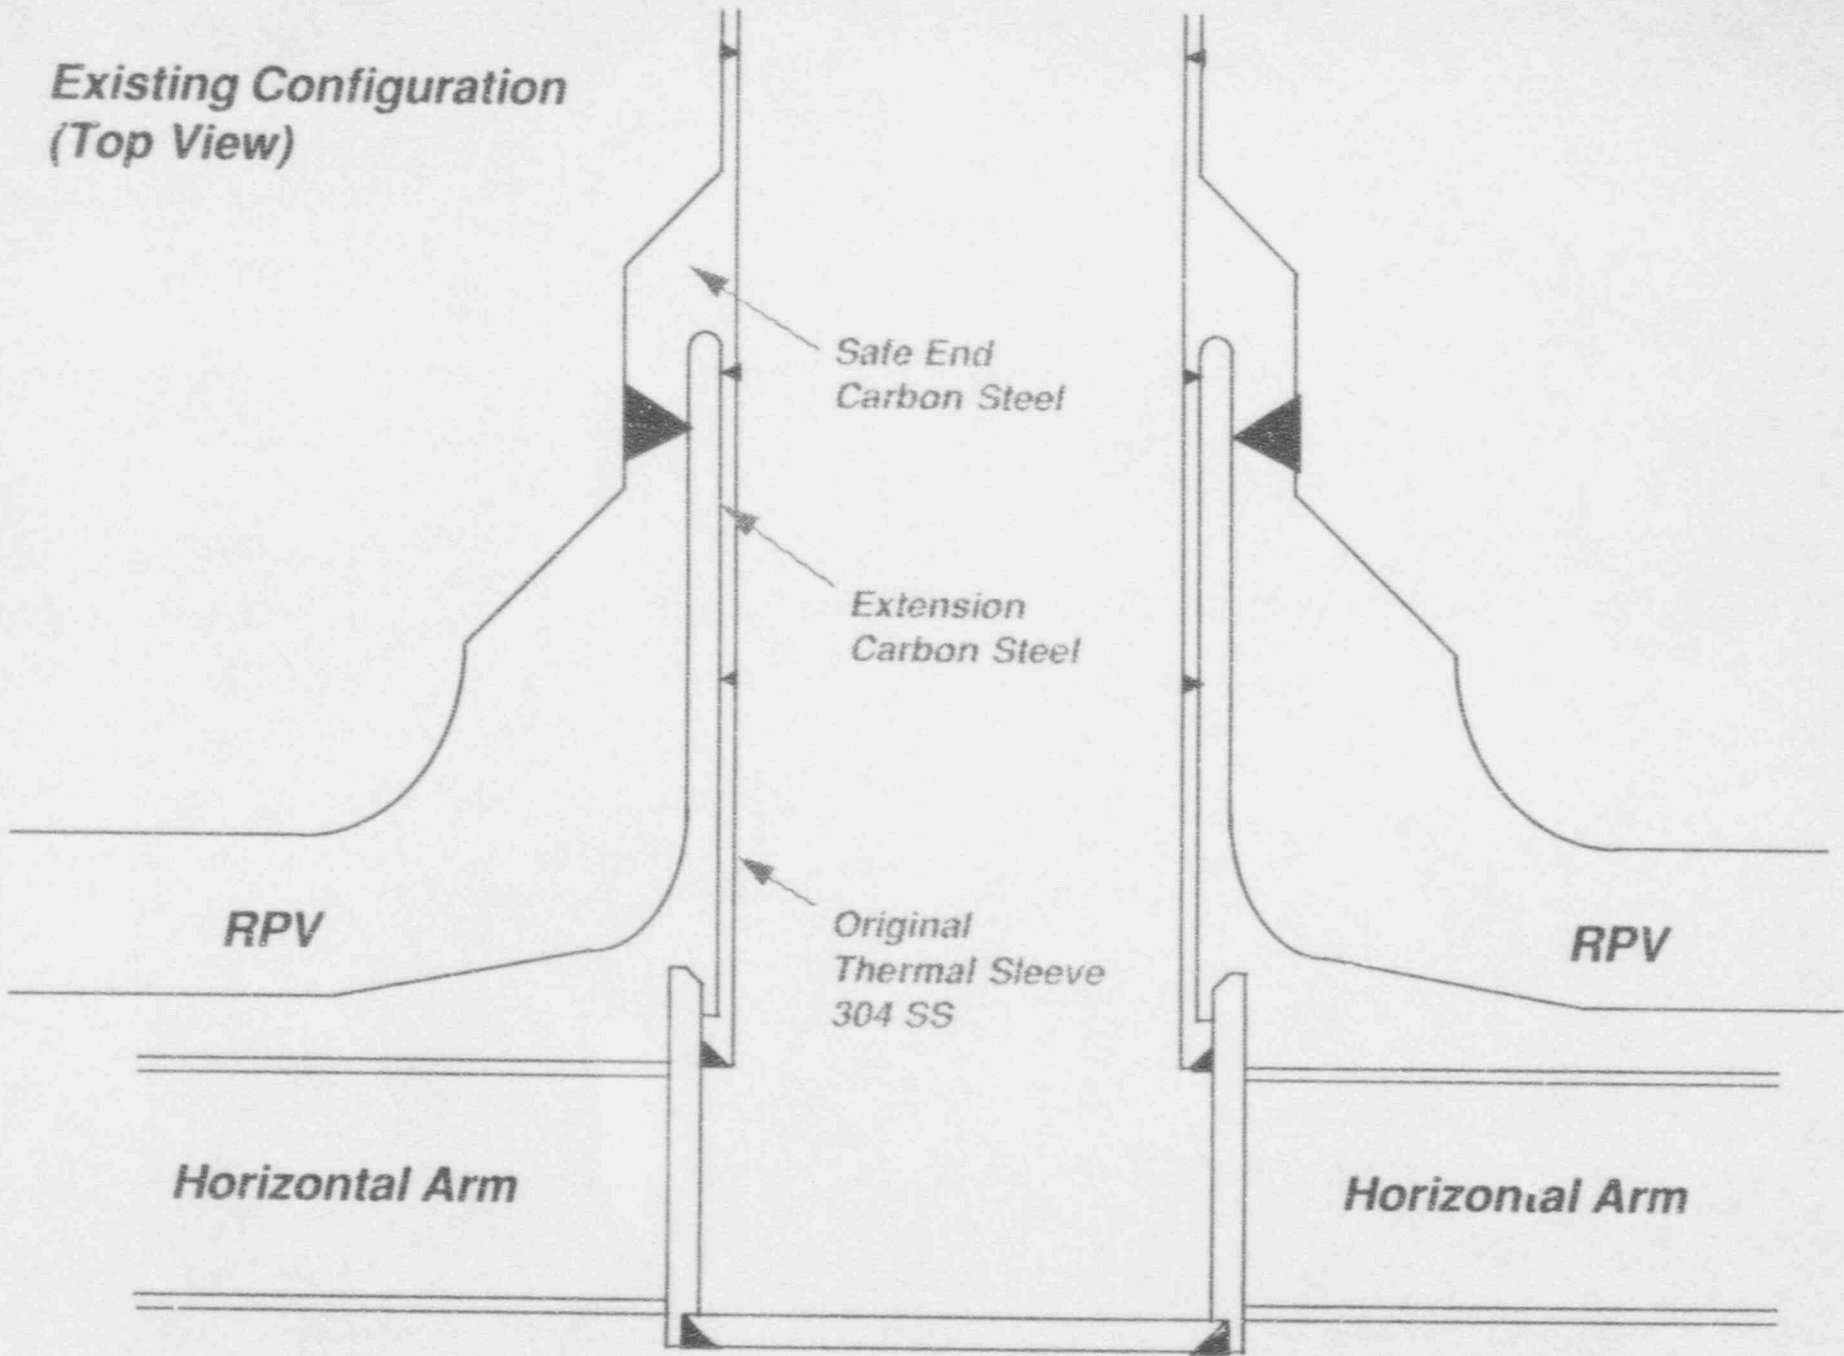
*Existing Configuration
(Top View)*

- **Found during February 1993 refueling outage**
 - Augmented visual inspection of CS piping per IE Bulletin 80-13
- **Approximately 2.25 inches long in left arm of the 'B' Core Spray Header**
- **UT performed to characterize crack**
 - through wall
 - established boundaries
- **5 inch schedule 40S pipe (0.258 wall thickness)**
