UNITED STATES  
NUCLEAR REGULATORY COMMISSION  
WASHINGTON, D. C. 20555

AEOD/E119

SUBJECT: LOSS OF RESIDUAL HEAT REMOVAL (RHR) CAPABILITY AT BRUNSWICK  
UNITS 1 AND 2

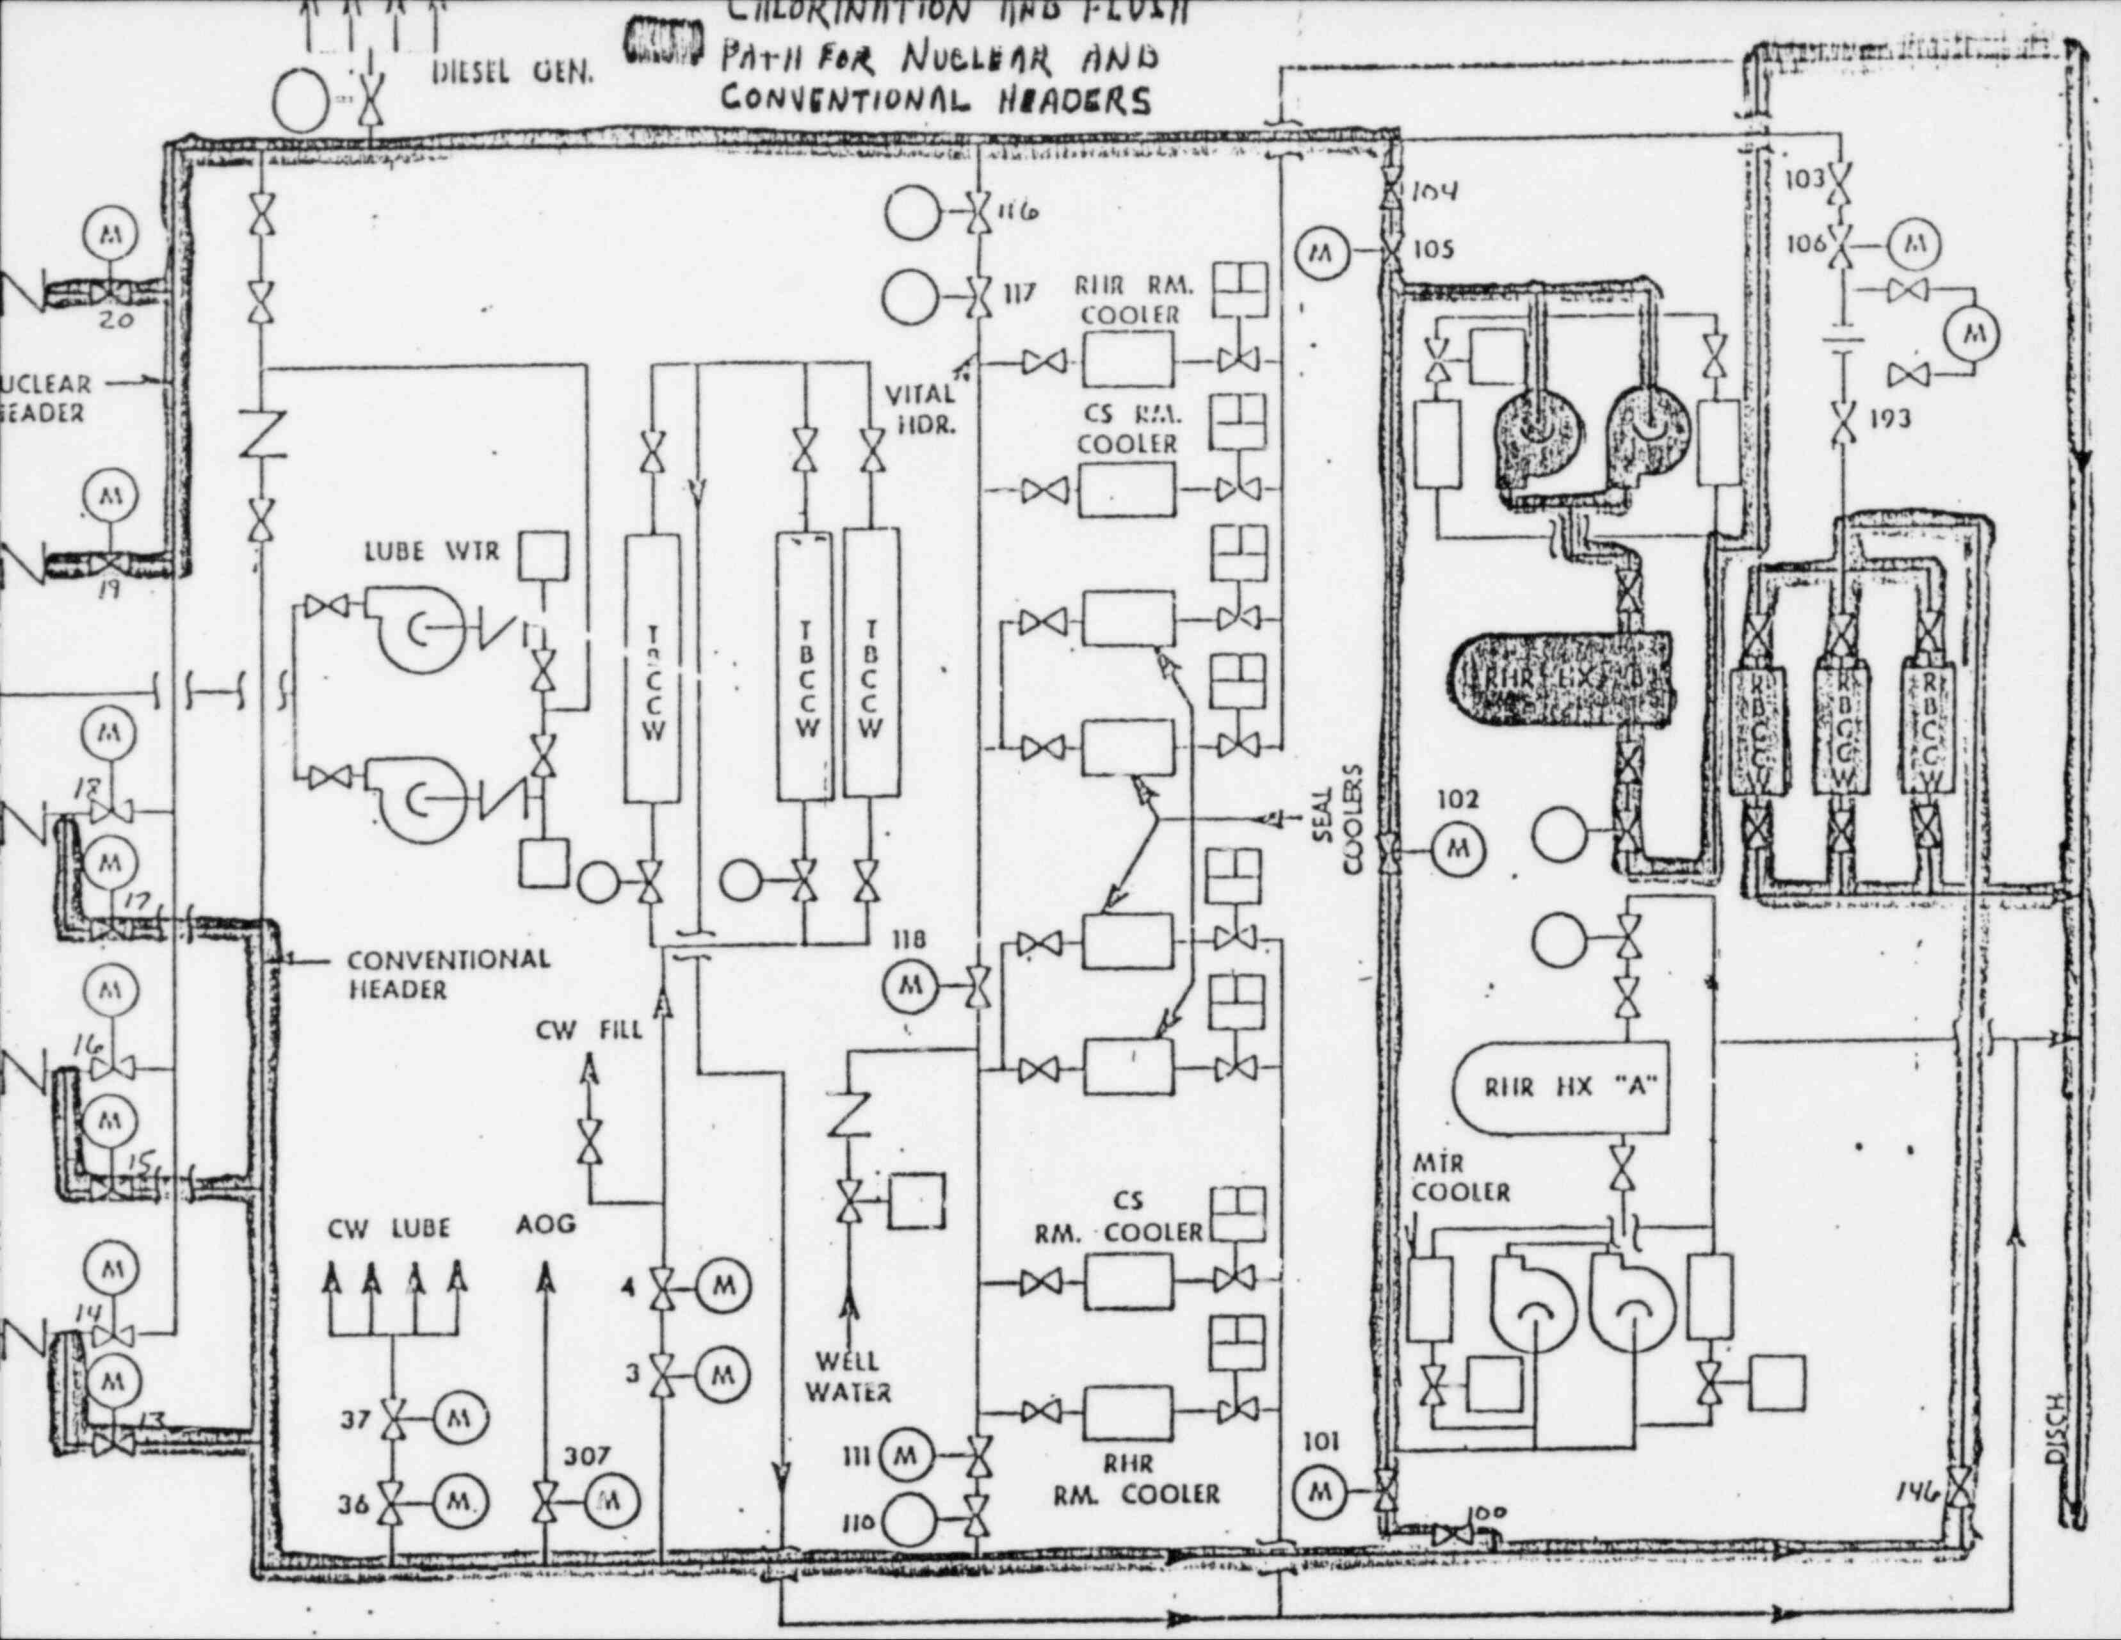
CHLORINATION AND FLUORINATION PATH FOR NUCLEAR AND CONVENTIONAL HEADERS

then flushed for 260 hours using the RBCCW HX water boxes as a collection point for shells. Figure 1 shows the chlorination and flush paths for the conventional and nuclear service water headers. Since shells were still found after 260 hours, the licensee concluded that cleaning the system by flushing was ineffective and resorted to mechanical cleaning.

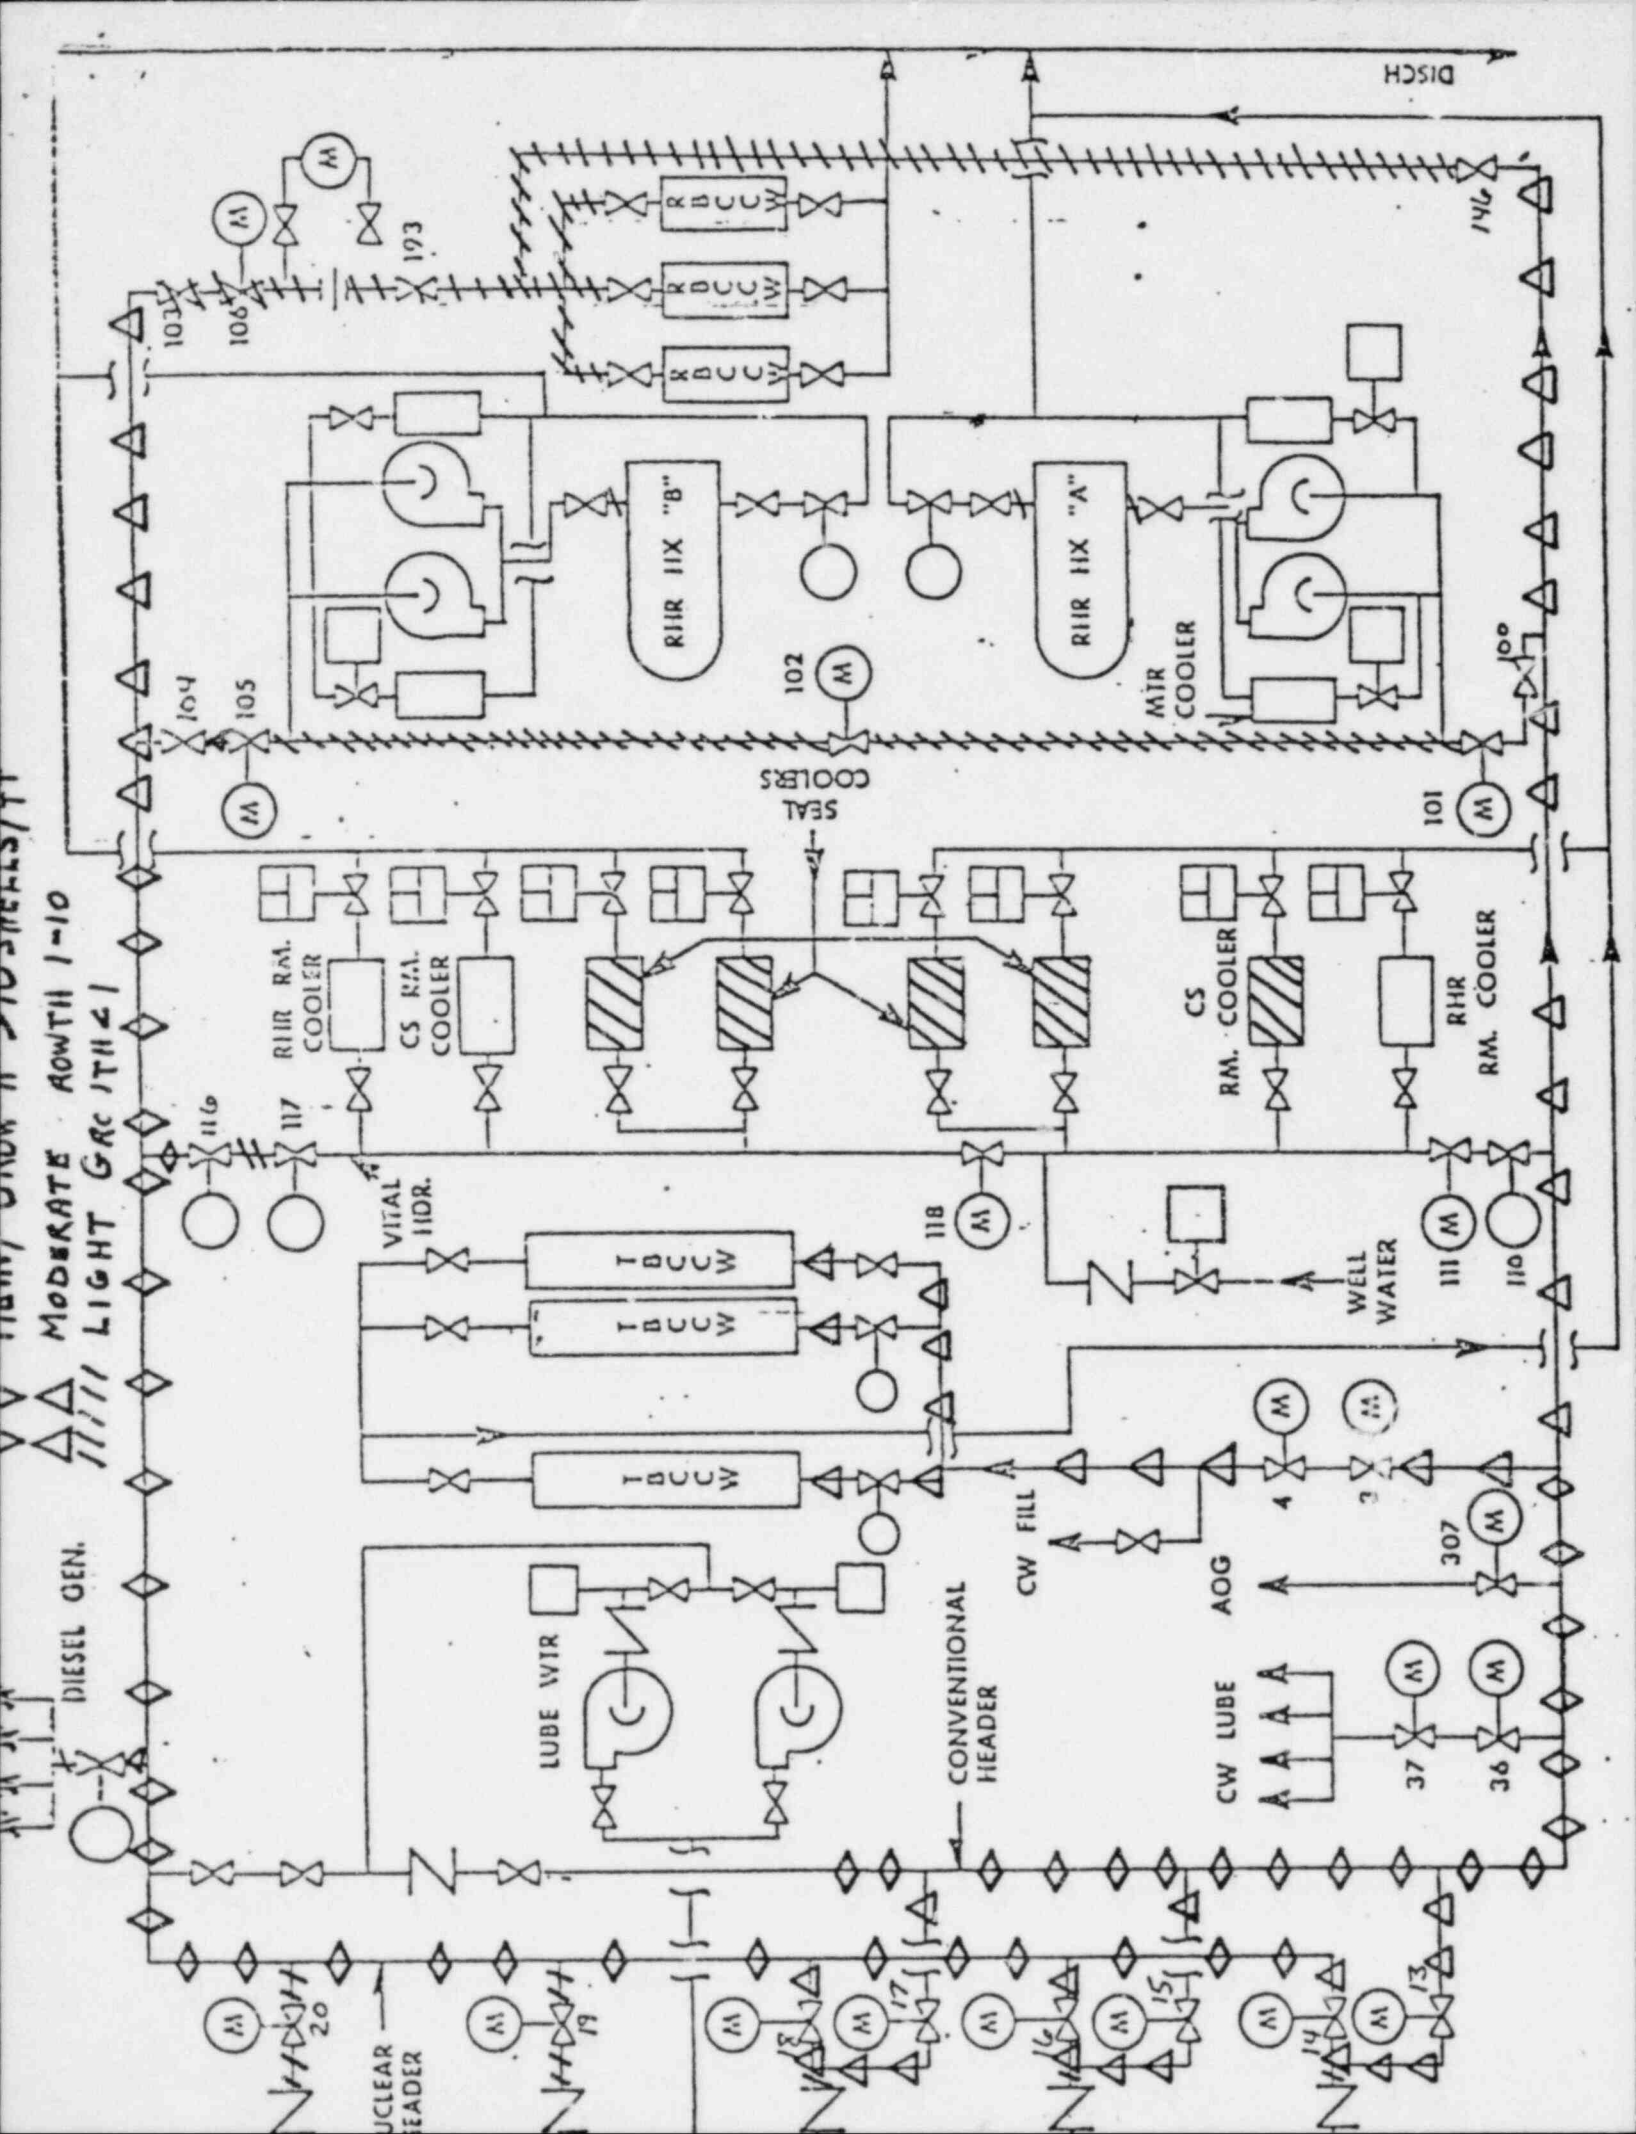
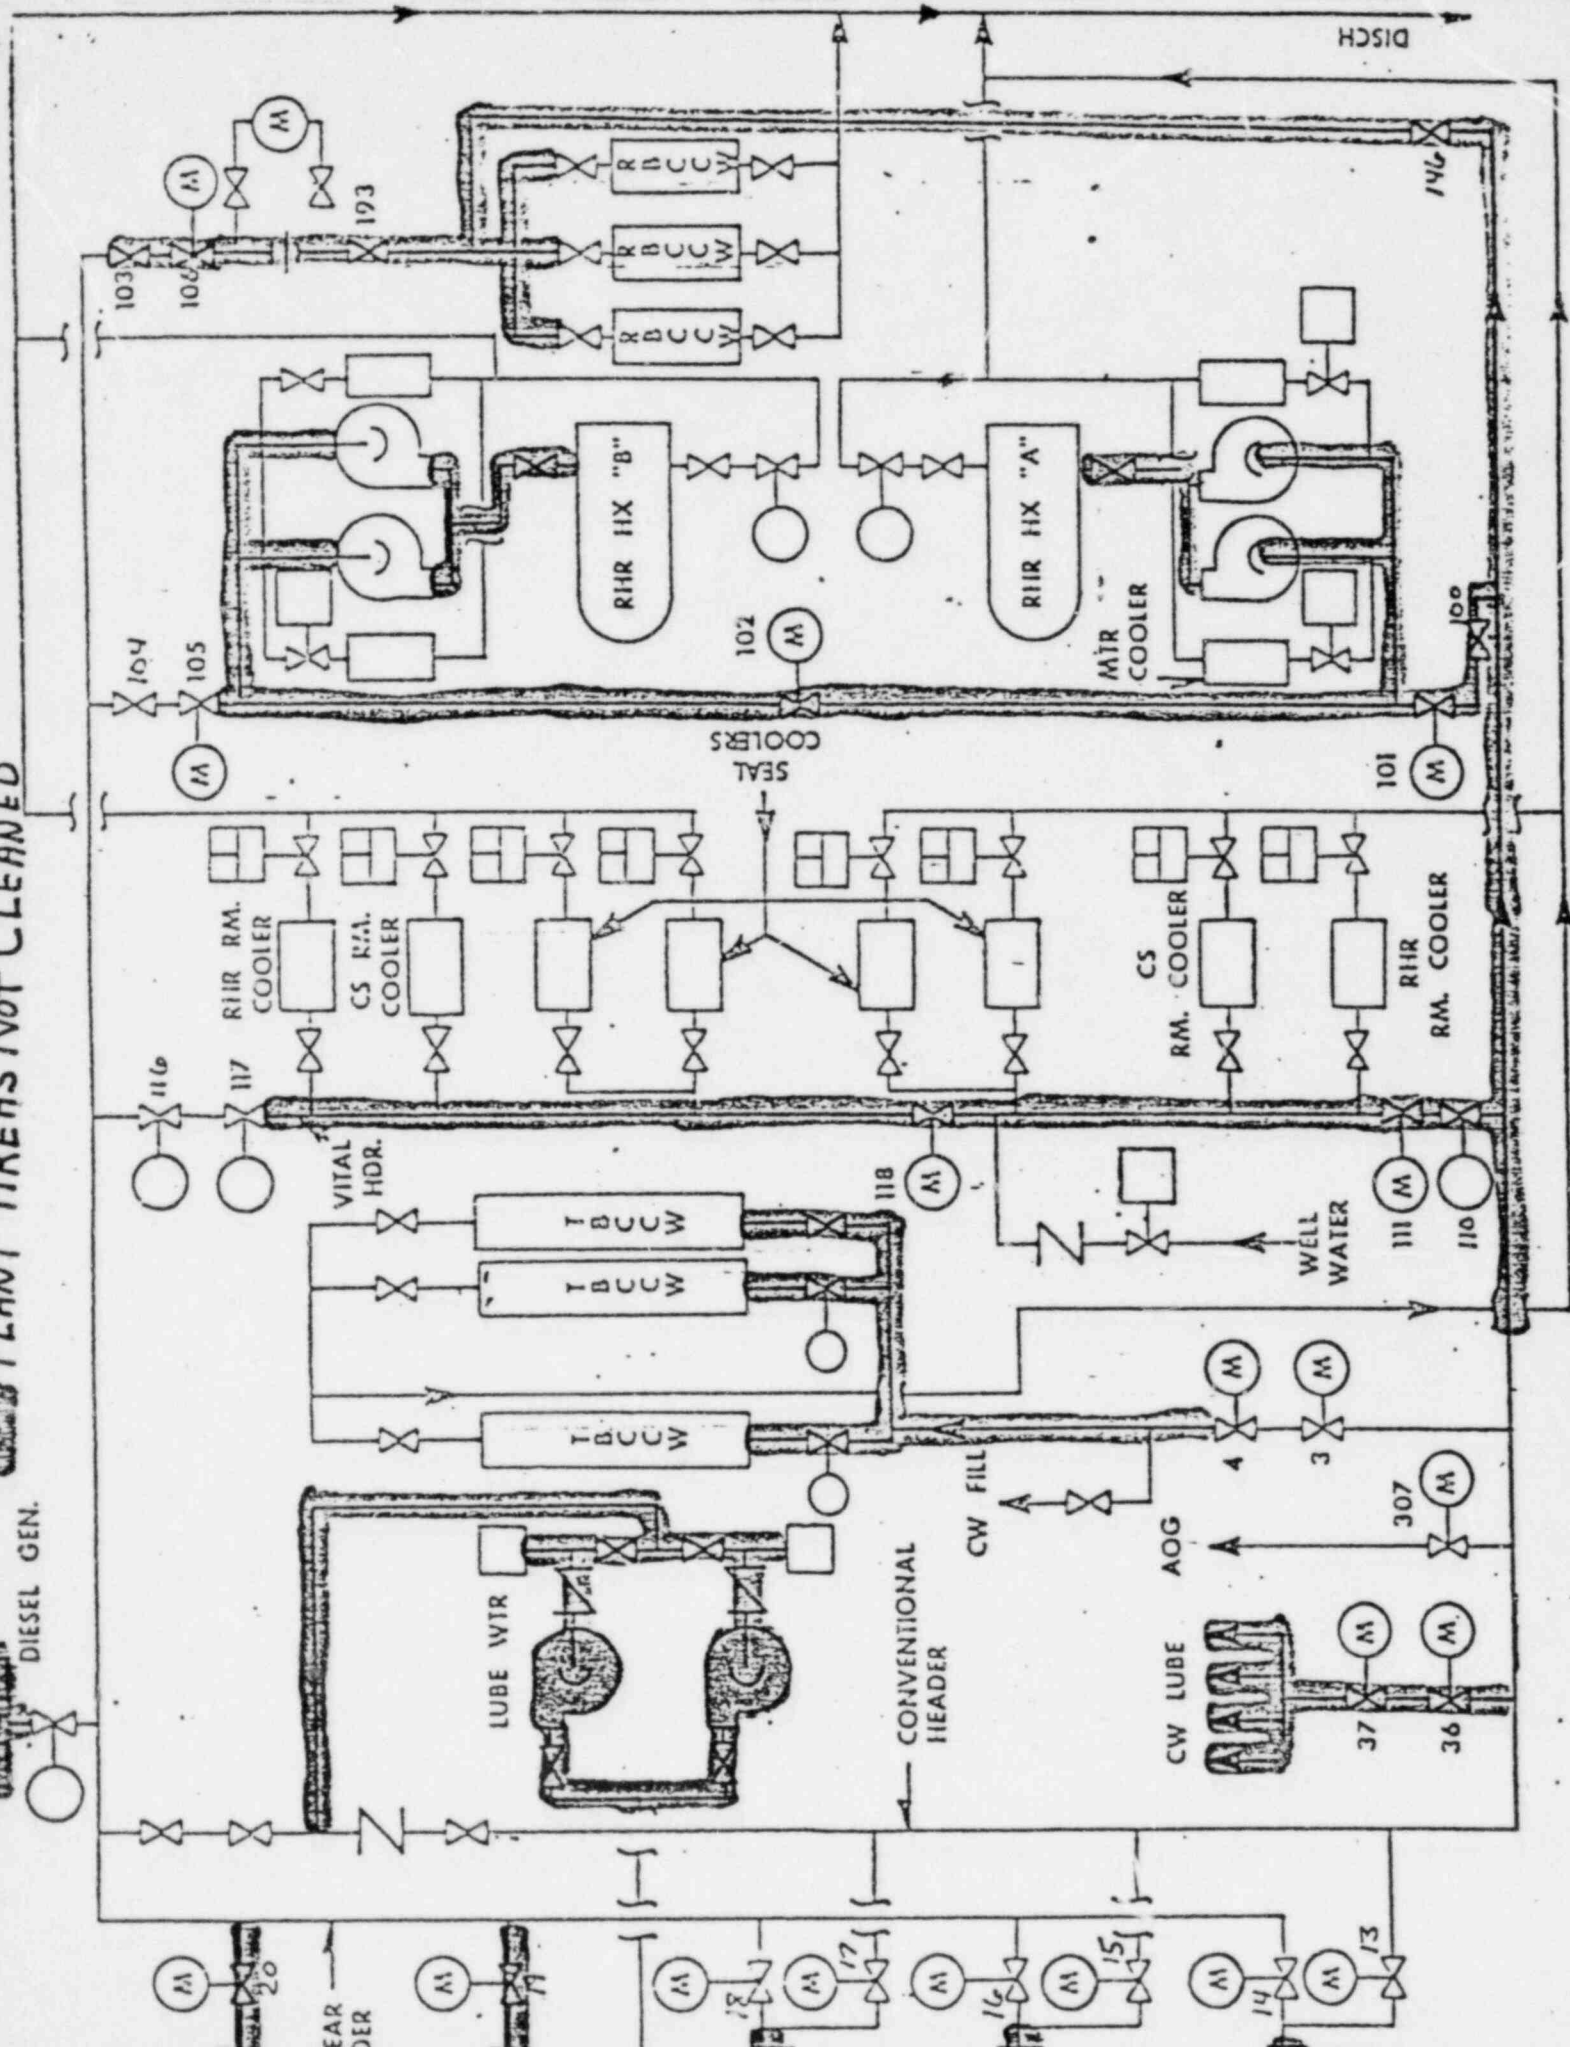
Figure 2

non-calcareous organisms were hydrozoans and polychaete worms. The most common species encountered was the American oyster. These organisms formed a layer approximately one-inch thick on the bottom of the pipe tapering off to 1/2 inch on the top. As was expected, more organisms were found in the larger diameter pipes, where flow rates are lower (about 3.36 fps in the 30 inch header with one service water pump running) than in the smaller diameter pipes with higher flow rates. Settlement of marine fouling larvae is dependent on flow velocity and larvae have difficulty attaching if the flow velocity is above four fps. It was also noted that the accumulation of organisms decreased proportionately with the distance from the intake structure. This may be due to the existence of an unfavorable temperature gradient or a depletion of the food supply. Pipes which are normally isolated were, for the most part, found to be clean. Isolated portions of the system including the RHRHXs are generally layed-up with well water. Detailed information on the location and extent of marine growth is shown in Figure 2.

MODERATE AOWTH 1-10  
LIGHT GRC ITH 41

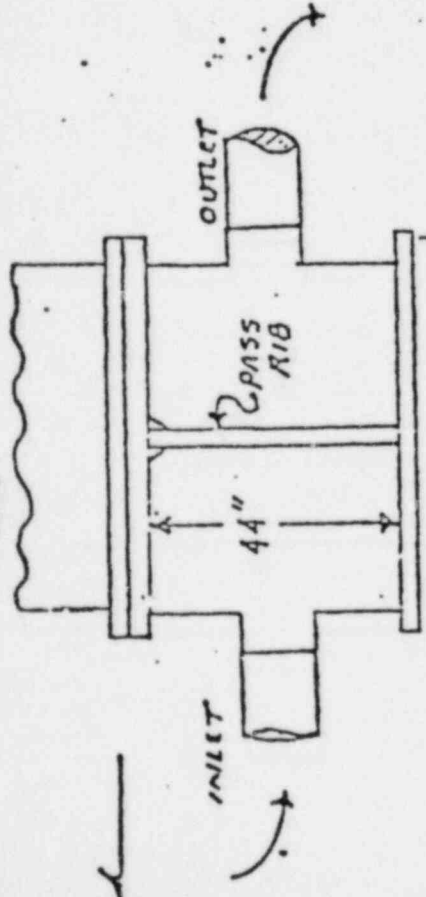
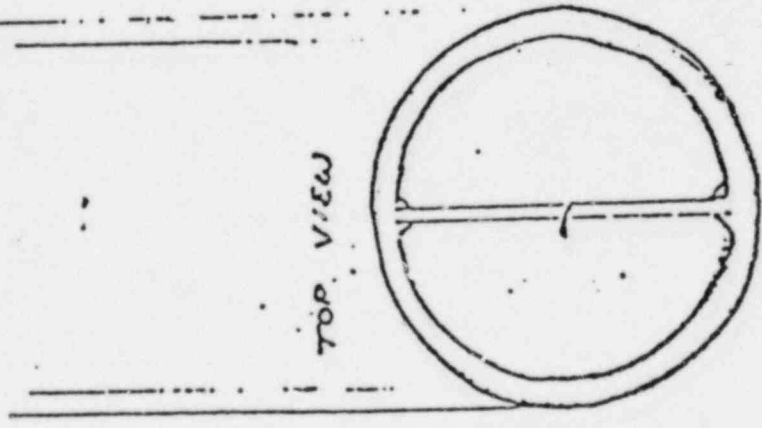
HX NORMAL OPERATION CONFIGURATION (CHANNEL ASSEMBLY)

The RHRHXs at Brunswick are vertical "U" tube HXs and are arranged such that the water box is below the copper nickel (Cu Ni) tubesheet. The water box of the HX is carbon steel explosively clad with Cu-Ni and has a 70-30 Cu Ni baffle plate that separates the inlet and outlet service water flow. The one-inch thick baffle plate, fabricated from Cu Ni, is welded on top to the tubesheet and on the sides to the water box. The bottom of the baffle plate extends approximately  $3/8$  inch into a machined groove in the water box cover which along with the baffle plate to tubesheet weld provides lateral stiffness. The baffle plate is 54  $1/2$  inches wide and 44  $3/4$  inches high and can generate significant horizontal and bending forces even at relatively low DPs due to its large surface area. It was stated by the licensee that ASME Code allowable stress would be reached in the baffle plate at a DP of 10.4 psi. The licensee, however, was of the opinion that the deflections were caused by DPs between 50 and 100 psi since they had experienced DPs of 30 psi with no apparent damage to the baffle plate.

Following the cleaning operations, the buckled RHR heat exchanger baffle plates were replaced and the heat exchangers were returned to their original design specifications (see Figure 8). Due to the Cu Ni used in these components, neither the welds nor the baffle plates themselves are as strong as in HXs in other plants with carbon steel baffles and water boxes. Figure 7 illustrates the deformation found in the heat exchangers and Table 3 summarizes the work which has been performed.

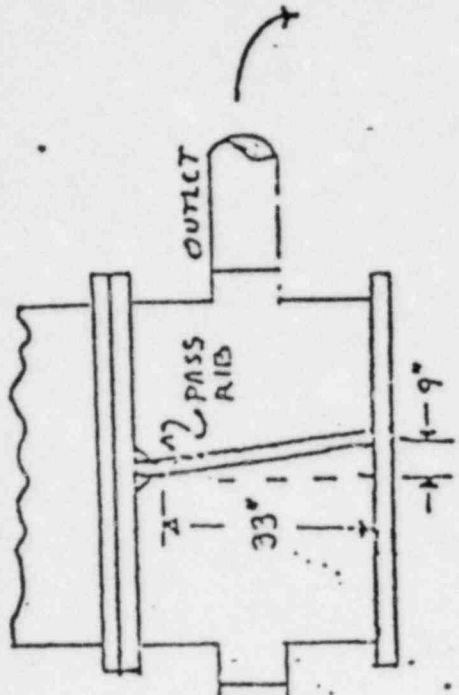
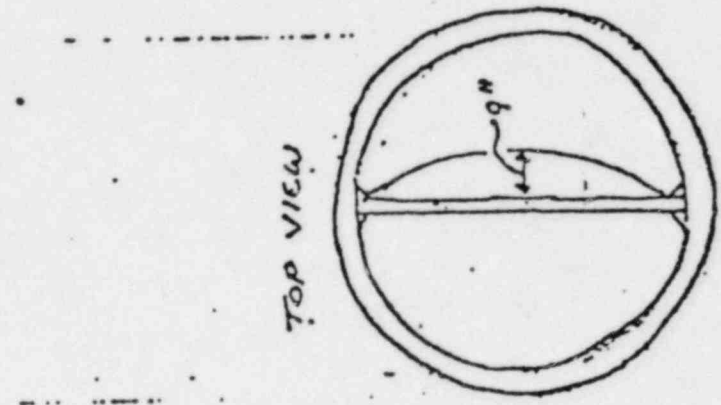
HX EXHIBITING DEFORMATION (CHANNEL ASSEMBLY)

The baffle plate was displaced nine inches.

The baffle plate was displaced nine inches and the side welds pulled loose to within eight to ten inches of the tubesheet.

The baffle plate was displaced approximately three inches at the bottom center. The deflection started three inches from one side of the water box and extended to nine inches from the opposite side. The side welds were intact and a layer of shells and shell fragments from two to five inches deep was found on the inlet side of the water box cover. Approximately 50% of the tubes had some shell blockage.

the piping, into the heat exchangers where they gradually accumulated. Eventually, the shells and shell fragments impinged on the tubesheet and were held blocking the tubes by the differential pressure between the inlet and outlet water box. As the number of tubes blocked increased, the differential pressure became greater until ultimately, the baffle plate became displaced.

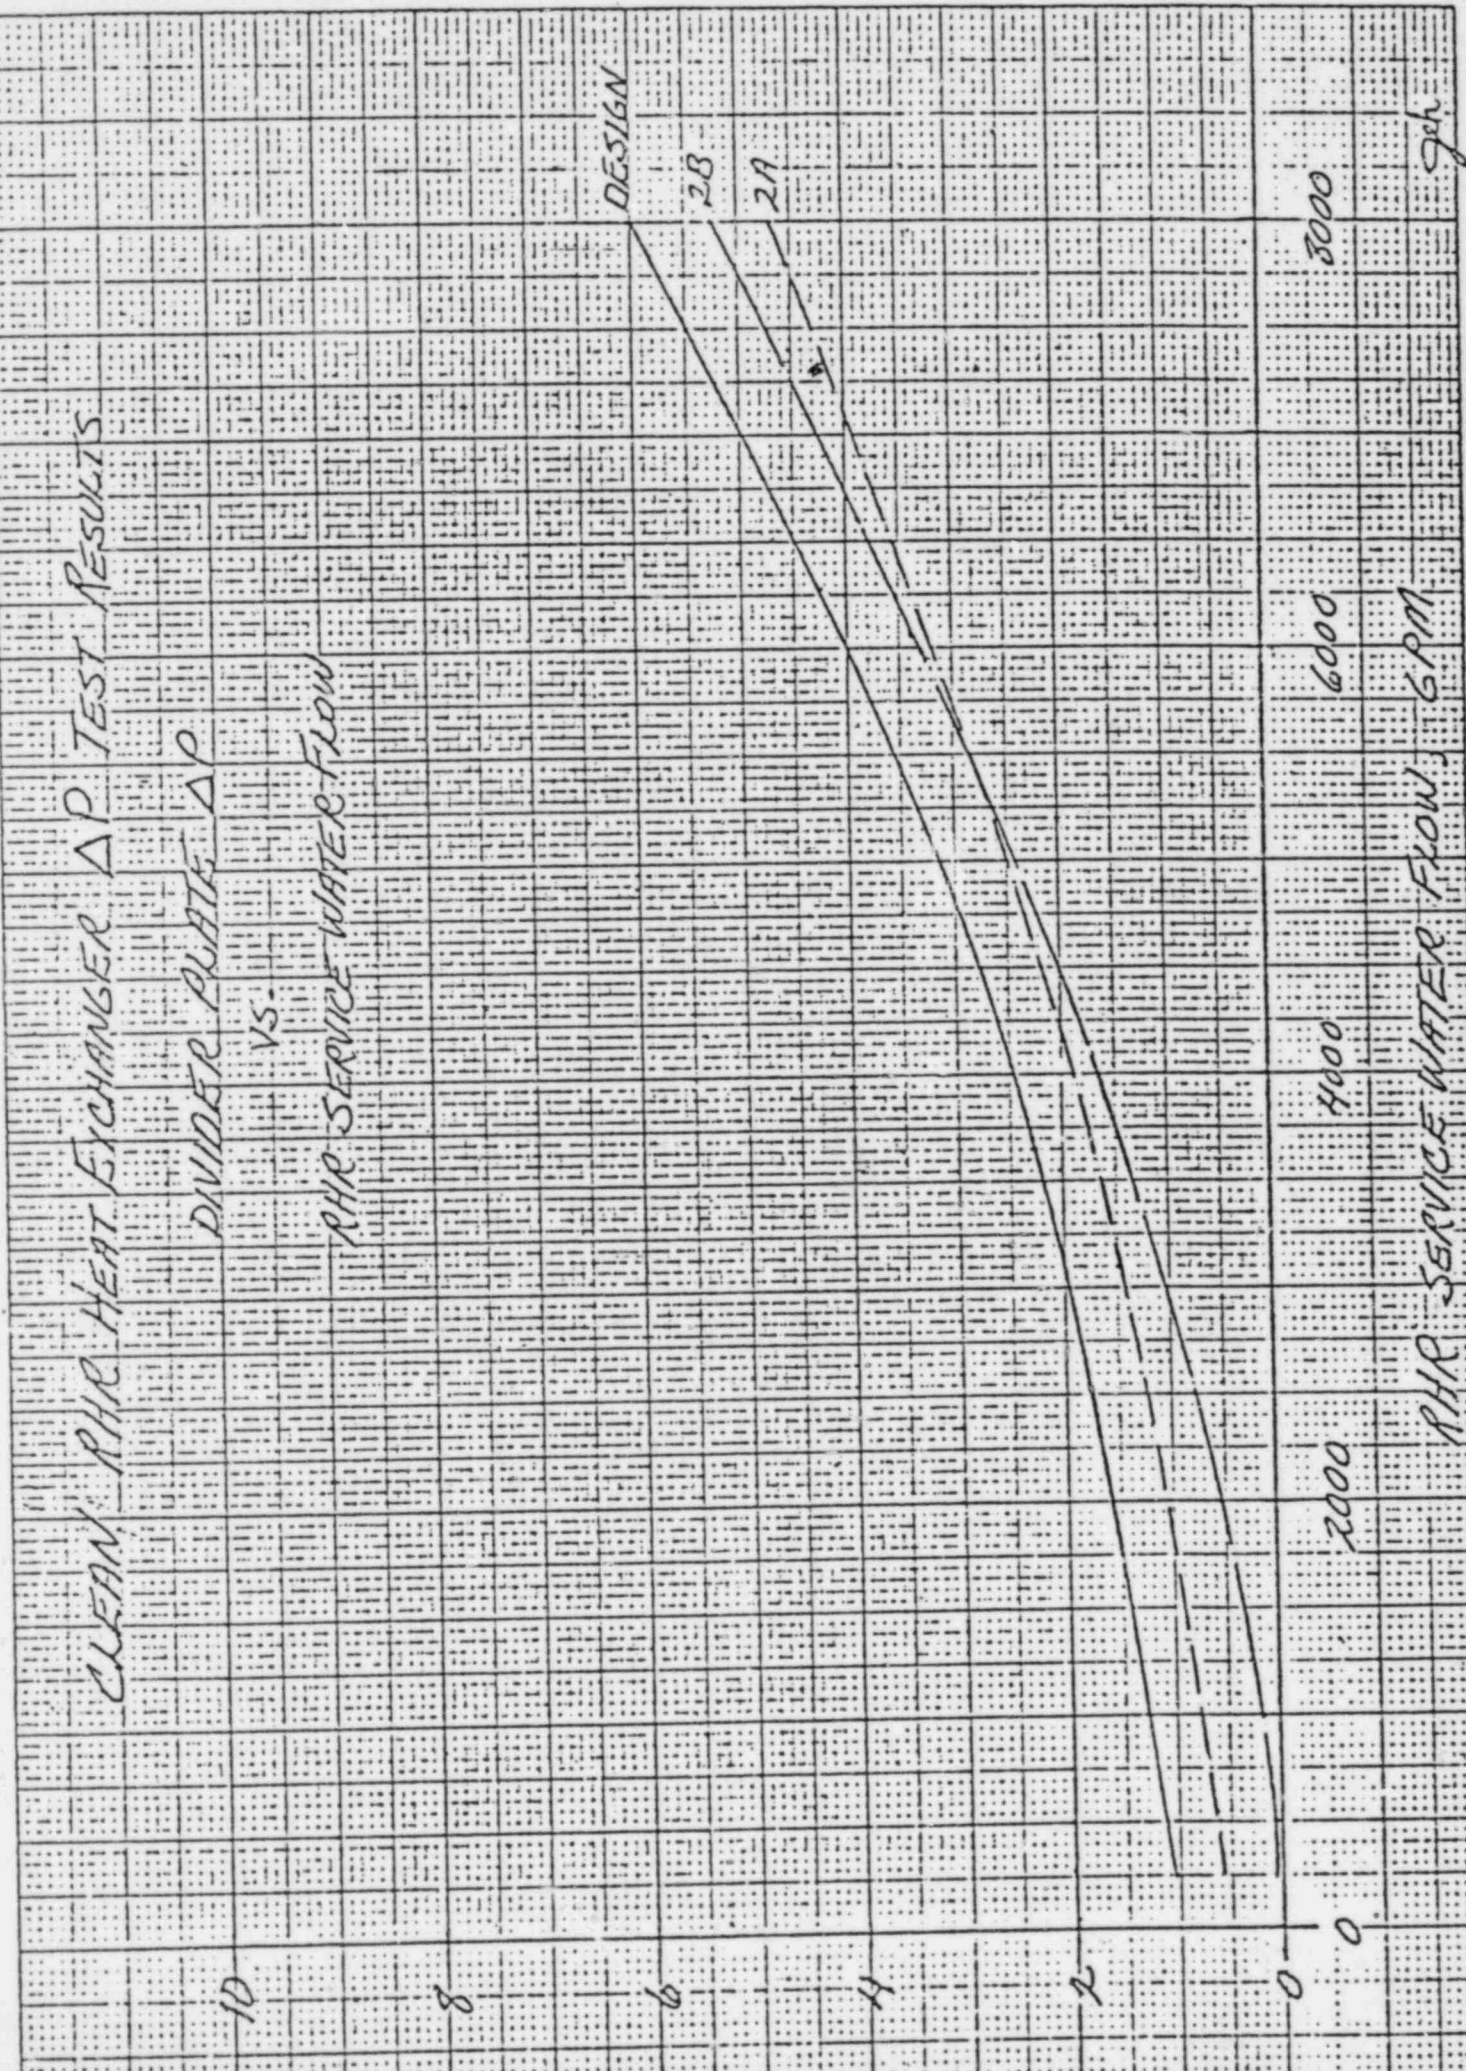
CLEAN RHR HEAT EXCHANGER  $\Delta P$  TEST RESULTS  
DIVIDER PLATE  $\Delta P$   
VS.  
RHR SERVICE WATER FLOW

In addition, a monitoring program has been initiated at Brunswick (see Table 4). The RHR heat exchangers will be tested monthly, at which time the flow rate and DP across the heat exchangers will be measured. The licensee stated that a sharp rise in DP would be expected as shells accumulate in the heat exchanger.
