SUBJECT: ARKANSAS NUCLEAR ONE-UNET NO. 2, DOCKET NO. 50-368

U.S. NUCLEAR REGULATORY COMMISSION  
OFFICE OF INSPECTION AND ENFORCEMENT

Report No. 50-368/81-17

Facility Name: Arkansas Nuclear One - Unit 2

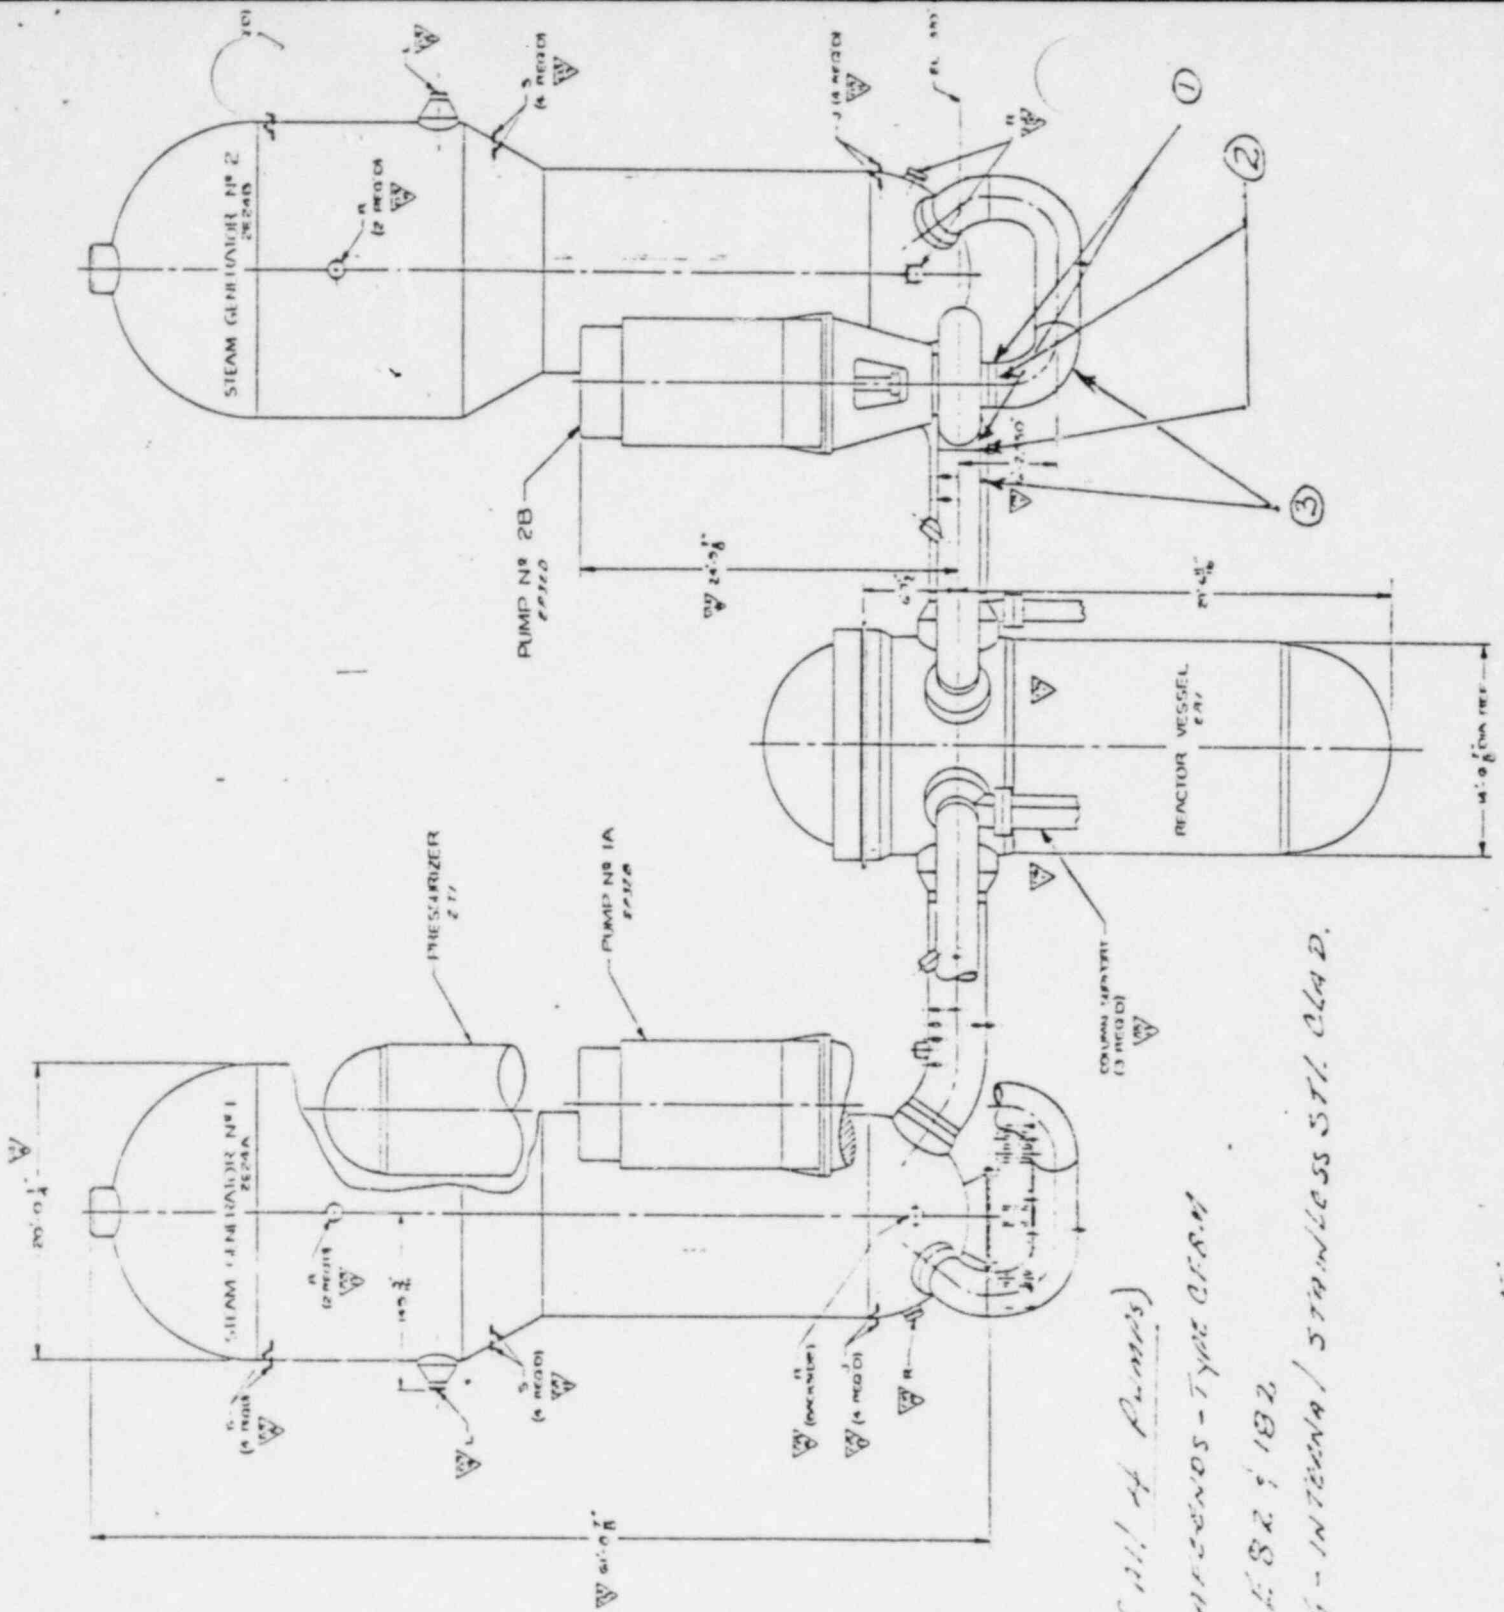
On May 5, 1981 AP&L reported to the NRC that during the current ISI in progress, liquid penetrant testing (LPT) disclosed unacceptable crack indications on the O.D. surface of welds joining the "A" reactor coolant pump safe ends (both suction and discharge sides) to the primary piping. AP&L also reported that grinding procedures were initiated to determine cracking characteristics and effect removal. The weldments involved are shown in Figure 1.

In addition to the above, the safe end welds on the "B" pump were examined by LPT methods. The LPT revealed several areas of linear indications having various lengths and orientation on the inconel weld external surface. Also, the weld-to-safe end fusion boundary exhibited linear disposed indications intermittently around the weld circumference. It was the inspectors consensus during the PT examination that penetrant characteristics did not reflect typical cracking conditions. Moreover, although the indications patterns were not extensive, they were indeed quite similar to the surface

discontinuities previously detected, and subsequently removed, on the "A" pump welds. After further surface cleaning and conditioning by controlled light grinding the indications were visually re-examined with the aid of an optical light microscope. It was determined that the weld surface indications were sharp grinding scratches not entirely removed during surface preparations by the fabricator. Also, the weld fusion zone indications were found to be code acceptable weld undercut conditions ( $<1/32$ " depth) which were partially masked by disturbed surface metal, apparently as a result of grinding to achieve good weld-to-piping transitions during fabrication.

Concurrent with the above investigation, the fabrication radiographs of all four reactor coolant pump safe end welds were reviewed by the inspector. This included the fabricator's acceptance radiographs of the inconel "Buttering" welds on the carbon steel pipe ends as well as the completed inconel to safe end weldment. The radiographs provided good correspondence with the visual evidence that the indications were innocuous, nonrelevant fabrication anomalies, as described above, and were present on the safe end welds of all four reactor coolant pumps. The radiography also demonstrated that the NSSS had exceeded the weld quality acceptance standards of ASME Code Section III in weldment fabrications.

All linear indications on the "A" and "B" RCP safe end welds and snubber lug were effectively removed by the modified grinding techniques. The existing cavities on the "A" pump welds were blended to surrounding surfaces to eliminate stress concentration effects. The depth of grinding for removal of indications was minimal (cosmetic) and did not violate the design minimum wall thickness. The entire welds were PT examined following repairs and found acceptable. A photographic record was made of the "B" pump welds and snubber lug conditions and of the repairs as required.

In addition to the above, a manual volumetric examination (UT) from the outside diameter was performed on the "A" RCP welds in accordance with plant ISI requirements and approved procedures. The UT evaluation resulted in no reportable reflectors as expected.

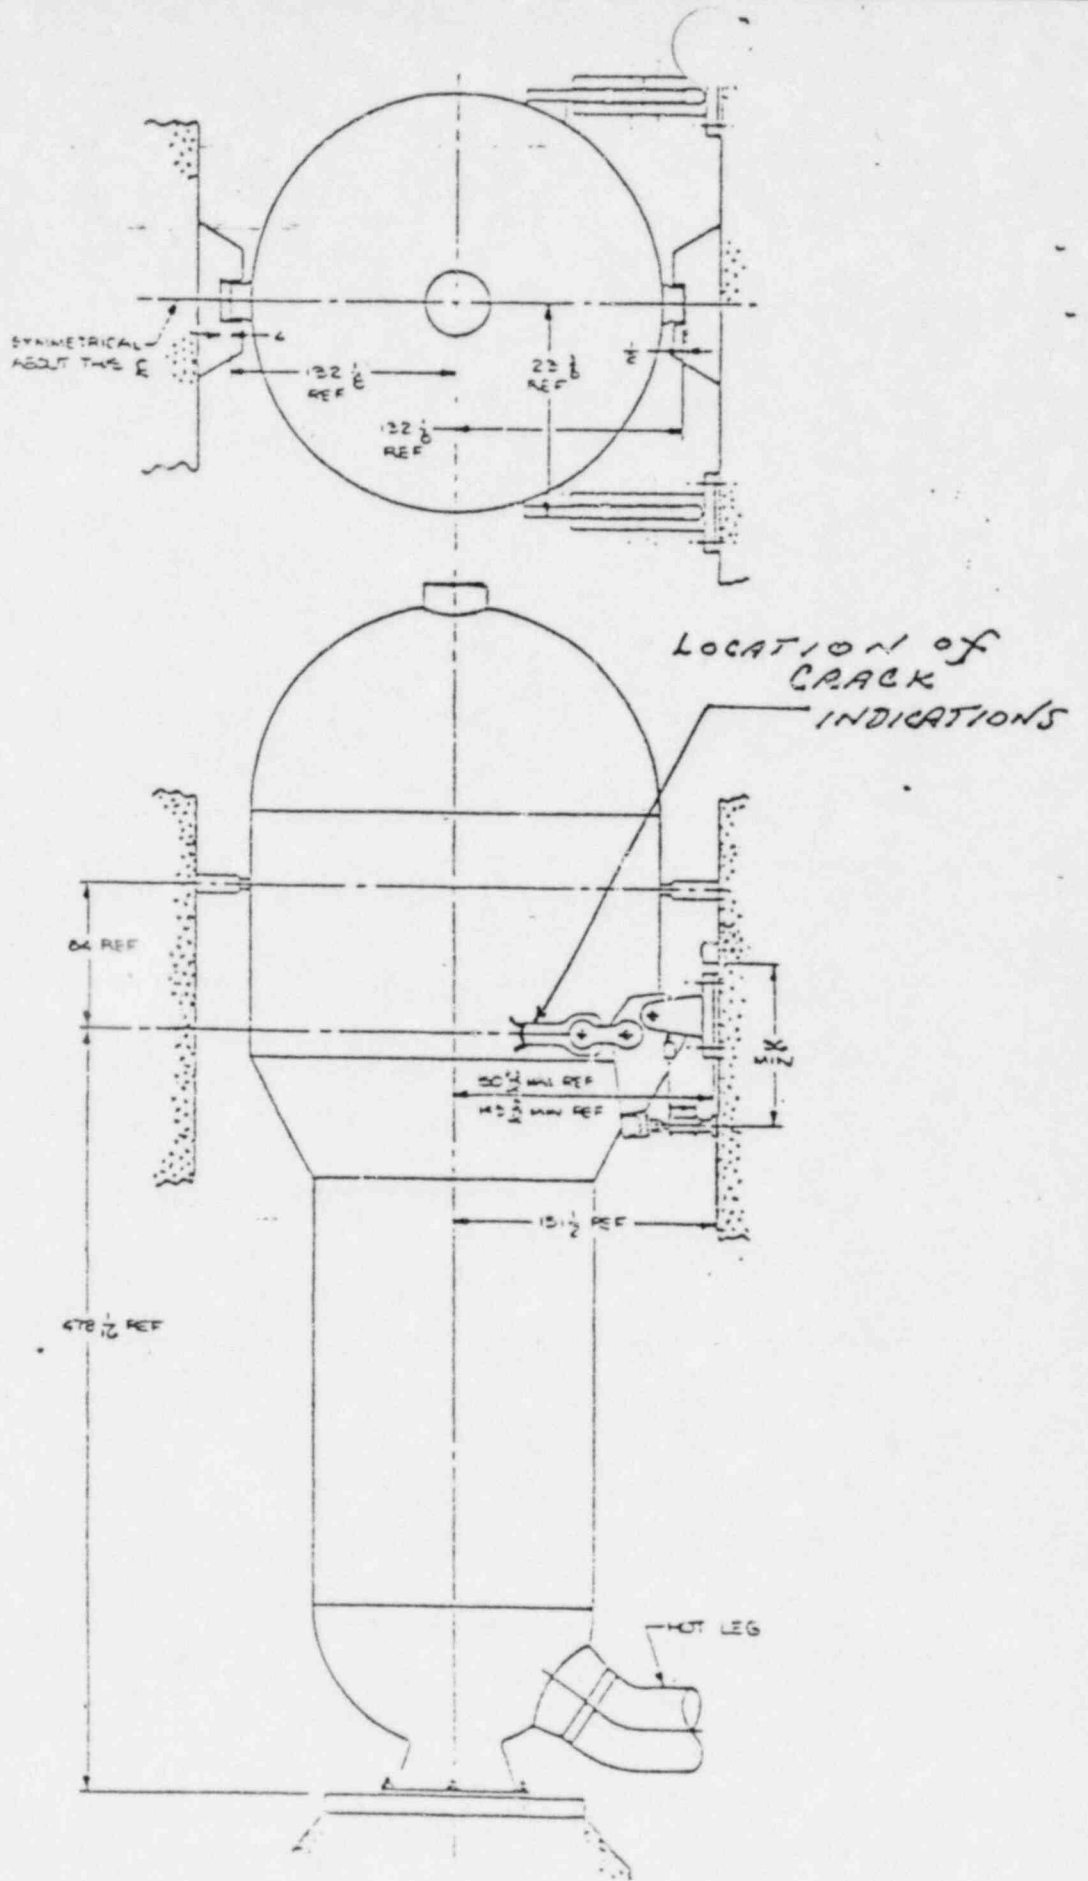
FIGURE 2

Following the above discussion AP&L further informed the staff that a LPT examination had also disclosed crack indications in an upper-side weld of a snubber lug forming an intergrally welded support to steam generator No. 2,

as shown in Figure 2. These indications were intermittently disposed linearly, ranging from 1/6" to 3/16" in length, along the edge of the weld to the vessel. At this time AP&L indicated a relief request would be submitted to change from a portion of the presently applicable ASME Section XI ISI Code (1974 Edition and Summer 1975 Addenda) to the later approved 1977 Edition and Addenda of the Code. Specifically, to permit use of the more definitive ISI acceptance criteria of the latter, as it relates to intergrally welded supports in evaluation of the snubber lug indications. On May 13, 1981 AP&L submitted their formal request for relief on this matter for staff consideration.

6. An investigation of the snubber lug welds also showed the reported "crack indications" were of similar characteristics as the pump welds; engendered by the welding process during installation on the vessel. These were removed by blend grinding and PT cleared.

Upon completion of the above investigation, a close visual examination (optically aided) of the reported snubber lug crack indications was made by the inspector. It was determined these indications were in fact due to (1) Partial weld bead foldover in making the final weld pass at the vessel shell and (2) shallow fusion craters in weld bead start and stop points, that were not entirely removed following welding of the lug to vessel shell.
