AEOD/C104

REPORT ON THE
MILLSTONE UNIT 2 LOSS OF 125 V DC BUS
EVENT ON JANUARY 2, 1981

OFFICE FOR ANALYSIS AND EVALUATION
OF OPERATIONAL DATA

November 1981

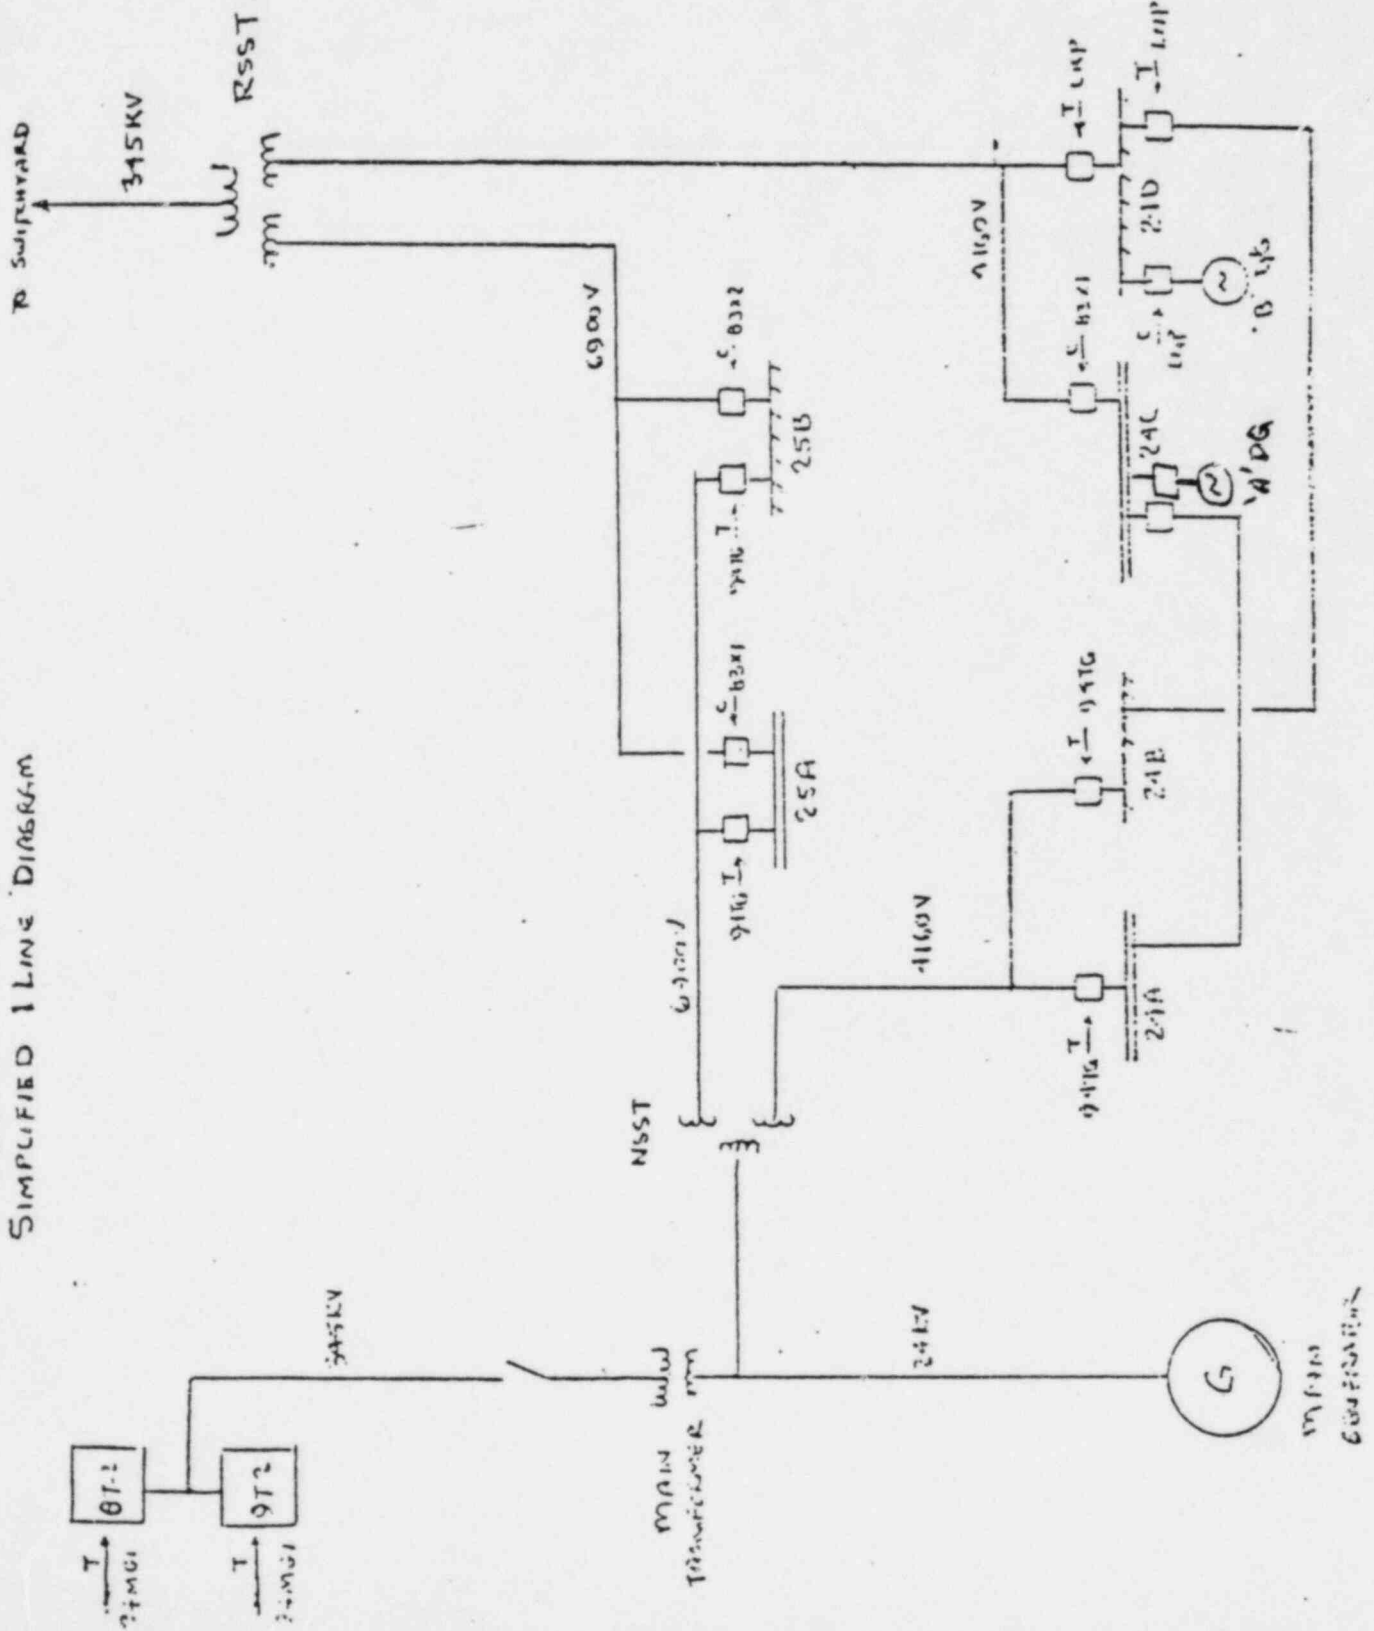
FIGURE - 2

On a turbine trip, the station auxiliary loads would normally fast-transfer from the normal station service transformer (NSST) to the reserve station

service transformer (RSST) (see Figure 2). This is accomplished by means of tripping lockout relay 94TG and energizing automatic transfer relays 83X1 and 83X2. Automatic trip of the main generator breakers is facilitated by relay 94MGI which operates when all four turbine stop valves are closed.

The licensee has initiated a study of the turbine and generator trip schemes and the NSST to RSST fast-transfer schemes to evaluate the need for redundant relays and power supplies so that these functions would occur with one dc bus de-energized; i.e., with one dc bus lost, normal offsite power would be automatically supplied to station auxiliaries associated with the other dc bus.

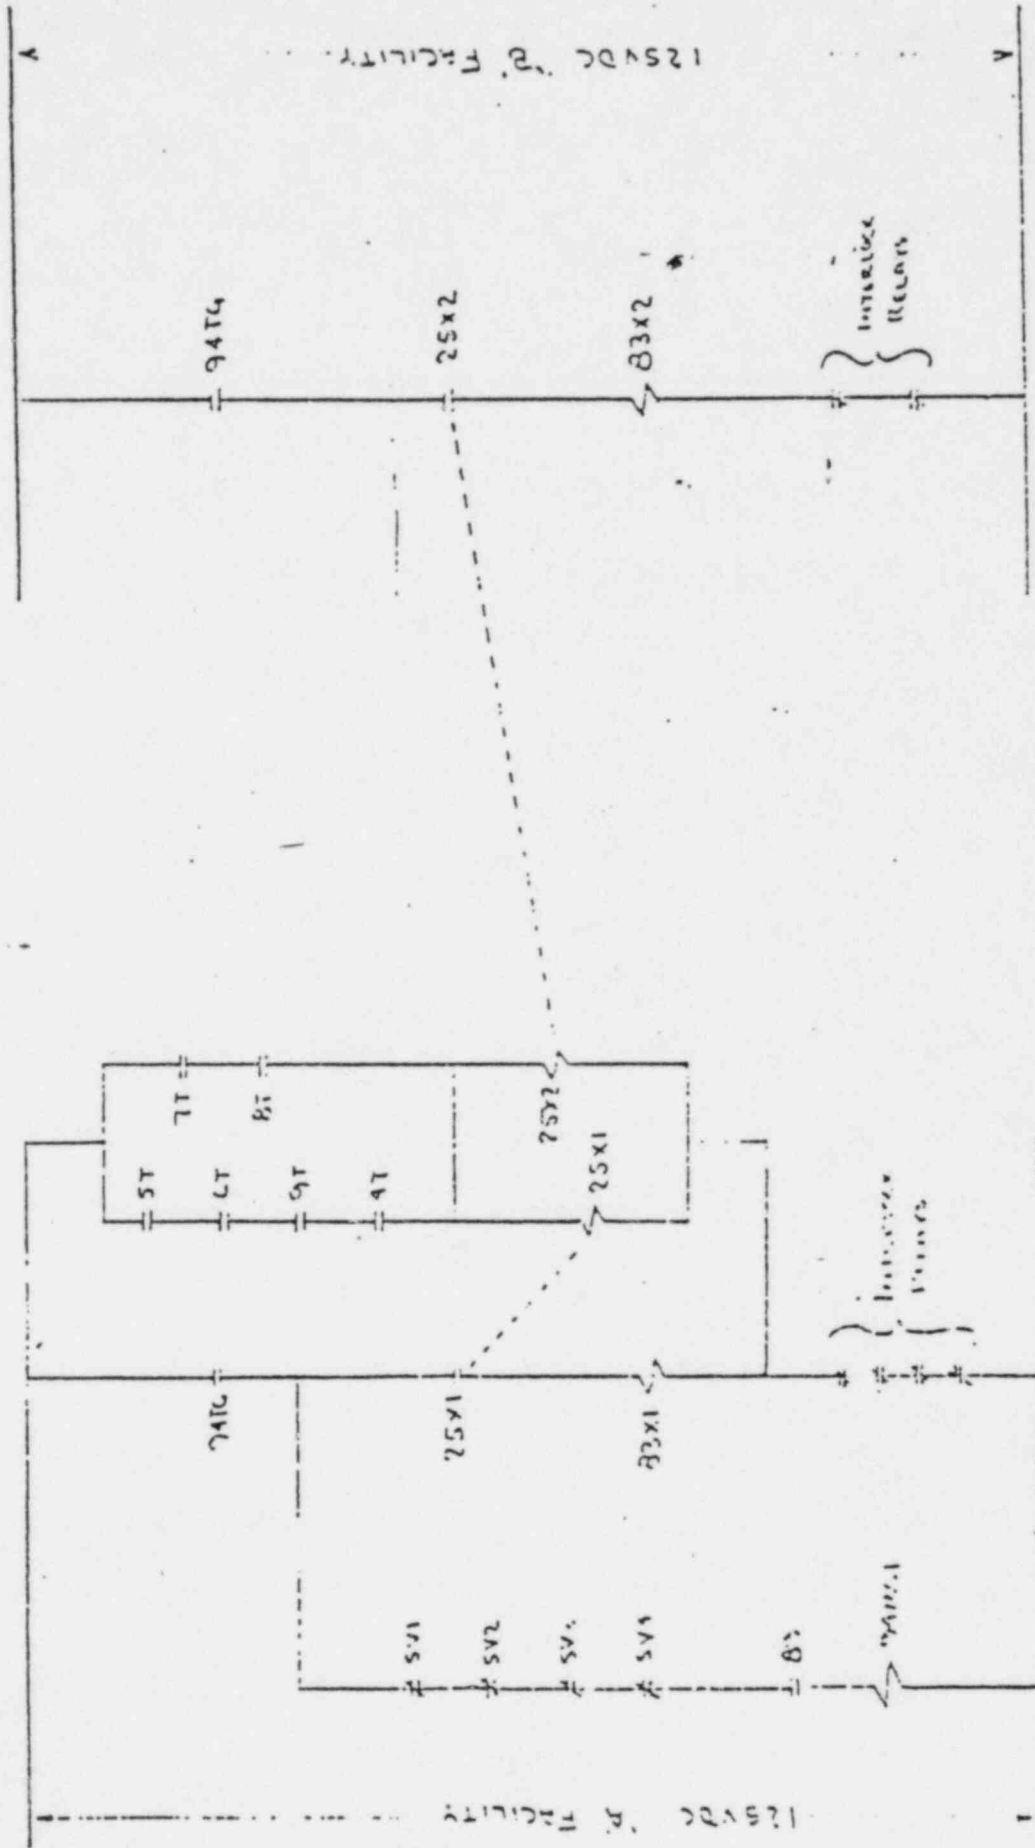
FIGURE - 3

During the event, however, only relay 94TG, which is connected to the "B" facility 125 V dc system, operated on the turbine trip from the 24 V dc logic. Relays 83X1 and 83X2, which are connected to the "A" facility 125V dc, did not operate. Contacts of the 94TG relay normally trip the four NSST breakers (two 6900 V bus breakers and two 4160 V bus breakers).

Since relays 83X1 and 83X2 did not operate (see Figure 3), the RSST supply breakers for buses 24D and 25B did not receive a close signal. With 4160 V bus 24D remaining de-energized, the emergency safeguards actuation system (ESAS) detected a loss of normal power (LNP), which caused load shedding

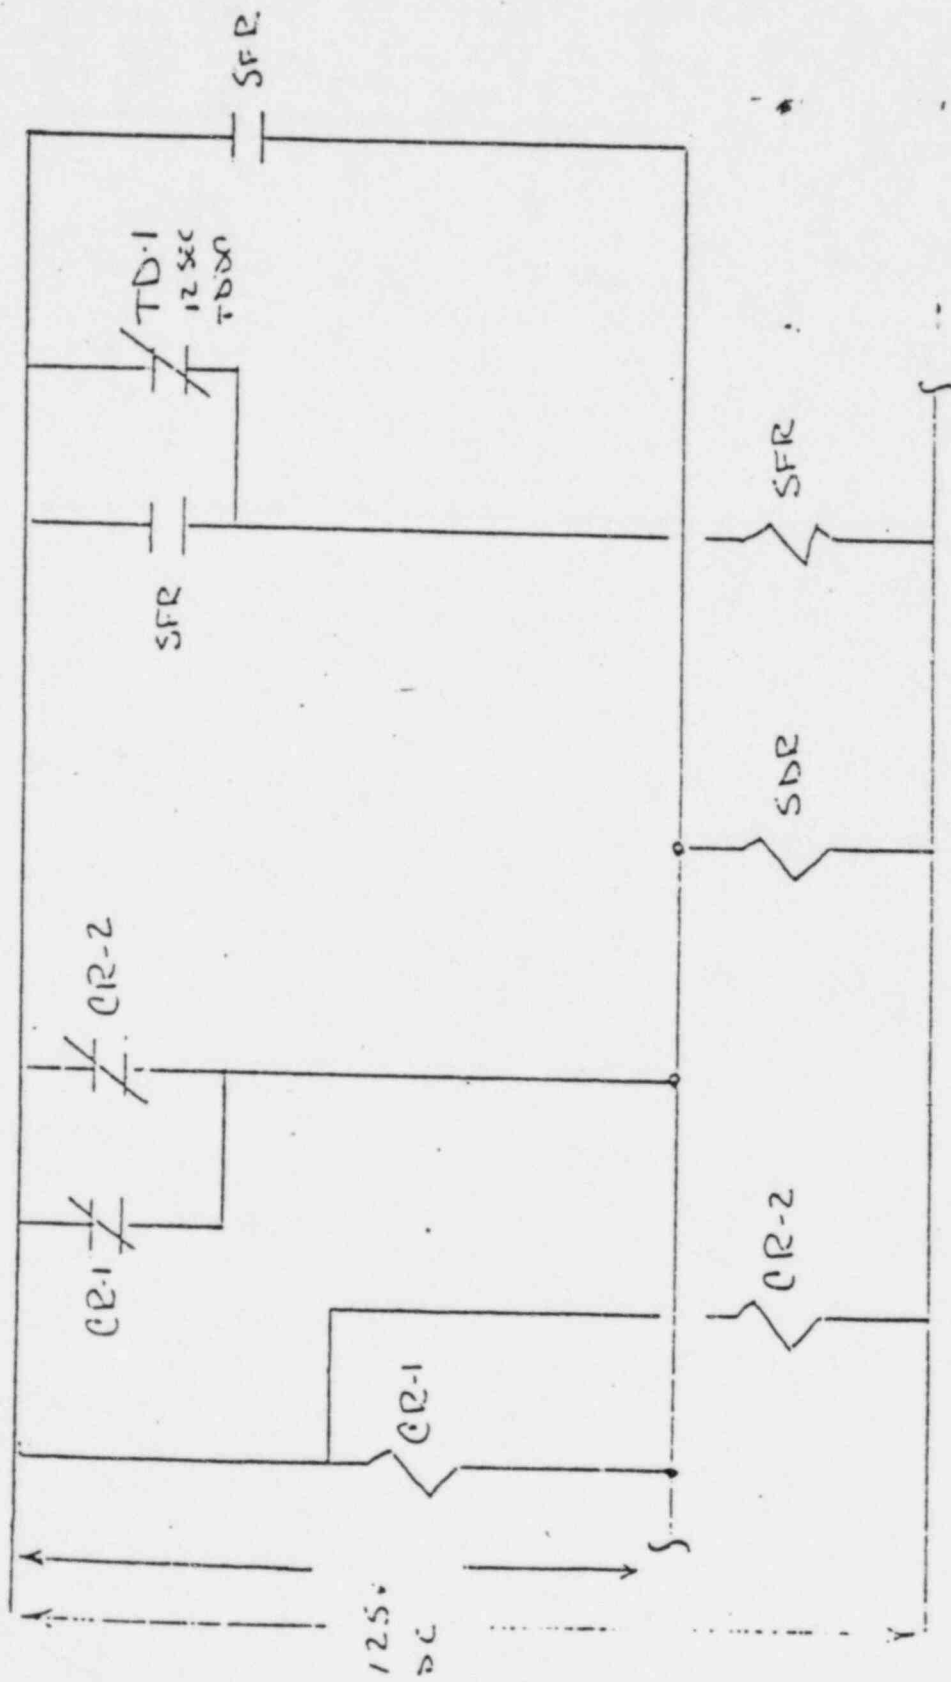
FIGURE - 4

"A" emergency diesel generator (EDG) failure-to-start relay (SFR) energized upon re-energization of the dc bus. This in turn energized the diesel shutdown relay (SDR) which stopped the engine (See Figure 4). On loss of dc control power and subsequent re-energization of the dc bus the SDR could be energized by operation of either the loss of dc power relays (CR-1 & CR-2) or the failure-to-start relay (SFR). Once tripped, local

- (a) Diesel Generator - The "A" diesel generator, that had "black started," was automatically tripped due to the actuation of the failure-to-start relay. To restart the diesel after this would require local reset action. The licensee considers the loss of a dc bus a single failure that would cause the loss of one train of redundant equipment; hence, re-energization of the dc bus and consequent events have no further safety consequence. When implemented, the licensee's revised procedures (to trip the DG and close the air valves) will assure that the DG is available again should dc power be restored. It is noted that even with dc power restored, the revised procedure does not assure the availability of the DG without additional operator action. We believe that the licensee's procedure should include a requirement to reset the diesel engine control when the dc bus is re-energized.
