TECHNICAL EVALUATION OF THE RESPONSE TO  
ATTACHMENT 1 OF ITEM 11.F.1 OF NUREG-0737  
"ADDITIONAL ACCIDENT MONITORING INSTRUMENTATION"  
FOR THE  
H. B. ROBINSON STEAM ELECTRIC PLANT, UNIT 2  
(DOCKET NO. 50-261)

SAFETY CONCERN ASSOCIATED WITH REACTOR VESSEL LEVEL  
INSTRUMENTATION IN BOILING WATER REACTORS

by the  
OFFICE FOR ANALYSIS AND EVALUATION  
OF OPERATIONAL DATA

January 1982

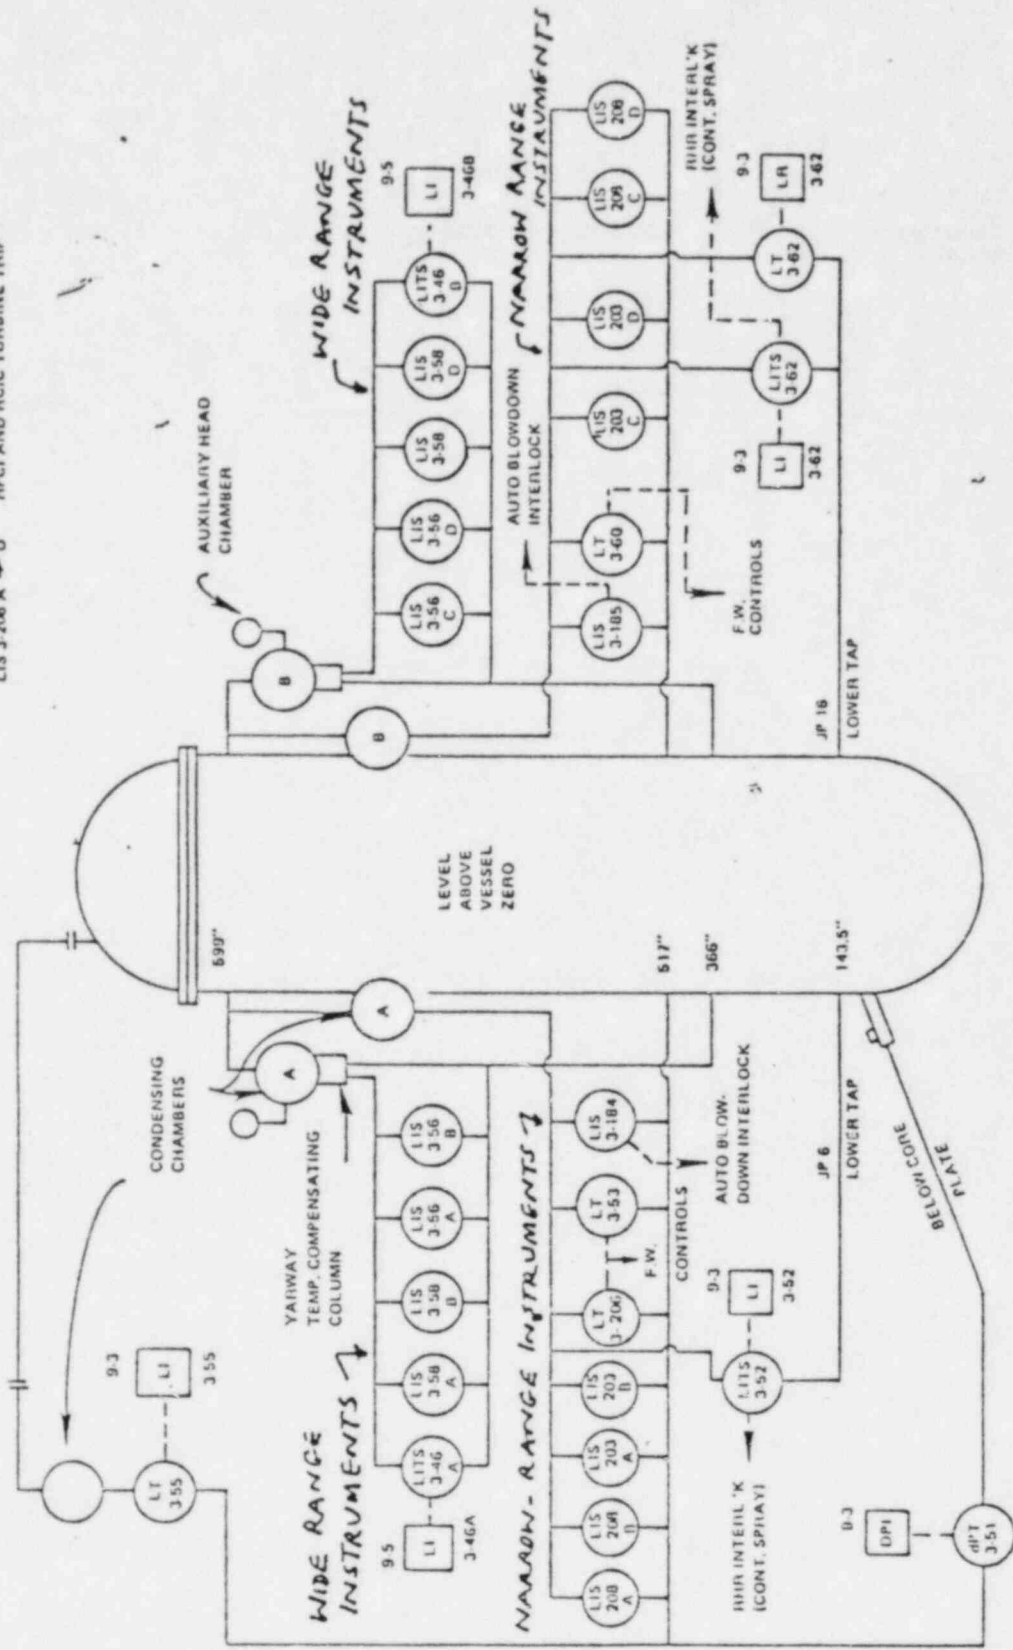
FIGURE 1 - Reactor Vessel Level Instrumentation

The level instruments that monitor normal or narrow range of the vessel water level are connected across two pairs of instrument lines (See Figure 1). One pair of instrument lines has the following level instruments:

The physical arrangement of these level instruments on two separate sets of instrument lines is such that the A and B sensors are connected to one set of instrument lines and the C and D sensors to another set. These sensors provide input to protection channels in the plant protection and emergency core cooling systems. The protection system and emergency core cooling system logic arrangements for these BWR instrument channels are the usual one-out-of-two-twice

Referring to Figure 1, if such a failure was to occur in the reference leg of the normal range level sensors A and B, then LIS 3-208A&B, LIS 3-203 A&B, LIS 3-184, LT 3-53 and LT 3-206 would all sense an increasing level. If LT 3-53 was selected by the control room operator for the level input to the feedwater control system (with the feedwater control mode switch in either the one or three element control), then the feedwater system would reduce feedwater flow into the reactor vessel. This would tend to decrease the actual reactor vessel water level. If prompt operator action is not taken to manually control the feedwater system, then eventually the vessel level would reach the low level scram setpoint. However, scram level sensors LIS 3-203A&B would sense a high level and would not actuate. Therefore, LIS 3-203C&D on the redundant instrument lines would be required to provide the necessary protective action.
