ARKANSAS POWER & LIGHT COMPANY

February 7, 1983

SUBJECT: Arkansas Nuclear One - Unit 1
Docket No. 50-313
License No. DPR-51
Steam Generator Inservice Inspections

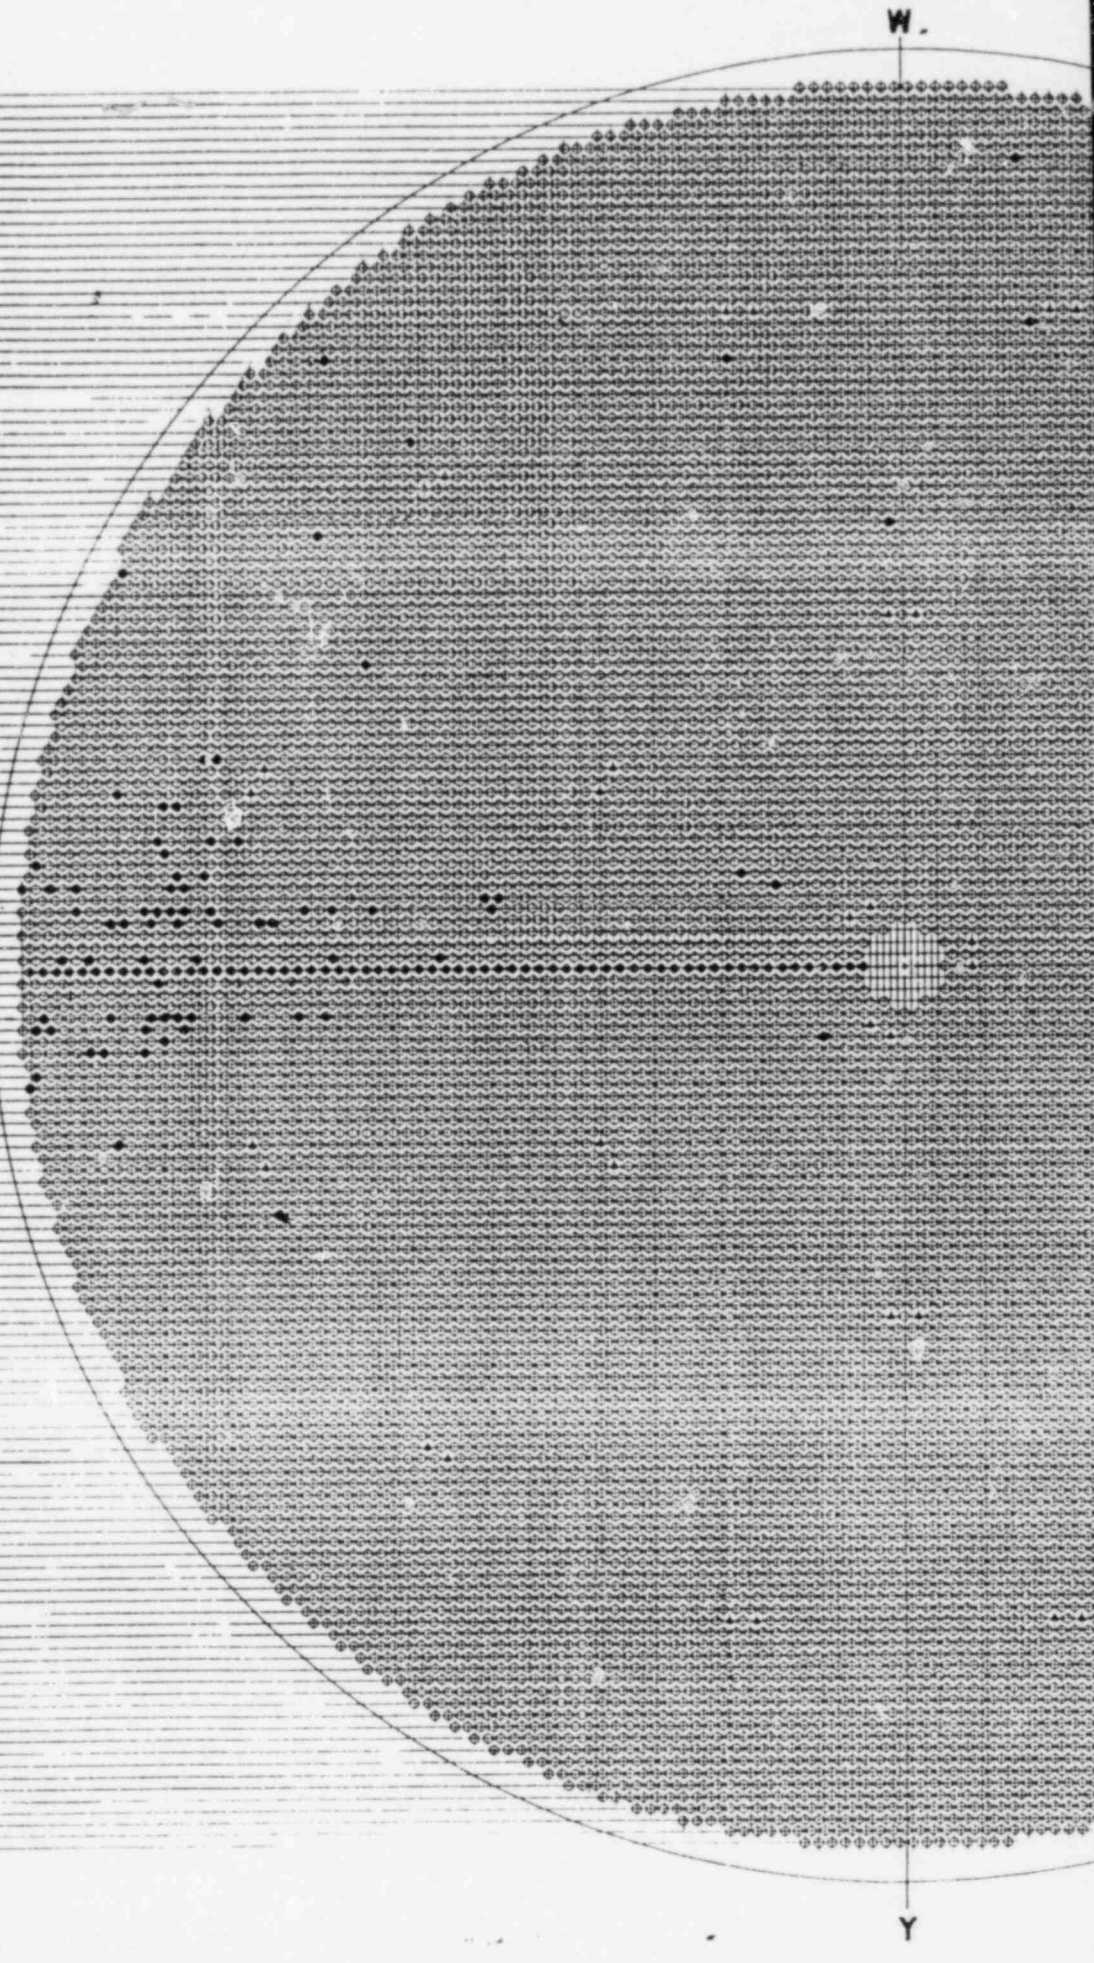
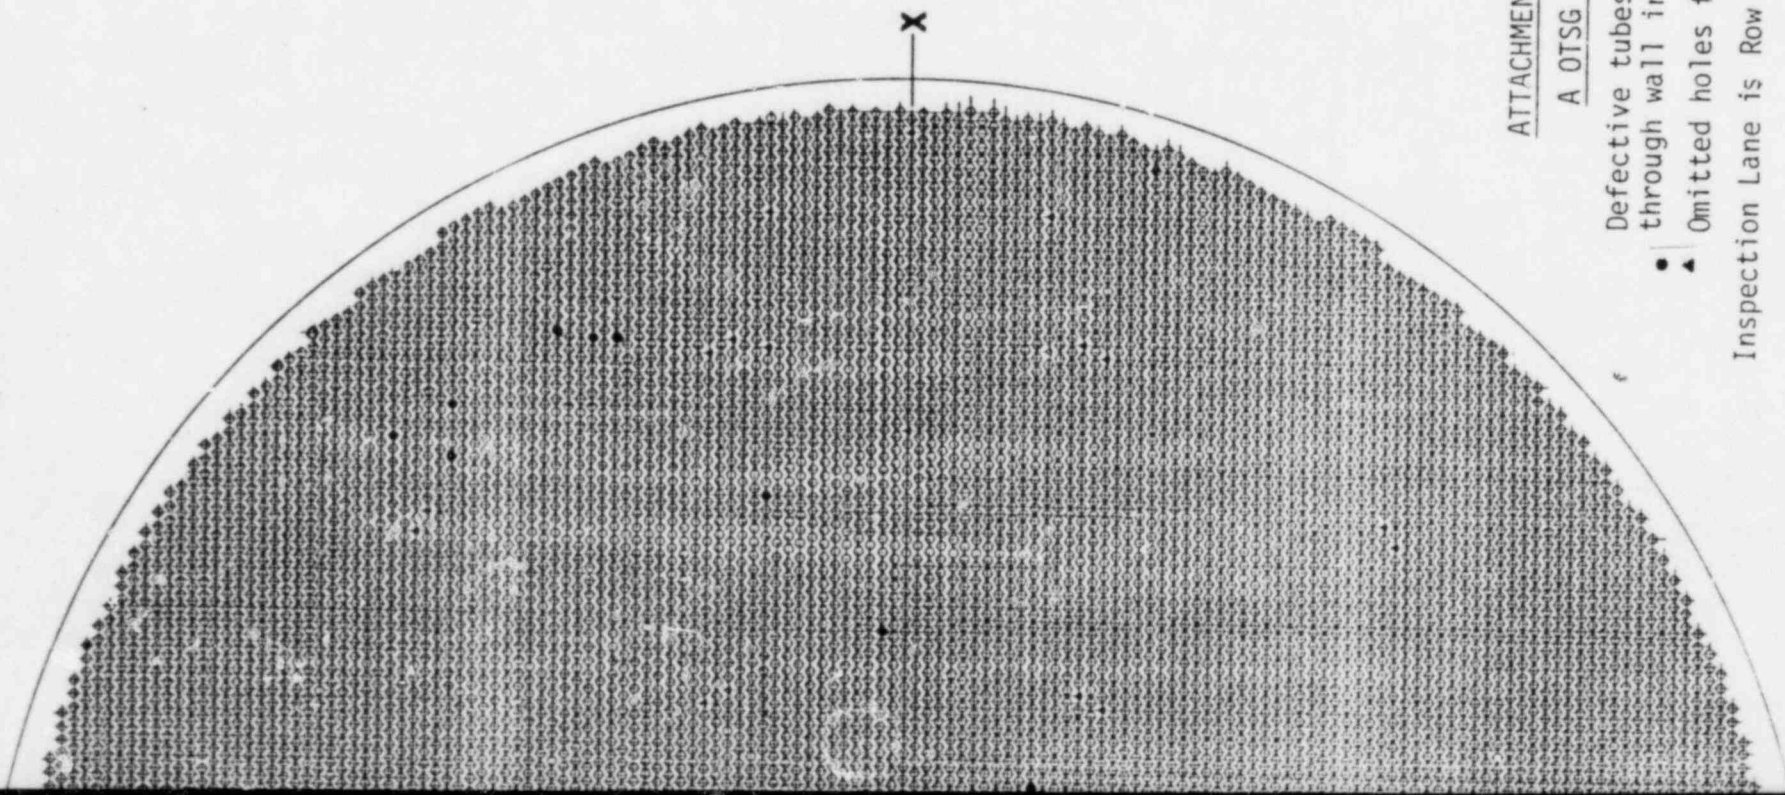
A OTSG TUBE SHEET MAP

The locations of the defective tubes in the A and B OTSG are shown in Attachments 1 and 2. A complete tabulation of defective and degraded tubes is contained in Attachment 3. Attachment 3 also list the through wall percentage and axial location of each indication. As can be seen from these attachments, the defective tubes are concentrated near the peripheral end of the lane region. In addition, with few exceptions, the indications are located in the upper tube sheet crevice region. As discussed in our

December 17, 1982, letter, such a pattern tends to support a failure hypothesis based on transport of contaminants up the open inspection lane. Such contaminants, when combined with exposure to oxygen, could produce the observed tube degradation. A review of the operational history of ANO-1 for the past cycle shows that exposure to oxygen did occur during the Spring 1982 outage. During this outage the secondary side of the steam generators were open and exposed to air during replacement of the main feedwater nozzles. A summary of significant operational events during the previous cycle is presented in Attachment 4. A sketch of the tube sheet crevice region is included as Attachment 5 (the majority of upper tube sheet defects are located within the first 10 inches from the secondary face of the tube sheet).

- Defective tubes (>40% through wall indications)
- ▲ Omitted holes for supports

Inspection Lane is Row 76 - Z Axis

Following completion of inspections in the A OTSG, tube plugging operations will begin. As a minimum, all tubes with greater than 40% through wall defects will be plugged as required by the Technical Specifications. B&W removable welded plugs will be used in locations where future tube sleeving may be desired. Conventional explosive plugs will be used in other areas of the steam generator. In addition, tubes with defects above the fifteenth (uppermost) support plate will be stabilized with a rigid stabilizer in accordance with B&W recommendations.

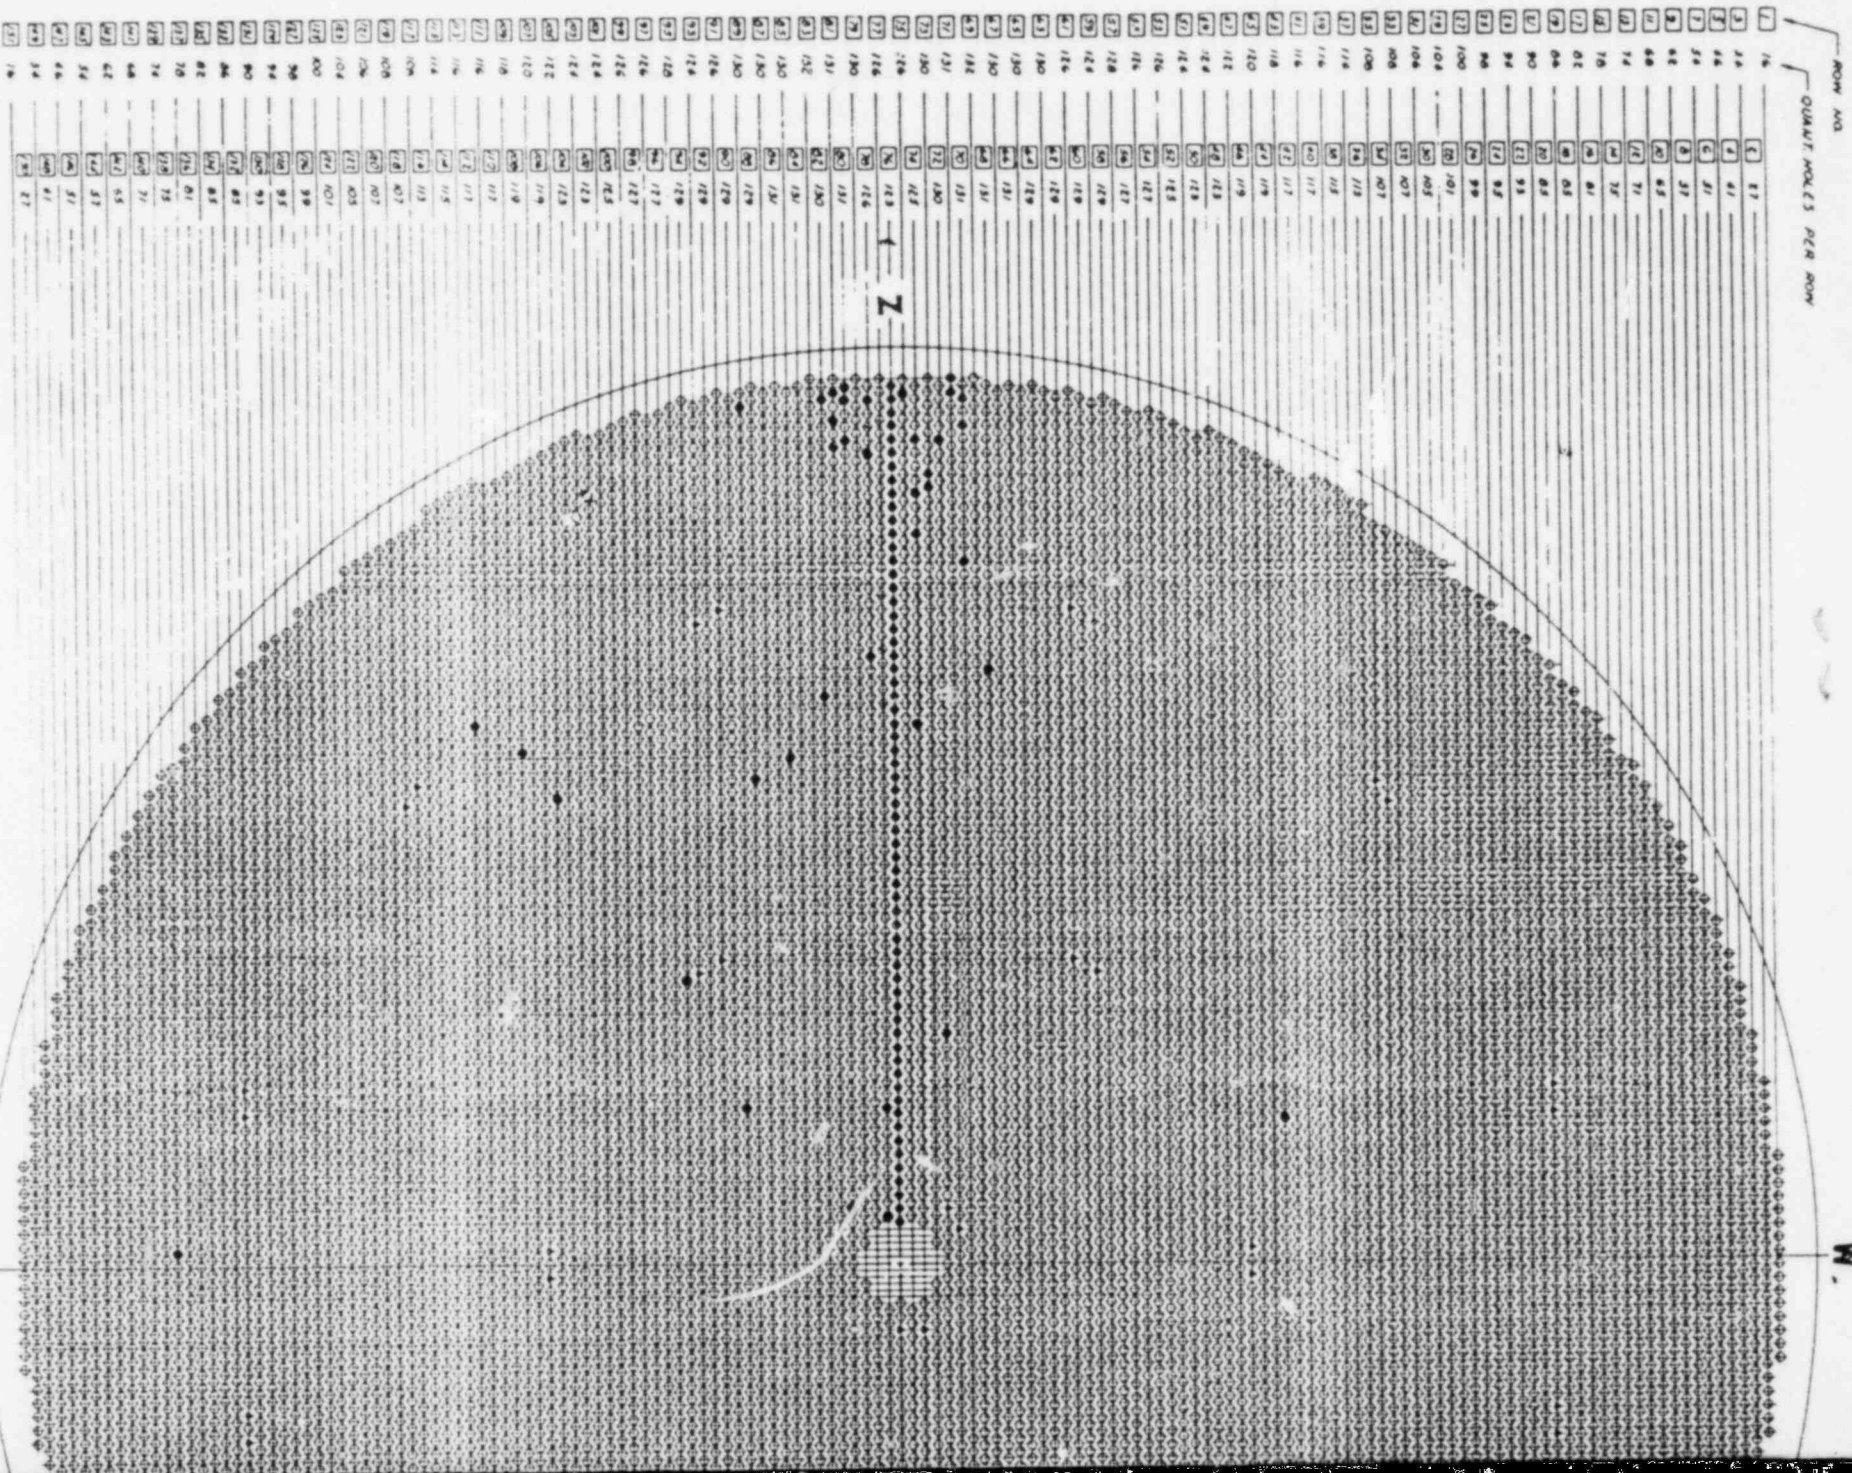
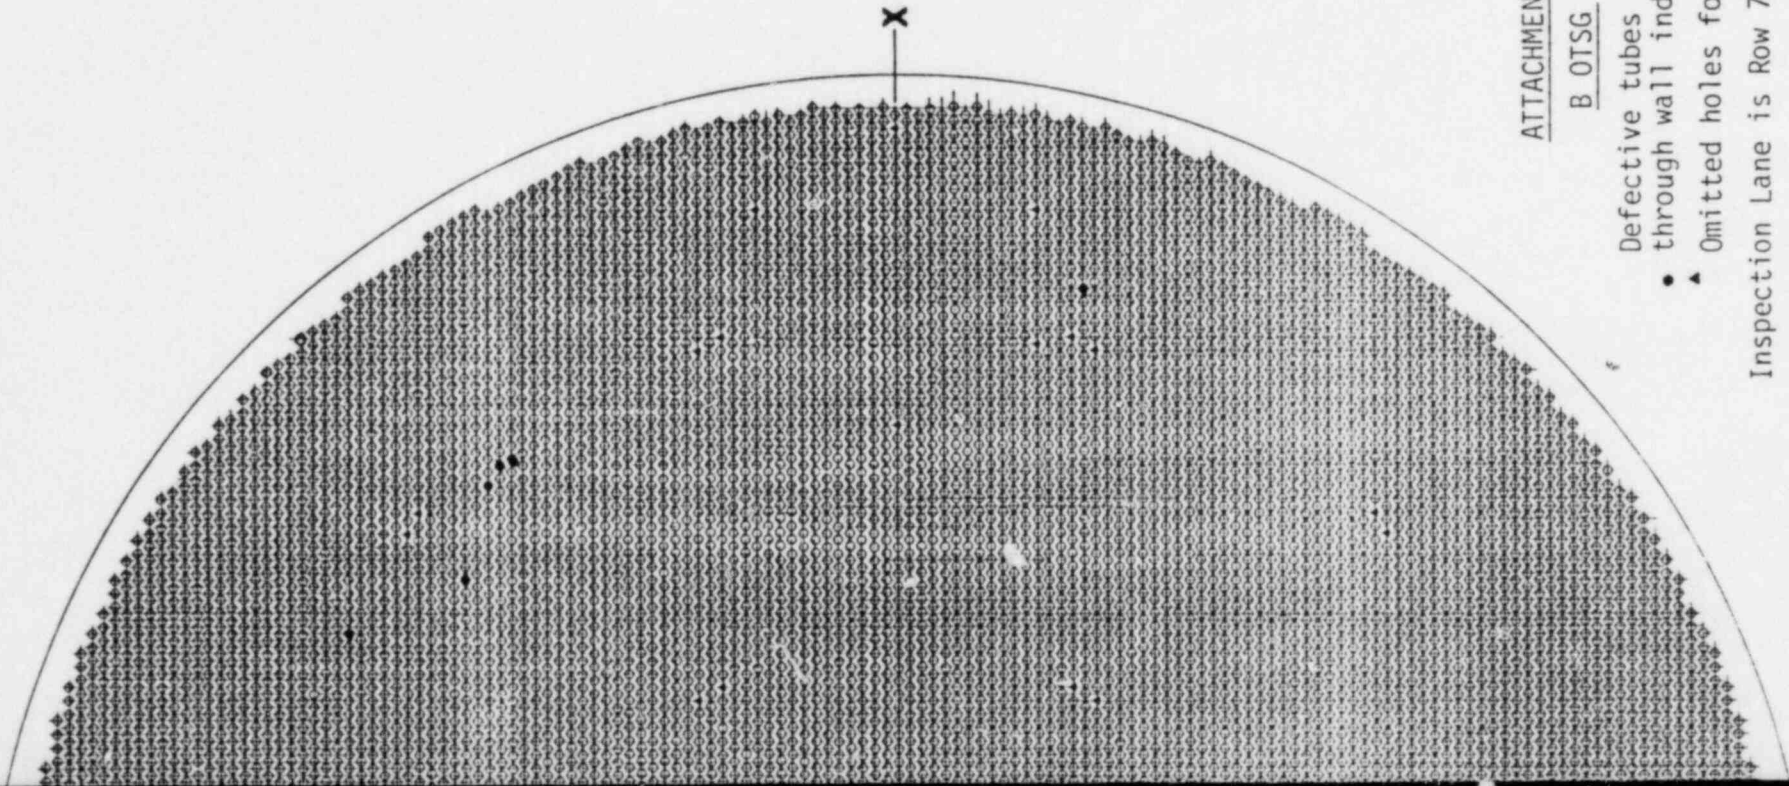
B OTSG TUBE SHEET MAP

- Defective tubes (>40% through wall indications)
- ▲ Omitted holes for supports

Inspection Lane is Row 76 - Z Axis
