UNITED STATES
NUCLEAR REGULATORY COMMISSION
WASHINGTON, D. C. 20555

FEB 24 1982

SUBJECT: REPETITIVE FAILURES OF EMERGENCY FEEDWATER FLOW VALVES AT
ARKANSAS UNIT 2 BECAUSE OF VALVE OPERATOR HYDRAULIC PROBLEMS

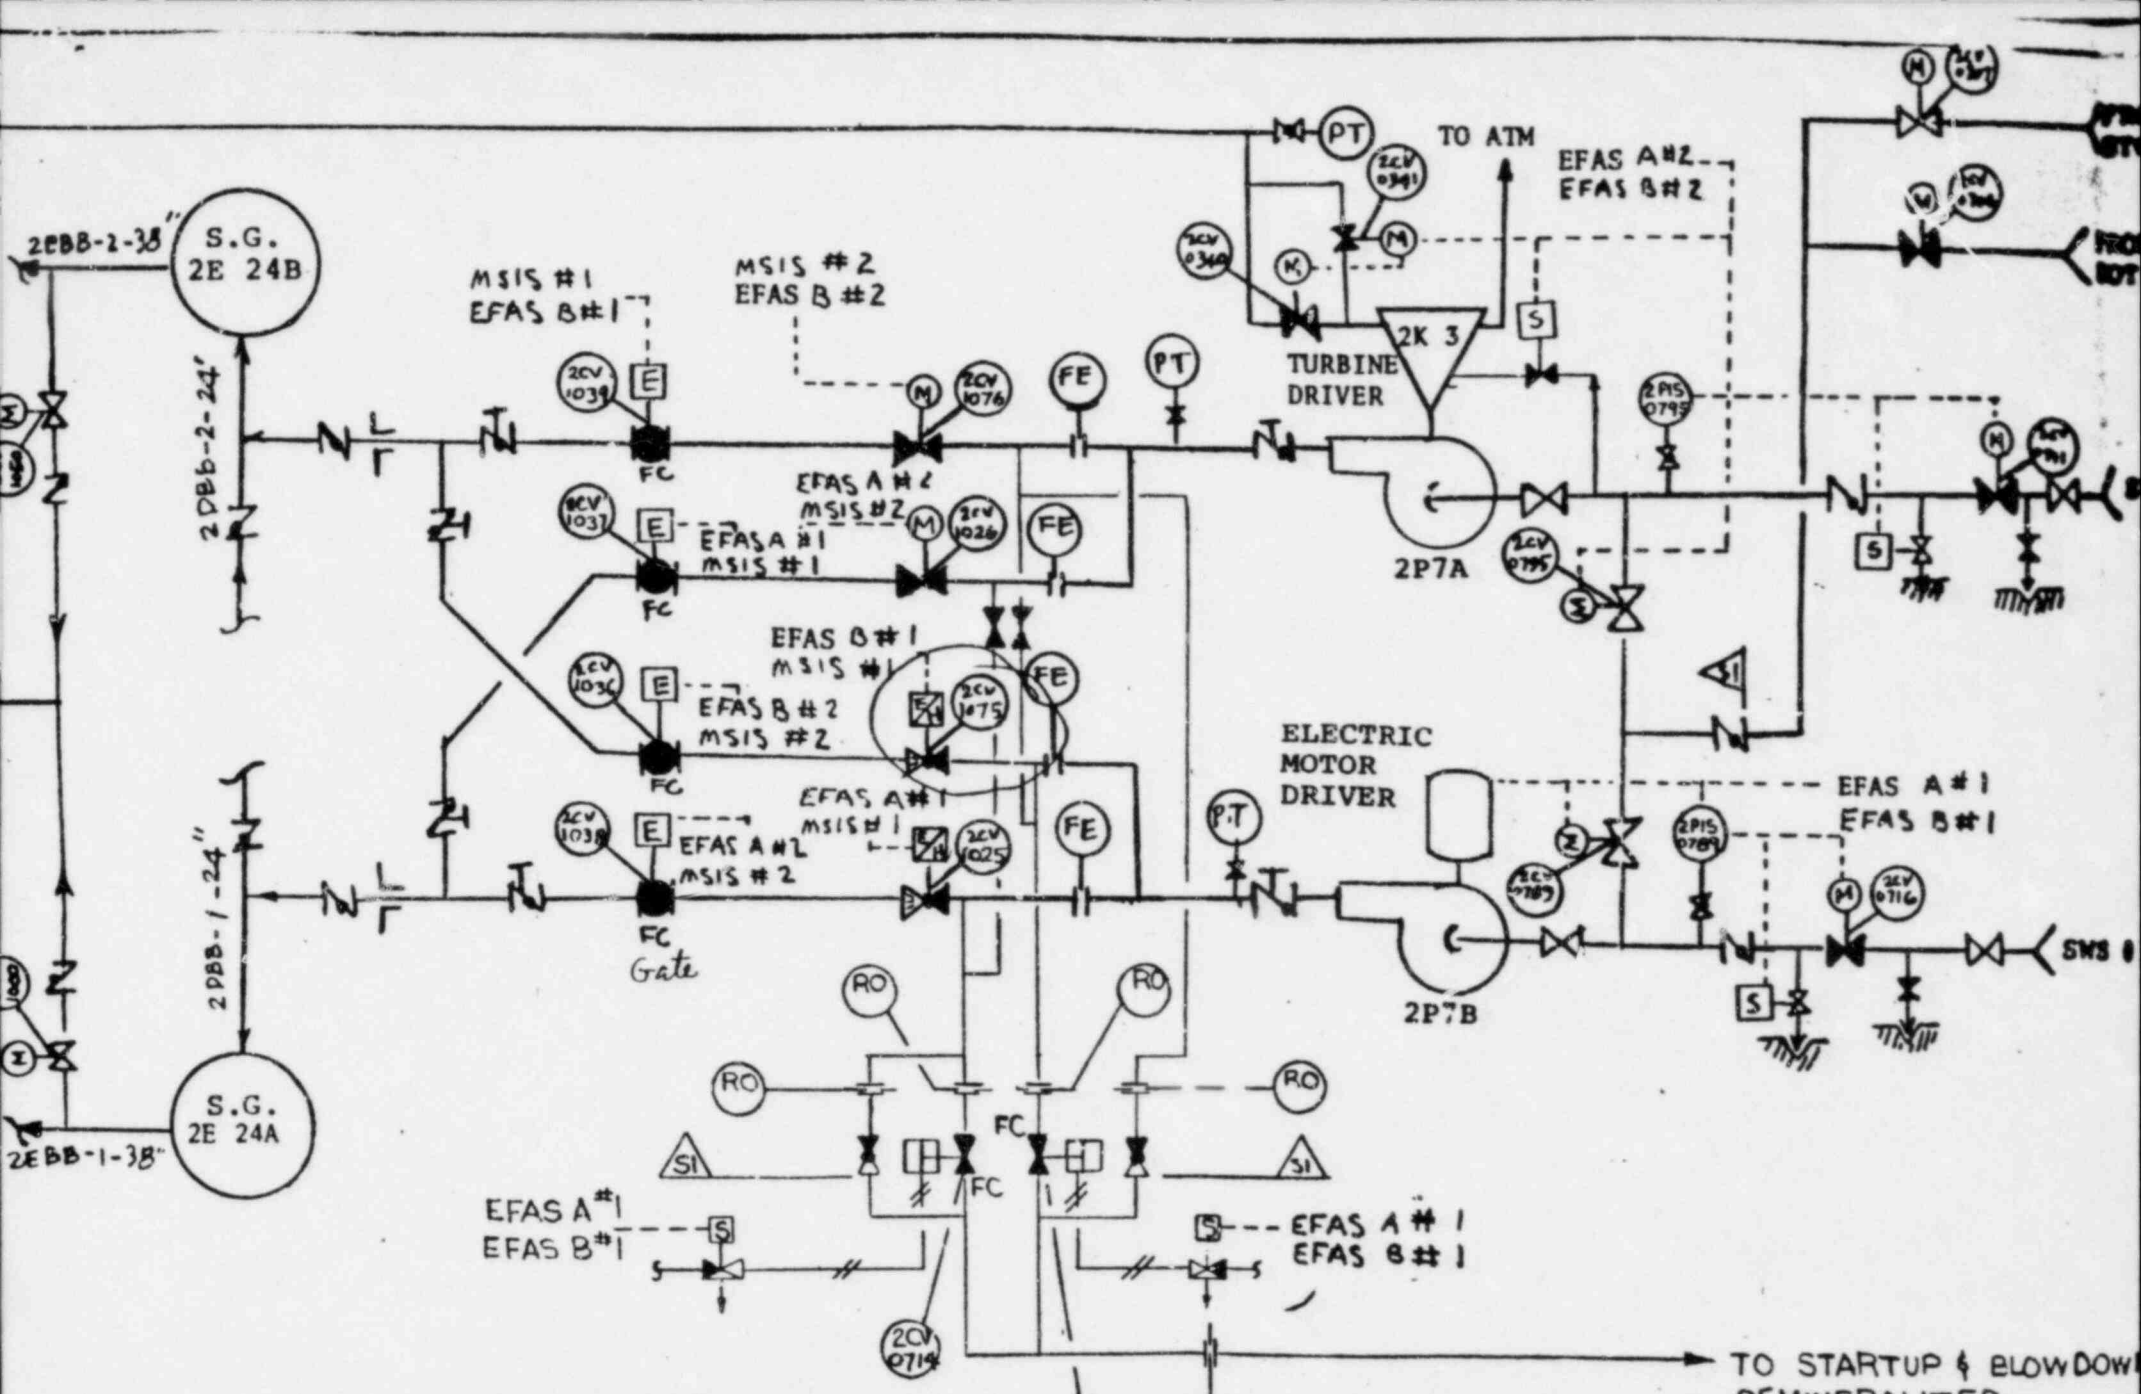
When each of the referenced LERs was examined, it was apparent that the fuse failure was an isolated event, and that valve operator hydraulic problems were a repetitive mode of failure in the EFW system. (There are only two hydraulically operated valves in the EFW system, 2CV-1025 and 2CV-1075 - see attached flow diagram.) It was found that some of the referenced LERs were not for problems similar to the original LER; however, the LERs that did pertain to valve operator hydraulic problems referenced some additional LERs that were not referenced in the original LER. This sequence of acquiring LERs on Emergency Feedwater flow control valve failures due to failures of the hydraulic operator was pursued until all relevant LERs were acquired. A draft table of the reported failures and the relevant LERs are attached.
