EVALUATION OF EVENTS INVOLVING DECAY HEAT REMOVAL SYSTEMS
IN NUCLEAR POWER PLANTS

J. A. Haried

Prepared for the
U.S. Nuclear Regulatory Commission
Office of Nuclear Reactor Regulation
Under Interagency Agreement DOE 40-544-75

March 1982

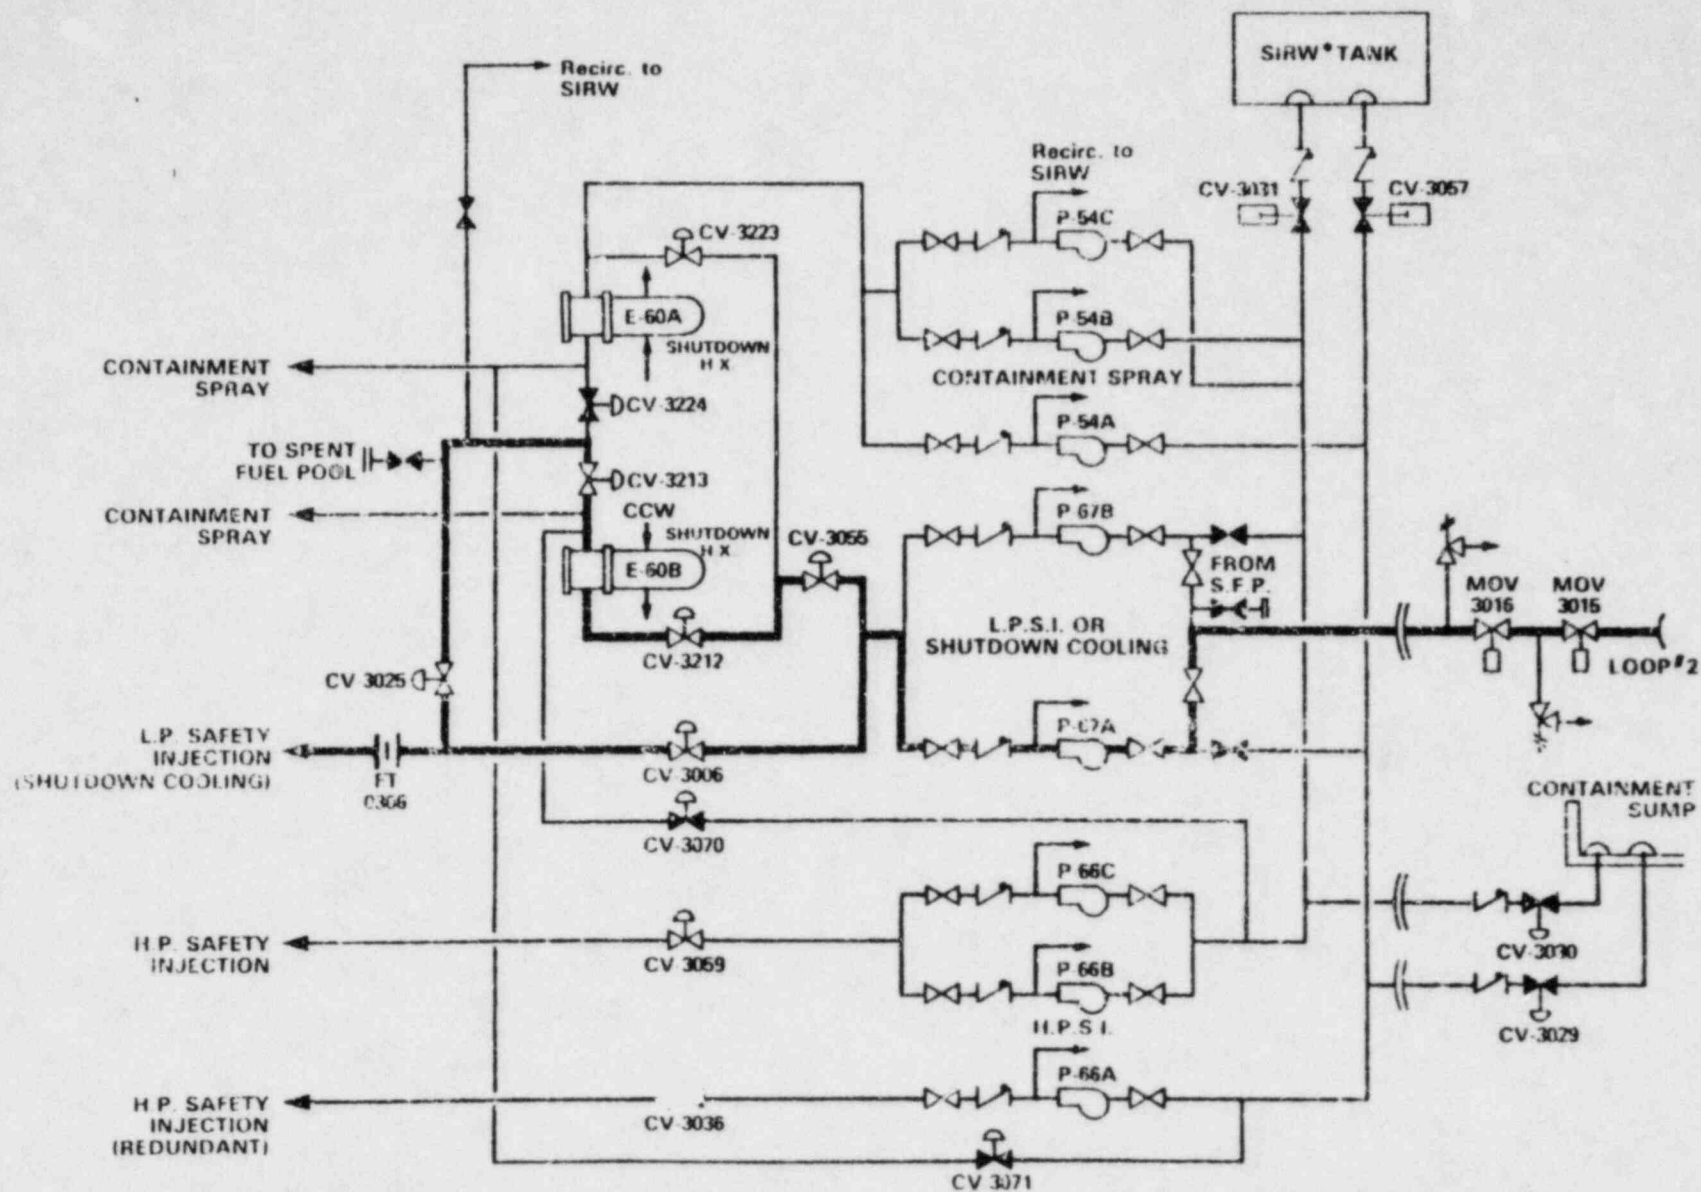
Fig. B.1. Palisades shutdown cooling systems.

The following lessons have been learned through the experience at Palisades:

1. A single failure can cause loss of shutdown cooling even if both trains of RHR are operable.
2. Moisture buildup in air lines can cause failure of one or more air-operated valves, particularly during periods of high air demand.

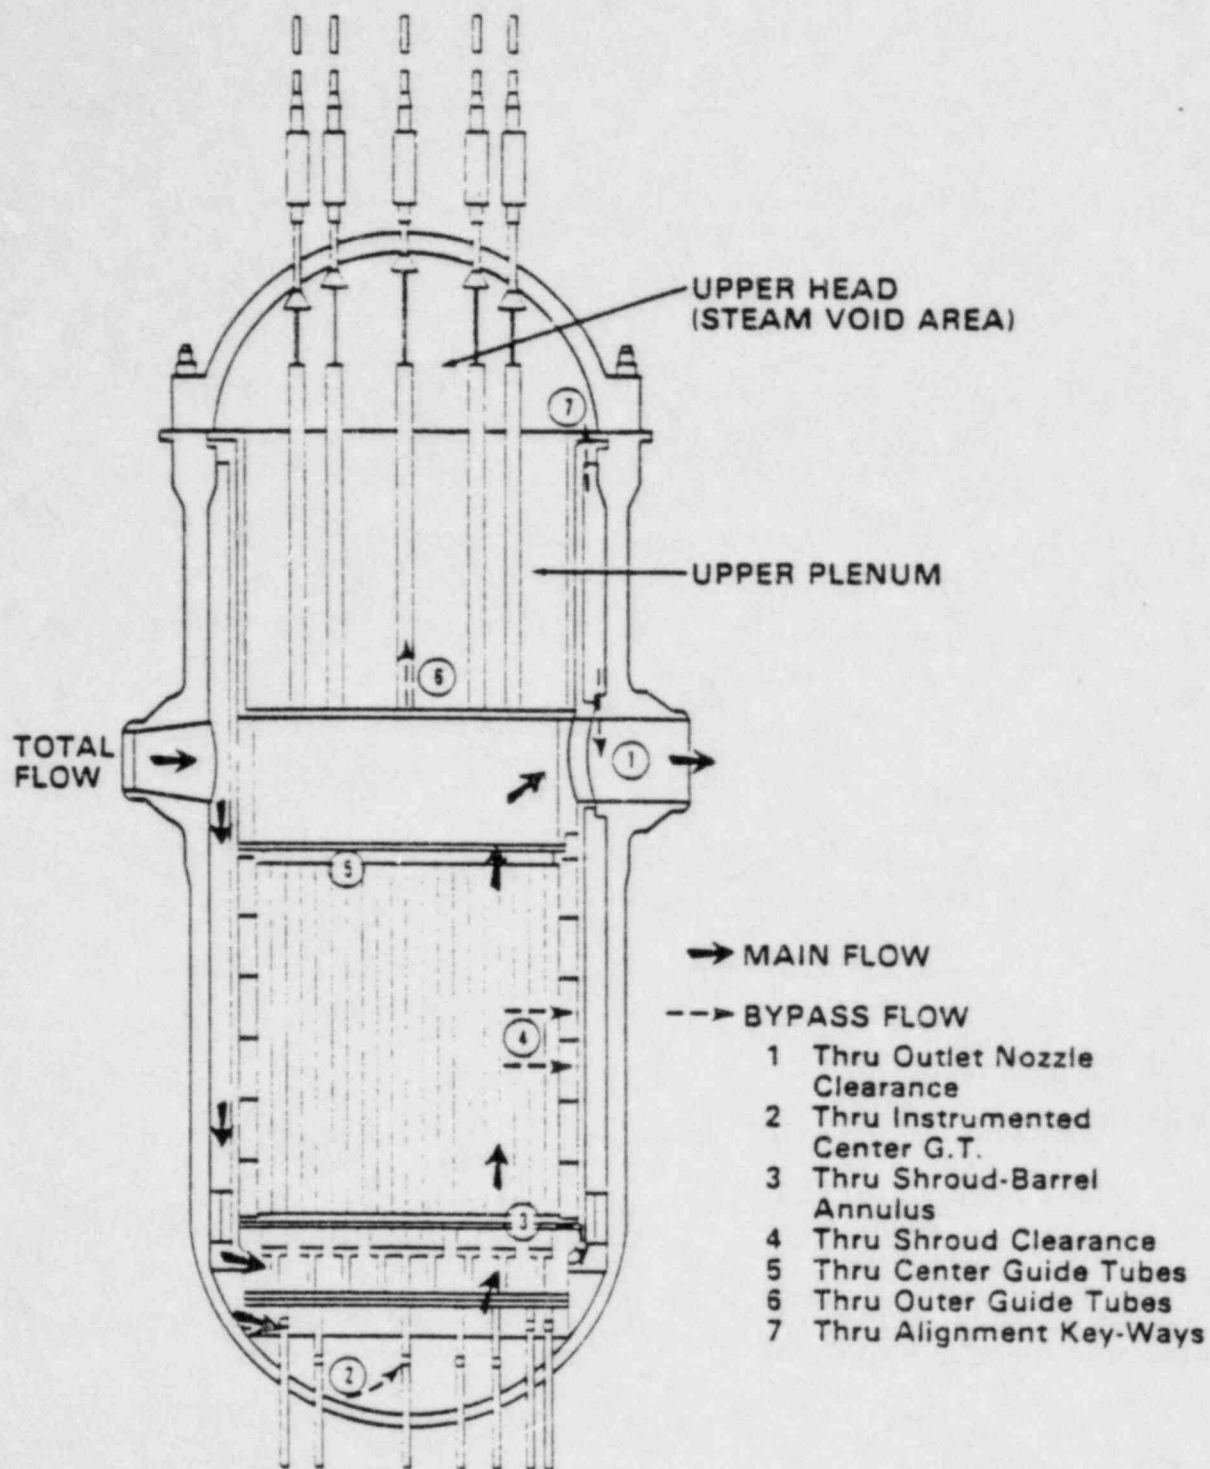
Fig. D.1. Reactor vessel flow paths.

The cold-calibrated pressurizer-water-level instrument indicated a rise to 64% and stayed constant while the hot-calibrated channels reached 100%. Although the constant level on the cold-calibrated channel indicated that the pressurizer was solid, the continued charging flow did not cause the pressure to rise above 1.4 MPa, as it should have if the RCS were solid. The absence of a pressure rise indicated that there was a leakage path from the RCS.

During the 90 min that the LPSI pump 1A was operating in the injection mode, the RWST gained about 17 m³. A path from the RCS to the RWST existed through the LPSI pump 1B minimum flow recirculation line

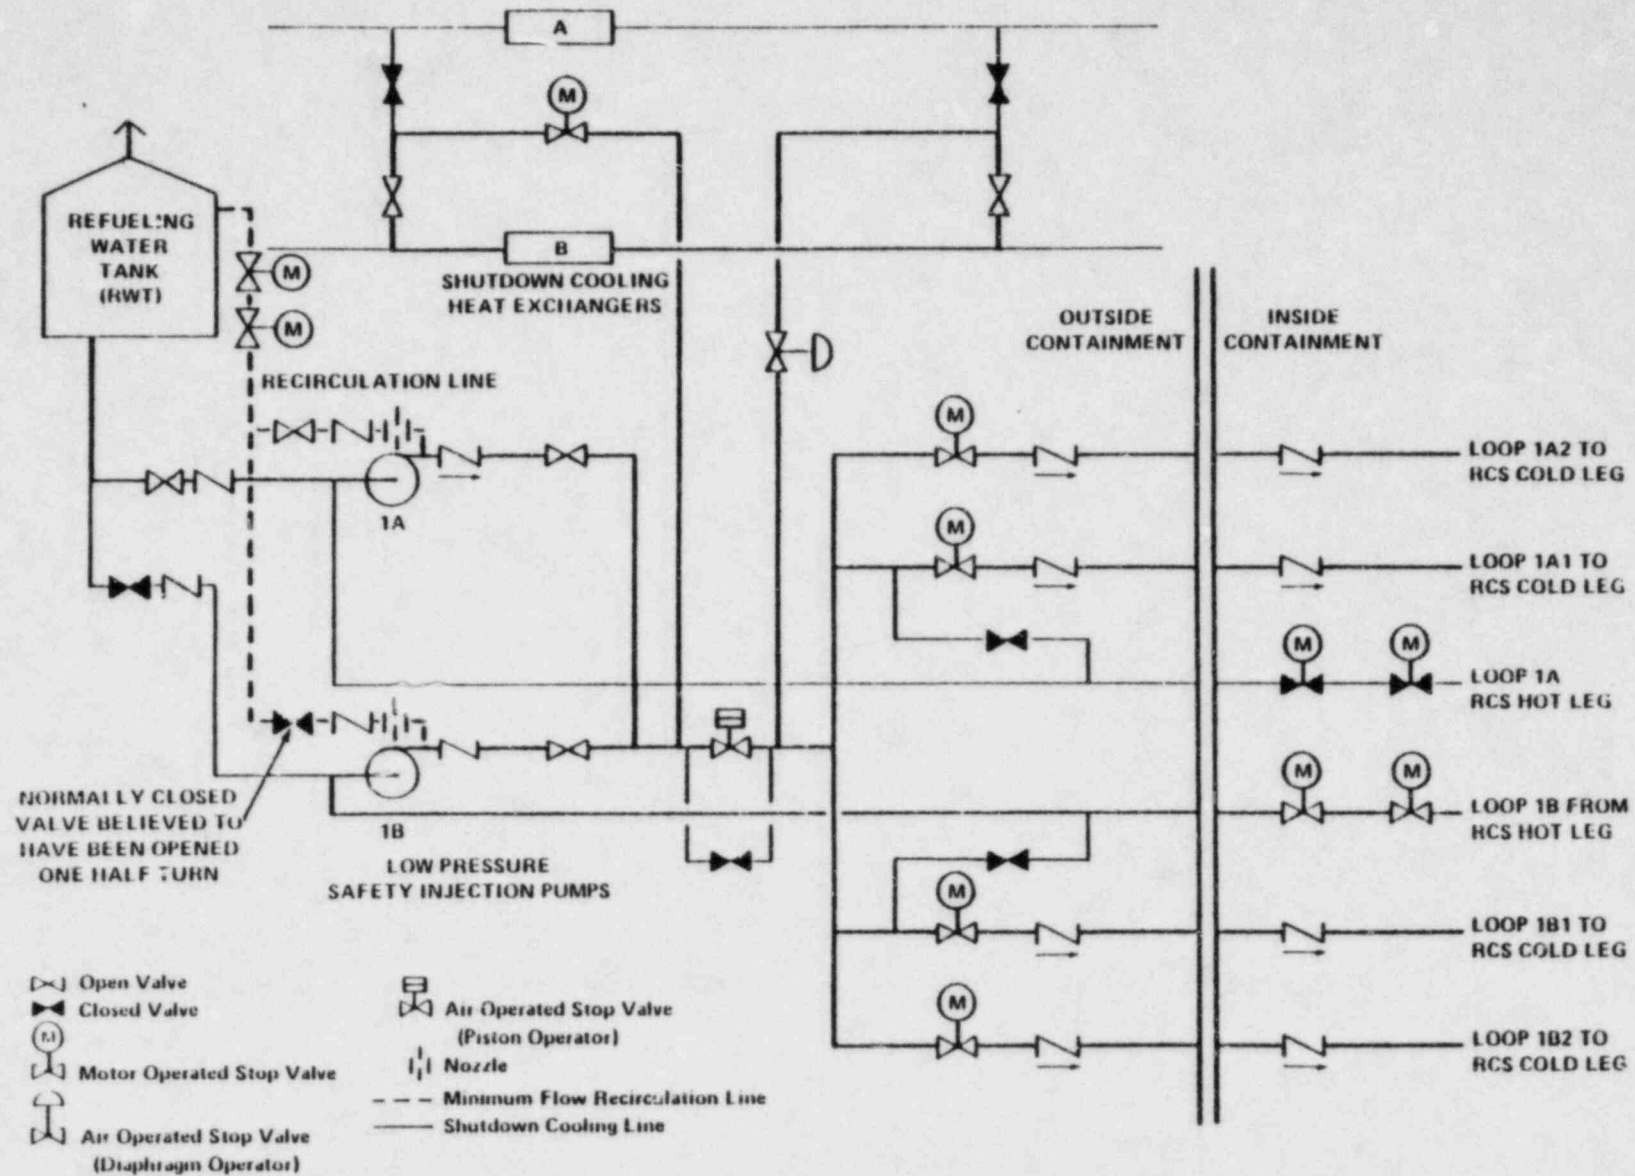
Fig. D.2. Shutdown cooling at St. Lucie.

(Fig. D.2). After the shutdown cooling system had been warmed, the pump 1B minimum flow manual isolation valve was closed; however, on a check subsequent to the discovery of an increasing RWST level, the valve was found to be one-half turn open, allowing the flow of water back to the RWST. Also, about 90 min after starting, pump 1A was stopped and its recirculation line was isolated. The LPCI pump 1A discharge check valve was a second suspected leakage path through the 1A minimum flow line to the RWST.

Actions recommended in the NRC's IE Circular include: (1) informing all facility-licensed personnel of the possibility of a steam-void formation in the reactor vessel head during natural-convection cooling, even when a high subcooling margin exists in the reactor coolant loops; (2) reviewing and revising procedures for using natural convection for shutdown cooling and cautioning operators against the conditions that occurred, including appropriate recovery action should they occur again; (3) establishing natural-convection cooldown and depressurization rates that will preclude steam-void formation and ensure adequate core cooling; (4) evaluating the design of CCW systems to determine their vulnerability to single failures that could cause loss of RCP cooling, simultaneous common-mode failure of all RCP seals, and reactor-coolant-system leaks through failed seals at multiple locations; and (5) using a temperature-monitoring system for the metal of the reactor vessel head to aid the operator in preventing the formation of a steam void in the reactor head during natural-convection cooling.
