HADDAM NECK PLANT

LICENSEE EVENT REPORT (LER)

TITLE (4)
Automatic 480 Volt Bus Transfer Failure Due to Circuit Breaker Malfunction

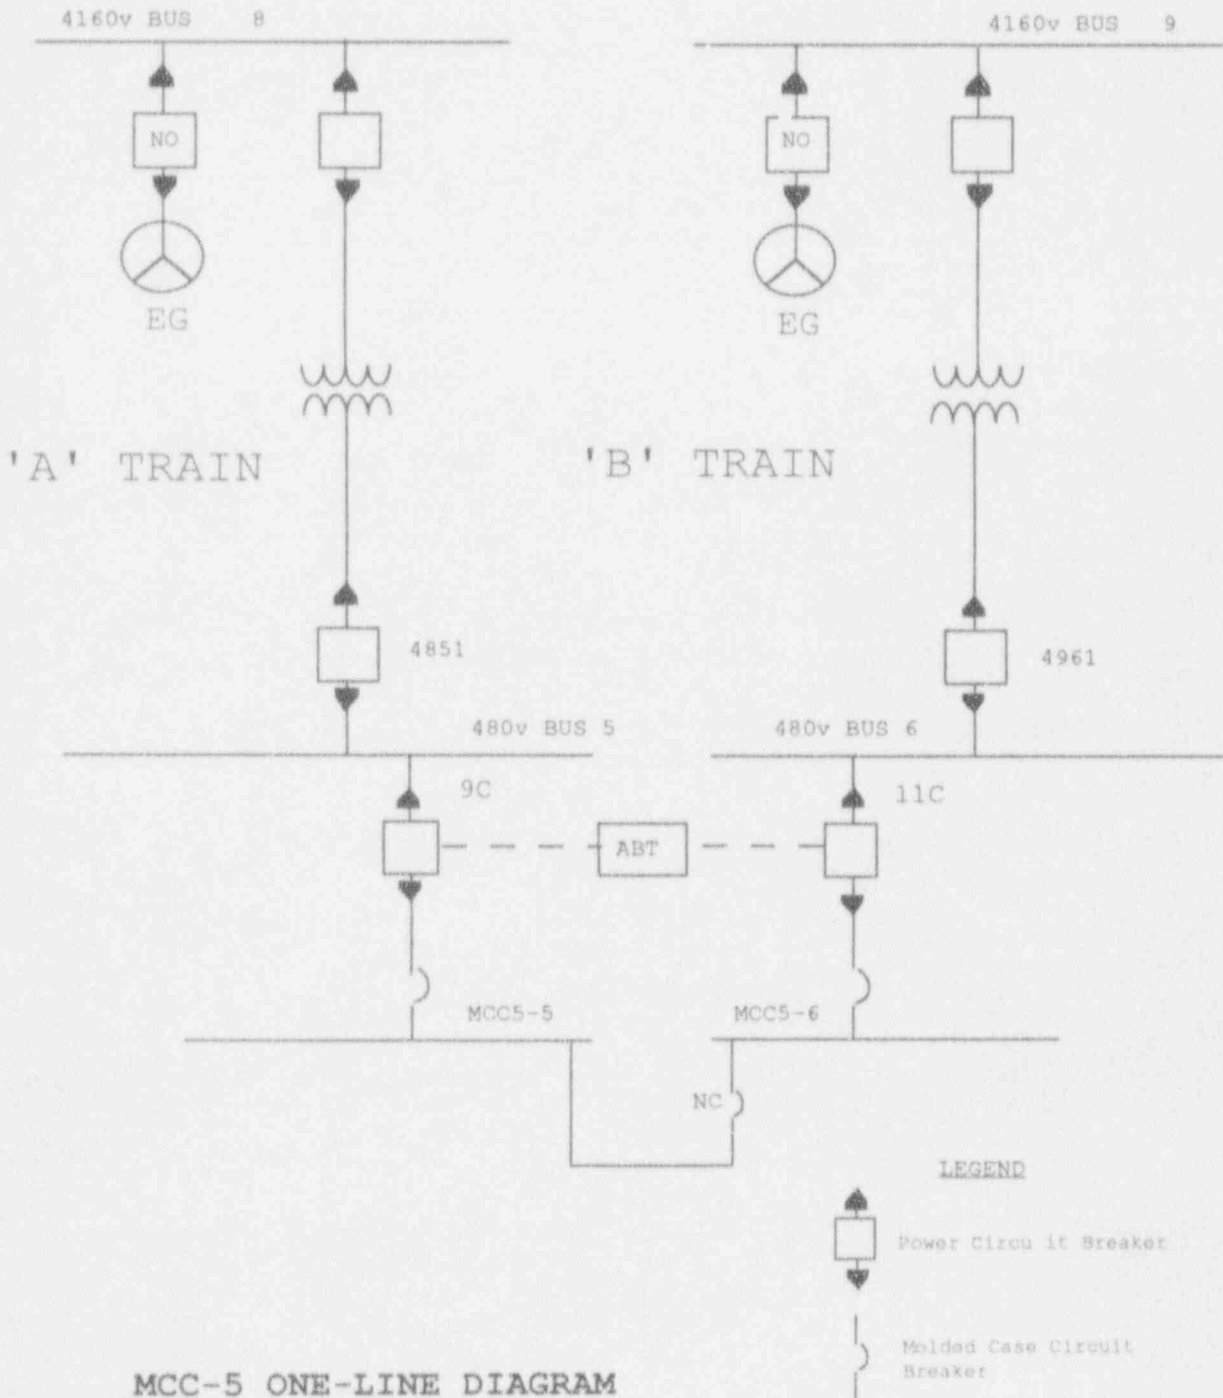
FIGURE 1

The Motor Control Center (MCC) 5 Automatic Bus Transfer (ABT) circuit provides power to MCC-5 from either of two 480 volt AC power sources (EIIIS Code: EK) (see Figure 1). MCC-5 is normally aligned so that bus 5 (Train 'A') provides power to MCC-5 via circuit breaker 9C. If for any reason bus 5 becomes de-energized the ABT scheme (see Figure 2) will transfer the feed for MCC-5 to bus 6 (Train 'B') via the 11C breaker. Upon restoration of bus 5 power the ABT scheme will then transfer the feed for MCC-5 back to bus 5 (the preferred supply). During the refueling outage of May to July 1993, an ABT failure was experienced. A root cause investigation performed following that failure was inconclusive yet a component, the 52X relay, common to both ABT circuit breakers (EIIIS Code: 52) was determined to be the most suspect. These components were replaced on both the bus 5 9C breaker and bus 6 11C breaker.

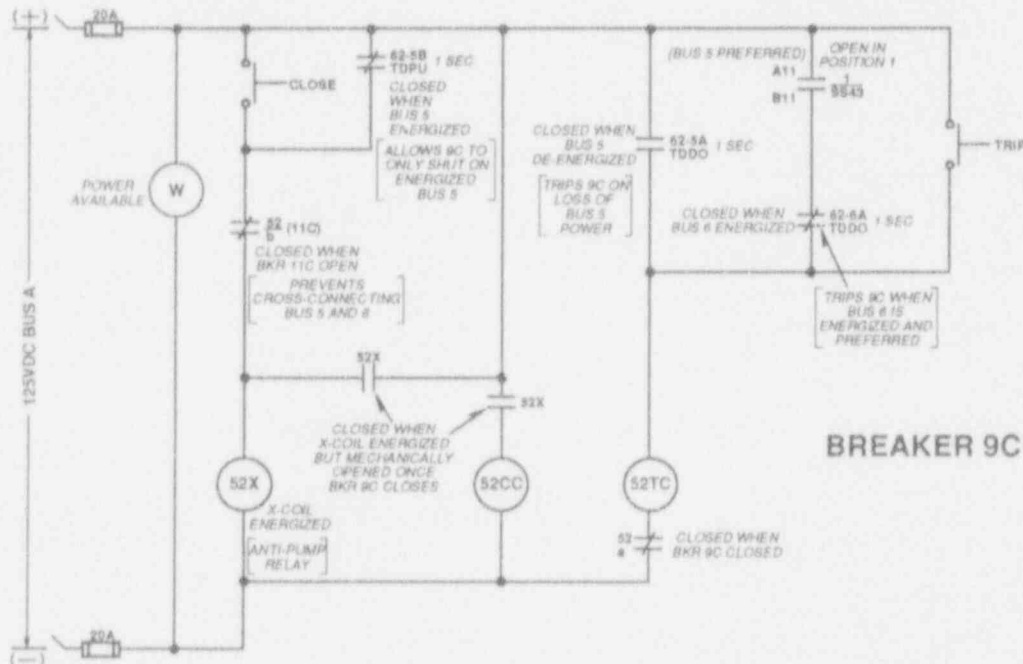
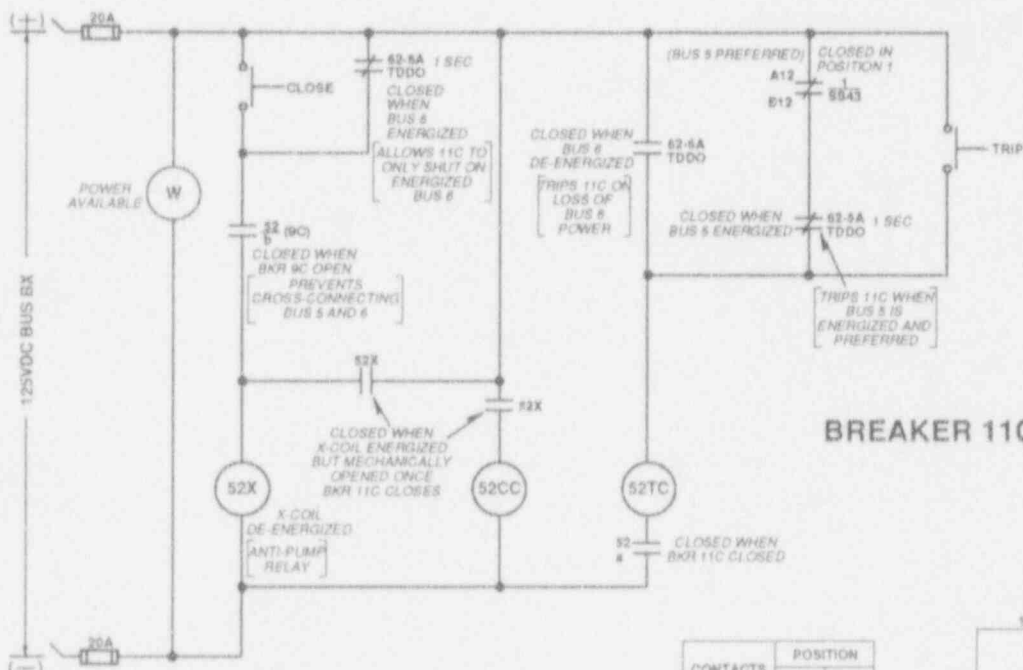
FIGURE 2

The apparent cause of the bus 6 11C breaker to not close when position 2 was selected on the SS43 switch has been determined to be due to a mechanical problem within the breaker operating mechanism. A snap retaining ring was discovered approximately a half inch away from its mounting slot. This allowed the manual operating shaft to move further into the breaker than designed. It was able to travel far enough into the breaker that it interfered with the trip bar and actually maintained the breaker in the tripped position. When the breaker was called upon to close it would close and immediately trip. Performance of a root cause evaluation to determine all the circumstances that led to the MCC-5 ABT failure, including an assessment of the previous root cause evaluation, is underway and will be completed prior to Mode 4.

1. Replacement of bus 6 breaker 11C manual operating mechanism.
2. Verification of position and condition of other breakers' manual operating shaft retaining devices.
3. Implementation of a modification to eliminate the preferred source selector switch SS43 and redesign the MCC-5 ABT scheme to block the trip of the normal feed bus 5 9C breaker on a total loss of AC power to minimize challenges to breaker operation.
