UNITED STATES
NUCLEAR REGULATORY COMMISSION
WASHINGTON, D. C. 20555

SUBJECT: SITE VISIT/MEETING NOTES - BRUNSWICK
STEAM ELECTRIC PLANT - MARCH 24, 1982

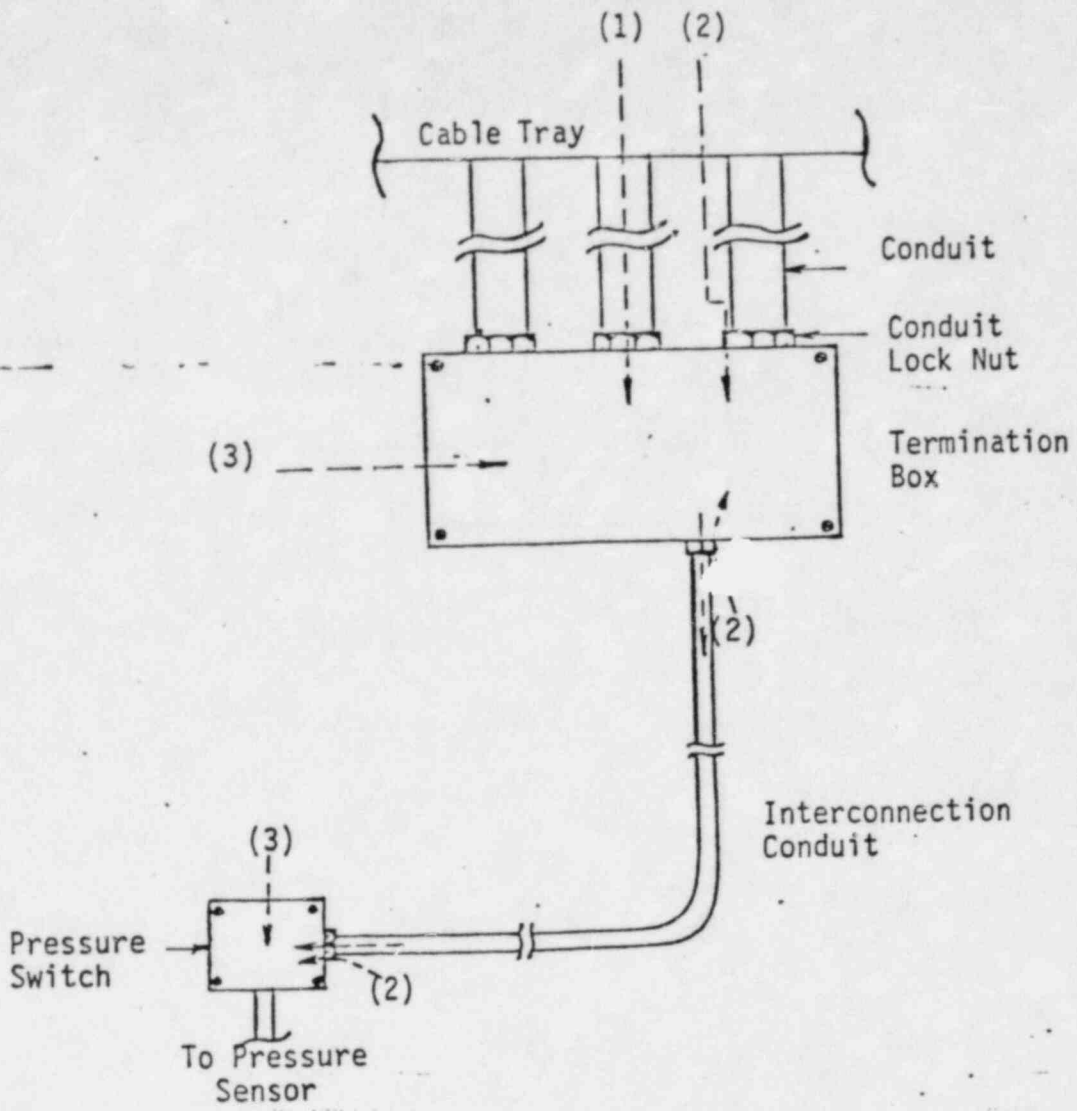
Figure 2: Brunswick Steam Electric Plant
Representative Moisture Intrusion Pathways

Investigation by BSEP personnel into the cause of these failures, along with similar failures noted in the past, has led BSEP personnel to conclude that several mechanisms for such equipment problems are most likely. These are (see figure 2):

- (1) Moisture entering into unsealed conduit connections at cable trays. These cable trays are located throughout the reactor building. The moisture subsequently condenses within the conduit and uses the conduit as a piped pathway to connecting equipment such as termination boxes and instrumentation;
- (2) Moisture in the local environment entering the equipment at moisture resistant but not moisture tight conduit connections; and
- (3) Moisture intrusion at improperly sealed equipment enclosure covers.

In both mechanisms 2 and 3, moisture may condense and enter the connecting conduit where, as in mechanism 1, other equipment may be affected. Also, BSEP personnel believe that mechanism 3 is a result of inadequate maintenance practices and lack of attention to details during resealing of equipment after calibration rather than from design or manufacturing problems. This conclusion was based on post maintenance/calibration equipment walkdowns which revealed enclosure or cover plate retaining screws loose and/or missing.

- (1) Cable Tray/Conduit/Equipment
- (2) Environment/Connectors/Equipment
- (3) Environment/Enclosure Covers/Equ

In an attempt to resolve these problems, BSEP personnel have decided to undertake several corrective and preventive measures. Included are:

- (1) Training - Affected personnel are required to take a four-week course which covers electronics and instrumentation and the associated installation techniques and problems. This course is taught by experienced CP&L personnel and includes hands-on training.

- (2) Maintenance Practices - Plant maintenance practices were revised to ensure proper sealing of applicable plant instrumentation housing and/or gaskets by a dedicated plant group. Figure 3 contains pertinent excerpts from the BSEP Maintenance Procedure Manual which address these revised practices.

- (3) Additional Sealing - All conduit-to-component junction points, both internally and externally, were sealed on the affected instrumentation. This was also done to all equipment on the seven instrument racks located on the reactor building outside containment -17 foot elevation which are subjected to the same environmental conditions as the failed equipment (Note: The instrumentation in the core spray rooms on -17 foot elevation was not included.) The sealing compound being used is Dow-Corning 732 RTV, a silicon-rubber compound. To date, no sealing problems, including wear-out or end-of-life aspects, have been experienced with this material. Figure 4 is a sample request and authorization form for this work.

- (4) Additional Study - The Architect/Engineer is working on a possible generic permanent fix to prevent wetting the racks and associated equipment.
- (5) Manufacturing Changes - Since the equipment failures do not appear to be attributable to manufacturing defects or problems, the manufacturer (Barksdale) has not been contacted.
