CONNECTICUT YANKEE ATOMIC POWER COMPANY

HADDAM NECK PLANT

LICENSEE EVENT REPORT (LER)

Pressurizer PORVs Failed to Fully Stroke Open During Testing

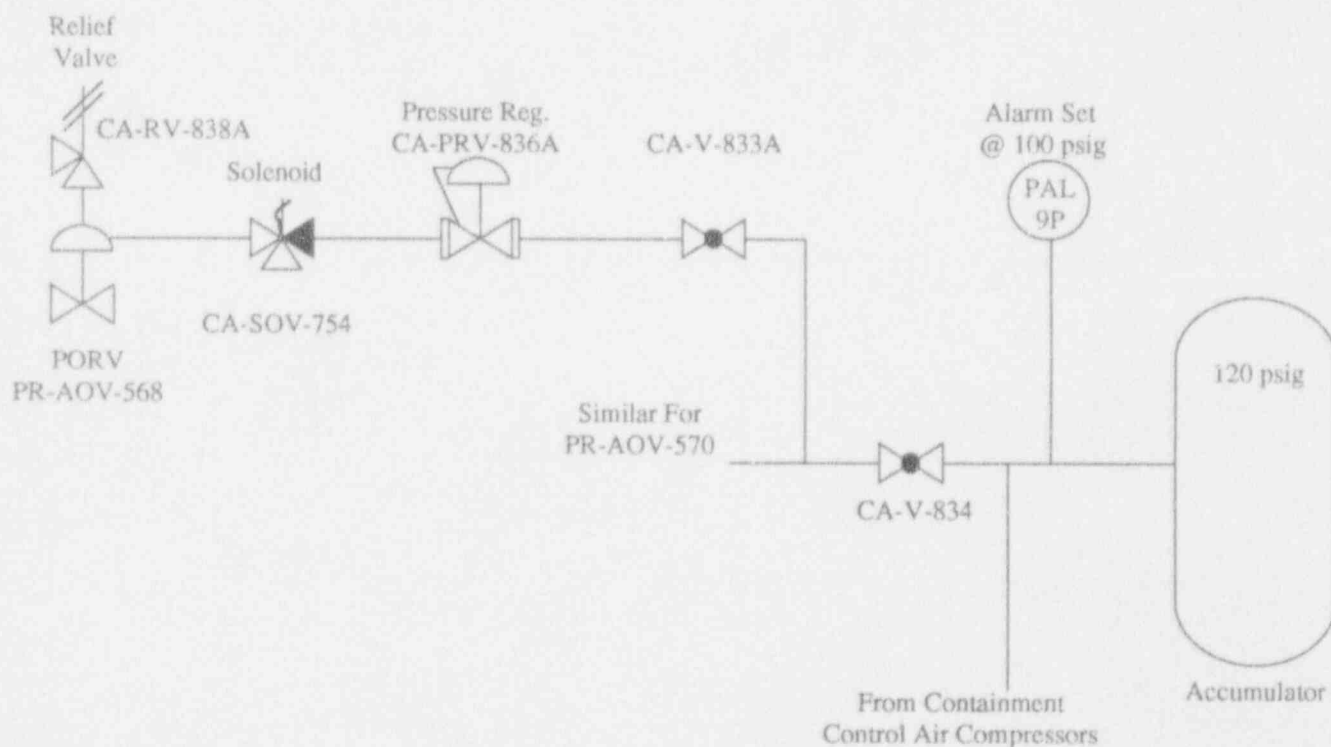
Figure 1

The control air system includes a 107 gallon emergency air accumulator to support PORV operation for the "feed-and-bleed" method of core cooling in the event of a failure of both non-safety related containment air compressors. The air supply lines which lead to the PORVs (Figure 1) are each provided with a pressure regulator (CA-PRV-836A & B) (EIIS Code: LD). These regulators reduce the air pressure being supplied from 120 psig to 85 psig.

- 1) Both PORV diaphragms leaked between the cover and the diaphragm.
- 2) The air regulators supplying both PORVs were set too low (77.3 PSIG and 75.1 versus the required 85 PSIG). The air regulator problem is secondary and would not alone have caused the failures.

The leaking diaphragms were caused by loose diaphragm cover bolts. Both PORV diaphragms were replaced during the 1993 refueling outage with a new style. The principle change was the substitution of a longer lasting material (EPDM) for the old Buna-N material. The manufacturer also changed the shape of the diaphragm somewhat although this was never communicated to the licensee. This change resulted in some difficulty installing the diaphragm. To overcome this a commonly used lubricant (Moly 55) was applied to aid installation. The PORVs were subsequently re-tested satisfactorily. Subsequent to the February 1994 failures an in-depth discussion with the manufacturer on the possible causes for failure revealed several aids to overcome installation problems. The most significant was the use of a sealant around the diaphragm's bolt circle. It is believed that the presence of lubricant instead of the sealant allowed some extrusion of the diaphragm from between the base and cover and away from the bolt holes. This extrusion also led to small tears at several diaphragm bolt holes, allowing the bolts to loosen over time.

1. Significant extrusion of the diaphragms was noted, raising questions as to the long term adequacy of this new style. Therefore, the new style diaphragms were replaced with the original Buna-N material which had no history of this kind of failure.
2. Discussions were conducted with the vendor regarding the incomplete communications issue.
3. The PORV air regulators were replaced.
