Subject: Zion Station Unit 1 and 2
Steam Generator Girth Weld Inspection Results
NRC Docket Nos. 50-295 and 50-304

**ZION STEAM GENERATOR
DUAL UNIT OUTAGE
UPPER SHELL TO TRANSITION CONE GIRTH WELD
INSPECTION AND INDICATION EVALUATION RESULTS**

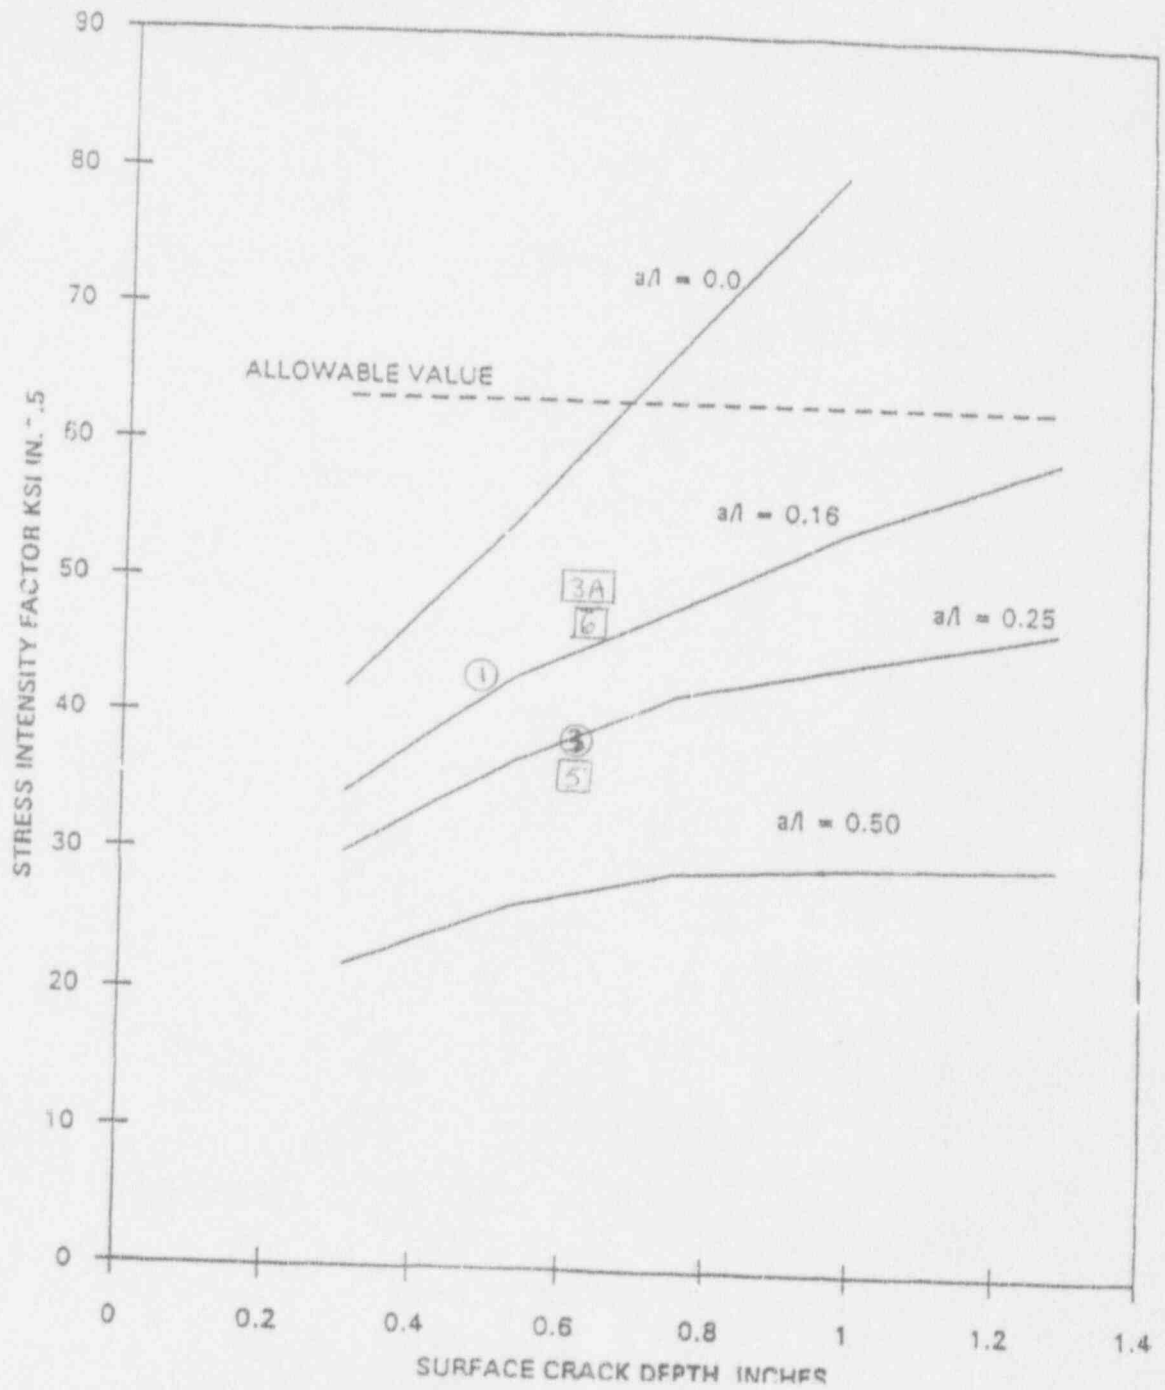
1A Steam Generator

Two 60 degree indications were determined to be "repeat" indications found at 45 degrees. All of the indications were classified as surface. The longest indication was also the deepest and was found to be 3 inches long and 0.27 inches deep. The average indication was approximately 1.2 inches long and 0.2 inches deep.

Three of the indications were classified as recordable and were accepted by fracture mechanics. Five of the indications were classified as non-recordable, three of which were acceptable per Section XI acceptance criteria, the remaining two were accepted by fracture mechanics. All of the indications were sized and evaluated at the 20% DAC level.

Indications in 1A and 1D Steam Generators will be monitored by UT as required by IWC-2420, which requires that flaws which were conditionally acceptable for service be monitored during the next inspection period.

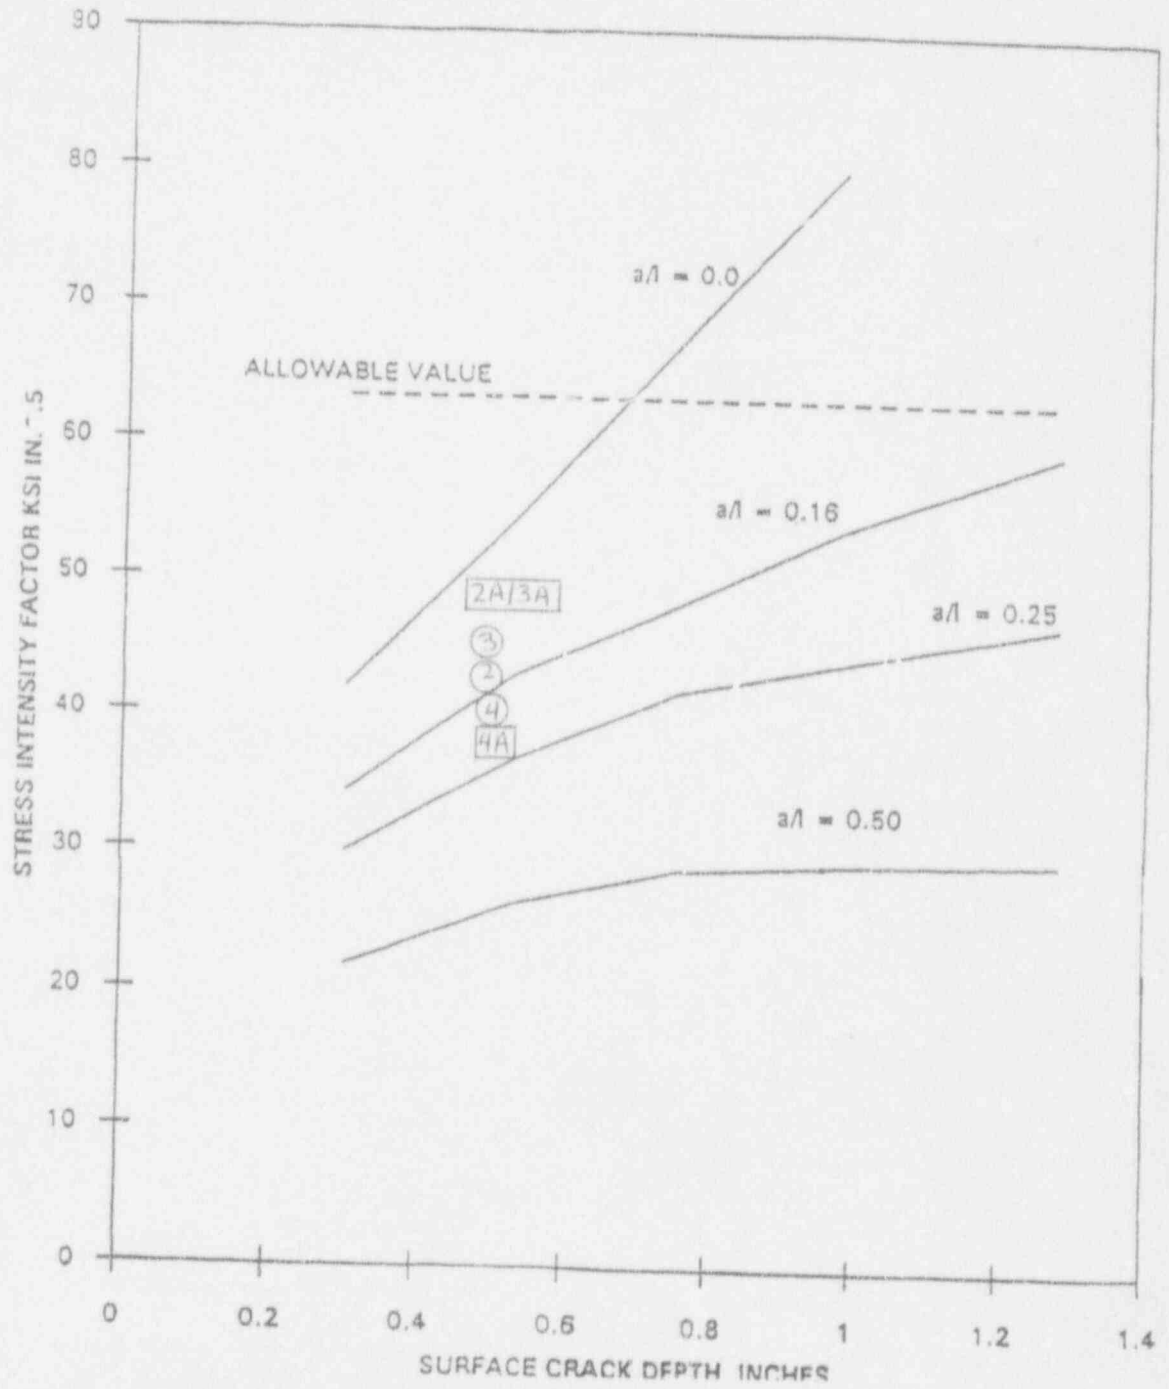
1D Steam Generator

All of the indications were classified as surface and were previously detected using UT in 1989 but were not confirmed as surface during the MT exams conducted in 1989 and 1992. No cracking was found in previously ground areas. The longest indication was also the deepest and was found to be 3 inches long and 0.19 inches deep. This 60 degree indication was found to contain two of the 45 degree indications. The average indication was found to be approximately 1.3 inches and 0.15 inches deep.

One indication was within Section XI acceptance criteria, the remaining indications were accepted by fracture mechanics. All indications were sized at the 20% DAC level.

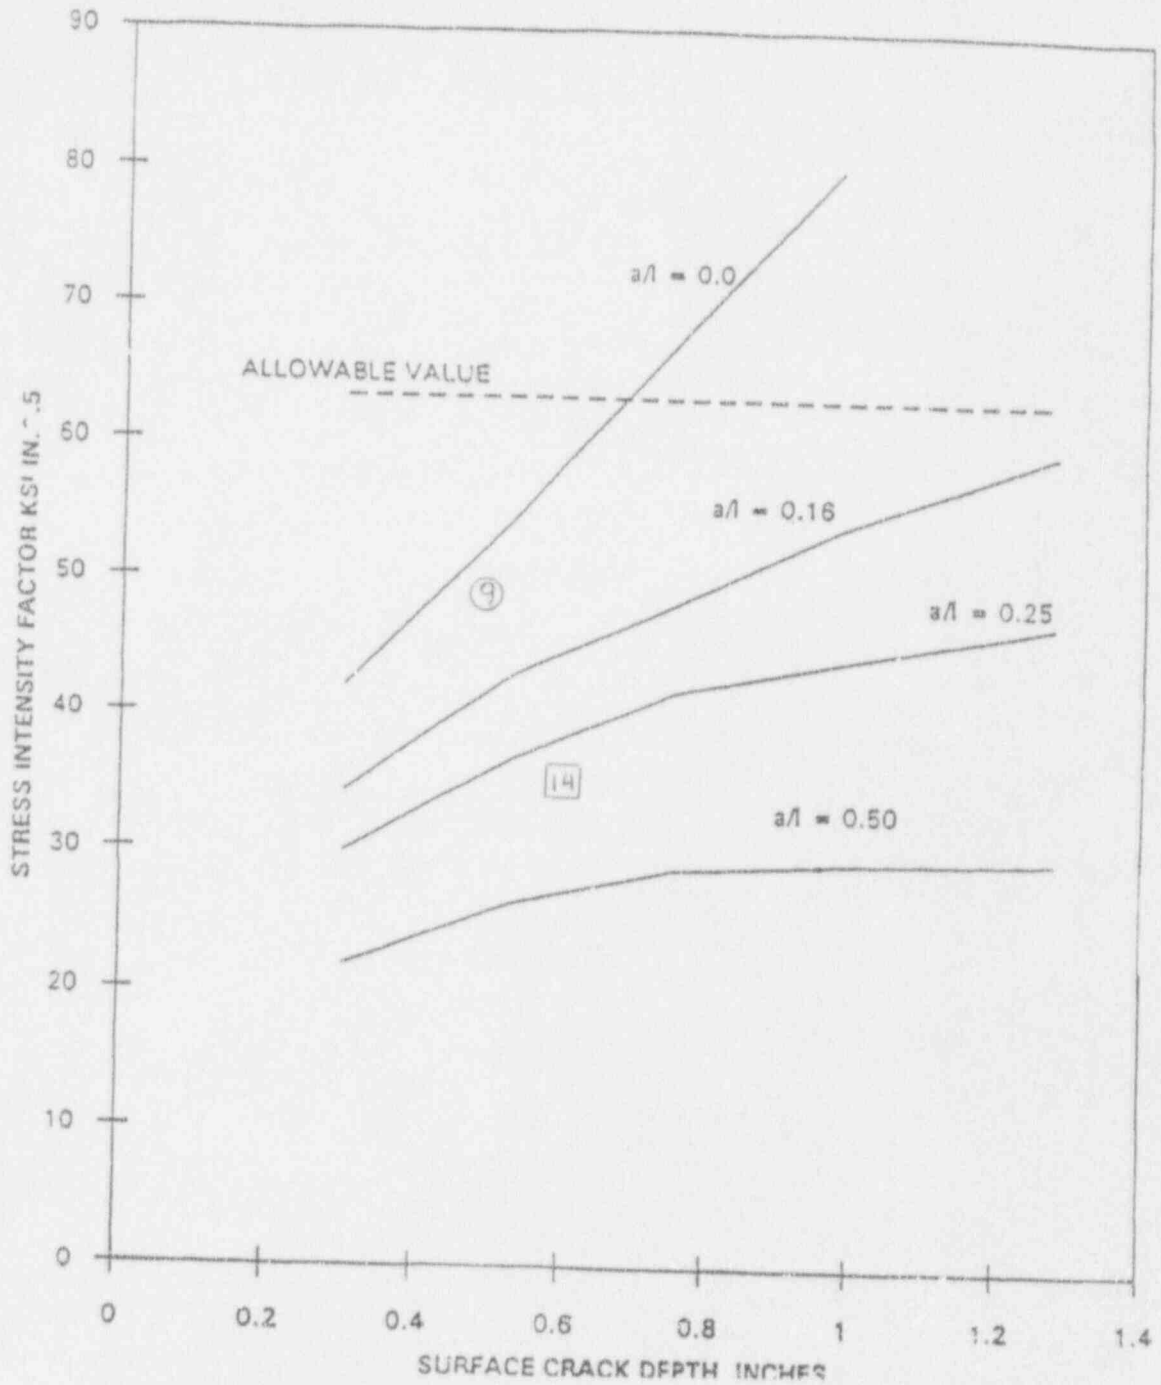
2A Steam Generator

Five indications were classified as surface. The remaining indications were classified as subsurface. The longest surface indication was 2.05 inches long (0.14 inches deep). The deepest surface indication was 0.23 inches deep and 0.85 inches long. The average surface indication was approximately 0.8 inches long and 0.15 inches deep.

One surface indication was classified as recordable and was within Section XI acceptance criteria. The remaining indications were classified as non-recordable. Two of those indications were within Section XI acceptance criteria, the other two were acceptable by fracture mechanics.

UT exams will be performed next refueling outage to monitor the indications in all four steam generators. In addition, UT examinations will also be performed as required by IWC-2420 which requires that flaws that were conditionally acceptable for service be monitored during the next inspection period which is estimated to end approximately December 1998.

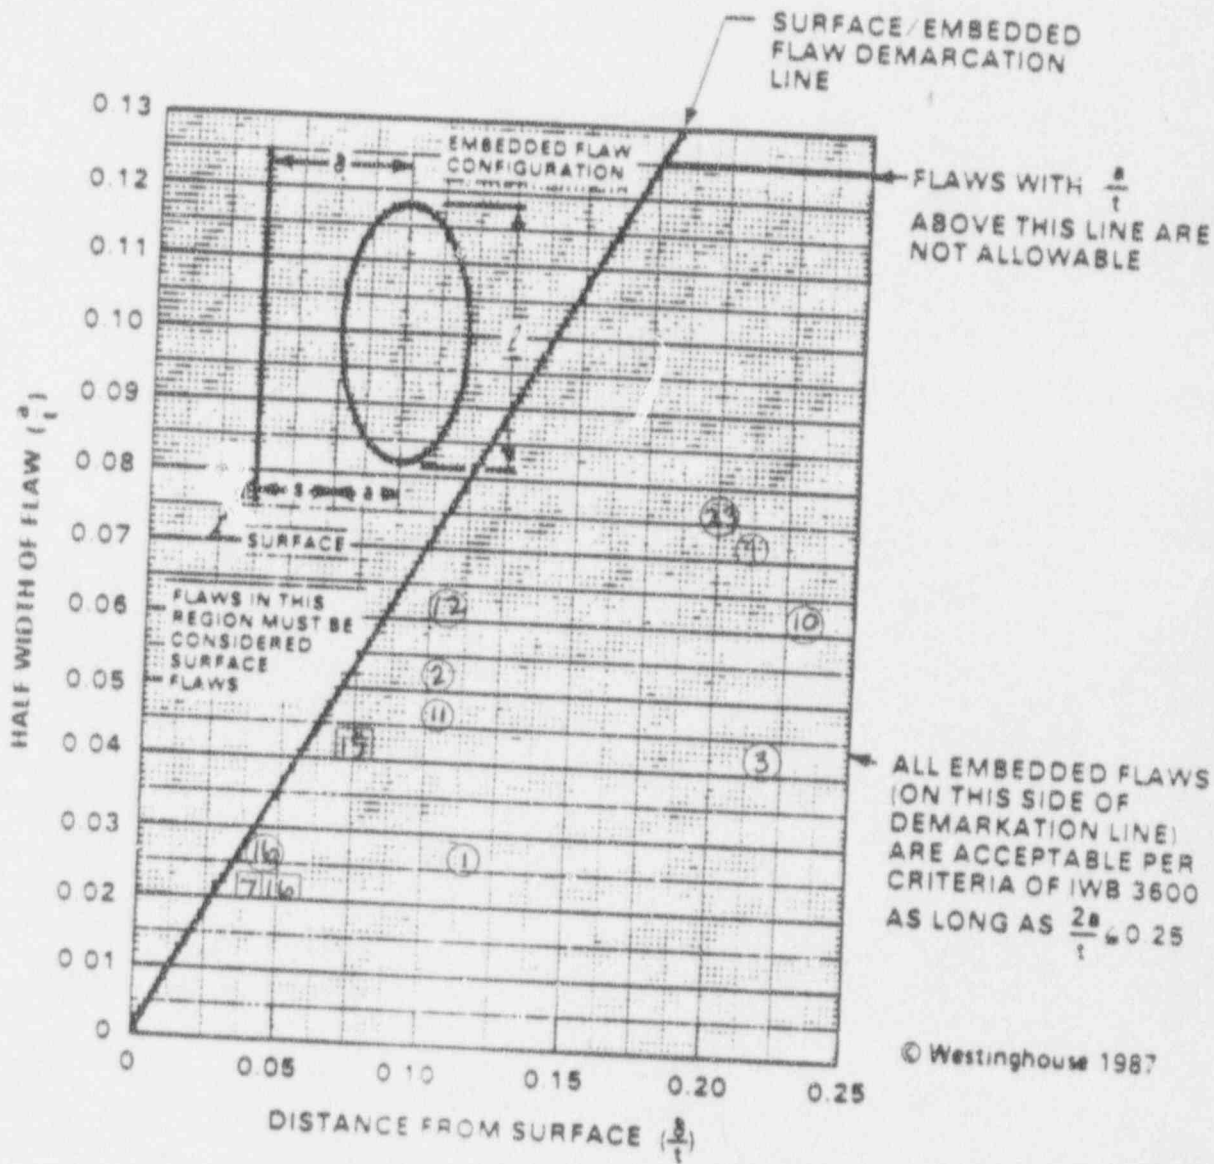
2A Steam Generator

All of the subsurface indications were either within Section XI acceptance criteria or acceptable by fracture mechanics.

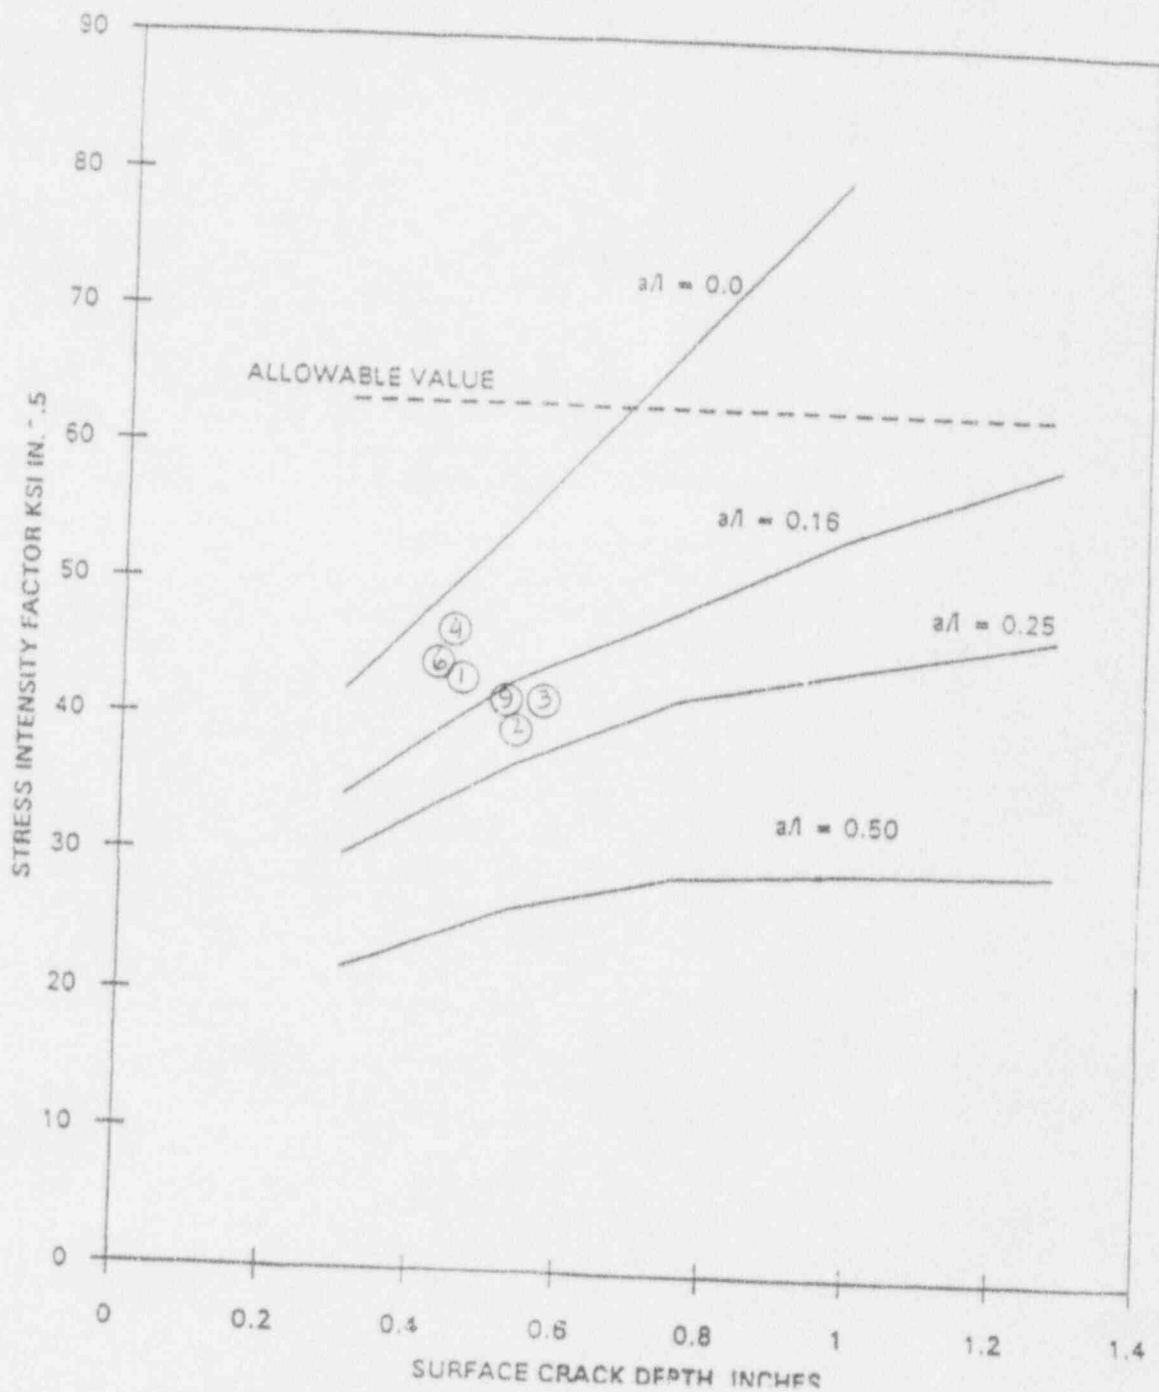
2B Steam Generator

Eight indications were classified as surface. The remaining indications were classified as subsurface. The longest surface indication was also the deepest and was found to be 1.3 inches long and 0.32 inches deep. The average surface indication was 1.2 inches long and 0.15 inches deep.

Four surface indications were classified as recordable, one of which was acceptable per Section XI criteria, the other three were accepted by fracture mechanics. The remaining surface indications were classified as non-recordable, one indication was acceptable per Section XI criteria, the remaining indications were accepted by fracture mechanics.

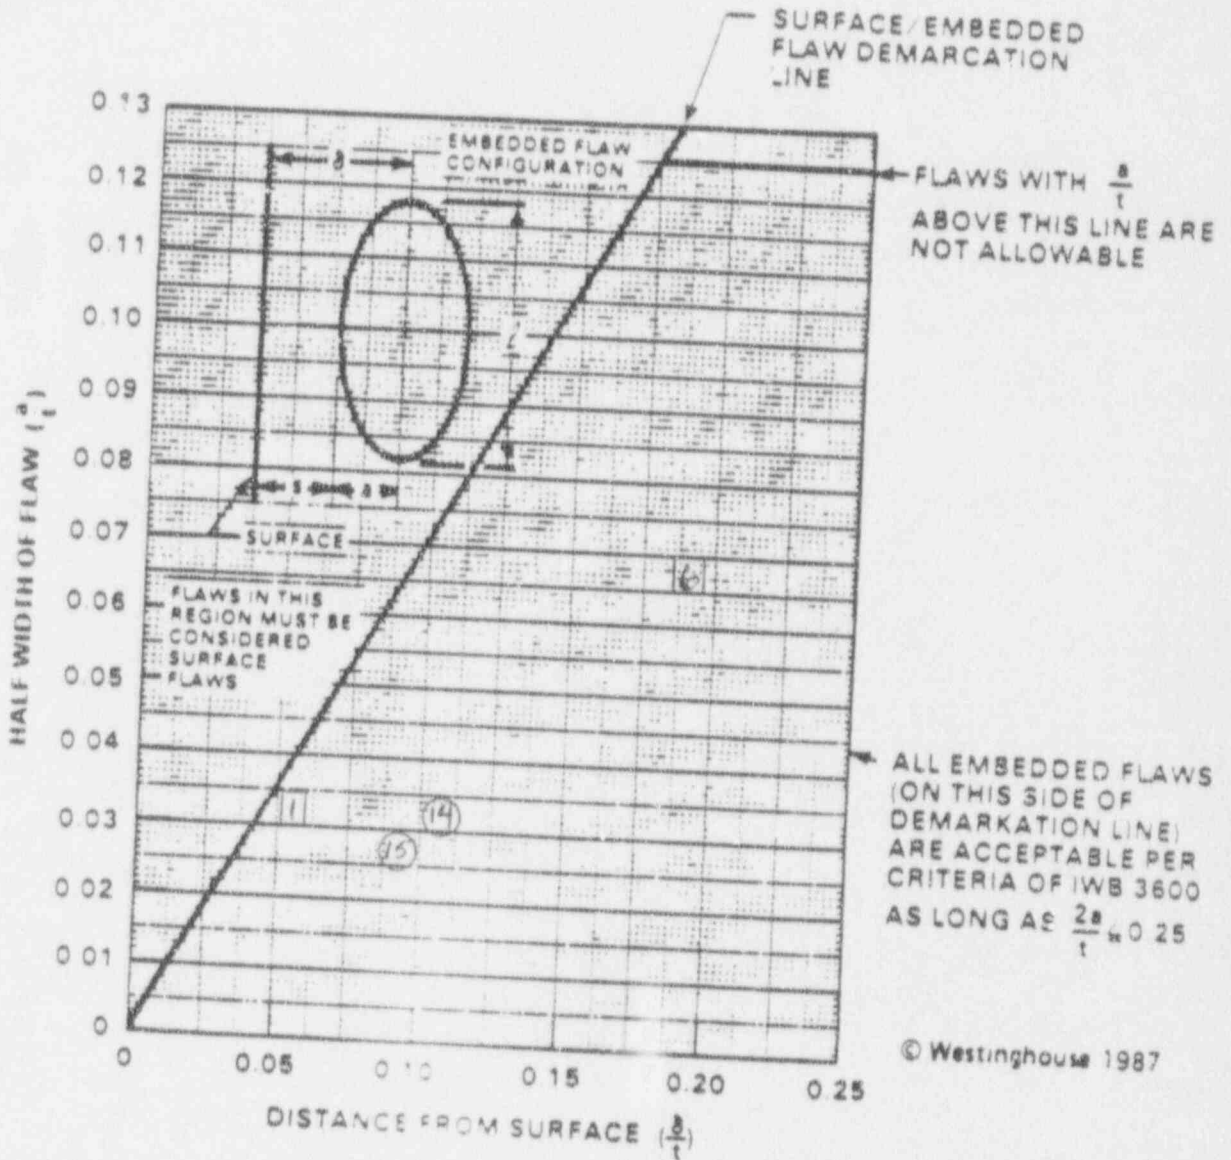
2B Steam Generator

All of the subsurface indications were either within Section XI acceptance criteria or acceptable by fracture mechanics.

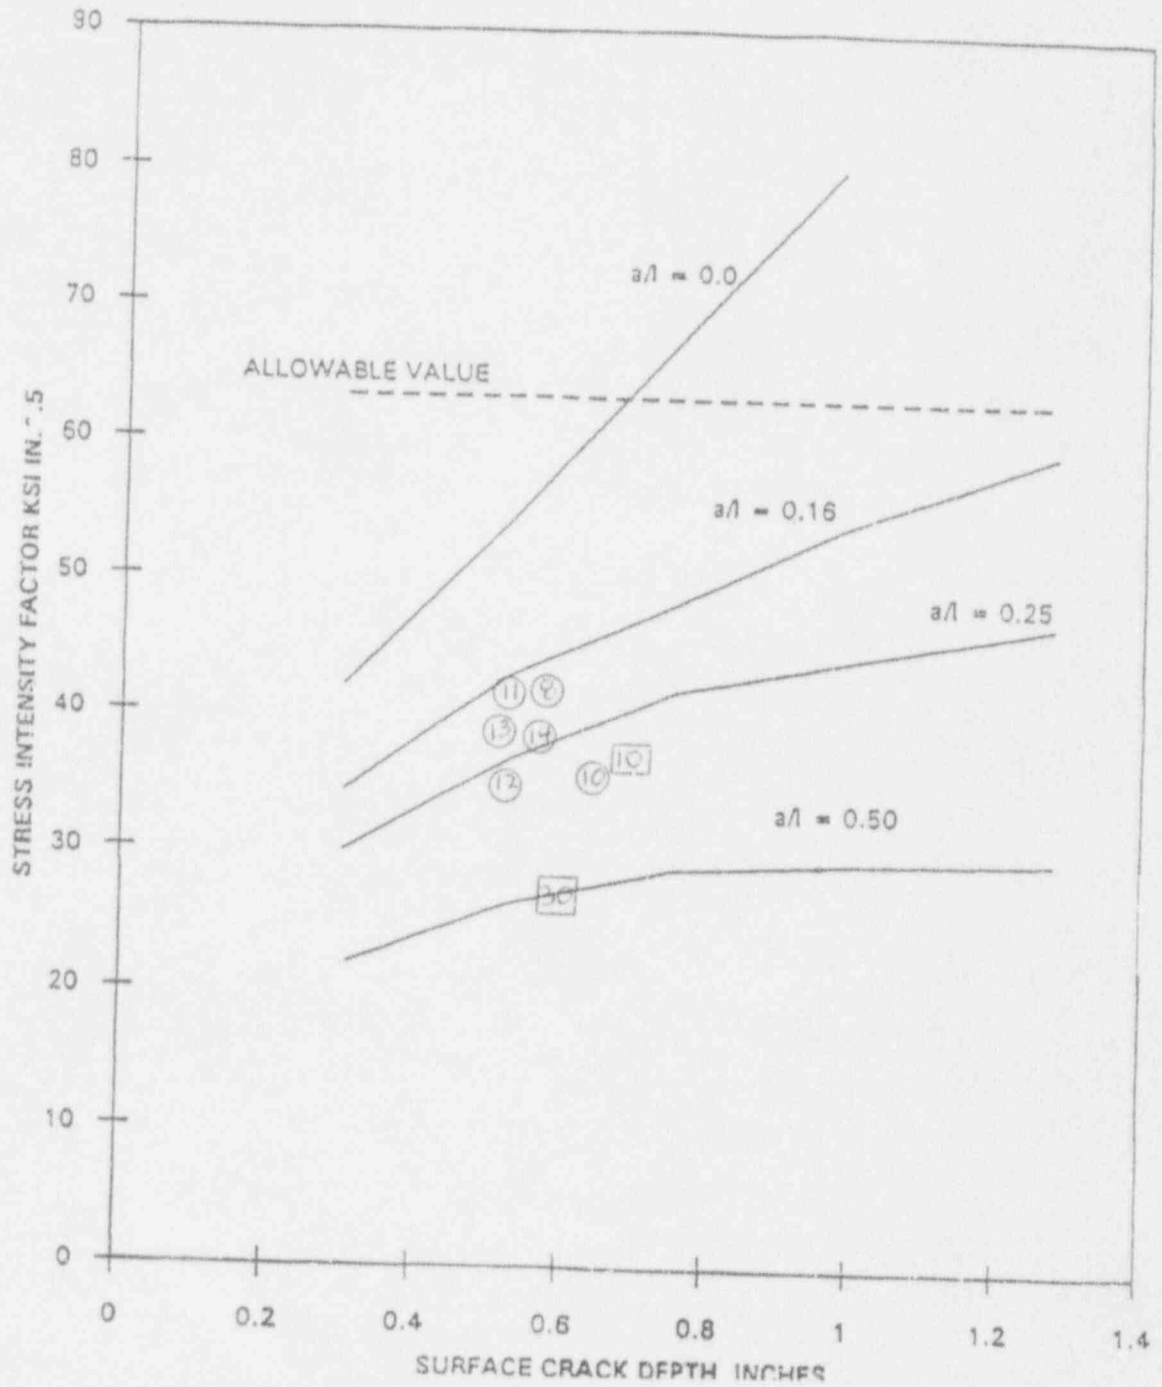
2C Steam Generator

Eleven indications were classified as surface. The remaining indications were classified as subsurface. The longest surface indication was 1.6" long and had a depth of 0.24". The deepest surface indication was 0.3 inches deep and 1 inch long. The average surface indication was approximately 0.85 inches long and 0.2 inches deep.

Two of the surface indications were classified as recordable and were acceptable per fracture mechanics. The remaining surface indications were classified as non-recordable. All of the surface indications were acceptable by fracture mechanics.

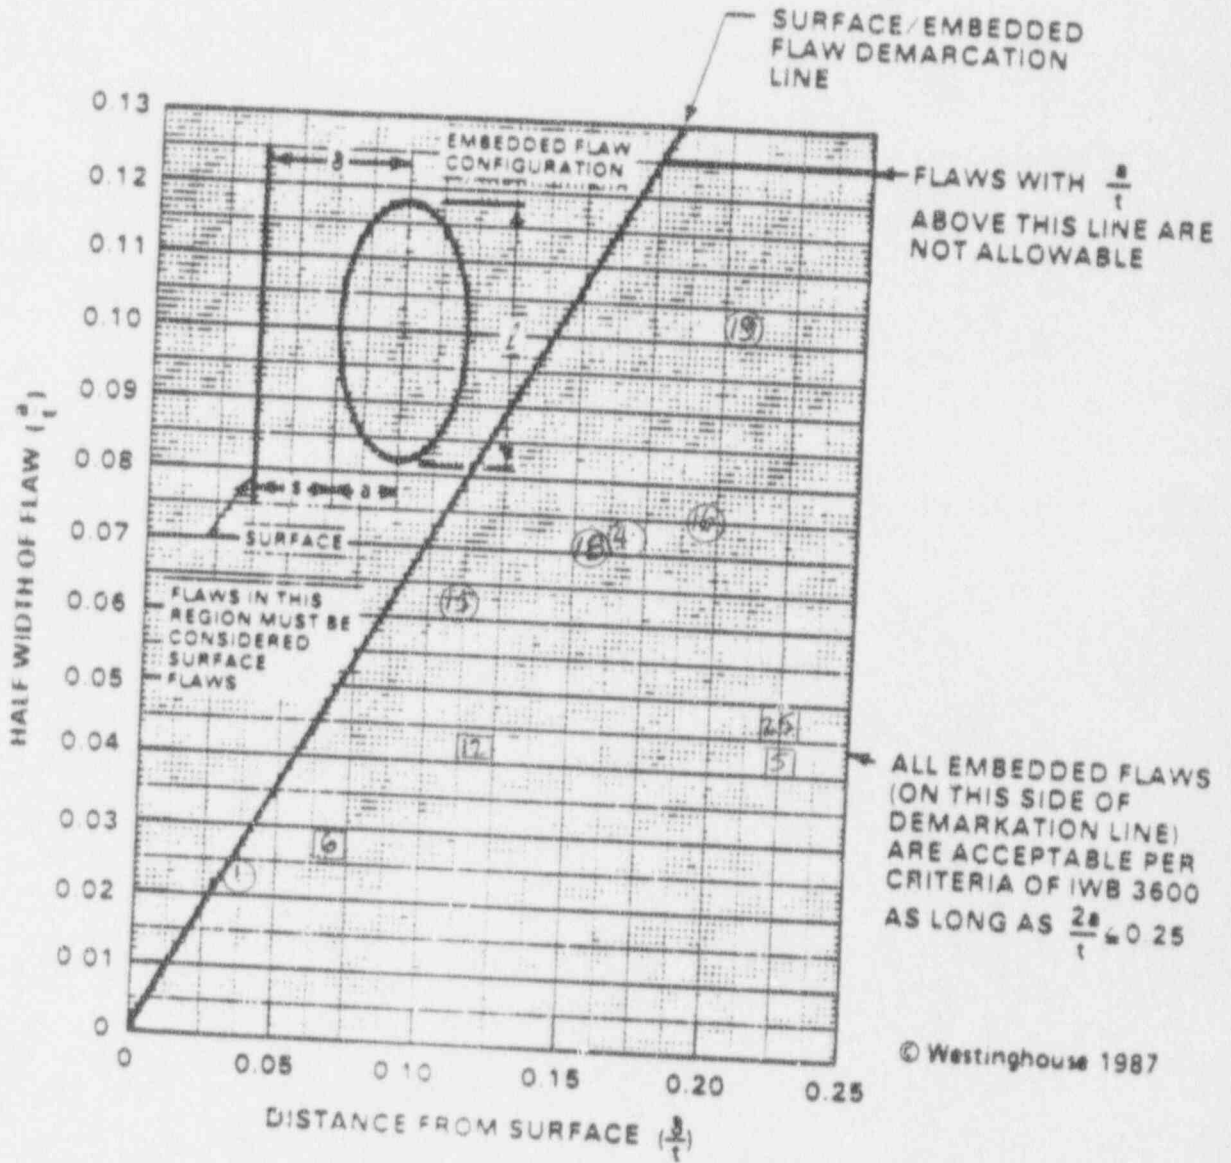
2C Steam Generator

All of the subsurface indications were either within Section XI acceptance criteria or acceptable by fracture mechanics.

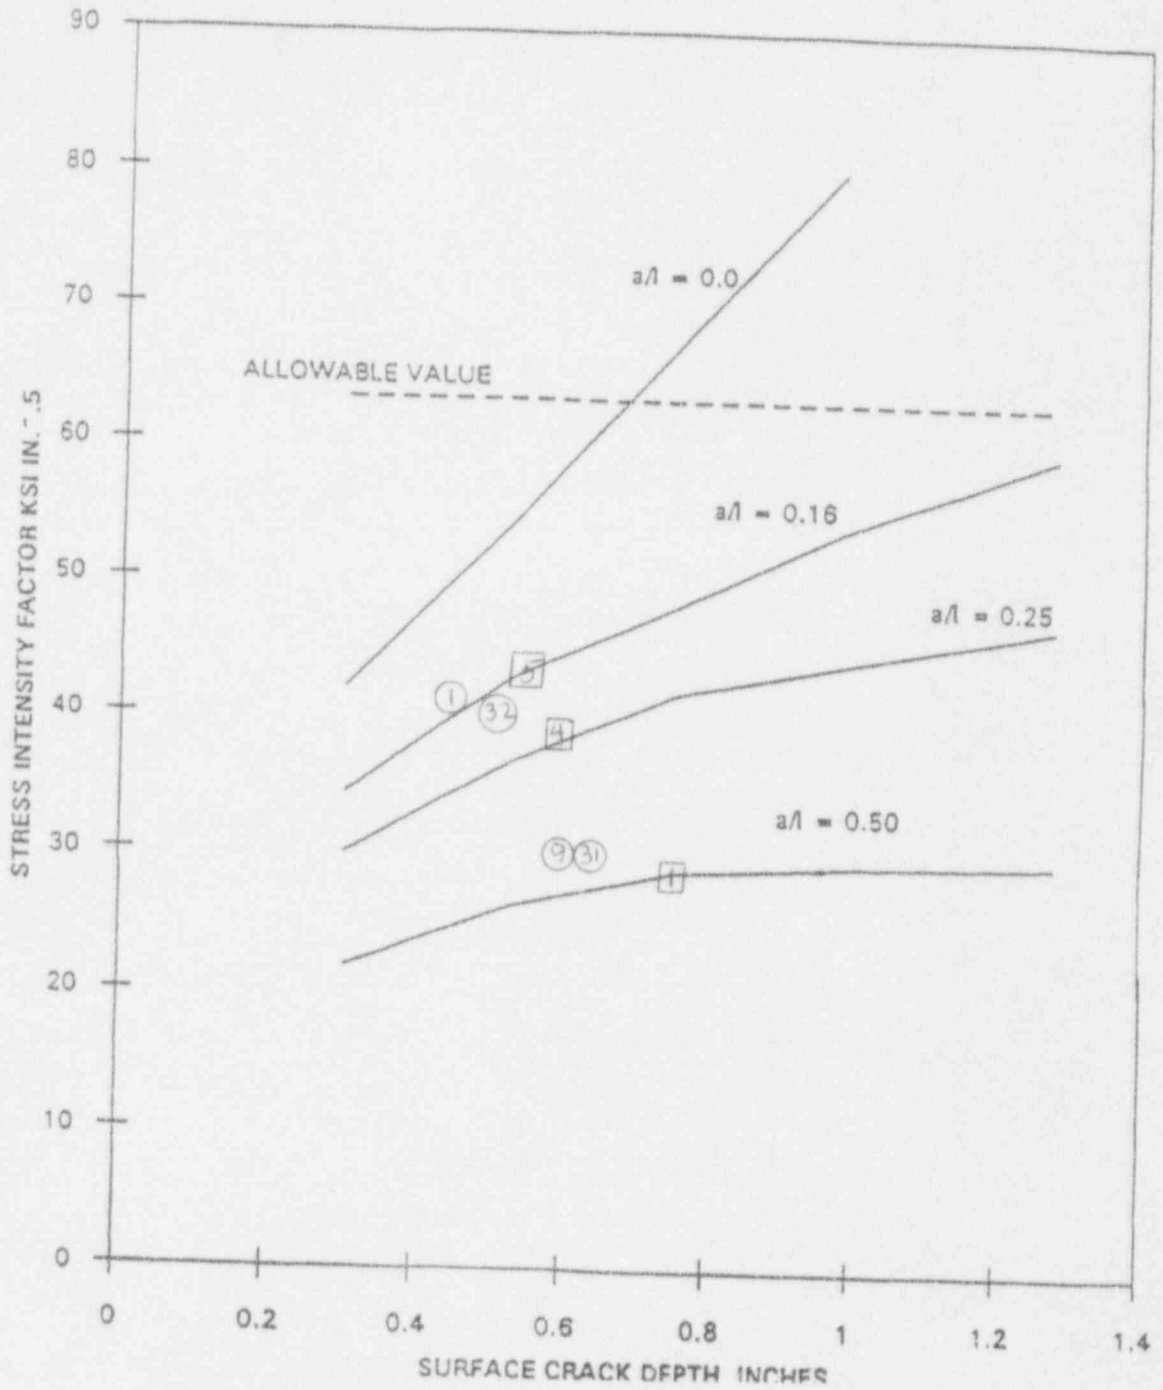
2D Steam Generator

Seven indications were classified as surface indications. The deepest surface indication was 0.8 inches long and 0.41 inches deep. The longest surface indication was 1.6 inches long and 0.2 inches deep. The average surface indication was approximately 1.2 inches long and 0.23 inches deep.

One of the surface indications was classified as recordable. The remaining surface indications were classified as non-recordable. All surface indication were accepted by fracture mechanics.

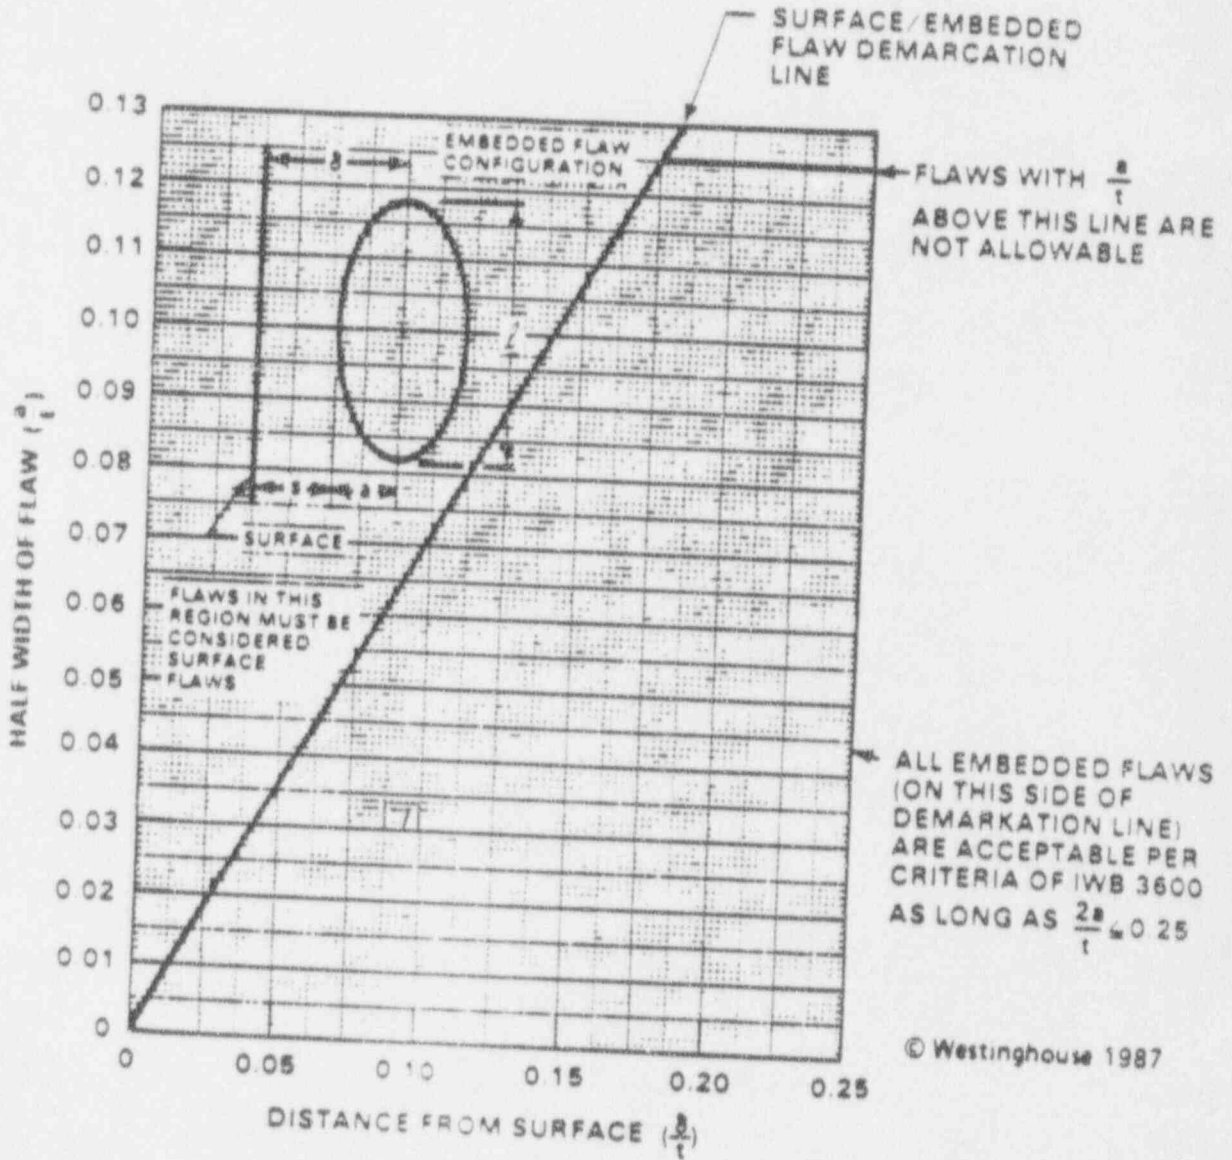
2D Steam Generator

All of the subsurface indications were either within Section XI acceptance criteria or acceptable by fracture mechanics.
