FERMI 2 TURBINE FAILURE
POST EVENT EARTHQUAKE INSTRUMENTATION DATA EVALUATION

Prepared for: Detroit Edison Company
Enrico Fermi 2 Job Site
6400 North Dixie Highway
Newport, MI 48166

Prepared by: Hopper and Associates
300 Vista Del Mar
Redondo Beach, CA 90277

February 4, 1994

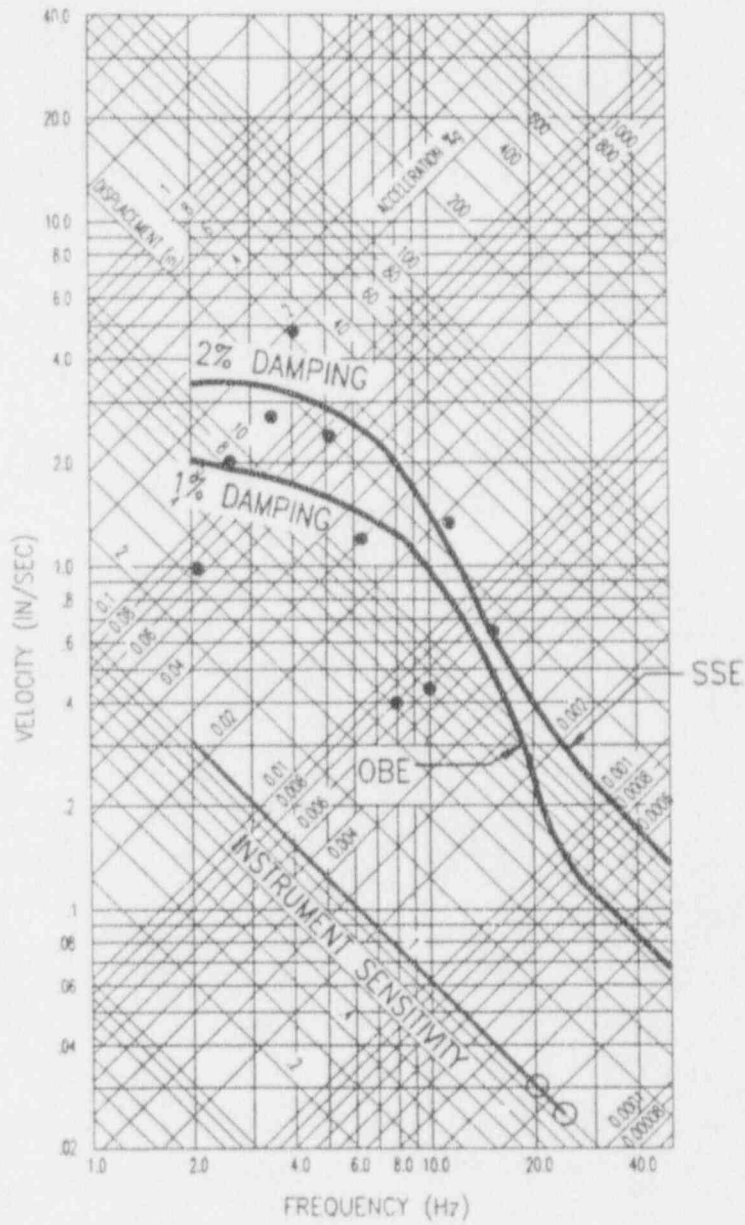
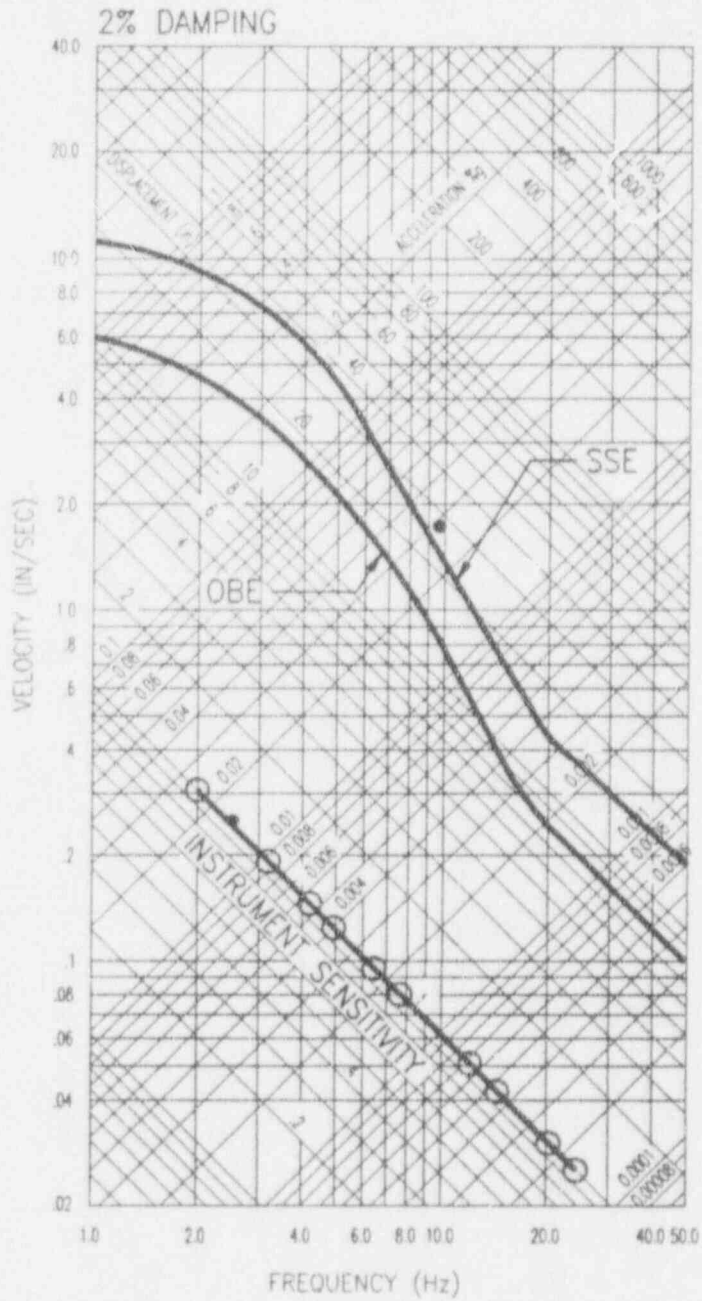
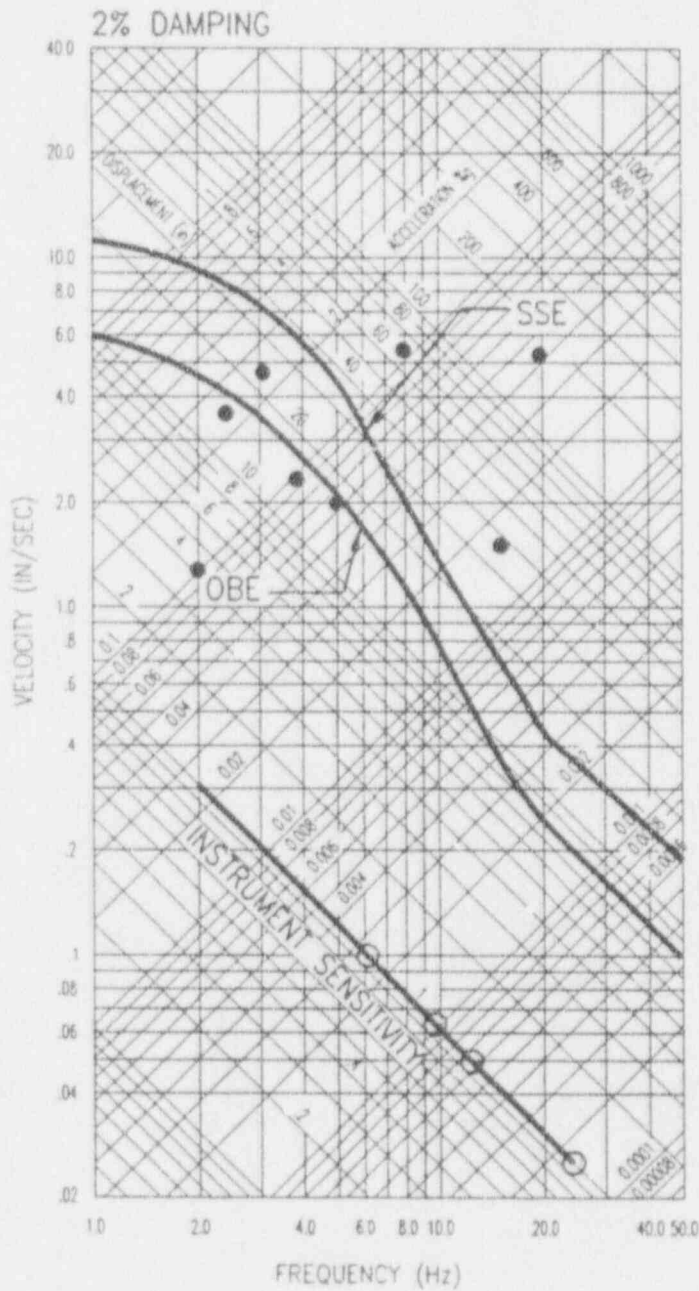
Instrumentation in the HPCI room also experienced local OBE and SSE exceedences. The active instrumentation exhibit OBE and SSE exceedences in the vertical direction, and OBE exceedences in the high frequencies in the north/south and east/west directions. The passive exhibit OBE exceedences in the low and high frequencies. The HPCI room vertical and east/west passive plates show very similar data trends and acceleration magnitudes compared to the HPCI room active vertical and east/west data records.

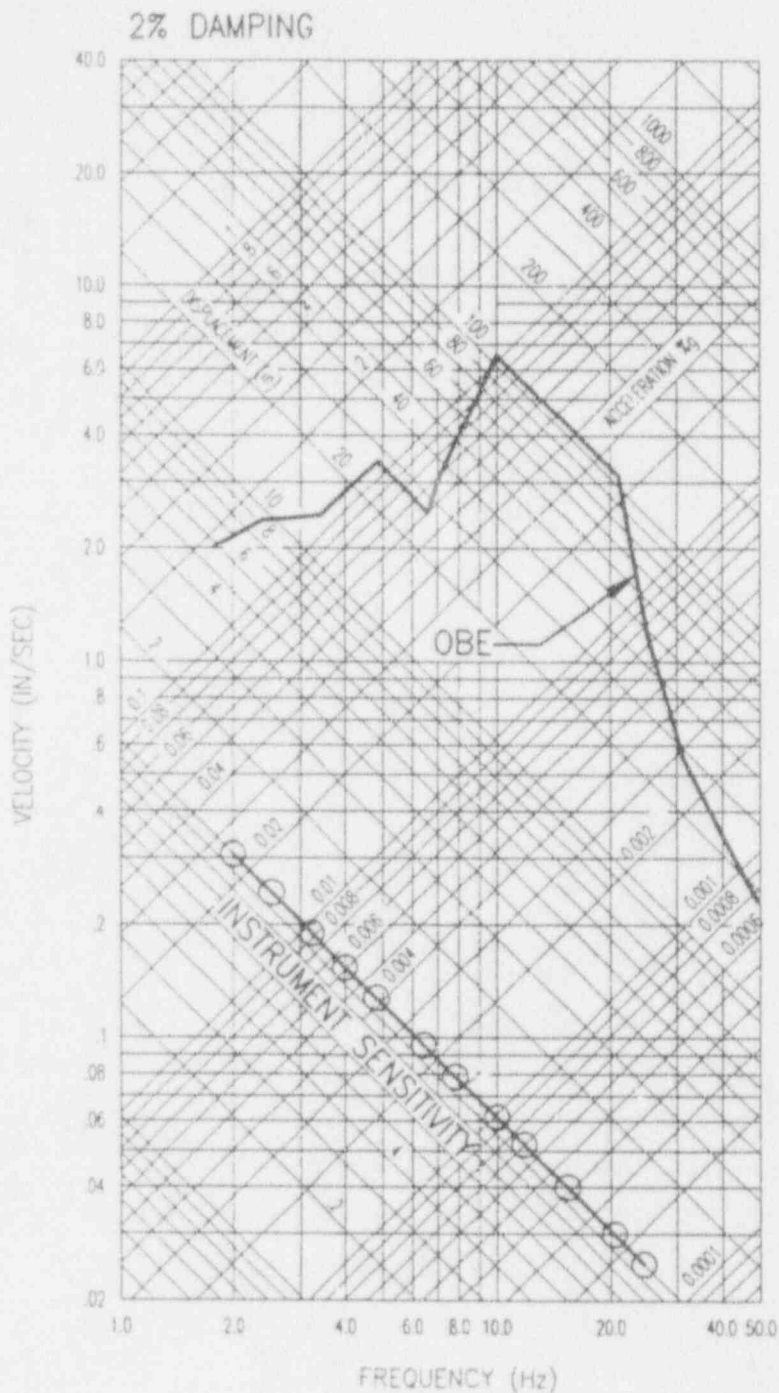
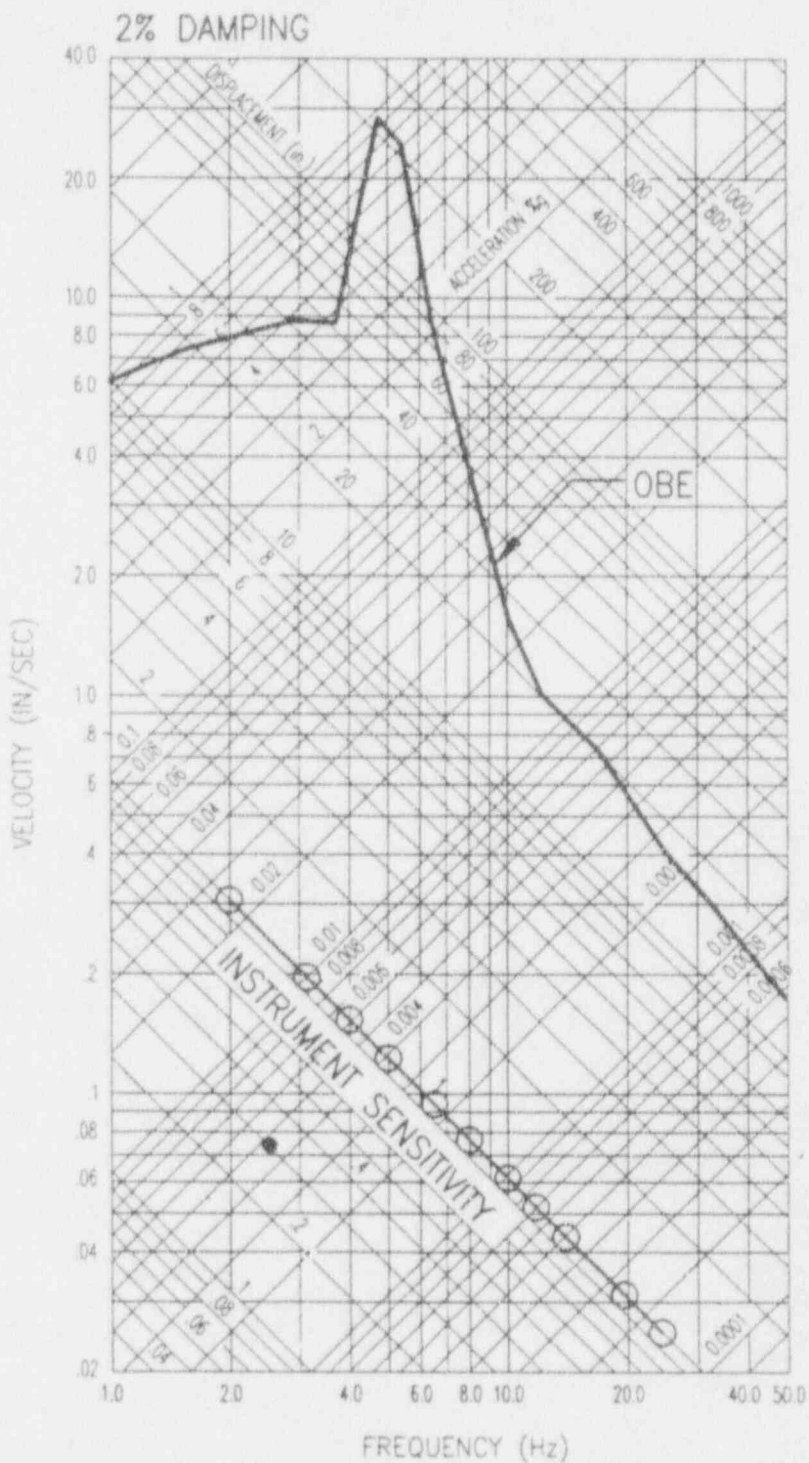
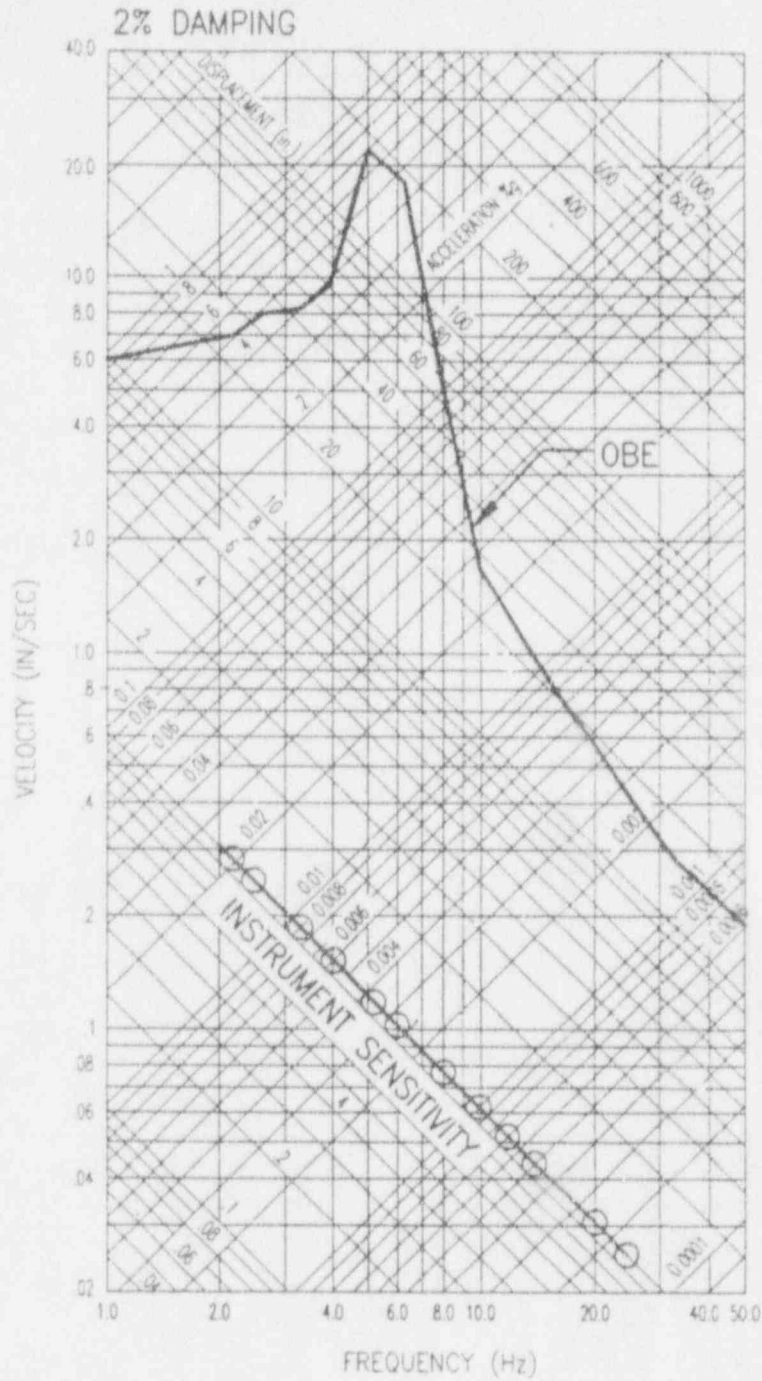
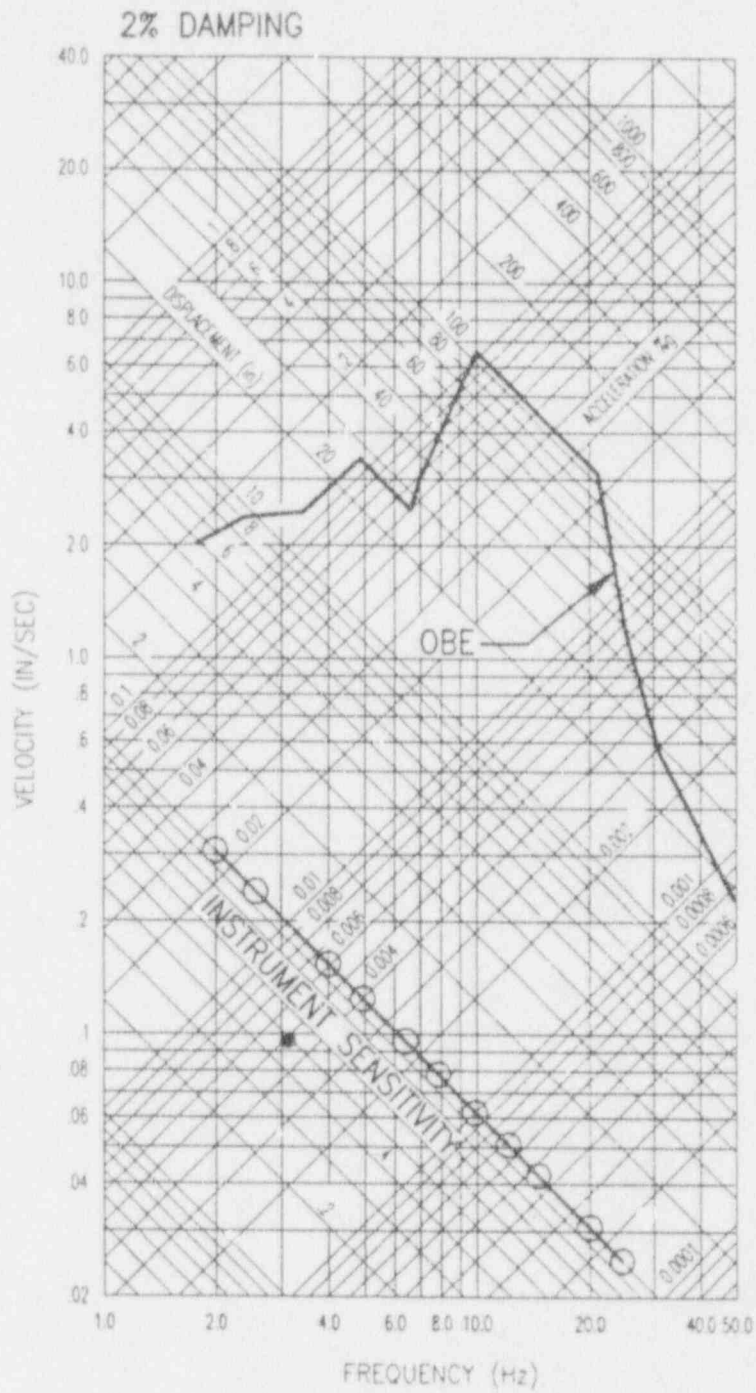
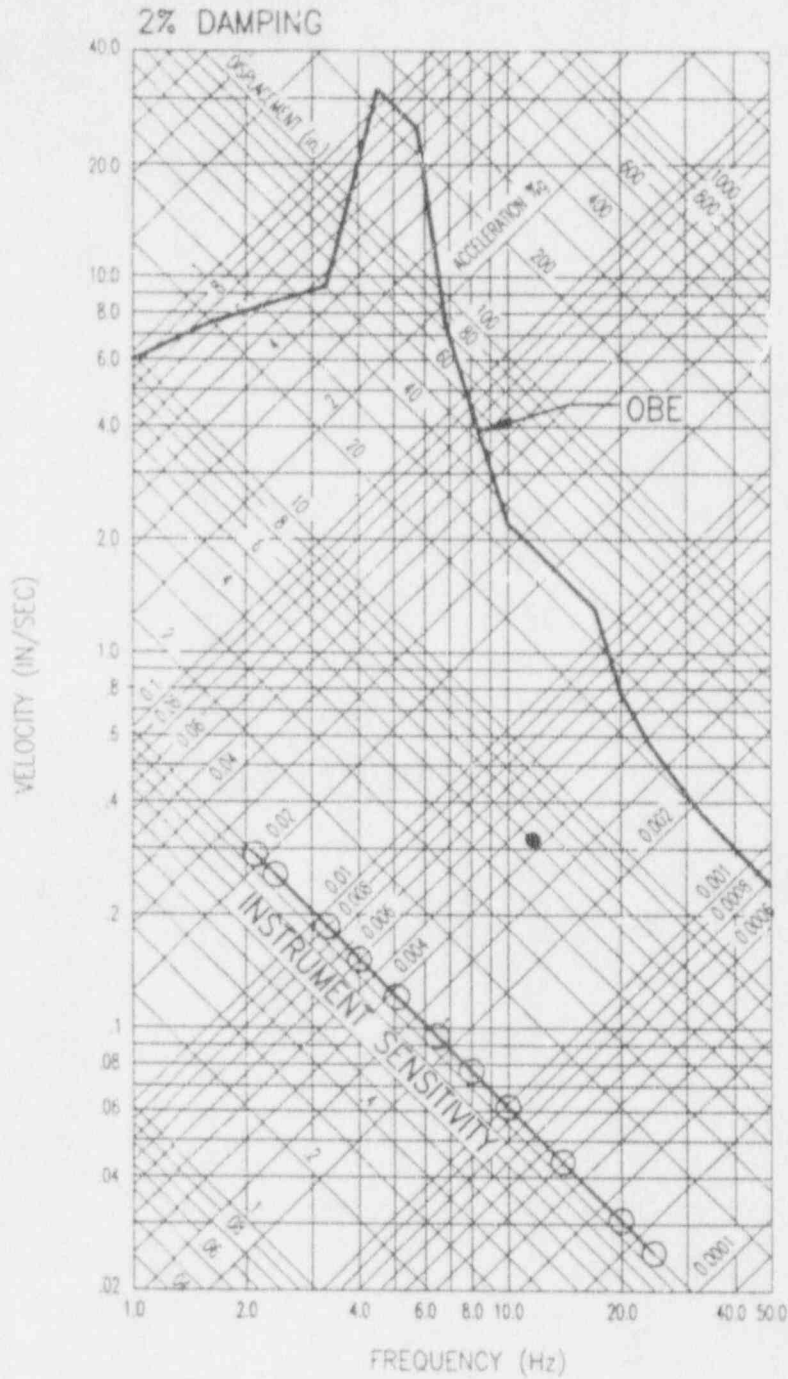
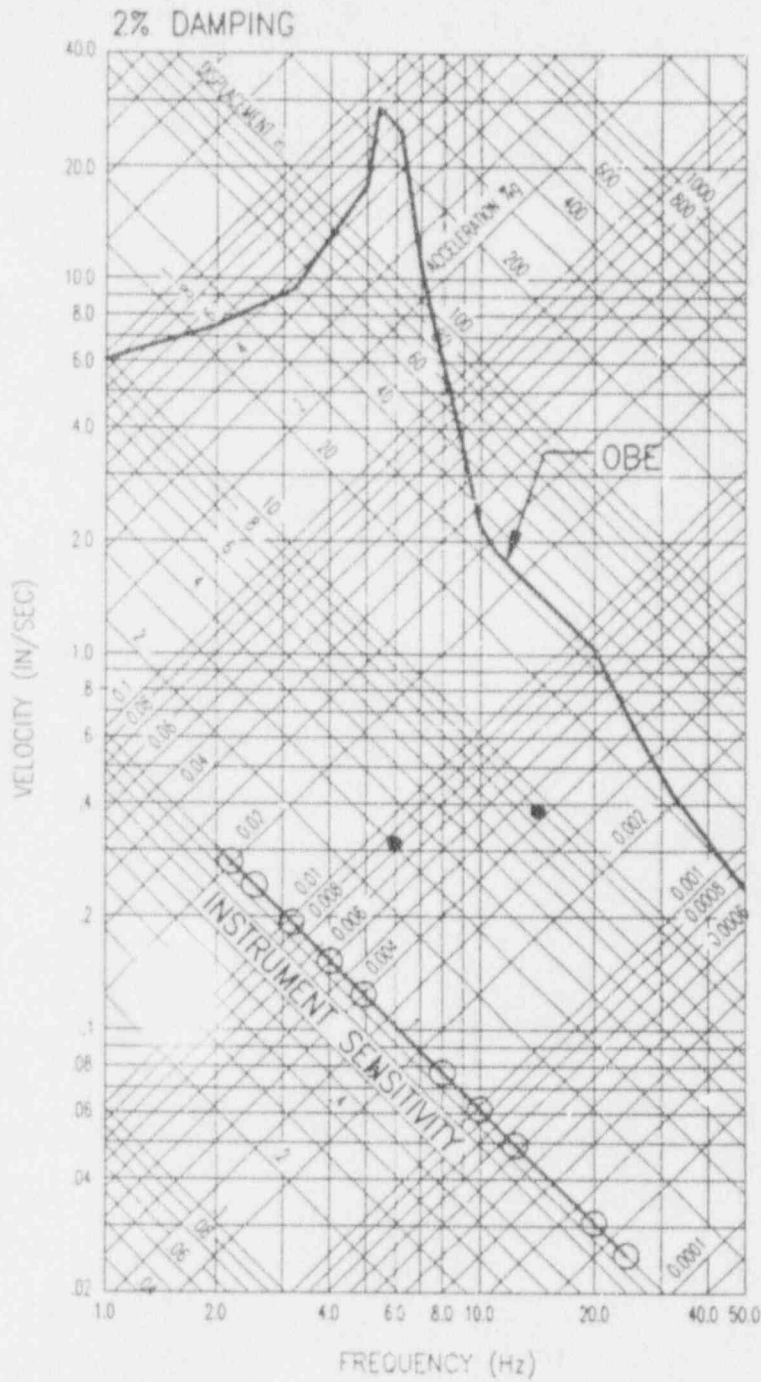
The turbine failure on December 25, 1993, did not result in a significant Reactor/Auxiliary building dynamic excitation or a building global exceedence of the OBE. This was demonstrated by the insignificant accelerations recorded by the passive sensors on the second and fifth floors of the Reactor/Auxiliary building.

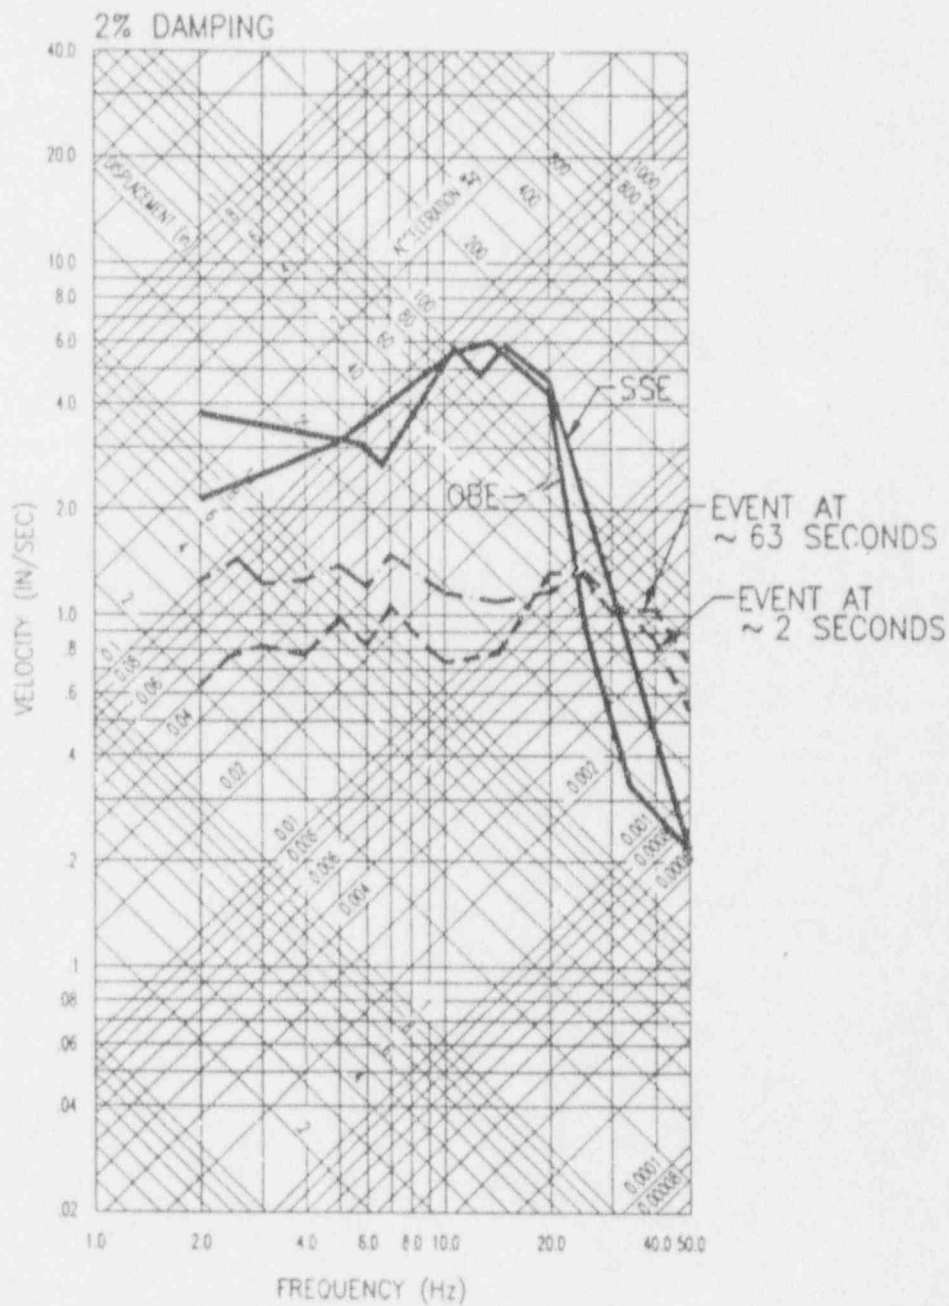
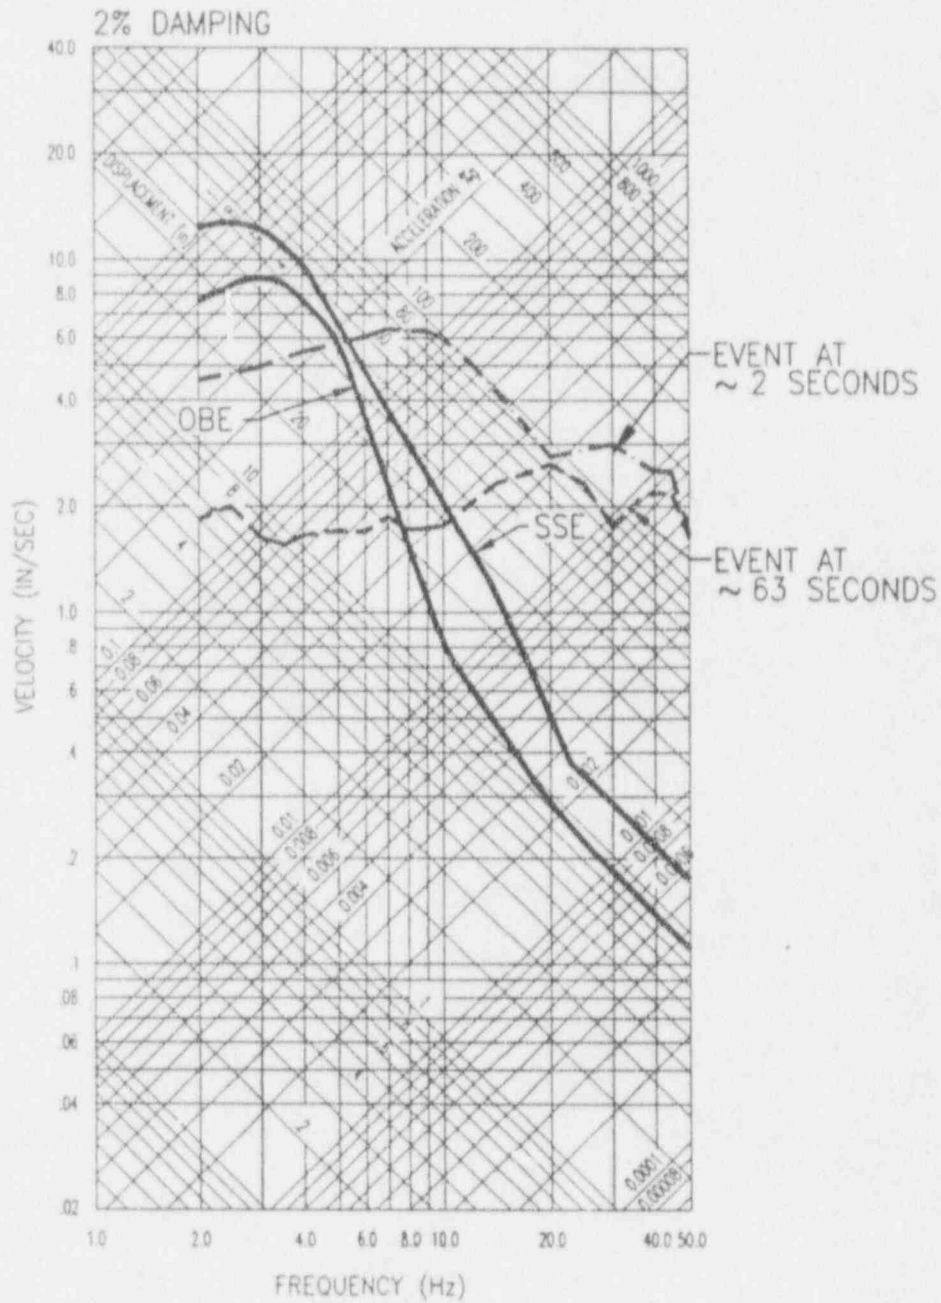
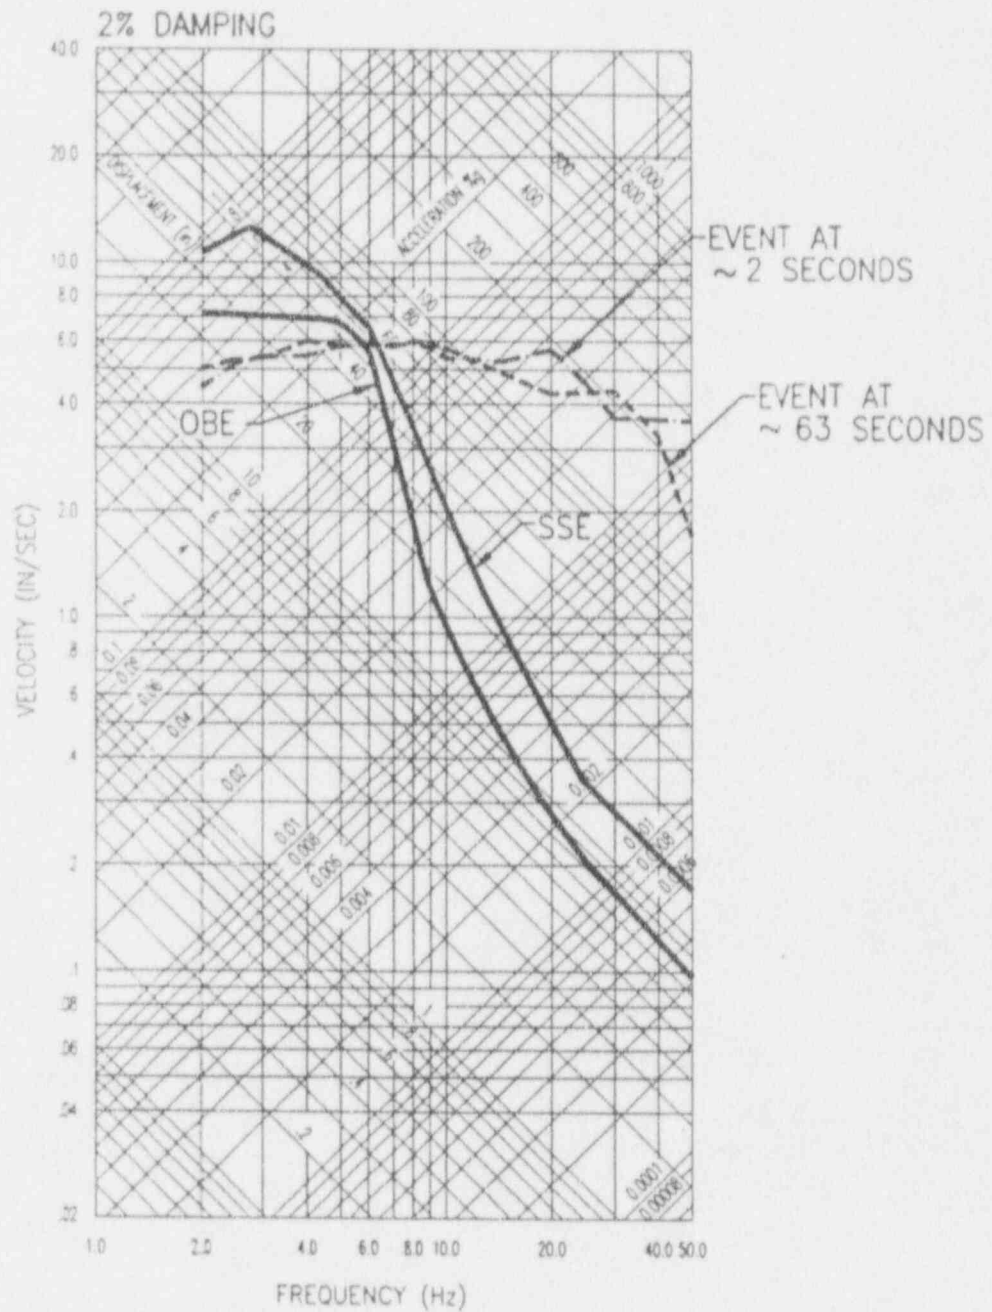
The active instrumentation at the RPV pedestal exhibit OBE and SSE exceedences at higher frequencies in all directions. The RPV pedestal sensor in the vertical direction is less severe than the HPCI room vertical direction, while the other directions are similar.

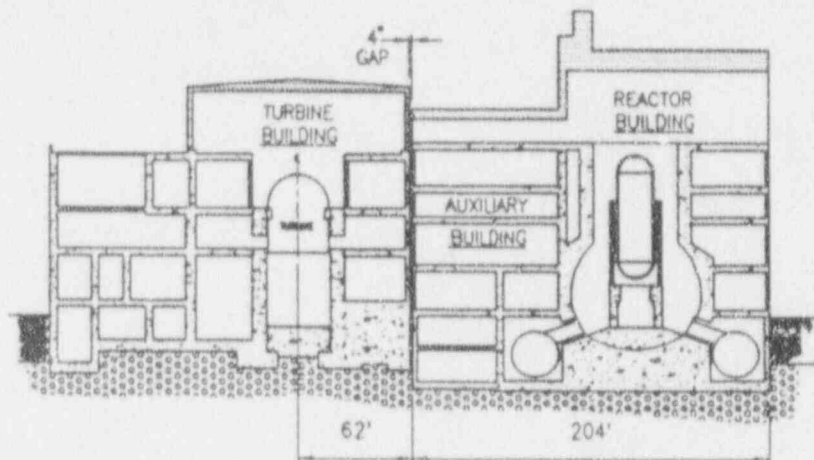
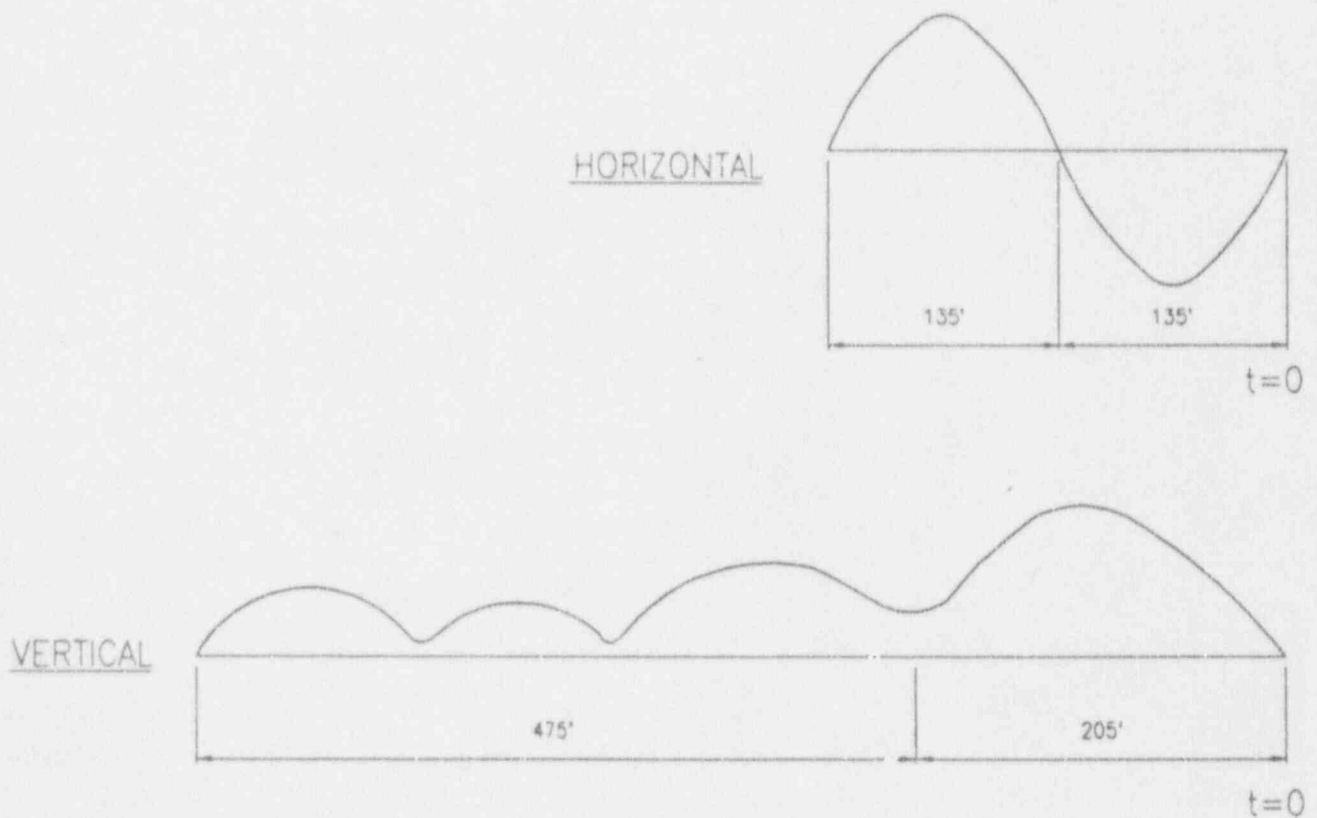
Figure 4.0.1

The turbine failure at Fermi 2 on December 25, 1993, should not be compared with a tectonic earthquake, and globally, the Reactor/Auxiliary building did not experience OBE excitation levels. The turbine failure was a shock incident, resulting in dynamic response phenomena or two single cycle waves propagating through the building foundation without exciting the structure above (Figure 4.0.1).

The shock wave length resulting from the turbine event at Fermi 2 was small compared to the building, and therefore produced local high accelerations, but the short duration, low energy, and small deformations associated with these high frequency accelerations did not compromise the structural integrity of the Reactor/Auxiliary building or the equipment therein.

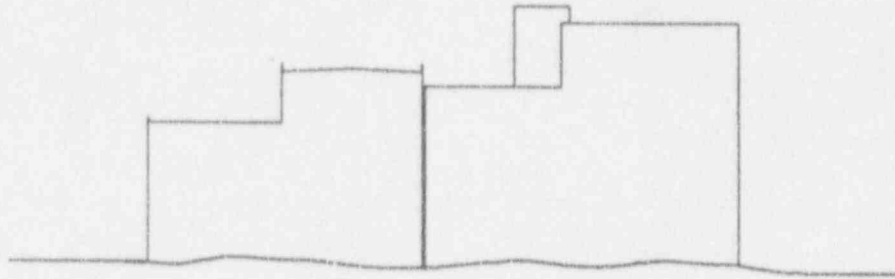
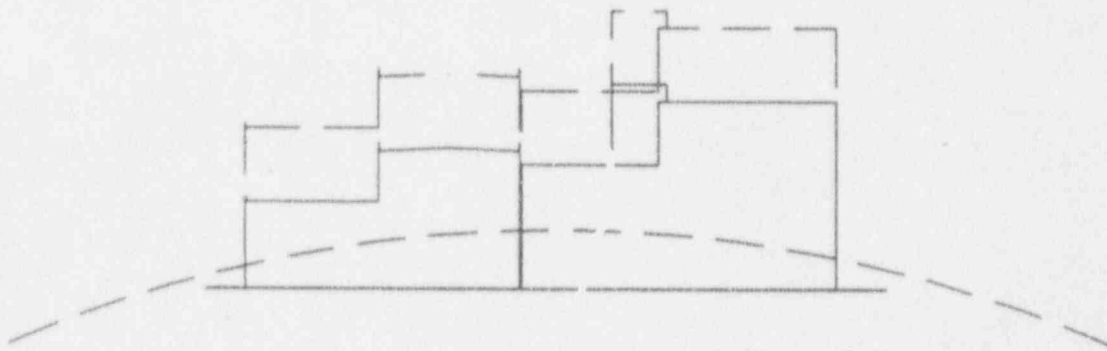
Figure 4.0.2

An earthquake imparts long duration, broad range frequencies, and high energy into a structure, while a shock impulse imparts short duration, high amplitude, and low energy into a structure. Industry standards recognize shock impulses do not cause significant structural stresses (Figure 4.0.2).
