U.S. NUCLEAR REGULATORY COMMISSION

Report Nos. 50-266/94002(DRP); 50-301/94002(DRP)

Facility Name: Point Beach Units 1 and 2

Dates: January 19 through February 28, 1994

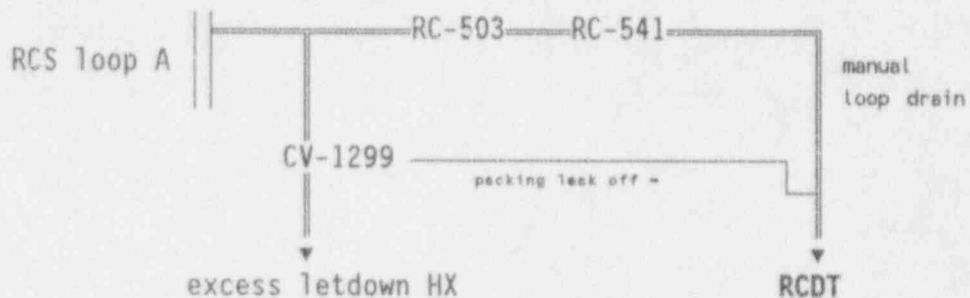
[figure 1.]

Operators entered containment to attempt locating the leak. Drainage piping leading to the RCDT from the A reactor coolant system (RCS) loop was found to be hot. Since the leakage was hot and flowing into the RCDT, this indicated that the leakage source was limited to either seepage past normally shut RCS loop A manual drain valves (RC-503 and RC-541) or a packing leak from the excess letdown heat exchanger inlet isolation valve (CV-1299). A simplified piping diagram appears in figure 1 below. Because

motor operated valve CV-1299 was the only one of these valves to have been operated during the lineup for excess letdown, it was suspected as the leakage source.

To reduce radiation levels sufficiently to permit access to the area of the coolant loop near these valves, reactor power was reduced to slightly below 2% and the generator was taken off line at 5:14 a.m. Upon entry into the area, personnel discovered that the leakage was not from CV-1299 packing, but seepage past valves RC-503 and RC-541. Apparently, the thermal shock of establishing excess letdown flow was sufficient to cause one or both of these valves to come off of their seats (one valve could have initially been off its seat). Each valve was able to be operated in the

shut direction about one-quarter turn, which stopped the leak. All leakage was contained within reactor coolant holding systems.

About two hours after initial identification of the leak, repairs on the normal letdown path were completed, normal coolant letdown was restored, and CV-1299 was shut to isolate the excess letdown flow path. However, this did not affect the leak rate, which was determined to be about 2 gpm. Plant management directed that the valve be cycled open and shut, but this still had no effect on leak rate. Further attempts at leak mitigation, including backseating the valve and increasing its closing torque, also had no effect on leak rate. The inspectors closely monitored the licensee's activities.

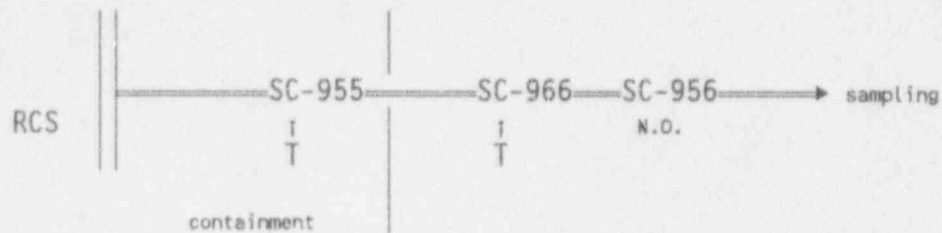
[figure 2.]

On February 17, plant management determined that one of two containment isolation valves on a coolant sample line was not missile protected and therefore did not satisfy the criteria for a containment isolation valve. This condition, which applied to both units, caused the plant to be outside its design basis and was reported to the NRC as required.

The coolant sample lines contain two trip valves (SC-955 and SC-966), one inside and one outside containment. Additionally, normally open manual isolation valve SC-956 is located downstream of SC-966. Trip valve SC-955 was found to not be missile protected. A simplified diagram appears in figure 2 below.

The Point Beach FSAR listed valves SC-966 and SC-956 as the containment isolation valves. However, manual valve SC-956 is neither leak tested nor qualified as a containment boundary. Both the trip valves are routinely leak tested. Plant management justified continued operation based on the low probability of a missile event damaging SC-955 coincident with a failure of SC-966. Corrective action was being evaluated with consideration being to provide missile protection for valve SC-955.

An evaluation had already been in progress to reclassify the containment isolation valves in accordance with current design criteria. The evaluation scope included all containment isolation valves listed in the FSAR. The project goal was to designate two trip valves at each containment penetration as the isolation valves and eliminate reliance on manual valves. This project resulted in the identification of the current condition in this system. This issue remains unresolved pending completion of the evaluation and subsequent review by the inspector (266/94002-03).
