U.S. NUCLEAR REGULATORY COMMISSION

Report No. 030-02809/94-001(DRSS)

Licensee: Bethesda Hospital  
619 Oak Street  
Cincinnati, OH 45206

Areas Inspected: This was an announced special inspection conducted in response to a licensee reported incident and potential misadministration involving a dislodged cesium-137 sealed source used in a brachytherapy treatment. The inspection also included a review of the licensee's organizational structure; facilities and equipment; training for nurses; Quality Management Program (QMP) for conventional brachytherapy; and activities associated with the High Dose Rate (HDR) remote afterloading brachytherapy device.

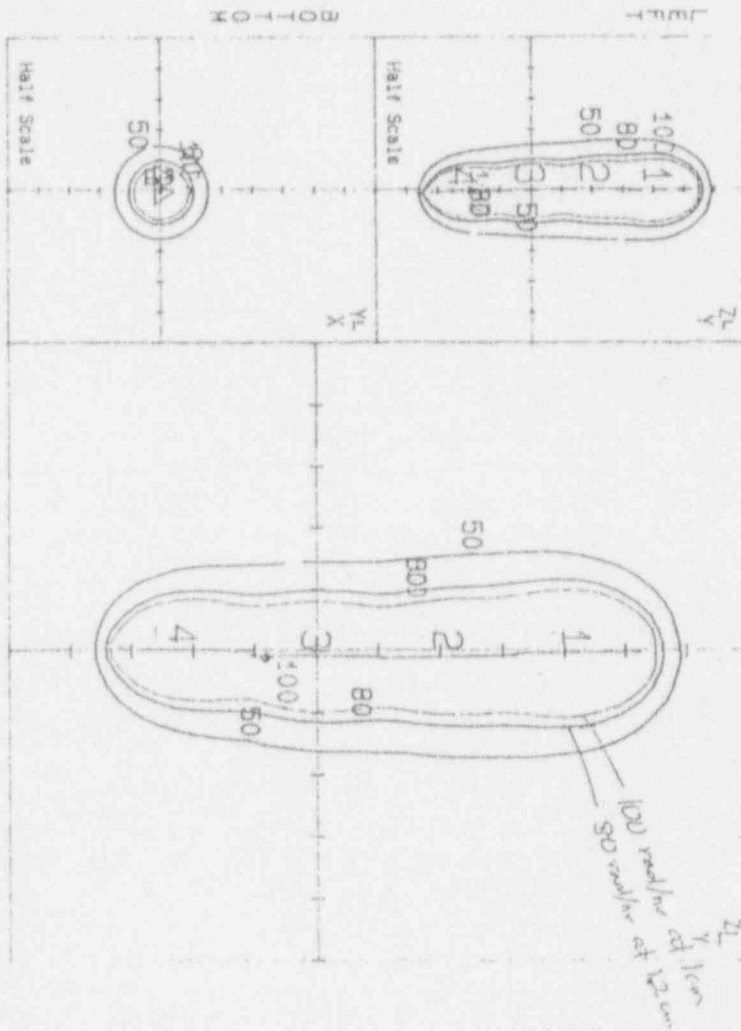
SLICE NO. 1    OFFSET 0.0

The licensee's written directive for this treatment was a combination of two documents, the "Sealed Source Request Form" (Attachment 2) and the treatment plan (Attachment 3). The written directive indicated that the authorized user prescribed 2,000 rads (cGy) at 1.2 centimeters or 24 hours. The inspection disclosed that the authorized user marked a simulator film to indicate the location of the prescribed dose. According to the authorized user, the 2,000 rad (cGy) dose was prescribed to a point located nearly 1.2 centimeters lateral to the 30 millicurie (1.1 GBq) cesium-137 source.

The written directive appears to provide conflicting information since a 24 hour treatment time at 80 cGy/hr (the dose rate at 1.2 cm from the 30 millicurie source) gives a dose of 1920 rads (cGy), not 2000 rads (cGy). The inspection confirmed that the authorized user initially intended to have the sources implanted for a 24 hour period. The 80 cGy/hr contour indicated on the treatment plan was used as an approximation for both location and dose. The licensee later calculated the exact dose rate at 1.2 cm lateral to the 30 millicurie (1.1 GBq) source to be 73.1 rads/hr (cGy/hr). On the basis of this calculation, the total dose prescribed for a 24 hour treatment period is 1753 rads (cGy).

ORIGINAL  
WRITTEN  
DIRECTIVE

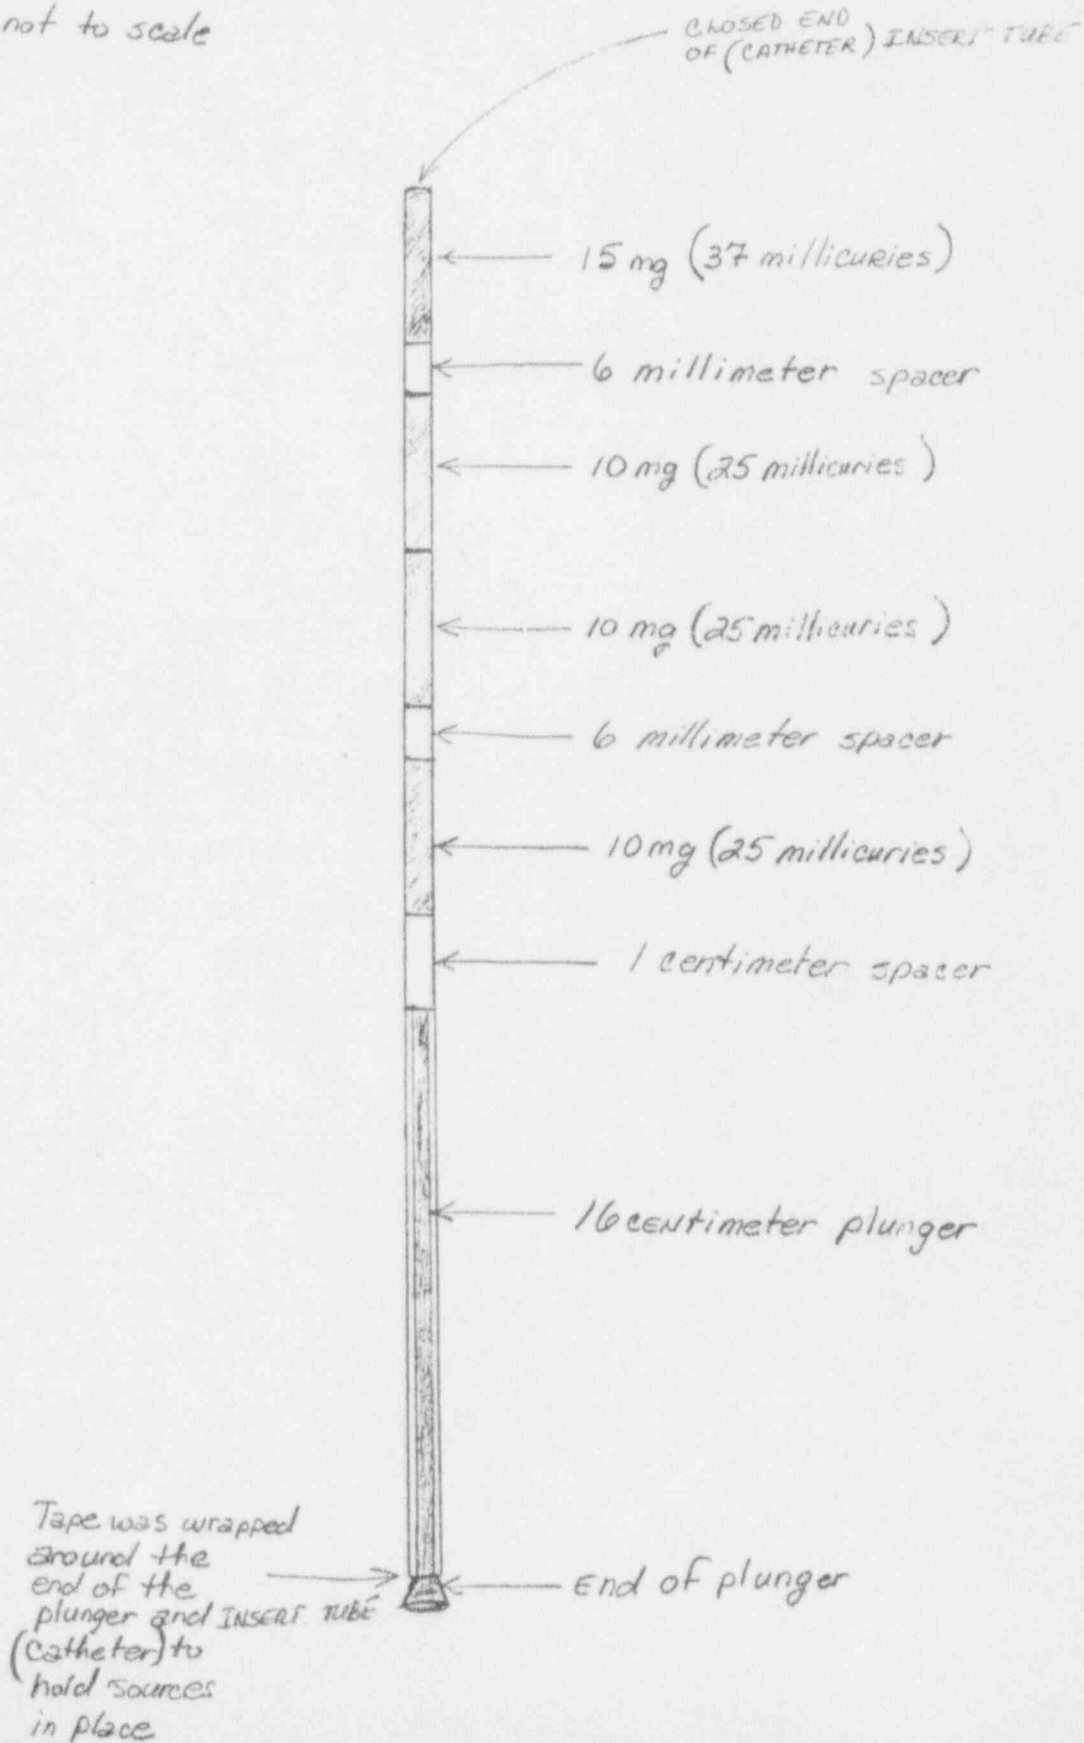
- (2) The cesium-137 sources were held in place by a "plunger" that was taped to the insert tube. The medical physicist stated that he wrapped tape around the "plunger" and insert tube two or three times as he usually did for vaginal implants. A few wraps of tape around a insert tube is sufficient for vaginal implants because the insert tube is inserted into an applicator that can be sealed at the end. In this case, however, the tape around the insert tube did not hold and the "plunger," spacer, and a cesium-137

source fell out of the insert tube. After this incident, the medical physicist admitted that to secure the "plunger," he should have taped over the end of the "plunger" and then wrapped tape around the circumference of the insert tube and "plunger."

The most distal source is assumed to have stayed in place for the duration of the treatment. Due to a slight kink near the end of the plastic insert, the dosimetrist found it difficult to dislodge the source from this position in the insert when she returned the sources to storage.

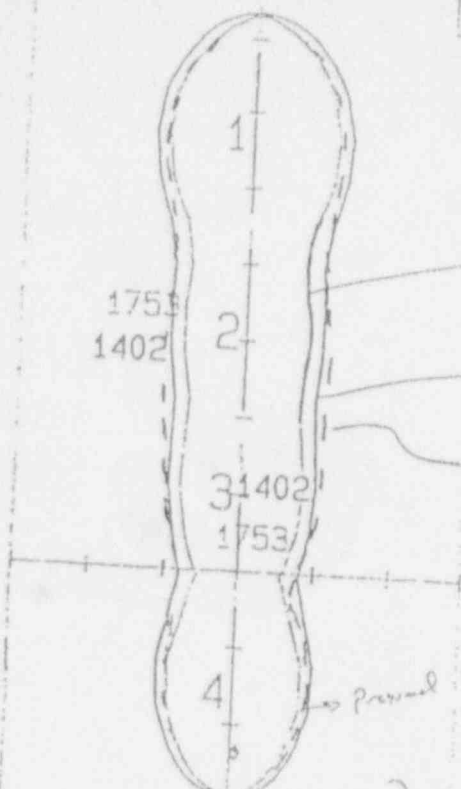
Reconfigured treatment  
plans - assuming  
loss of one source (4)  
and repositioning  
of sources # 2 and 3.

redistributed 1753

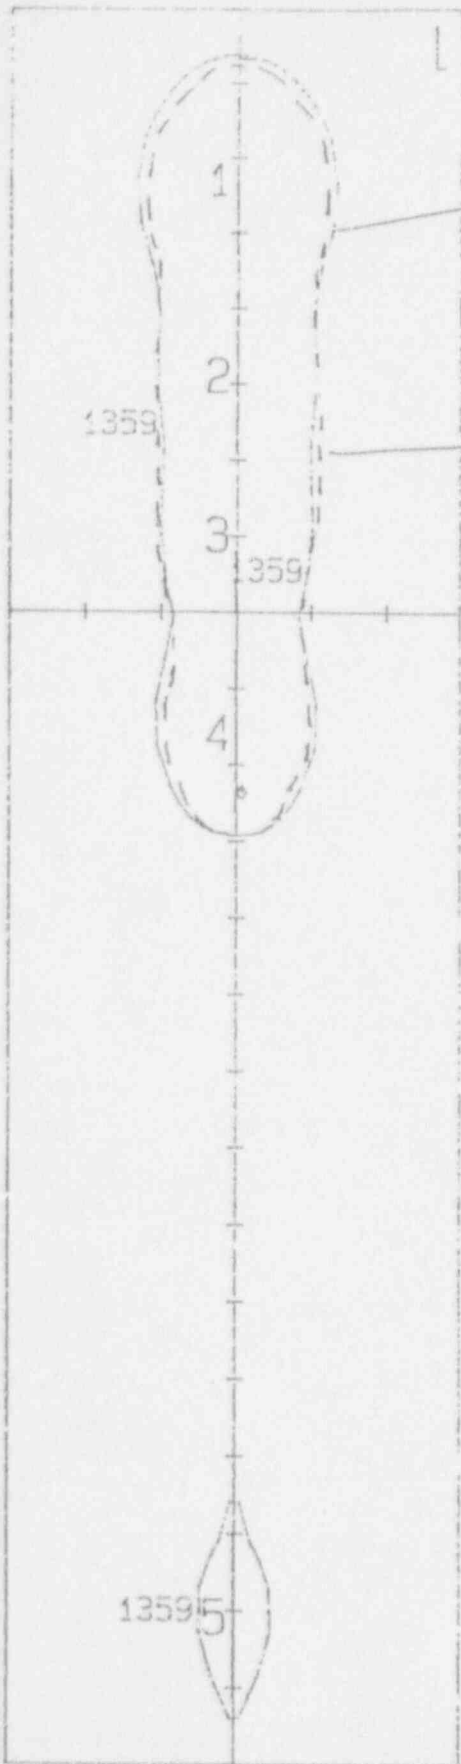
SLICE NO. 1

actual 80% (—)  $80\% \times 1699 = 1359$   
is "outside" ideal everywhere  
except for a short length near  
the middle of the implant

ideal (----) 1699 at 1.2 cm
