GPU Nuclear	TDR NO. <u>341</u>	REVISION NO. <u>0</u>
	BUDGET ACTIVITY NO. <u>120010</u>	PAGE _____ OF _____

PROJECT: TMI-1	DEPARTMENT/SECTION <u>OTSG Failure Analysis</u>
RELEASE DATE _____ REVISION DATE _____

DOCUMENT TITLE: TMI-1 OTSG Failure Analysis Report

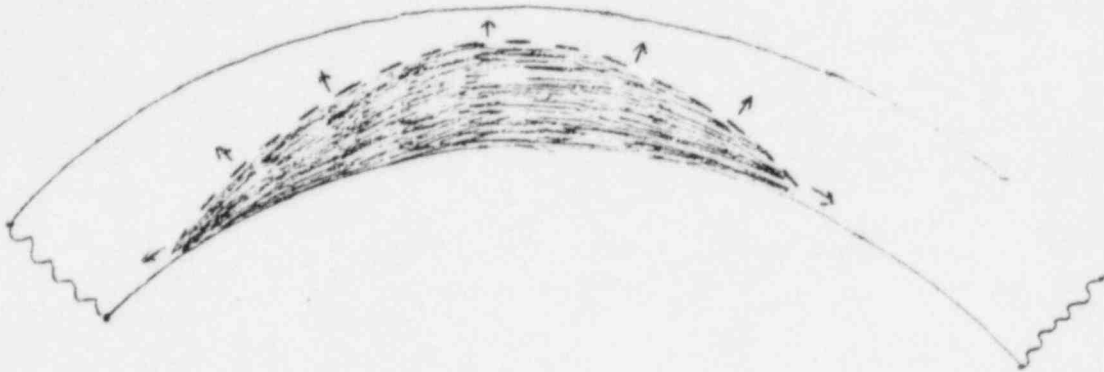
FIGURE VI - 1

- 9) In all cases to date, cracks which have been examined either by metallography or by bend testing, have shown the defects to be at least 90% and generally 100% through wall in penetration. No defects in the range of 10% to 50% have been observed. This would suggest that crack growth rates

a) Advancing crack not yet through wall.

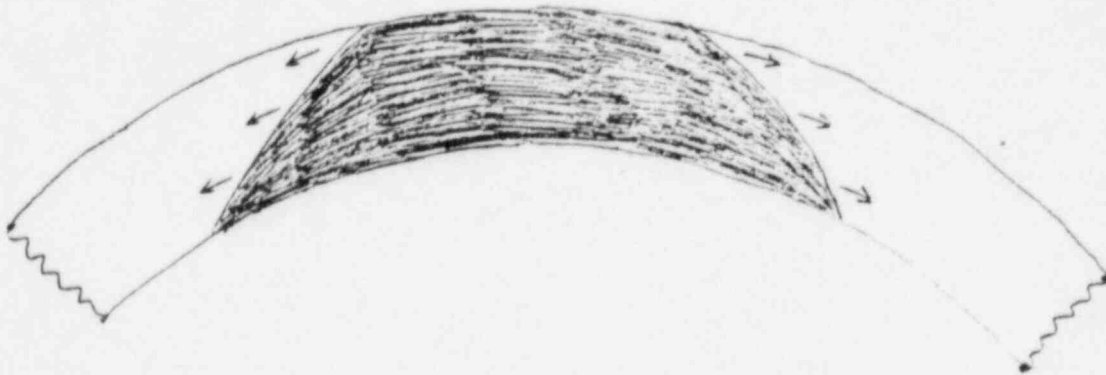
b) 100% through-wall crack continuing to grow.

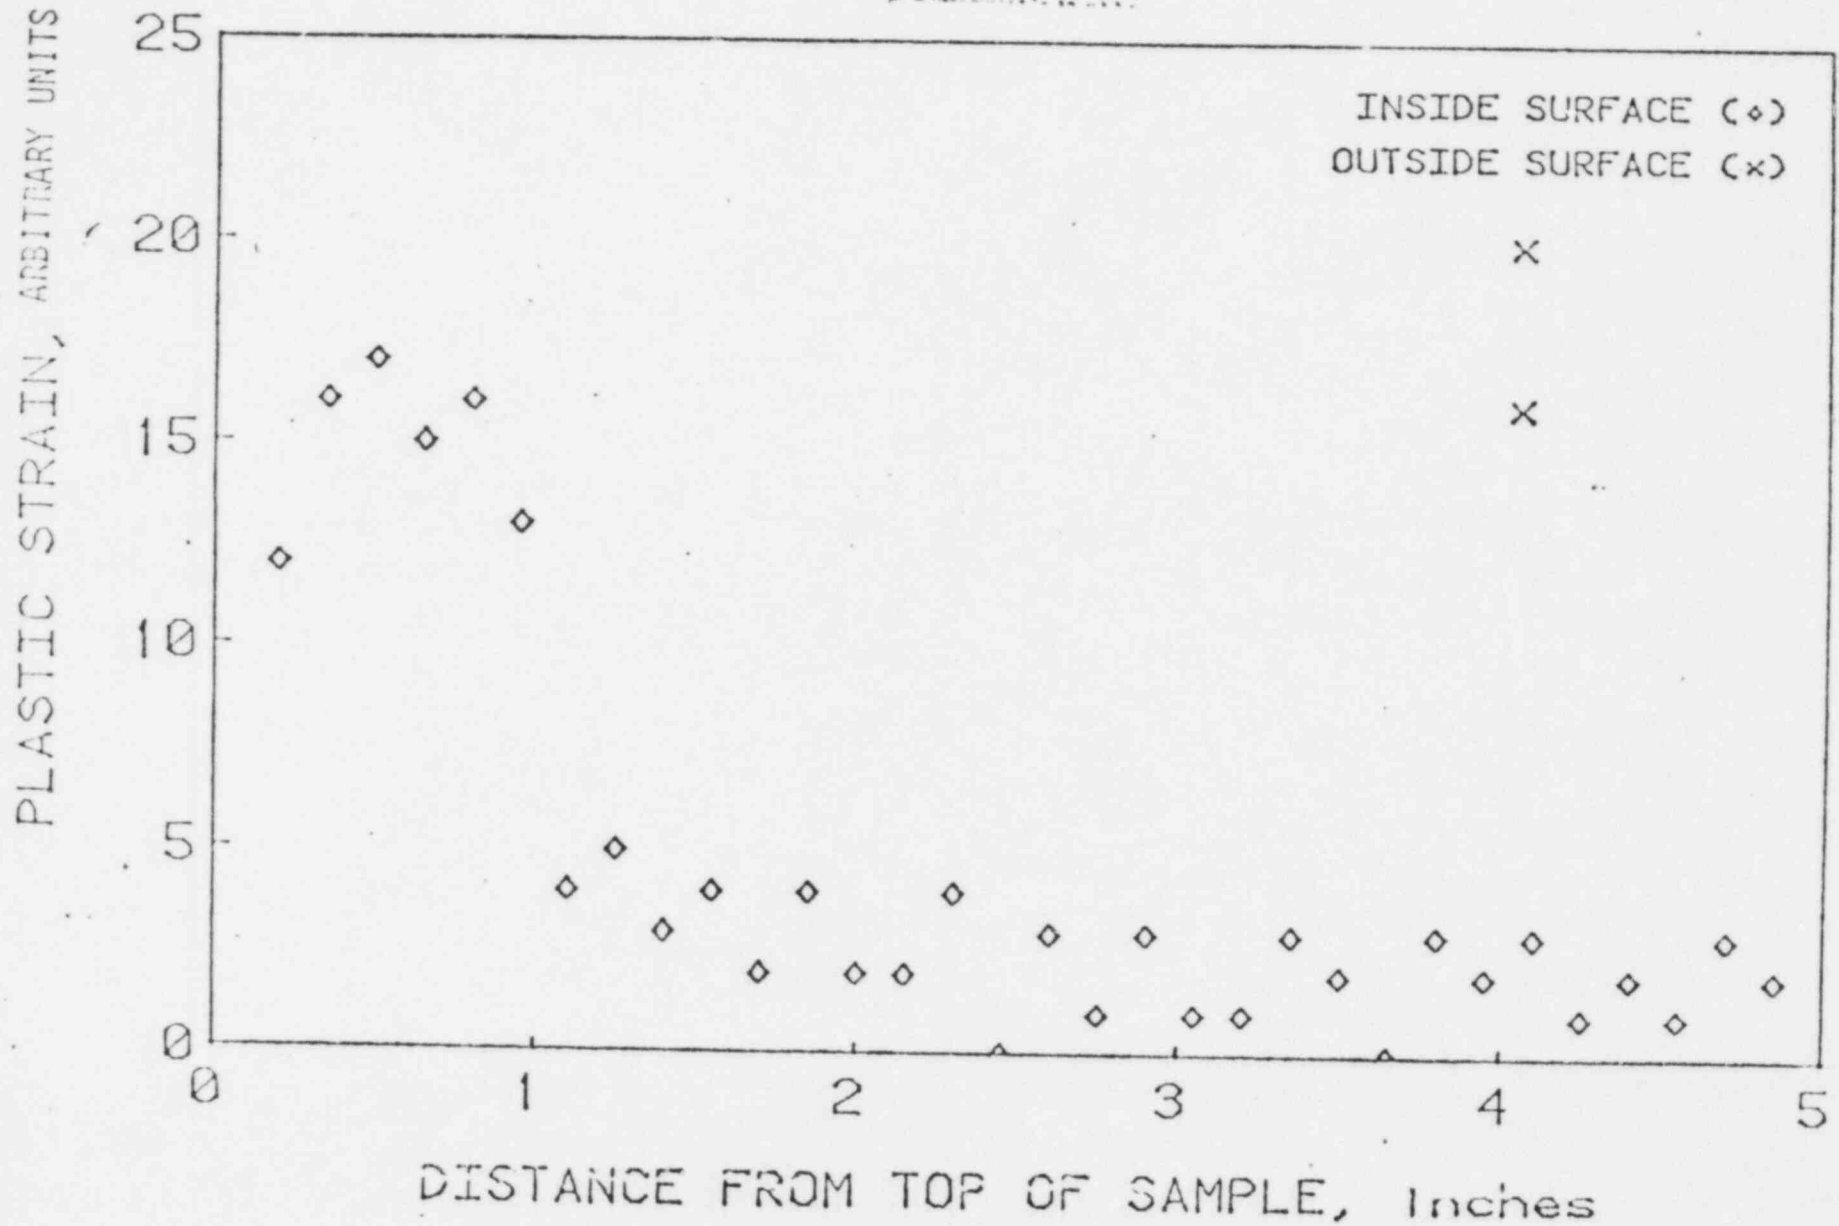
PLASTIC STRAIN VS POSITION
TMI-1 TUBE SAMPLE Aii-66

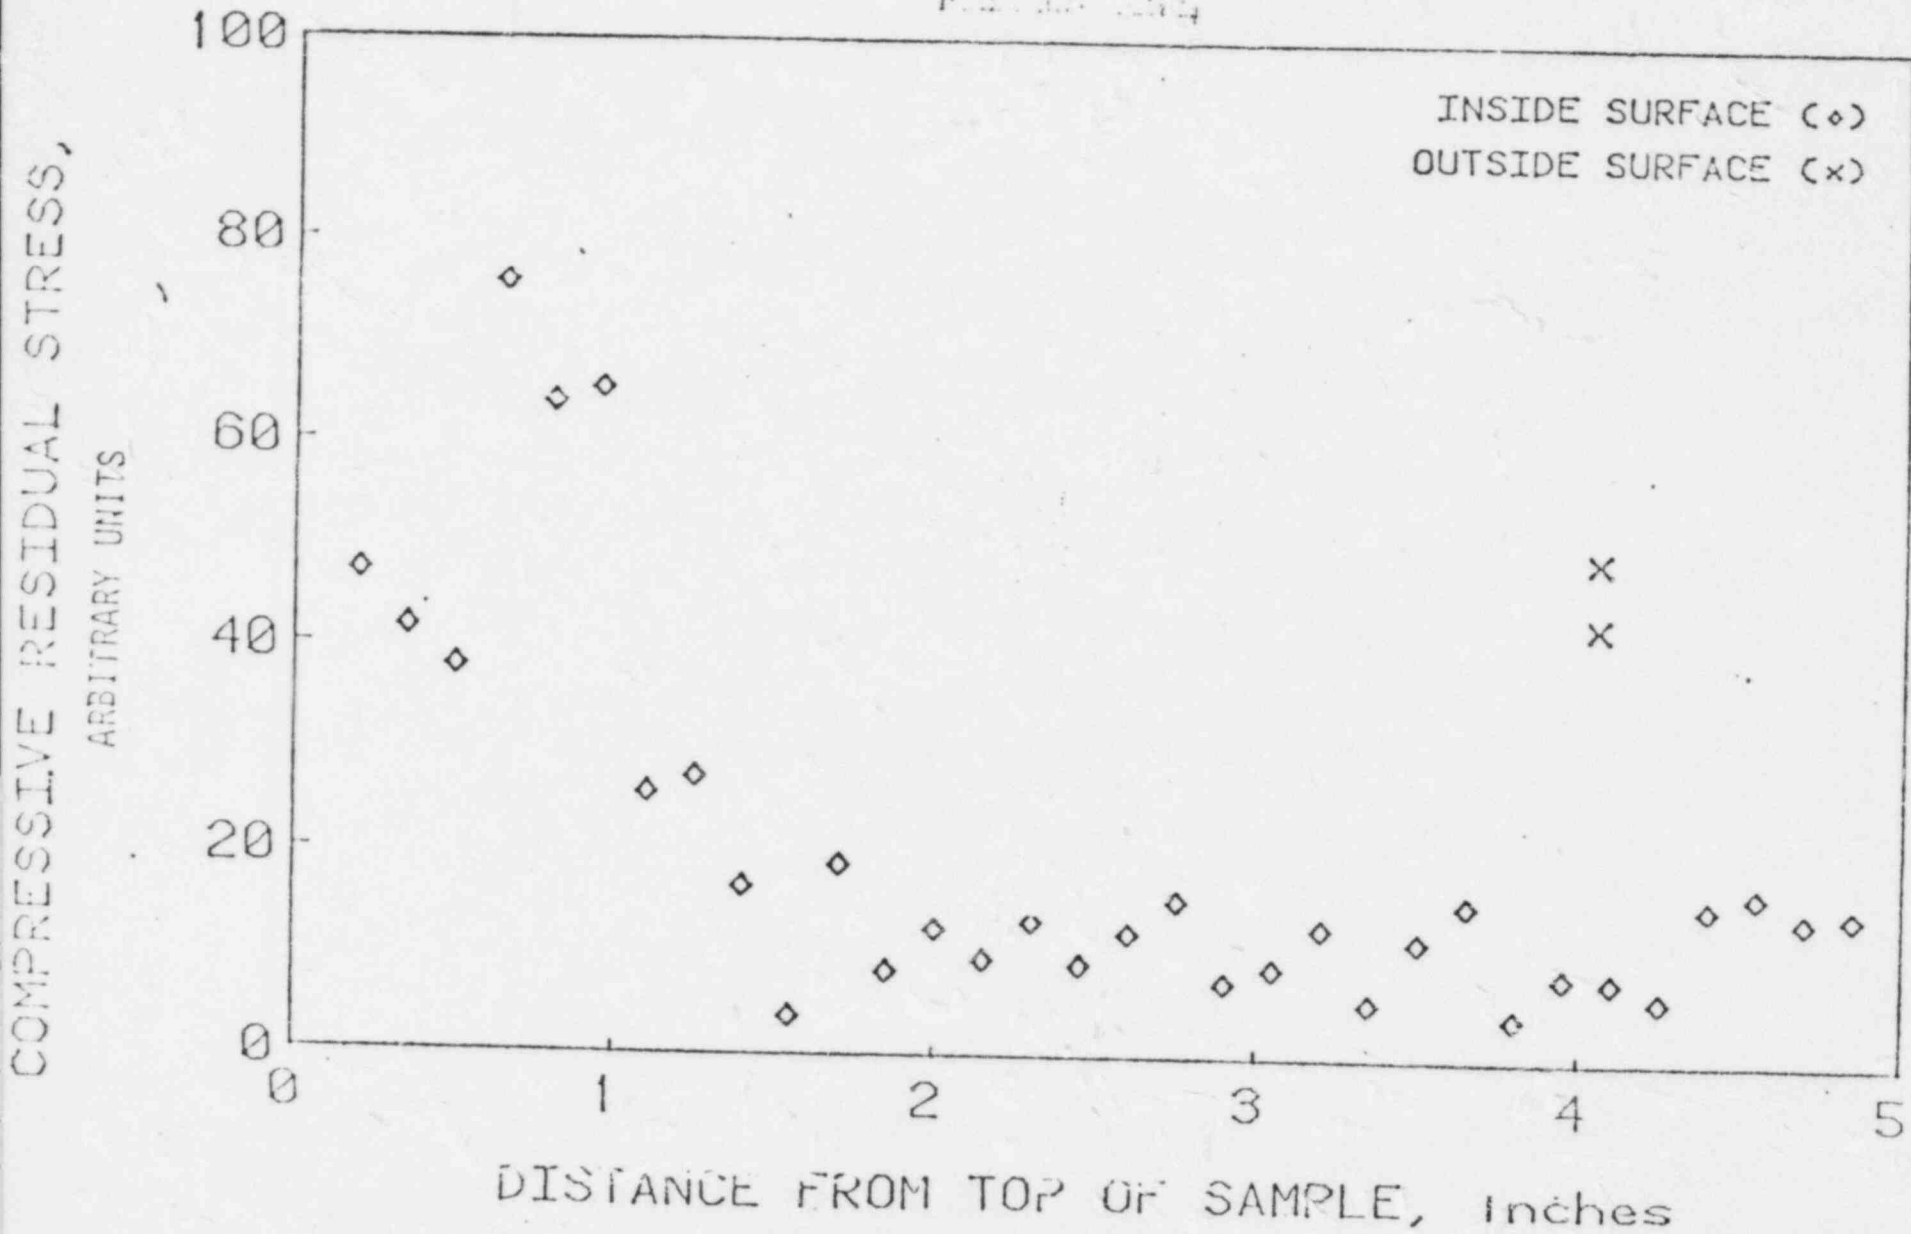
FIGURE VI - 4

RESIDUAL STRESS VS POSITION
TMI-1 TUBE SAMPLE A11-66
