UNITED STATES  
NUCLEAR REGULATORY COMMISSION  
REGION II  
101 MARIETTA STREET, N.W., SUITE 2900  
ATLANTA, GEORGIA 30323-0199

Report No.: 50-395/94-07

Facility Name: Virgil C. Summer Nuclear Station

Inspection Conducted: February 1-28, 1994

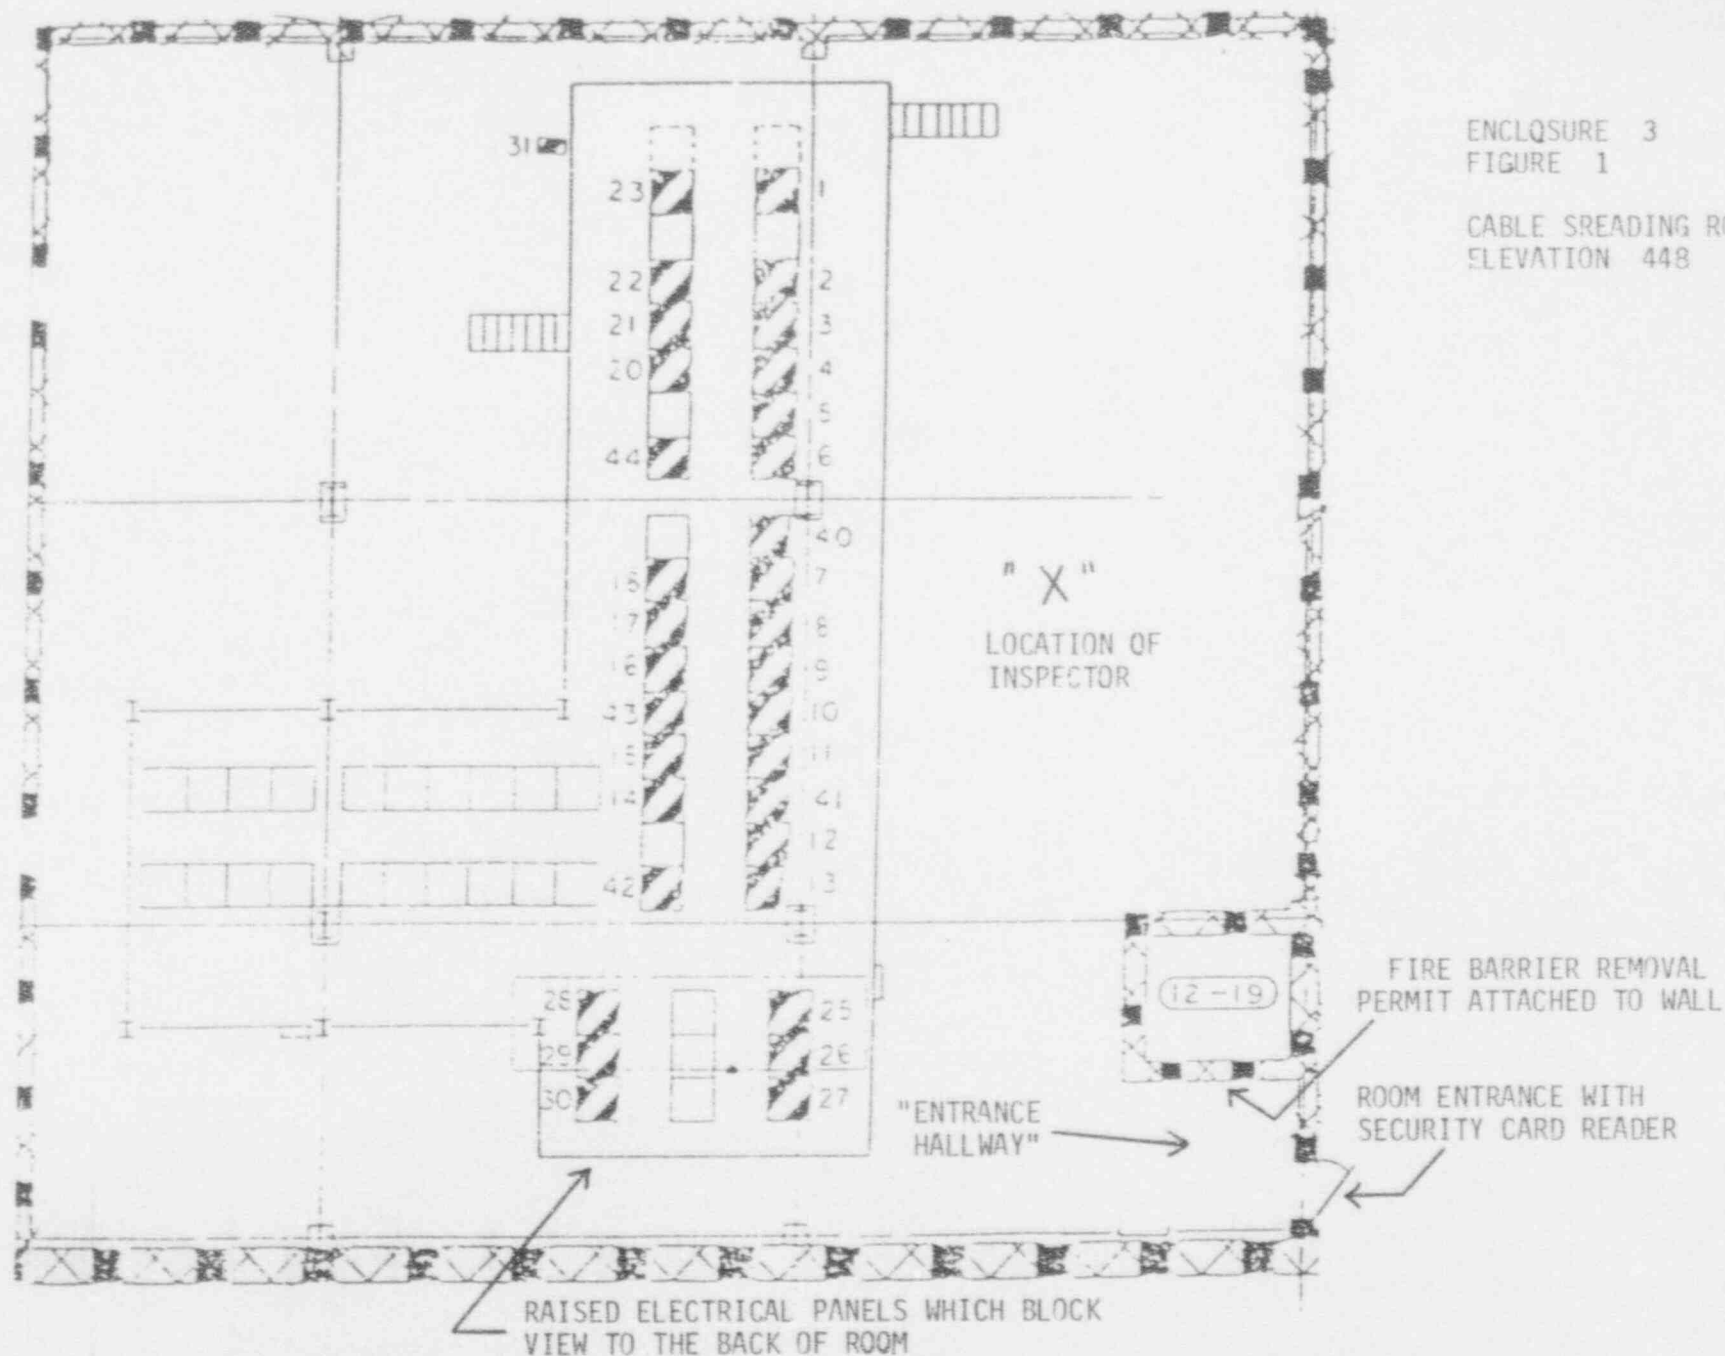
ENCLOSURE 3  
FIGURE 1

As shown on cable spreading room sketch (Figure 1), the fire watch area tag was located near the entrance door. When the RFW performed the tour the inspector was standing at location "X". During the short time the RFW was in the room, the inspector noted that the RFW did not step beyond the "entrance hallway" and look into the main portion of the cable spreading room. The inspector verified the RFW had entered the room at that time by reviewing the security access records for the room. The duration of the RFW's patrol in the room was 24 seconds. The inspector obtained security access records for cable spreading rooms, elevations 448 and 425, for the February 7-9, 1994, time period. Cable spreading room, elevation 425, had an assigned hourly RFW for the same degraded condition. Review of the 142 hourly RFW records revealed the following observations: 79 patrol durations were less than or equal to 20 seconds; 12 patrol durations were less than or equal to 10 seconds (the shortest duration was 6 seconds); and only 2 patrol durations were greater than 40 seconds.

The inspector questioned the ability to accomplish the duties of a hourly roving fire watch for areas as large as the cable spreading rooms (approximate room sizes are 4700 and 3600 square feet) within these short periods of time. FPP-004 specifies that a RFW patrol through the affected room or area once per hour, look for signs of smoke or fire, and look for items that may create a fire hazard. Also, FPP-004 states to include a brief description of the specific area to be watched (i.e., exact location of the degraded equipment or transient combustible) on the fire watch area tag. For the tags in the two cable spreading rooms the description block contained "Appendix R Concerns".

The inspector did not dispute the ability of a RFW to detect a fire, however, the fire detection system (smoke detectors) should also be capable of detecting a fire that was noticeable from the entrance of the room. The basis for a roving fire watch is to compensate for some degraded condition of the fire protection system. This compensation should include early detection of a fire (i.e., smoldering or hot items) and inspections for excessive combustible material or other unexpected conditions. The inspector does not believe the hourly RFW could provide these types of compensatory measure based on the length of time they were in the room and the large size of the rooms.

As implemented, the hourly RFW did not appear to provide the measures needed to compensate for the failure to meet the cable separation criteria required by 10 CFR 50, Appendix R, or as described in the V. C. Summer Fire Protection Evaluation Report. This is identified as unresolved item 50-395/94-07-04, pending further review by the inspector.

The licensee provided the RFWs with additional verbal guidance for the hourly patrols. Currently the RFWs are walking through the areas and spending more time during their patrols. The inspector verified this in discussions with RFWs and a review of recent security access records for the cable spreading rooms. Also the licensee informed the inspector that they were reviewing the instructions in FPP-004 for needed changes to ensure fire watches fully understand management's expectations.
