Subject: Licensee Event Report (LER) 94-01-01: Reactor Trip and Safety Injection Due to Inadvertent MSIV Closure

FACILITY NAME (1)
Seabrook Station

TITLE (4)
Reactor Trip and Safety Injection due to Inadvertent MSIV Closure

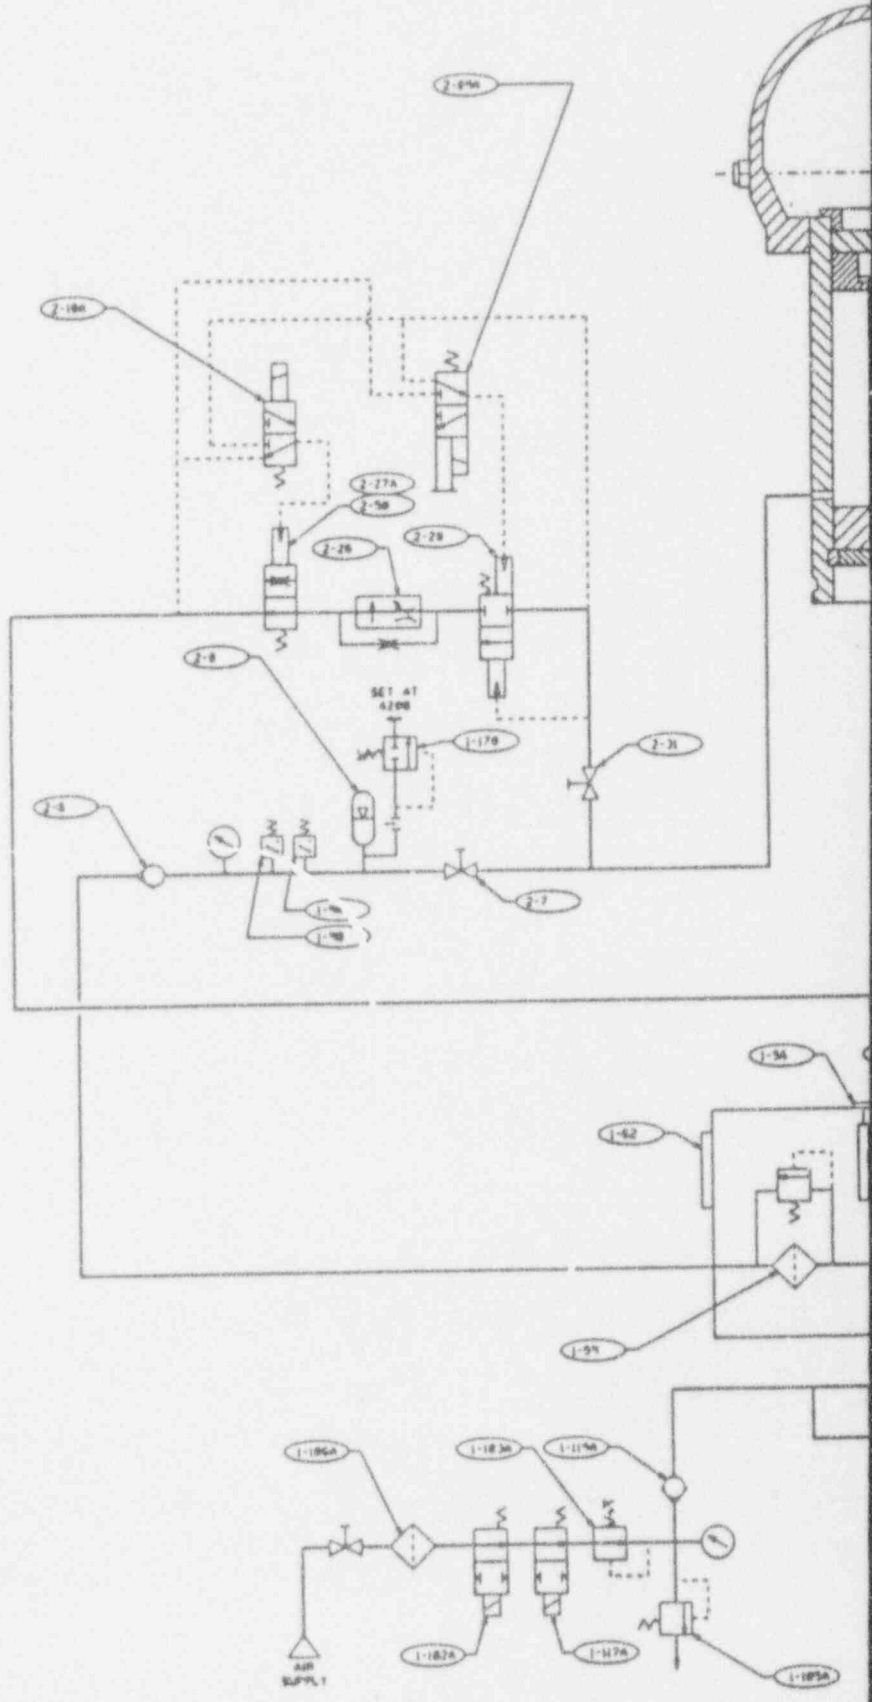
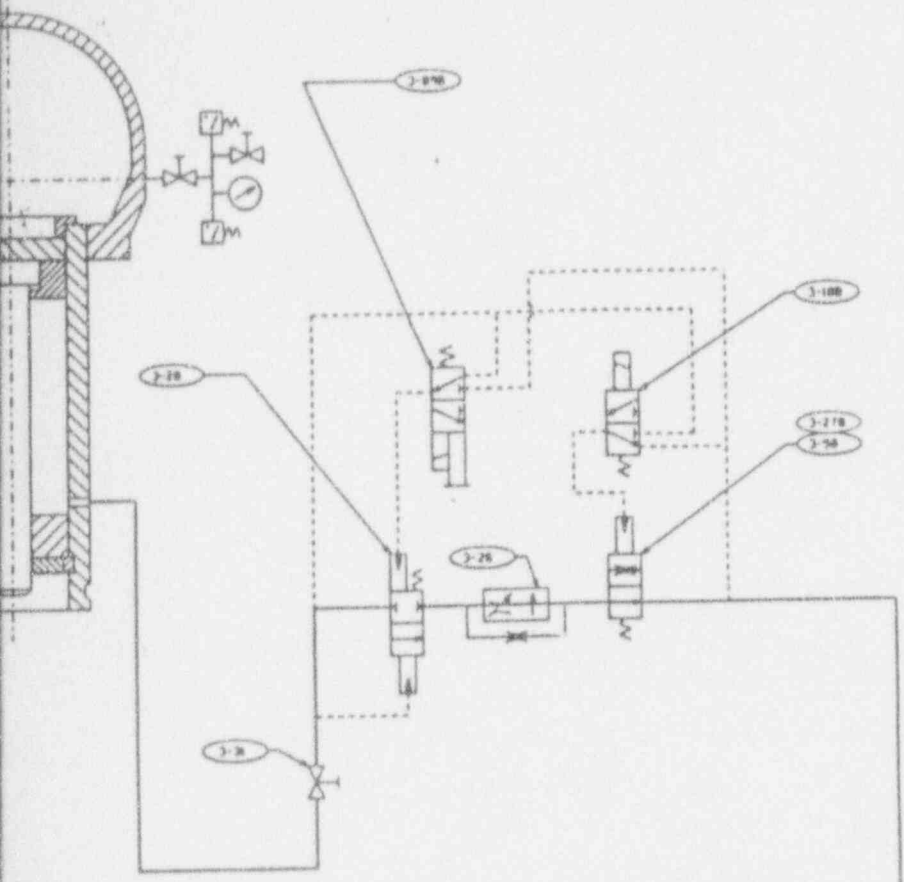
PUMP SIDE MANIFOLD
(1" TRAIN)

The train B main dump valve was determined to be sticking. The valve's disc was both out of tolerance (0.001 inches over maximum allowable size) and it had a machining burr and scoring on the outside surface.

The train B main dump solenoid pilot valve was found to exhibit seat leakage. Foreign material was found on the valve seat and in the air side of the valve shifting mechanism.

The hydraulic pump did not provide adequate capacity thereby delaying the repressurization of the hydraulic system. The pump's discharge filter was deformed and the filter material was split. Brass filings were found inside the hydraulic pump's air motor.

The piston in the hydraulic system's thermal accumulator was found in a fixed position.
