Maine Yankee

Subject: Maine Yankee Licensee Event Report 94-003, Service Water Flow
Measured Outside Design Basis

LICENSEE EVENT REPORT (LER)

TITLE (4)
Service Water Flow Potentially Outside Design Basis

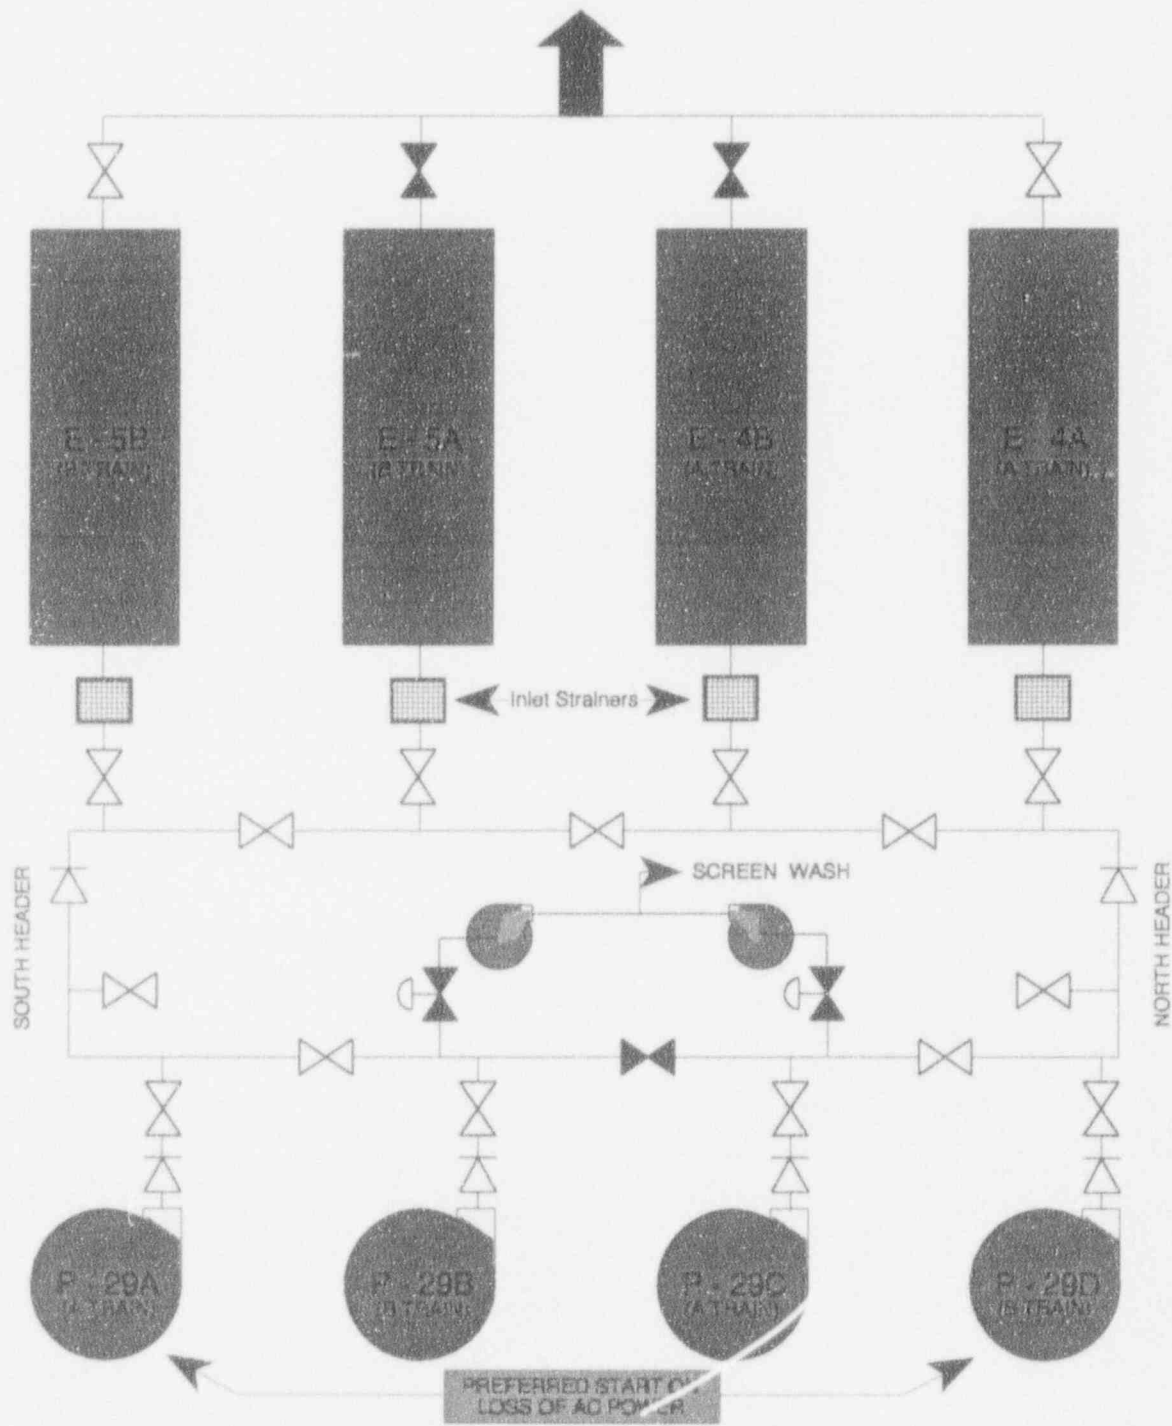
Figure 1: Simplified Service Water System Diagram

On February 22, 1994, Maine Yankee concluded that the measured Service Water system flow rates were less than that assumed in the design analysis. Service Water provides brackish river water as the ultimate heat sink for Maine Yankee's component cooling water system. Component Cooling water provides cooling for various emergency core cooling system (ECCS) and containment cooling equipment (See figure 1 for a simplified diagram of the system). The Service Water system was originally designed to provide 10,000 gallons per minute per pump at design conditions. Initial design conditions included: a design basis large break loss of coolant accident with ECCS in the recirculation mode, a loss of offsite power, service water intake water is assumed to be at its design low tide level and highest summer temperature for the duration of the accident. Additionally, since 1990, analysis flow has been conservatively reduced to allow for postulated piping failures and additional heat exchanger pressure drop. The 10,000 gpm flow requirement was based upon intake water temperatures of 90°F when the outboard heat exchangers are in service and 80°F when the inboard heat exchangers are in service. The temperature differences are due to the outboard heat exchangers being larger.
