SECY-94-077

FOR: The Commissioners  
FROM: James M. Taylor  
Executive Director for Operations  
SUBJECT: MAGNITUDE 6.7 NORTHRIDGE EARTHQUAKE OF JANUARY 17, 1994

To inform the Commission of the details of the Magnitude 6.7 Northridge Earthquake of January 17, 1994.

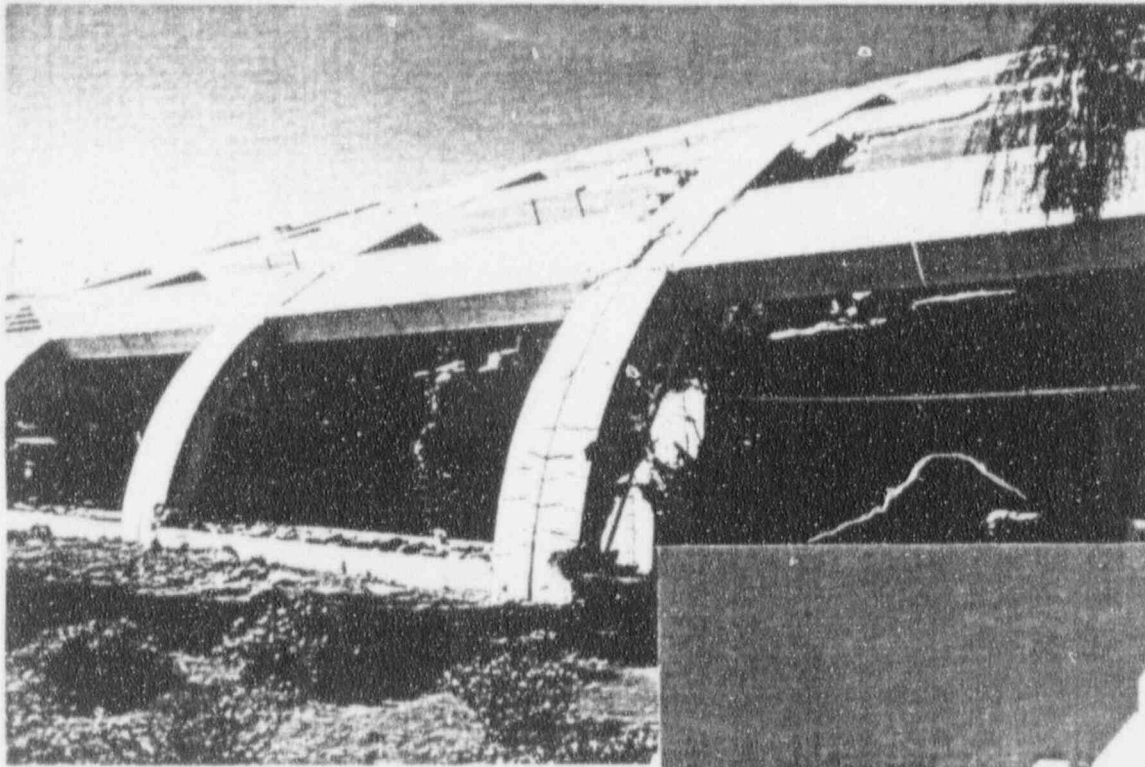
The California State University at Northridge parking structure collapsed (Figures 3 and 4). The proximity of the campus to the epicenter resulted in high vertical accelerations input into the base of the structure. Poor connection details (for instance, short development length of reinforcing steel between columns and floor slabs, short bearing seat at each beam end), high vertical accelerations, and seismic-induced horizontal movement contributed to the collapse of the structure.

Figures 3 and 4. A ductile failure in the exterior columns of the California State University at Northridge parking structure (Figure 3). Precast column elements were poorly tied to adjacent columns (Figure 4). Also, in Figure 4 note the short development length of the reinforcement steel and the short bearing seat.

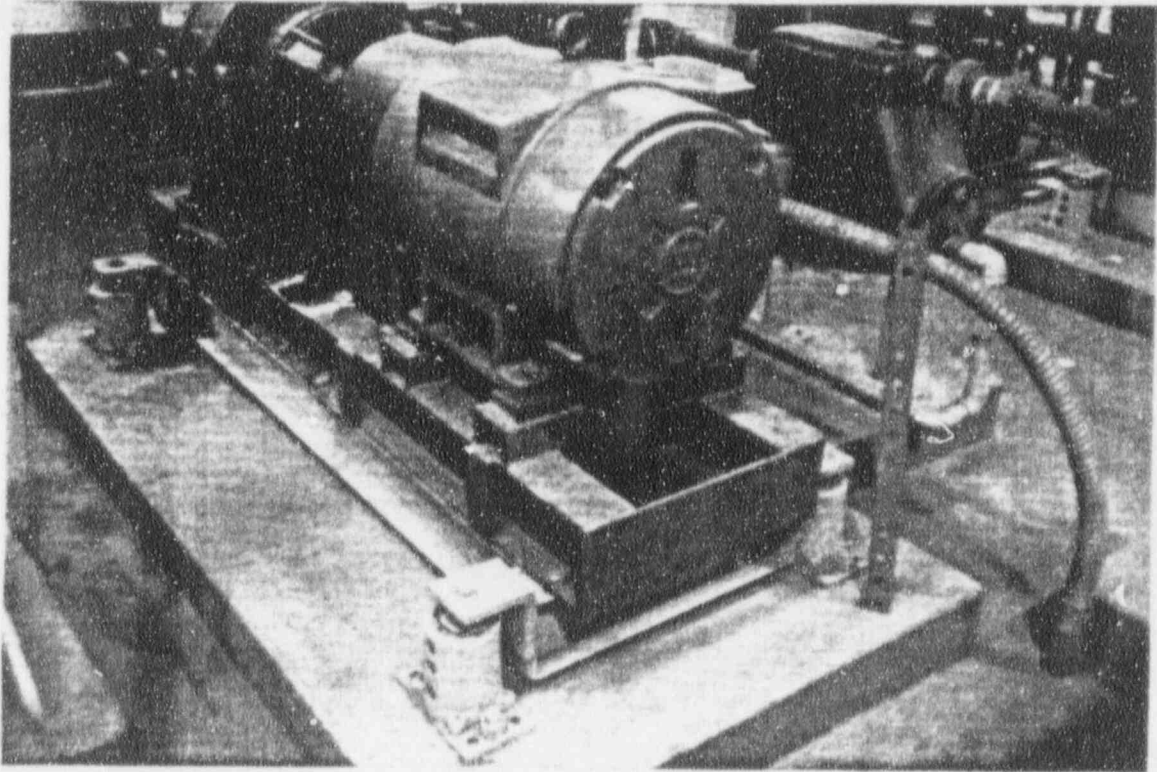
Well engineered structures and equipment that may have experienced ground motion far in excess of their design remained functional (Figure 5). Components made of brittle materials, such as ceramic insulators and cast iron components, received damage consistent with other earthquakes (Figure 6).

Figures 5 and 6. Mechanical and electrical equipment (Figure 5) located in some power systems was well anchored. However, there was major damage to ceramic insulators. Figure 6 depicts the "grave yard" not the insitu location.

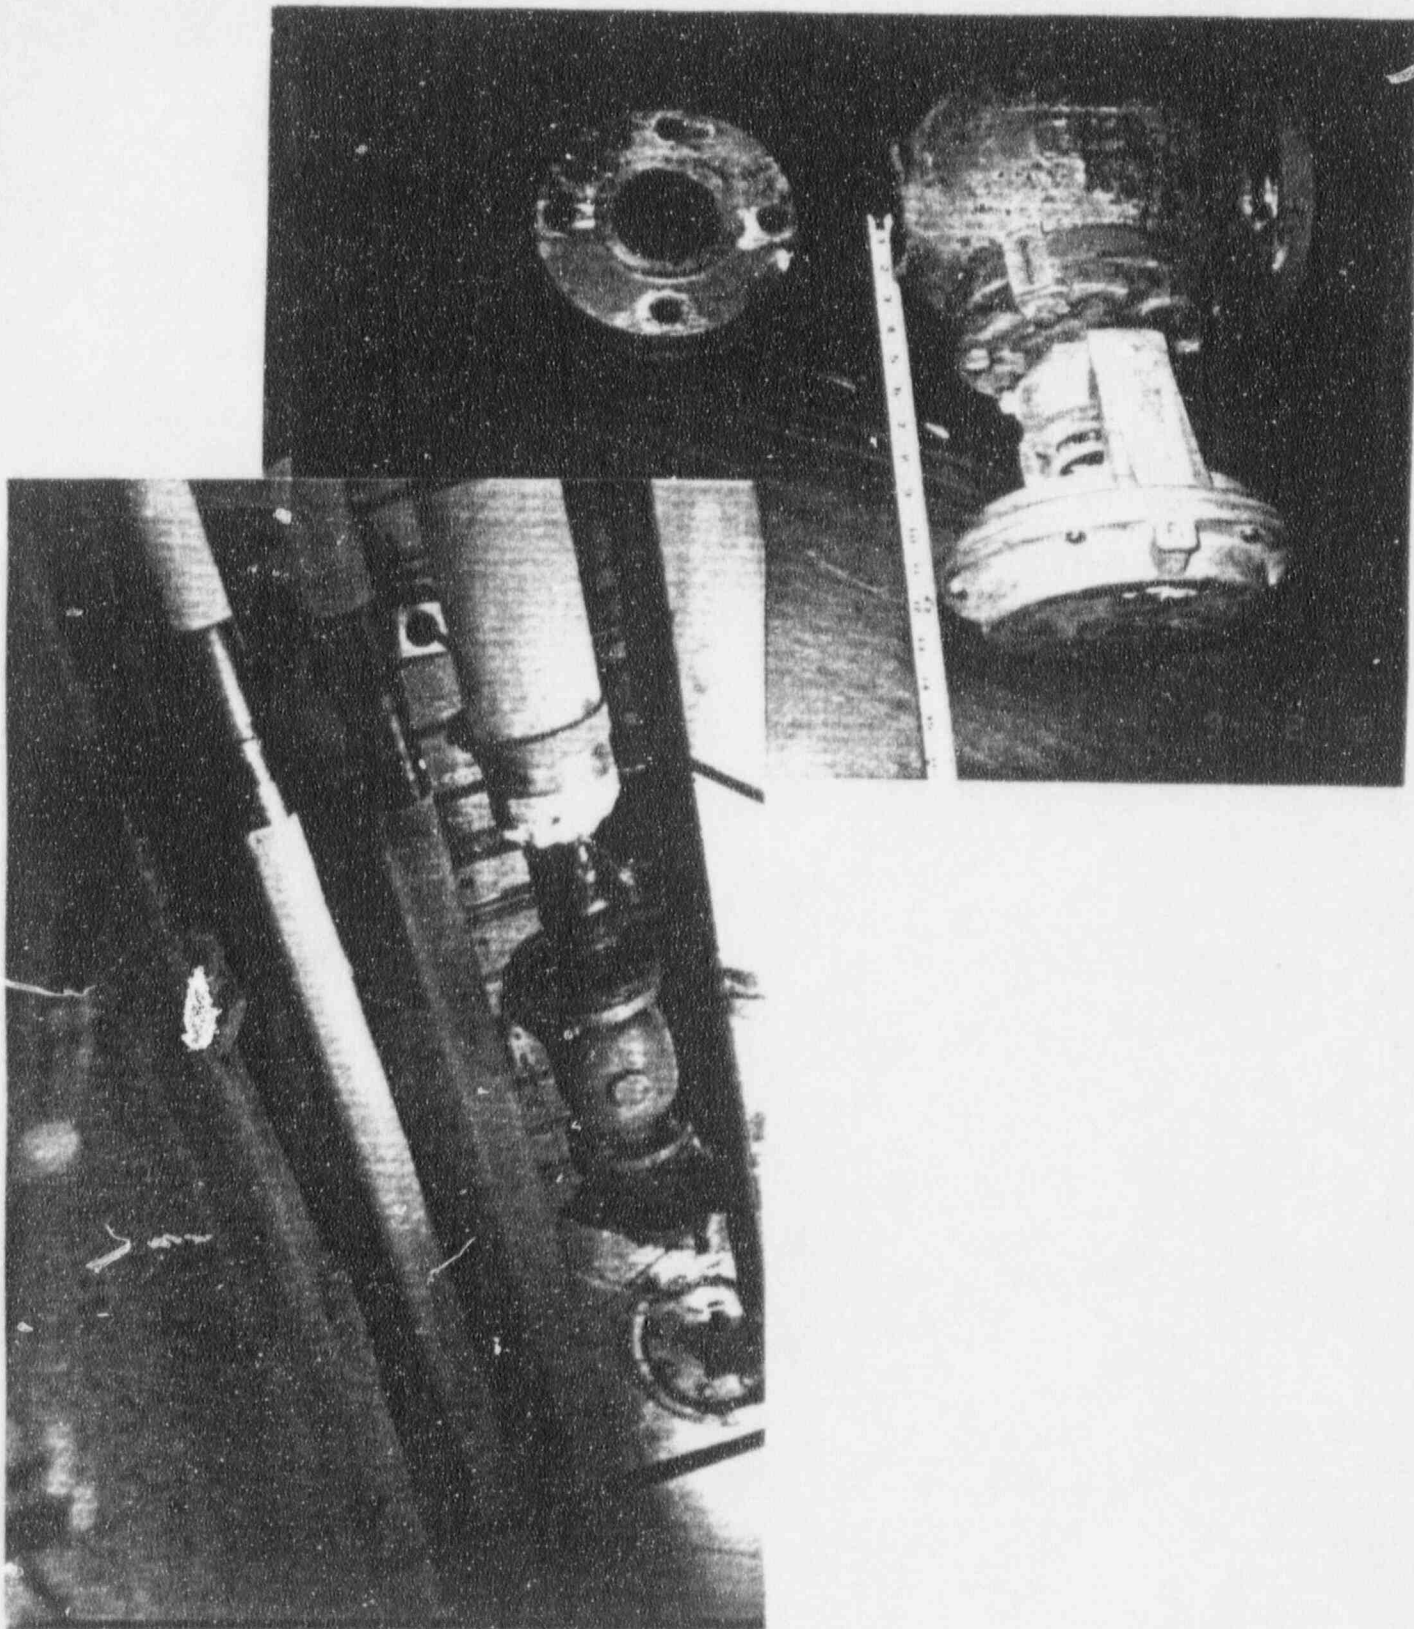
Two piping system failures were noted. A 3-inch valve body on a 4-inch piping line failed. Failure was possibly inertia induced (Figures 7 and 8). Also, there were reported breaks in the flange area of a 6-inch tee, and near the 3-inch end of a 6-inch to 3-inch reducer. The cause of these breaks is unknown.

Figures 7 and 8. Possible inertia failure of a 3-inch valve body. Figure 7 shows the failed valve; Figure 8 shows the insitu location of the replacement valve.

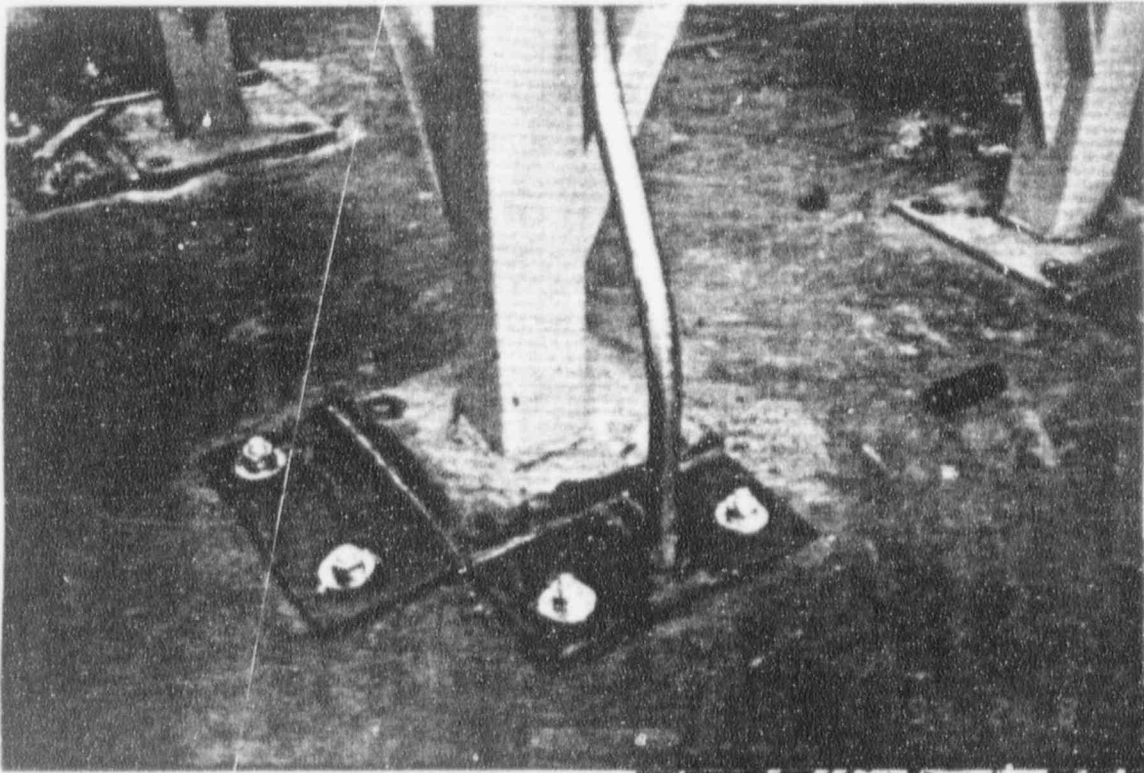
Figures 9 and 10. Kickplates butt welded to the original support plates were added as a post-earthquake upgrade to air handlers (Figure 9). The original anchorage will be replaced by through bolts from the floor below. Rod hung pumps did not fail (Figure 10). The support below the pump is a post-earthquake upgrade.

The lessons learned from this and other earthquakes, principally the need to upgrade anchorage, are being implemented. Butt welded kickplates were added to an air handler support in addition to through-the-floor bolting (Figure 9). Supports were added for hung valves (Figure 10), conduit, and tubing.

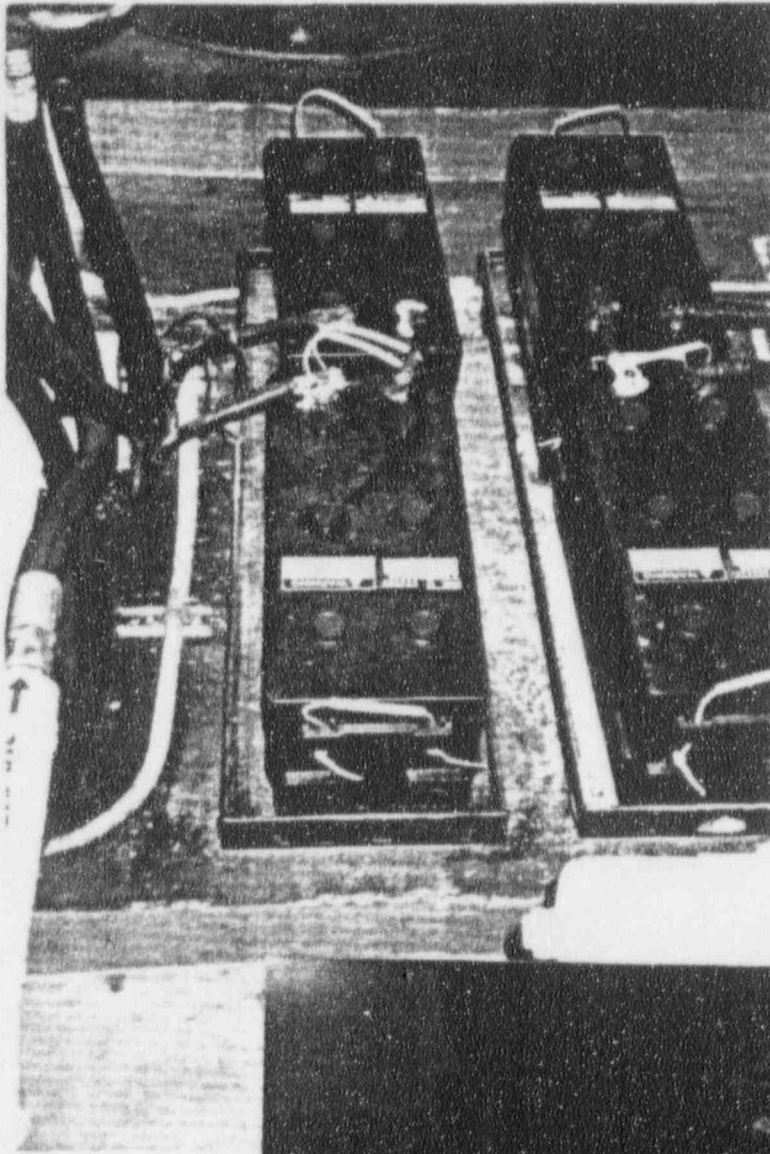
Figures 11 and 12. The batteries (Figure 11) displaced because they were not supported or confined. Isolators located on air handlers were broken (Figure 12).

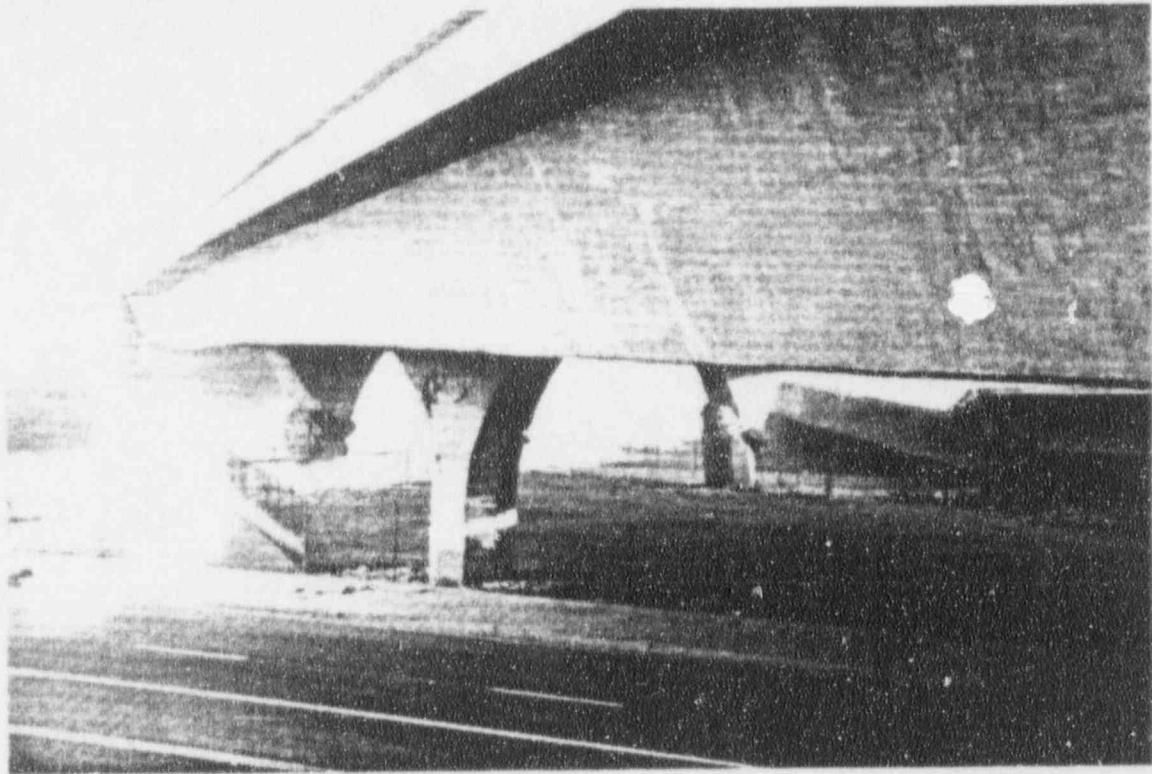
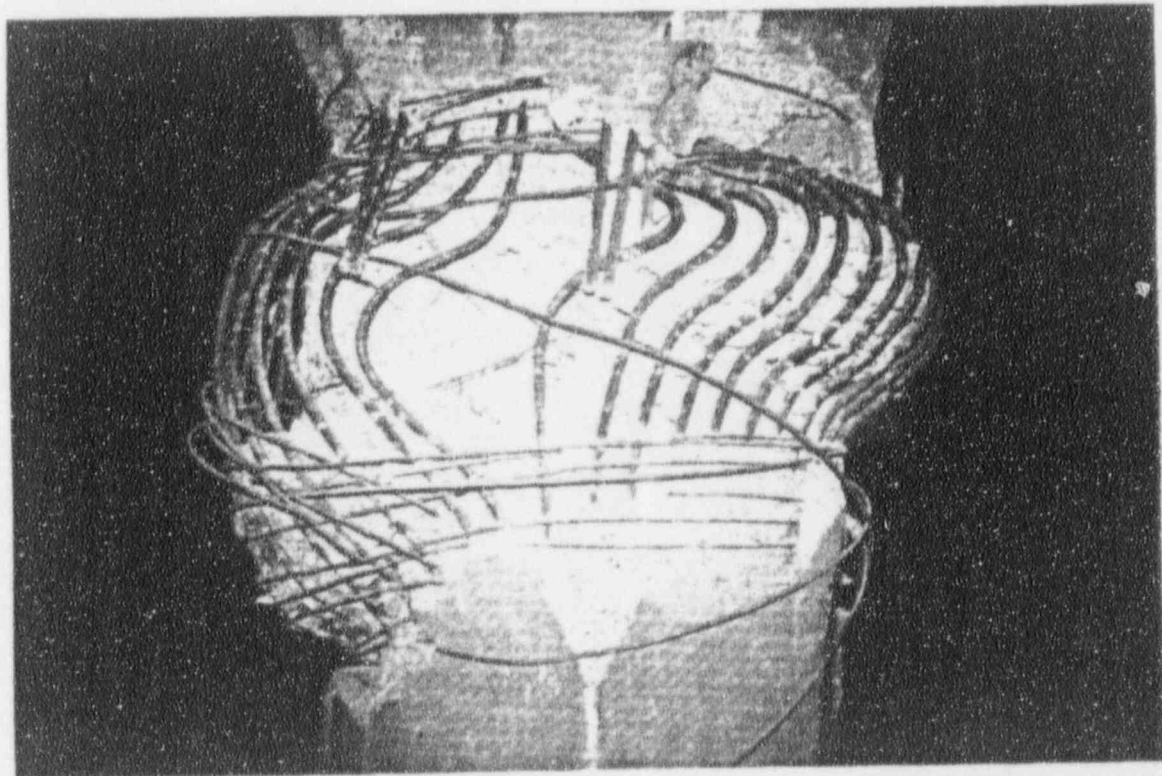
Damage to highway overpasses and bridges occurs throughout the San Fernando Valley. Major damage and collapse were observed on Interstates 5, 10, and 210, and State Routes 14 and 118. Damage modes included shear failure of columns and bents (beams and columns), leading to settlement and collapse of the roadway deck above (Figures 13 and 14). Due to the proximity of the epicenter, the 118 Freeway bridge over San Fernando Mission and Gothic Streets experienced several cycles of relatively high vertical input acceleration. The bridge columns lost core confinement of the concrete, thereby losing their capacity to support large vertical loads.

Figures 13 and 14. The bridge columns lost core confinement of the concrete and thereby lost their ability to support large vertical loads.

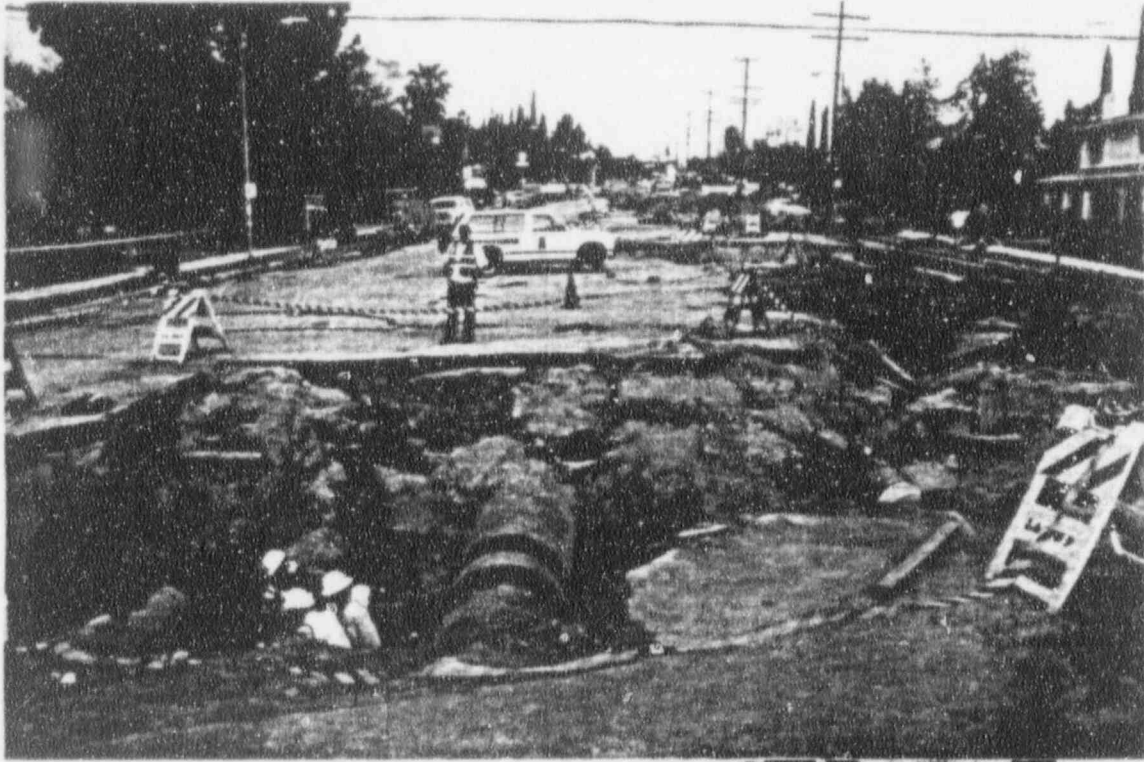
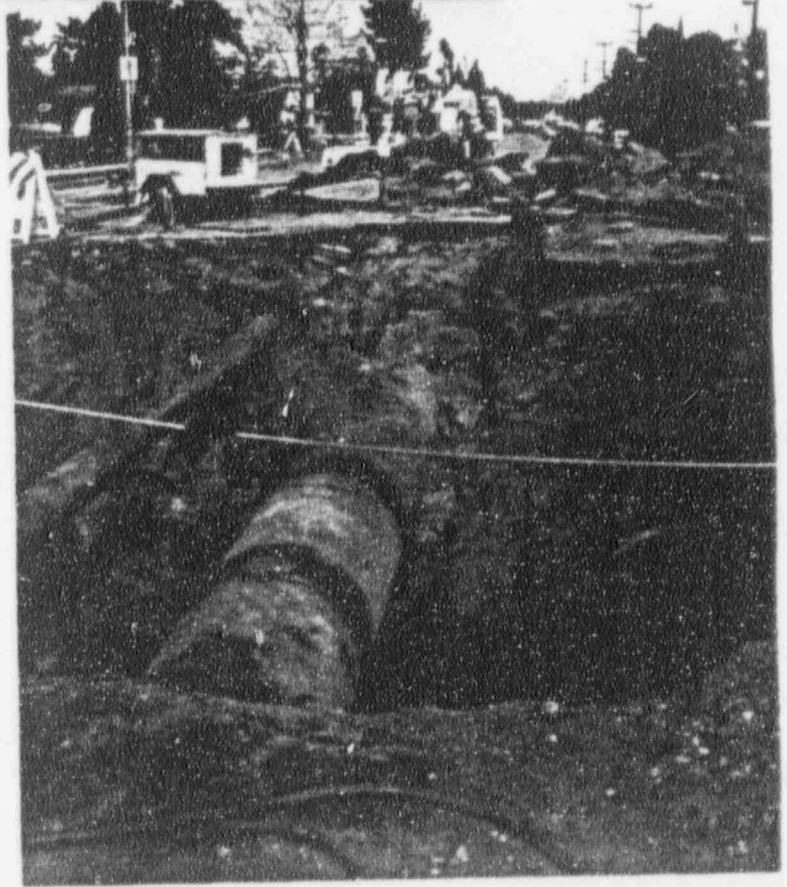
Figures 15 and 16. Several lifelines were severely impacted. These lifelines included 40- and 60-inch diameter water lines and 6- and 22-inch diameter gas lines.

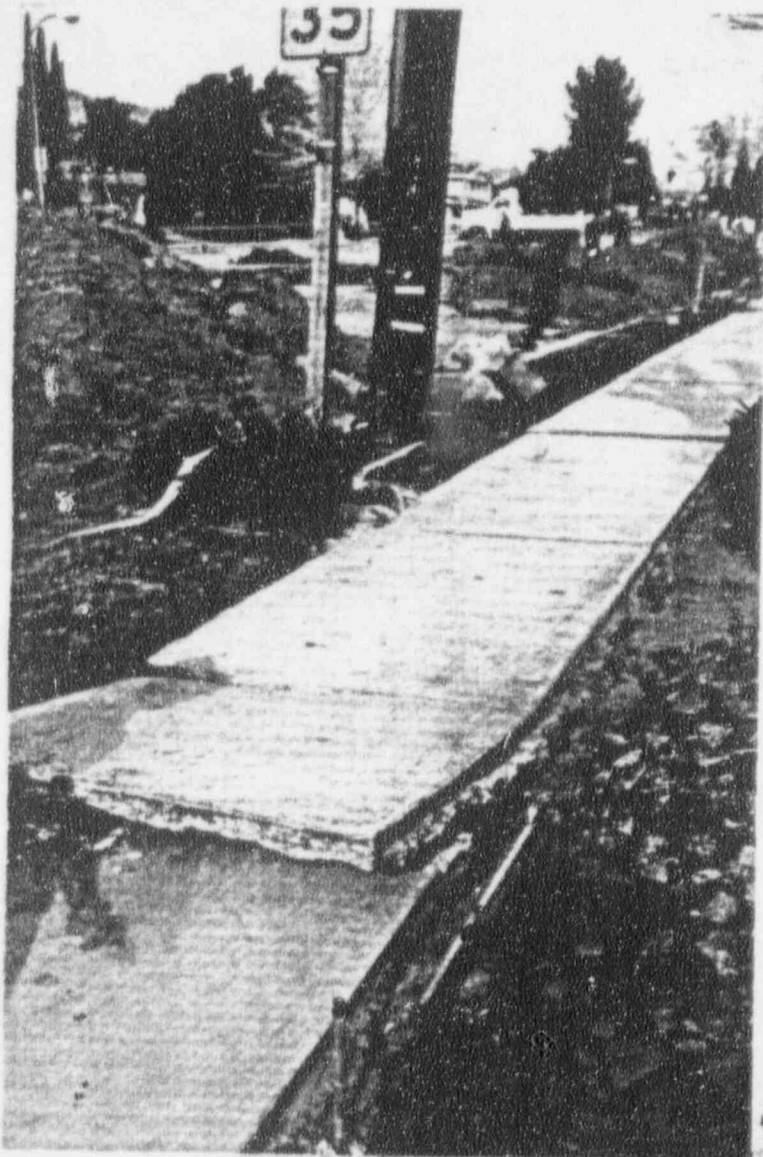
Figures 17 and 18. A 2-foot length of the north portion of the sidewalk moved over the south portion of the sidewalk (Figure 17). In contrast to the buried pipes shown in Figures 15 and 16, this above-ground, 5½-foot diameter pipeline (Figure 18) appears to have very little distress. The location of this pipeline is a mile closer to the epicenter than the pipes shown in Figures 15 and 16.
