UNITED STATES  
NUCLEAR REGULATORY COMMISSION  
REGION III  
799 ROOSEVELT ROAD  
GLEN ELLYN, ILLINOIS 60137

SUBJECT: WISCONSIN PUBLIC SERVICE CORPORATION (KEWAUNEE)  
RECOMMENDED CIVIL PENALTY

This refers to the inspection conducted May 3-5, 18 and June 5, 1978 by Region III (Chicago) representatives at the Kewaunee Nuclear Power Plant, Kewaunee, Wisconsin, of activities authorized by NRC Operating License No. DPR-43.

Inspection on May 3-5 and 18 and June 5, 1978 (Report No. 50-305/78-07)  
Areas Inspected: Routine, unannounced inspection of radiation protection activities during refueling, including: procedures; advance planning; external exposure control; posting, labeling, and control; surveys; and corrective action on previous noncompliance. The inspection involved 62 inspector-hours on site by two NRC inspectors.  
Results: Of the six areas reviewed, no noncompliance or deviations were found in three areas. Three apparent items of noncompliance were found in three areas (violation - not following procedure; violation - inadequate surveys; infraction - failure to provide radiation monitoring device). (Paragraph 4)

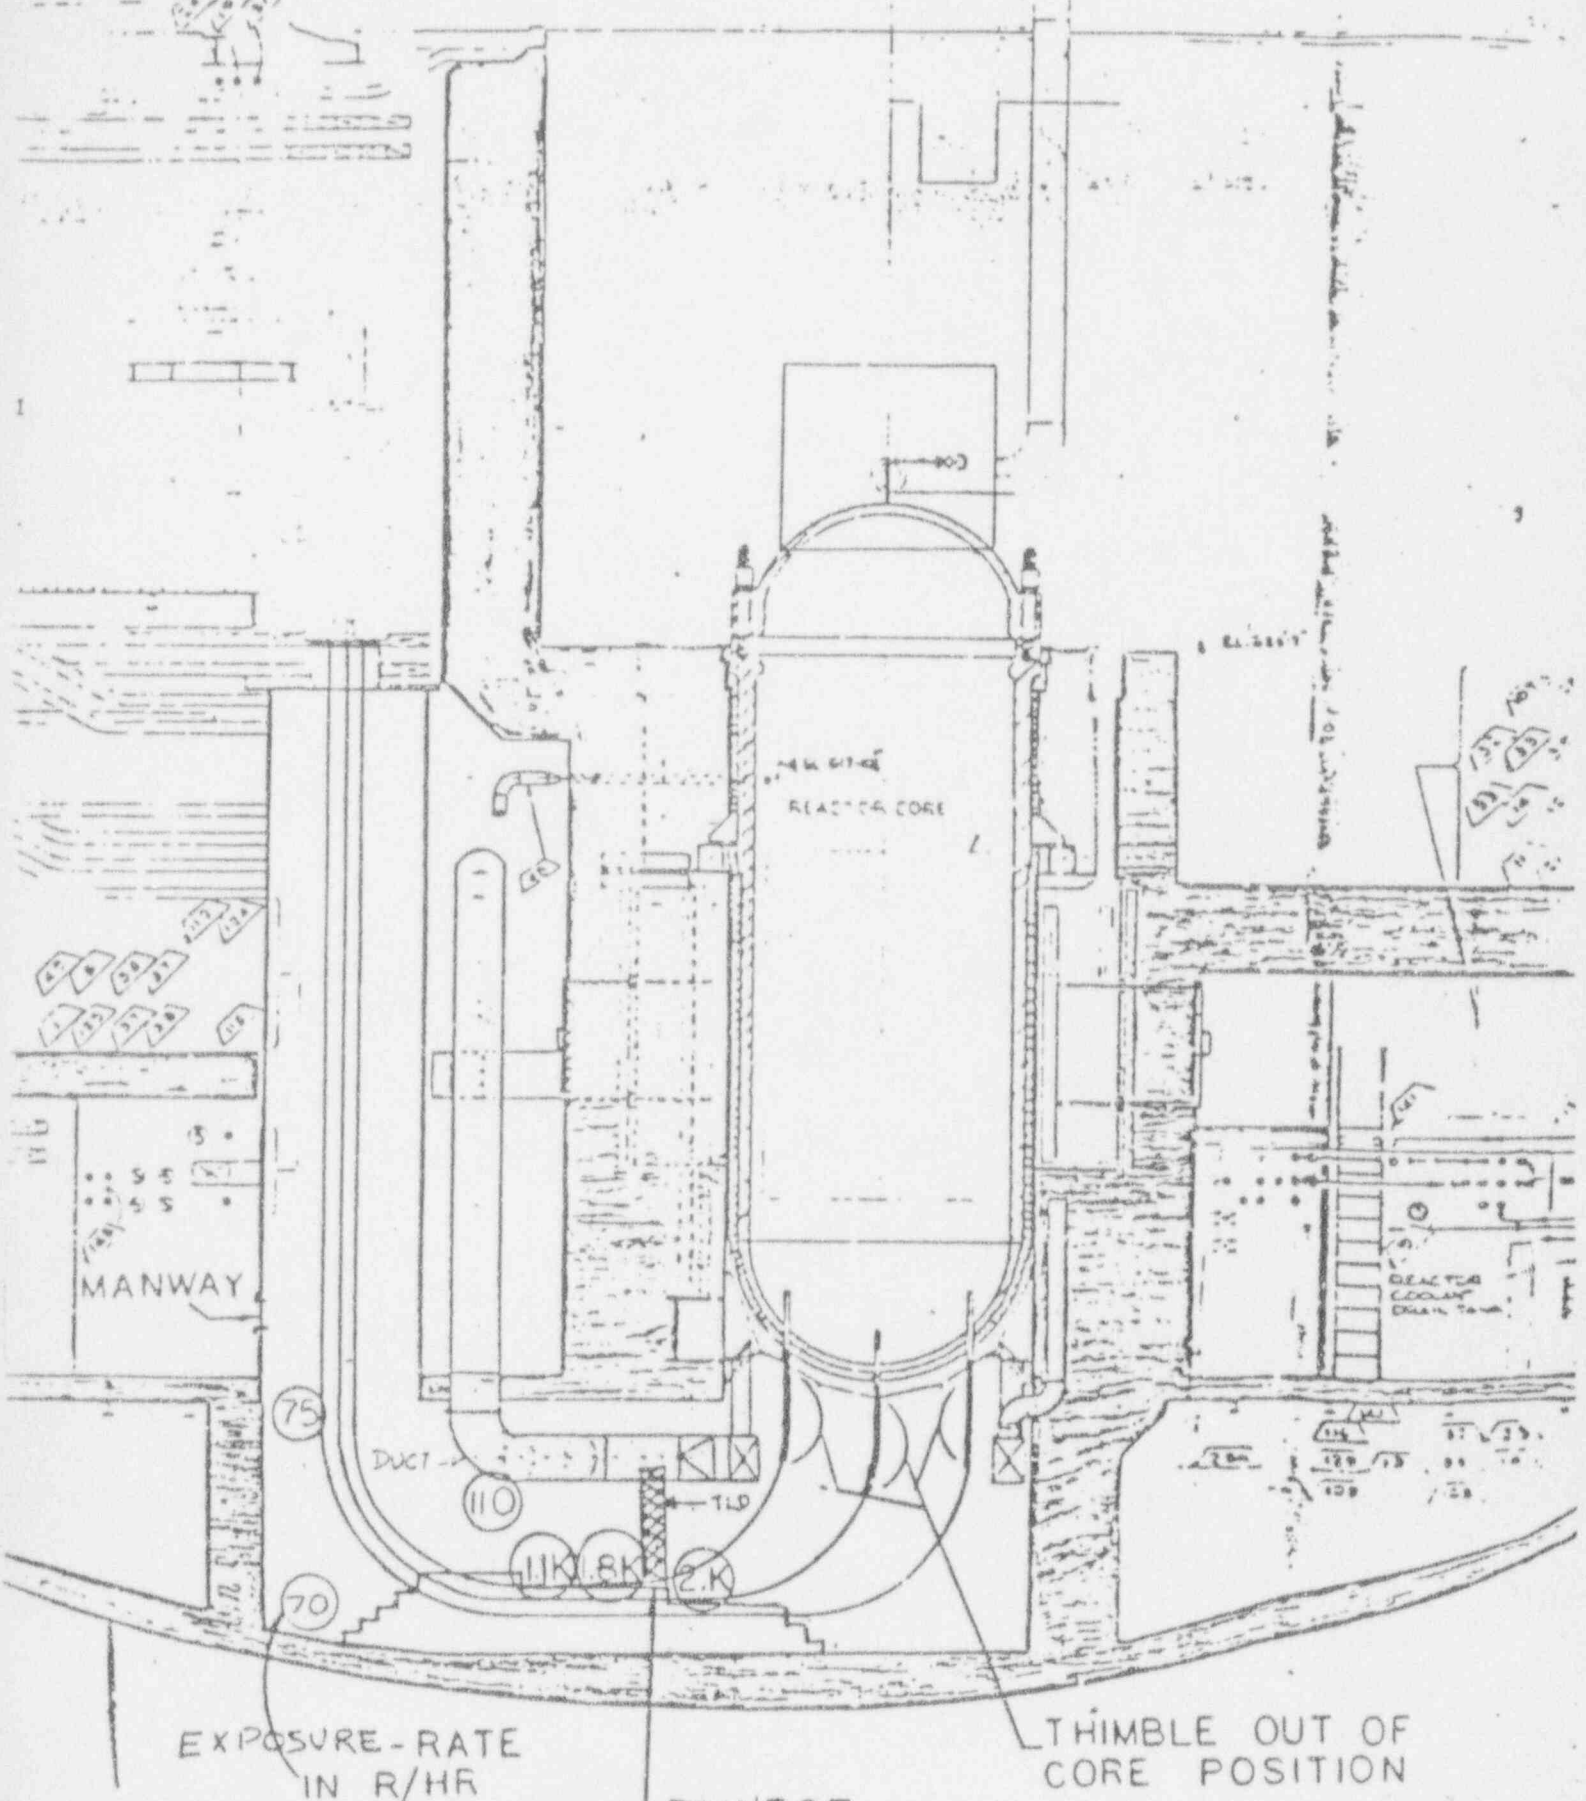
FIGURE 1.

On May 2, 1978, between 0230 and 0245, the shift supervisor on duty entered the reactor cavity (Figures 1 and 2), designated Sump C by the licensee, to check for leaks from the refueling cavity, which was about two thirds full. The sound of water running in the cavity had been heard through the opened entrance hatch shortly before. At the time of the entry, the in-core instrument thimbles were in the withdrawn position and the cavity was a recognized high radiation area having a posted exposure rate of 70 R/hr.

Two persons who observed the entry agreed that the duration was less than 30 seconds. Upon exit the shift supervisor's 0 to 200 mR personal dosimeter, an inappropriate dosimeter for such an entry, was noted to be offscale. The plant health physicist, who was notified at home of the occurrence, came to the plant and initiated a remote survey of the cavity. By 0600 the survey using a Jordan Radector showed exposure rates ranging from 1 R/hr at the entrance hatch to 2000 R/hr at the farthest insertion of the Radector probe.

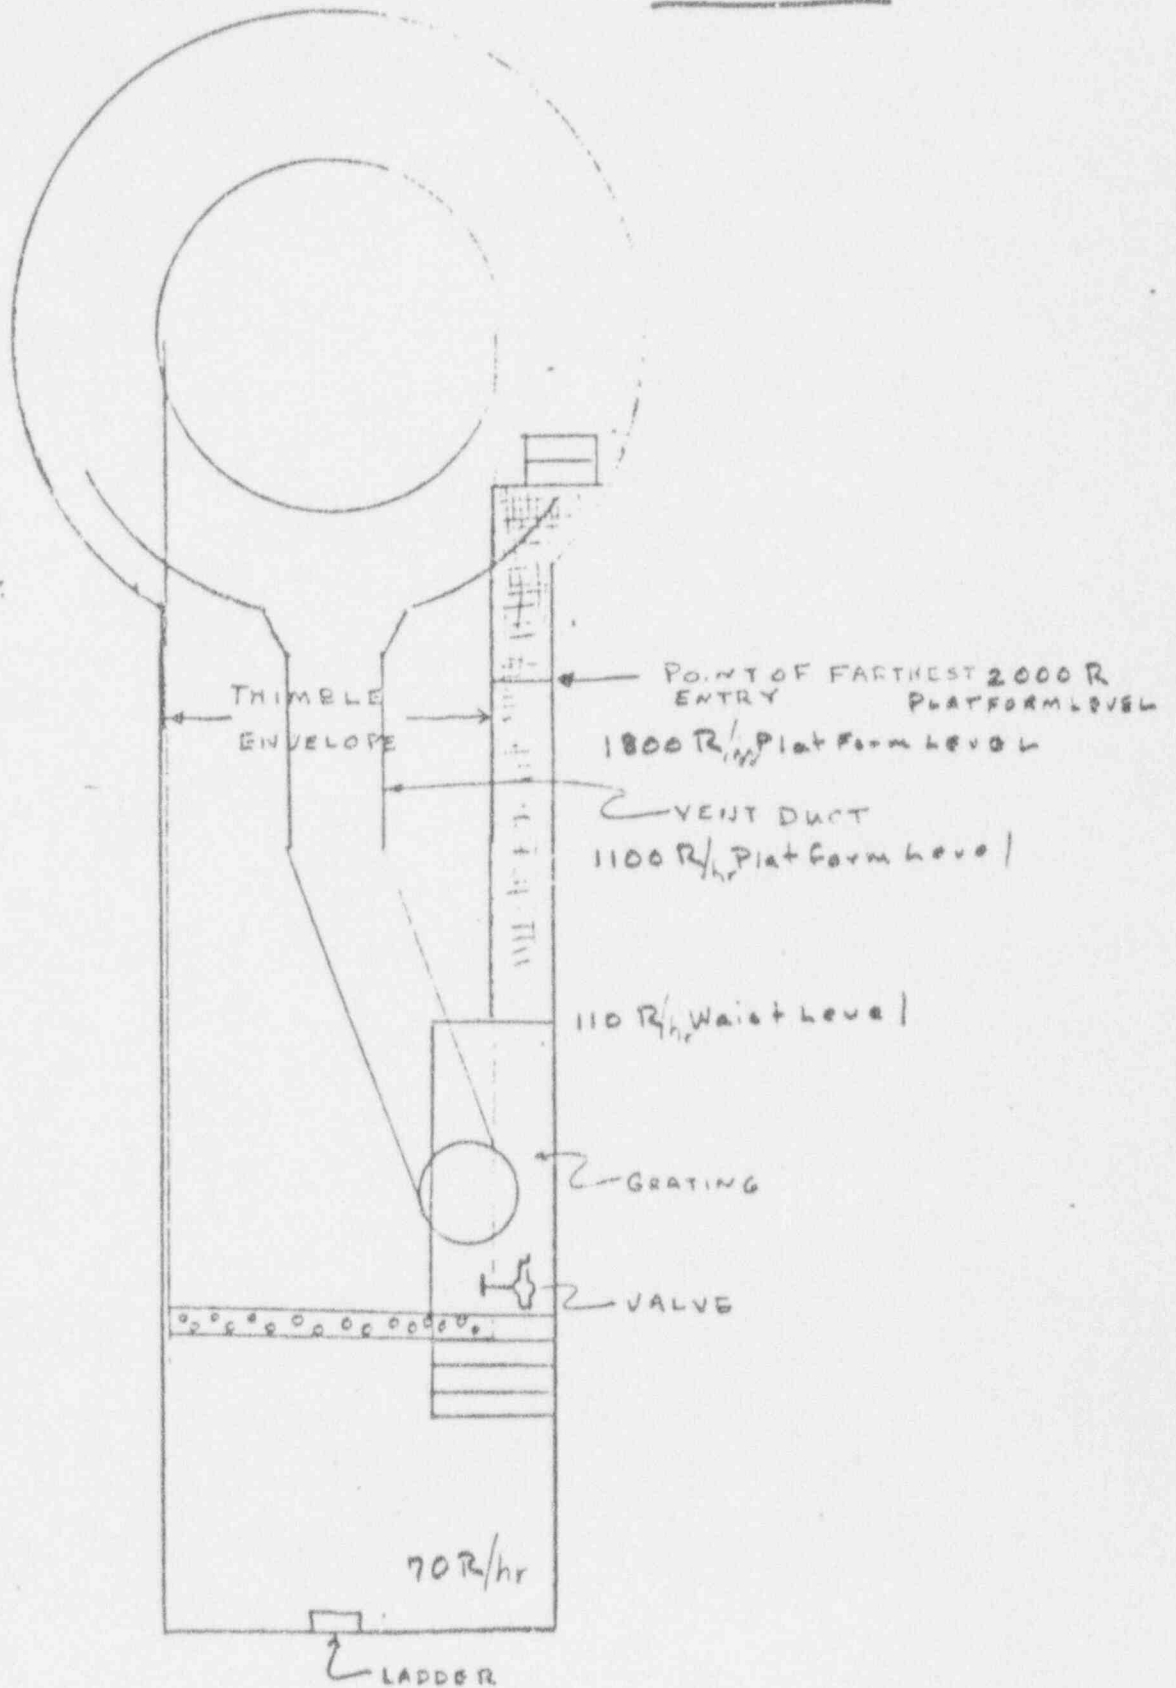
Figure 2

The shift supervisor entered down a ten-foot vertical ladder to the bottom of the cavity, ascended four steps to a grating, and then walked horizontally about twelve feet. At this point he crouched, looked up under the reactor vessel, immediately spotted water leaking, and retraced his path out of the cavity. (He, the technician, and the auxiliary operator described his movements in the cavity as very rapid, virtually running in and out. Both the technician, who was noting time with a sweep second hand on a watch, and the auxiliary operator stated that the total entry time was less than 30 seconds.) The shift supervisor's 0 to 200 mR dosimeter, read upon exit, was offscale. He then left containment.

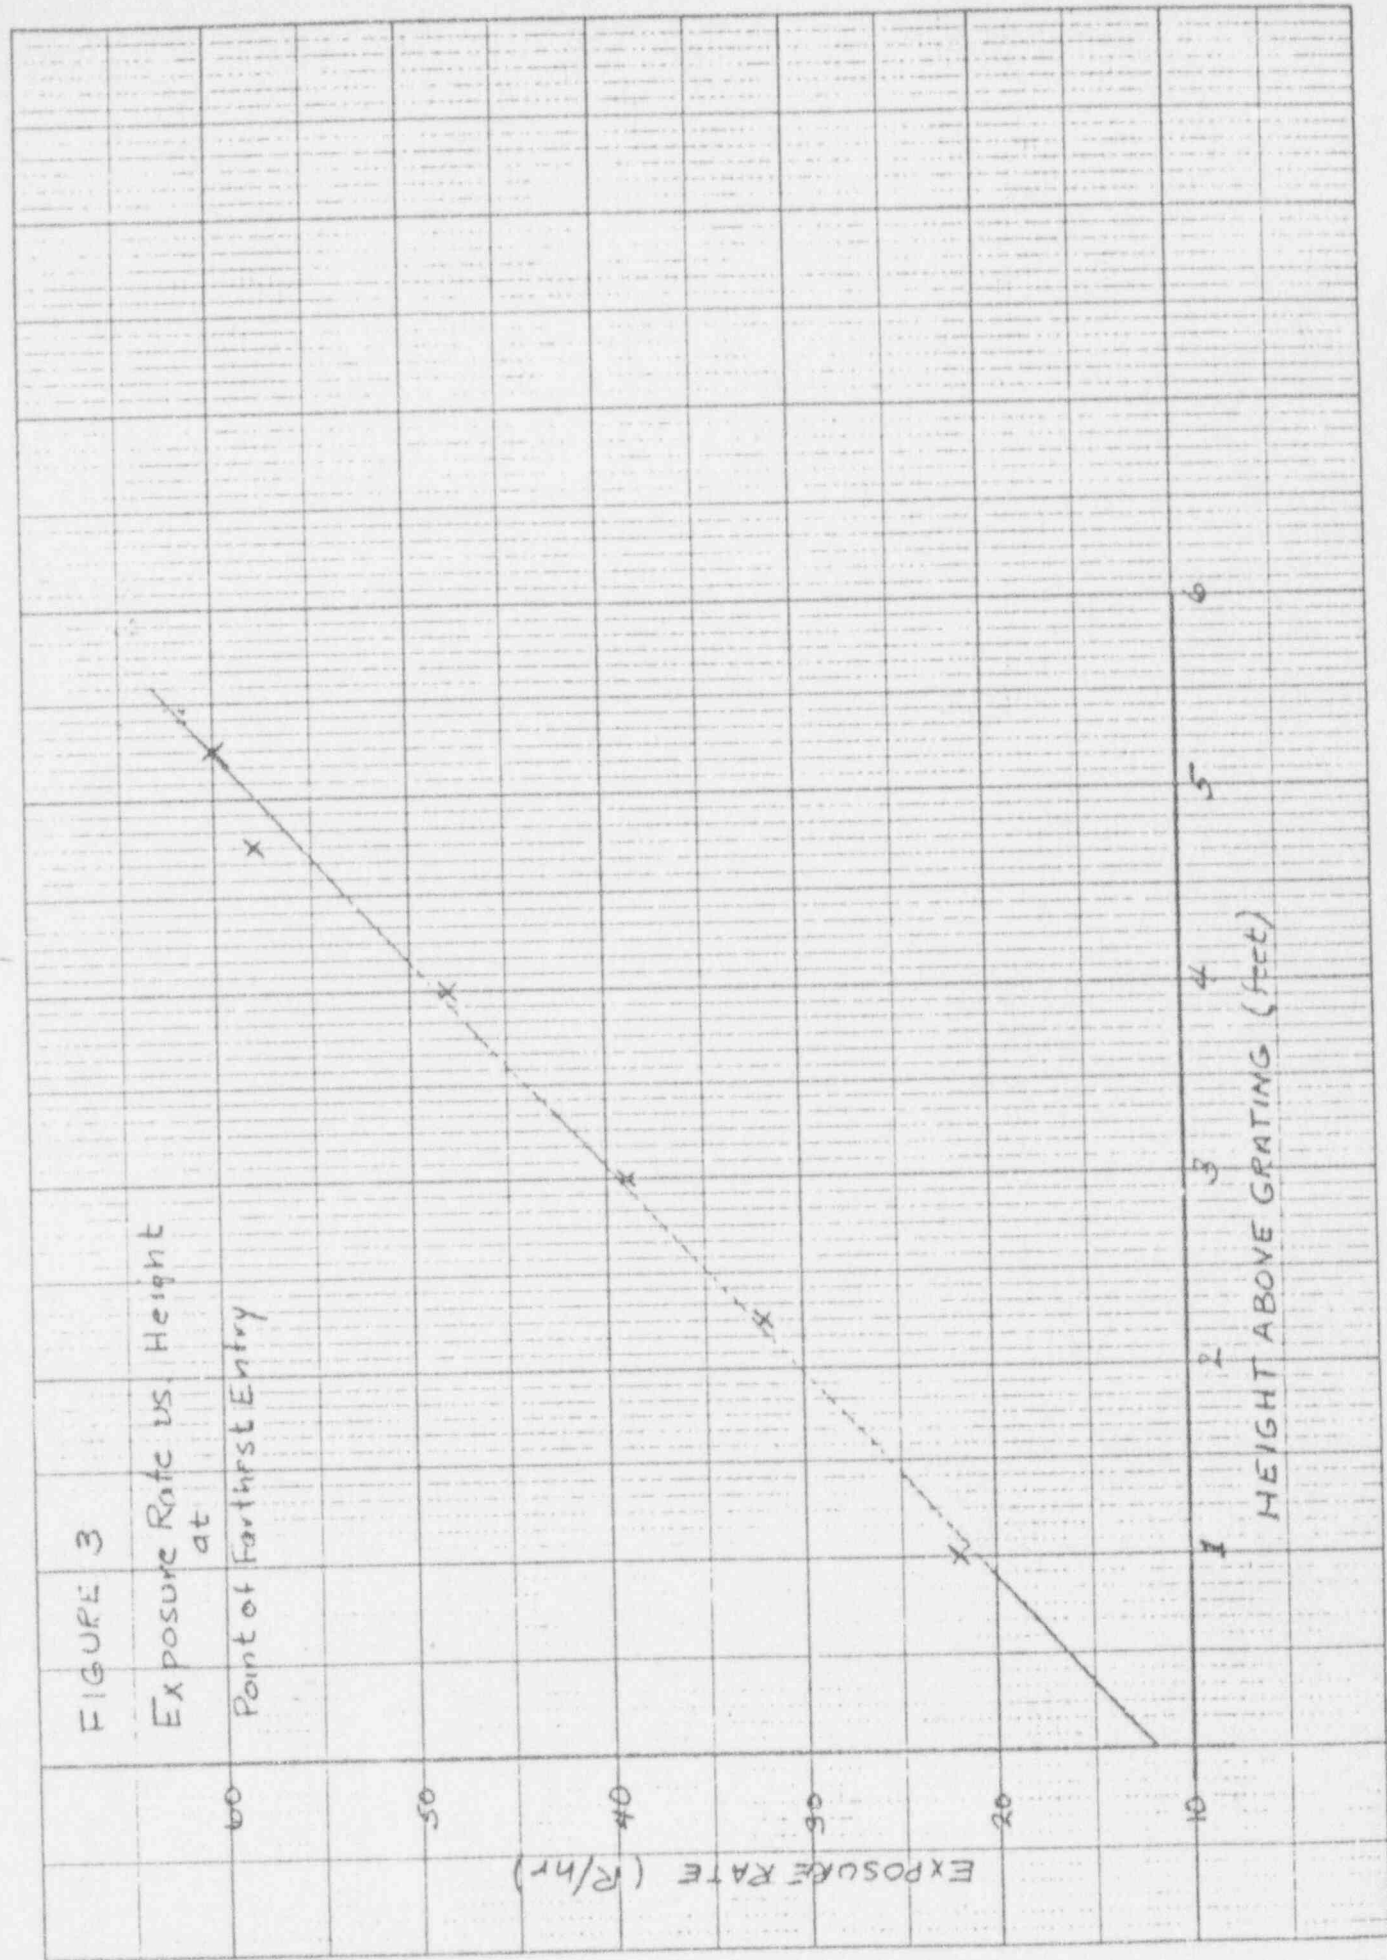
FIGURE 3

Exposure Rate vs. Height  
at  
Point of Farthest Entry

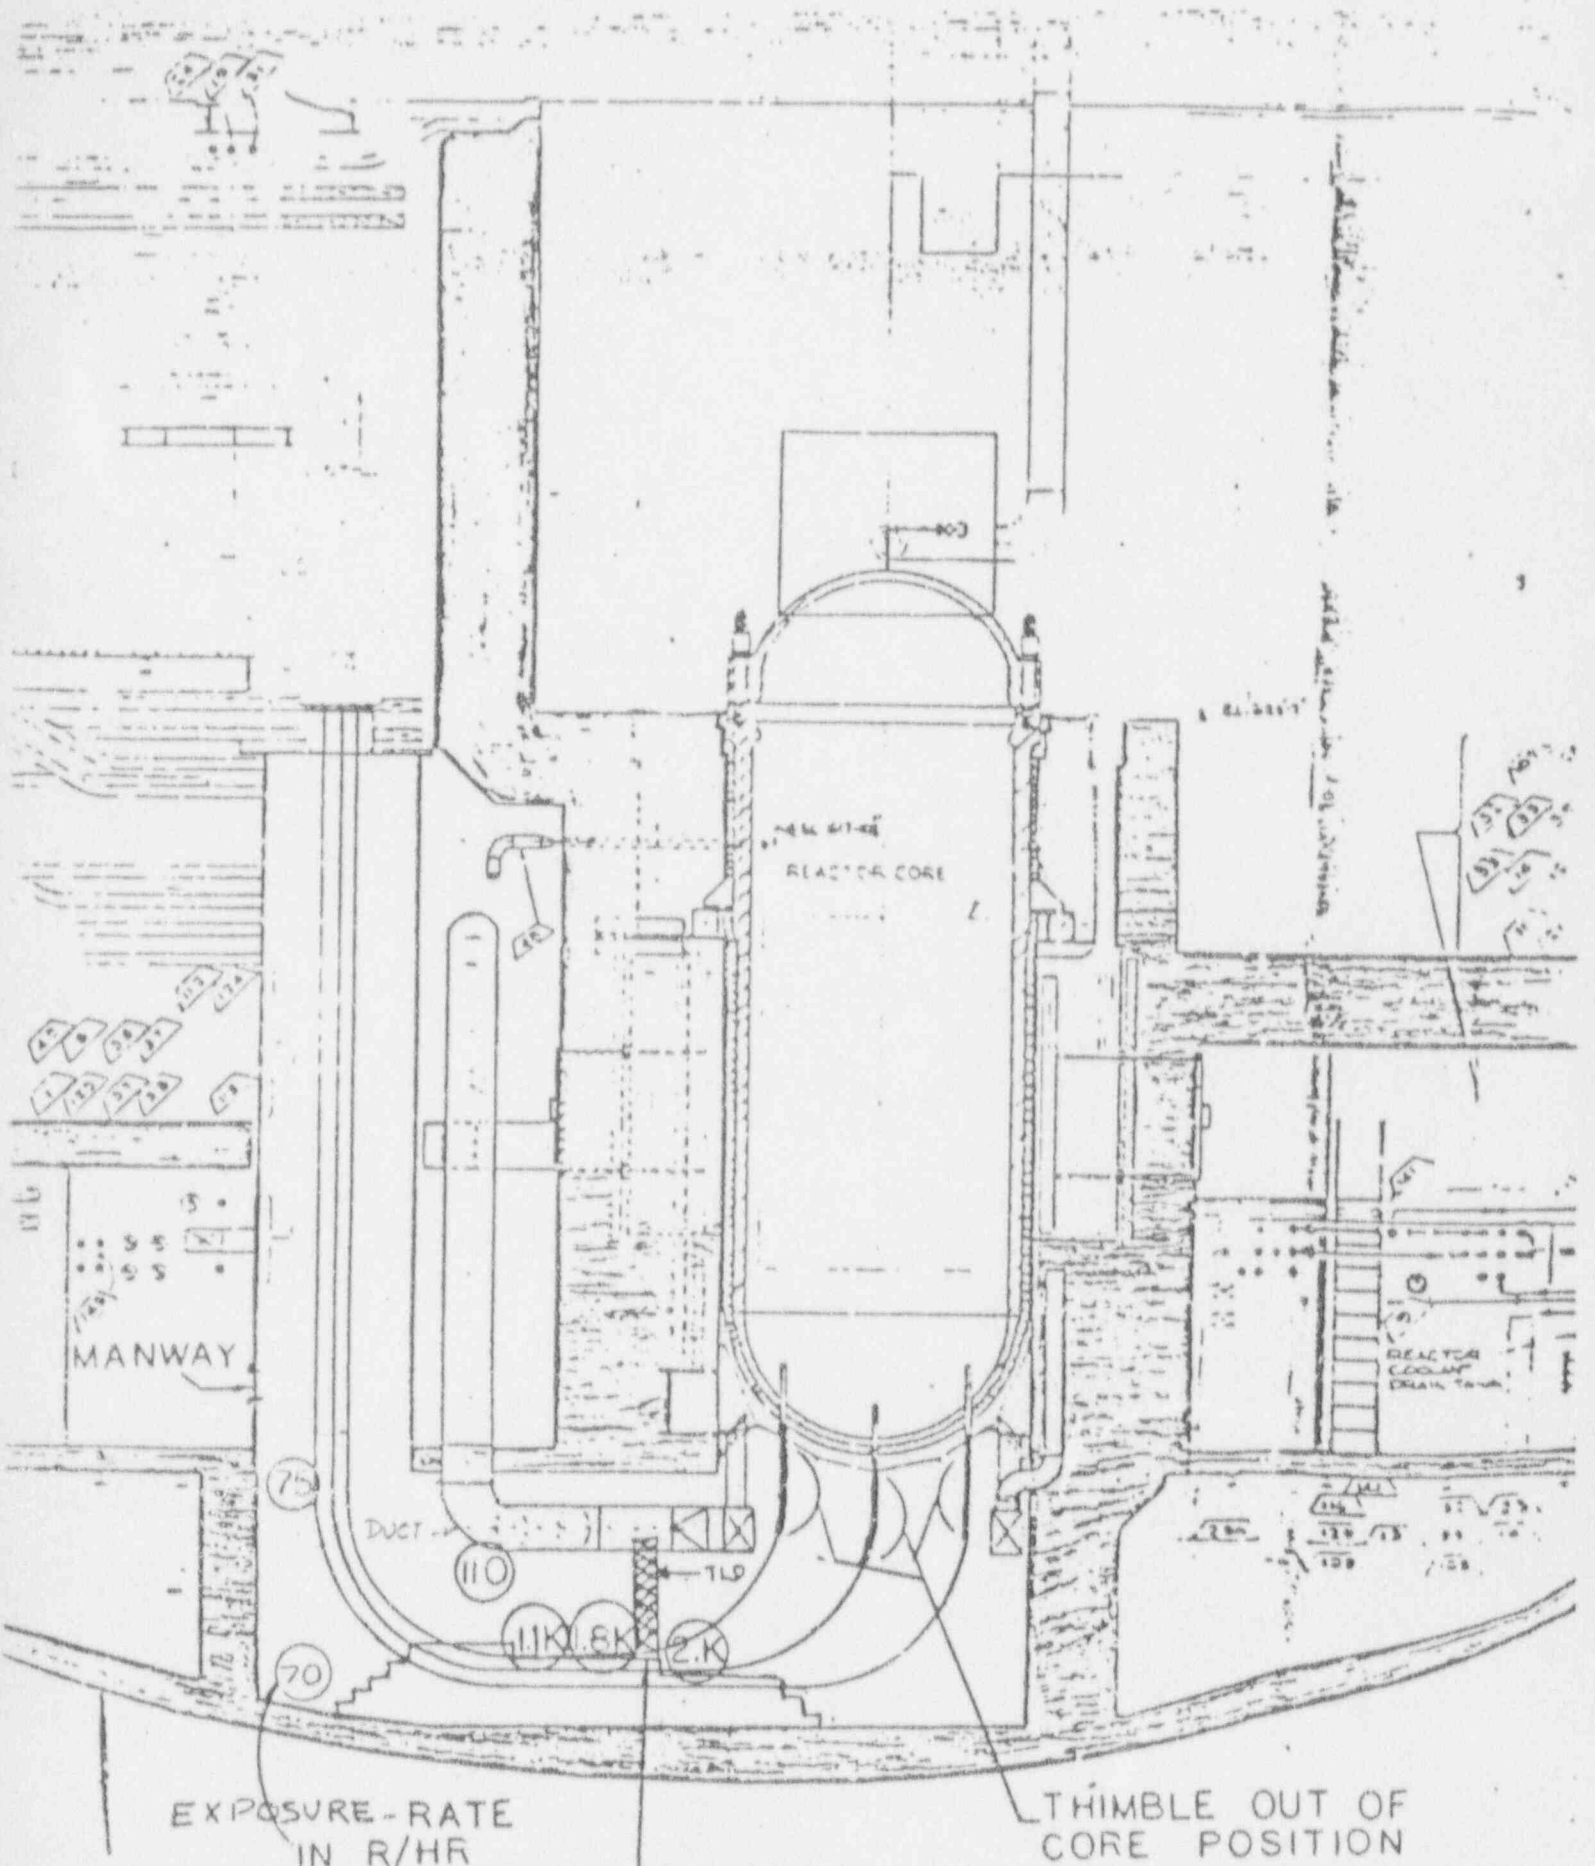
FIGURE 1.

On May 2, 1978, between 0230 and 0245, the shift supervisor on duty entered the reactor cavity (Figures 1 and 2), designated Sump C by the licensee, to check for leaks from the refueling cavity, which was about two thirds full. The sound of water running in the cavity had been heard through the opened entrance hatch shortly before. At the time of the entry, the in-core instrument thimbles were in the withdrawn position and the cavity was a recognized high radiation area having a posted exposure rate of 70 R/hr.

Two persons who observed the entry agreed that the duration was less than 30 seconds. Upon exit the shift supervisor's 0 to 200 mR personal dosimeter, an inappropriate dosimeter for such an entry, was noted to be offscale. The plant health physicist, who was notified at home of the occurrence, came to the plant and initiated a remote survey of the cavity. By 0600 the survey using a Jordan Radector showed exposure rates ranging from 1 R/hr at the entrance hatch to 2000 R/hr at the farthest insertion of the Radector probe.

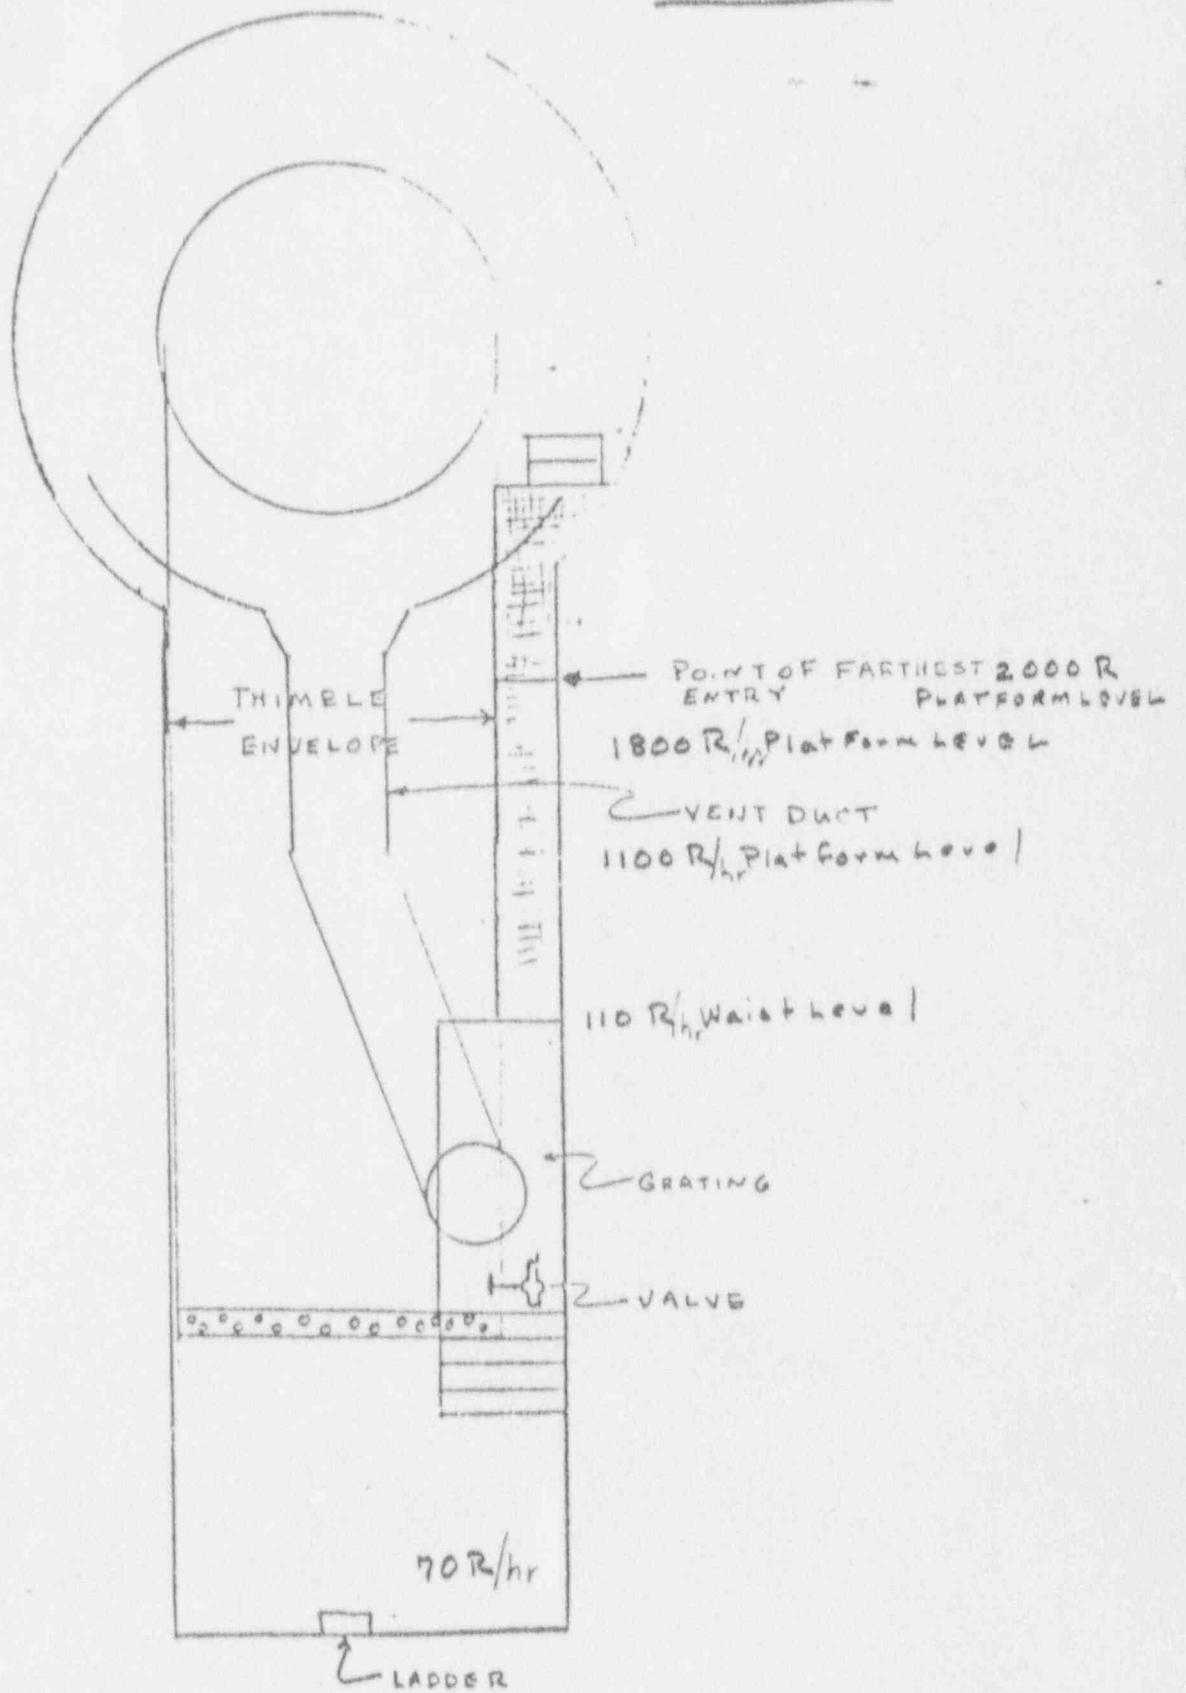
Figure 2

The shift supervisor entered down a ten-foot vertical ladder to the bottom of the cavity, ascended four steps to a grating, and then walked horizontally about twelve feet. At this point he crouched, looked up under the reactor vessel, immediately spotted water leaking, and retraced his path out of the cavity. (He, the technician, and the auxiliary operator described his movements in the cavity as very rapid, virtually running in and out. Both the technician, who was noting time with a sweep second hand on a watch, and the auxiliary operator stated that the total entry time was less than 30 seconds.) The shift supervisor's 0 to 200 mR dosimeter, read upon exit, was offscale. He then left containment.
