REPORT ON FAULTS AND SOIL FEATURES MAPPED
IN THE DISCHARGE TUNNEL EXCAVATION
MILLSTONE UNIT 3

AUGUST 1982

MILLSTONE NUCLEAR POWER STATION - UNIT 3
DOCKET NO. 50-423

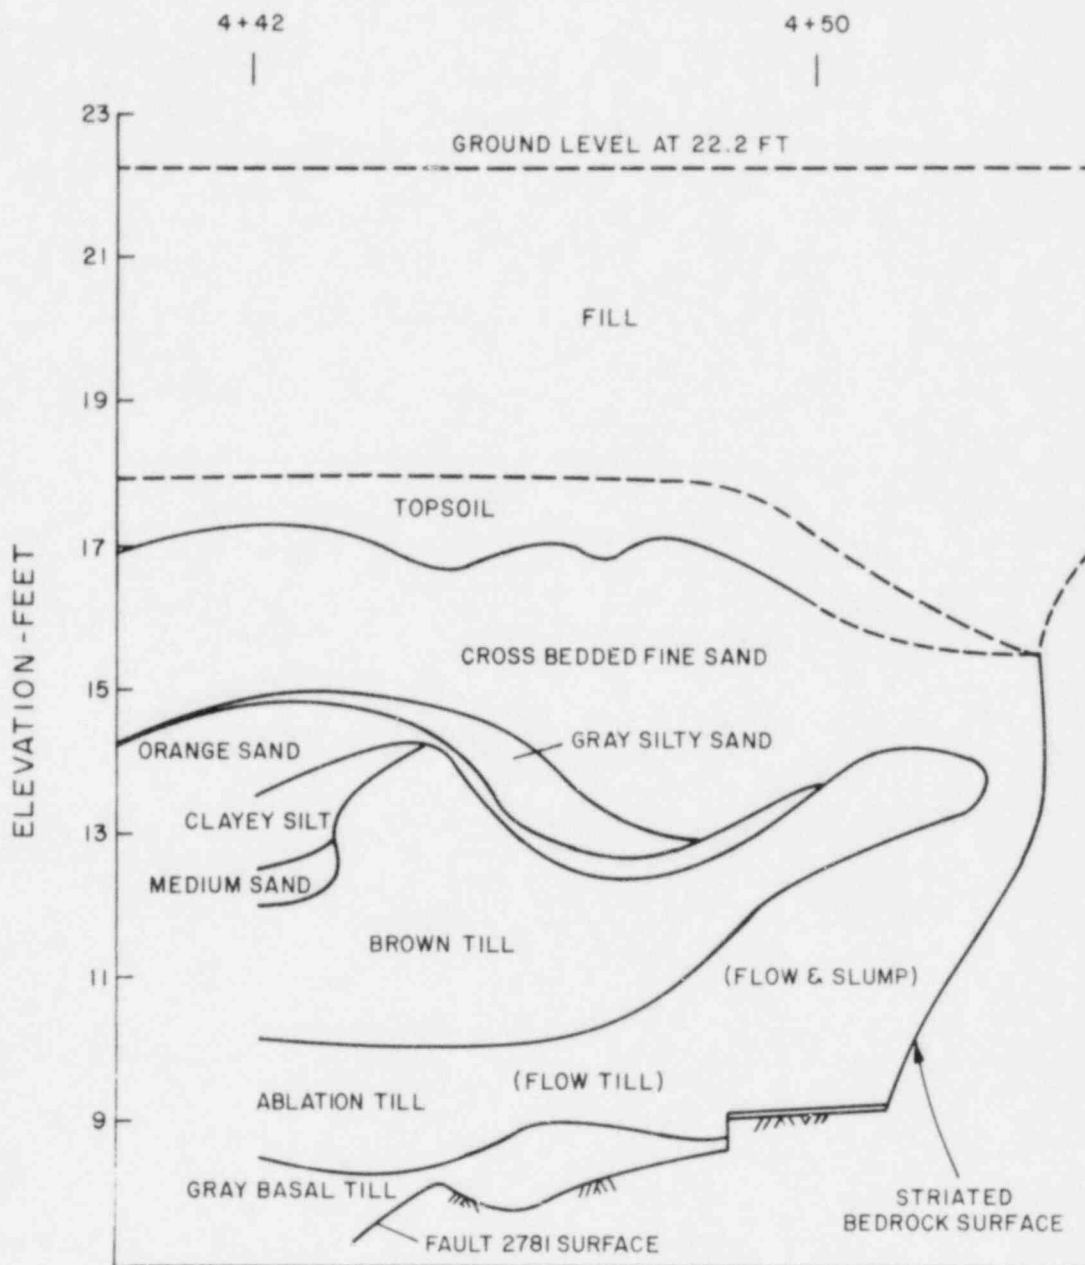
FIGURE 5
 SKETCH MAP OF SOIL OVER FAULT
 2781, NORTH WALL
 MILLSTONE NUCLEAR POWER PLANT
 UNIT 3

Unconsolidated soil deposits overlying exposures of the fault on the walls of the tunnel were examined and mapped. (See Figures 5, 6, and 7). Basal till was seen to overlie the fault directly and continuously with no offset, nor disruption of crude layering in the overlying ablation flow-till. Similarly, horizontally stratified outwash deposits were found to be continuous across the projection of the fault on the south wall and had no offsets of any kind (Figure 7). The evidence indicates tectonic movement prior to the last advance of ice about 15,000 to 18,000 yr. BP (Black, 1982 Appendix B; Caldwell, 1978).

At fault 2781, on the north wall of the trench, a well polished and striated surface of the bedrock was exposed. On cleaning off a veneer of compact basal till that covered part of that surface the timing of displacement of small joint blocks of the rock became evident immediately. Two small joint blocks in the accompanying photo (Fig. 1) are separated from each other 1/4 to 1/2 in. by compact till; both are separated by about 1 in. of till from unjointed bedrock below. Moreover, the two joint blocks are offset horizontally up to an inch along the steeply inclined joint so that the south block (with 6 in. scale) juts to the west. The irregular edge of the joint is not worn or rounded in any way, nor is the block rotated as it would be if the ice were moving at the time of displacement. That displaced block would have been an obstacle to the moving ice that polished and striated the surface. The displacements and injection of till must have occurred after ice movement ceased, but while considerable hydrostatic head existed in the ice to inject the compact basal till into the joints. The displacements are typical of the spalling or fracturing that occurs during unloading of continental masses of ice thousands of feet thick. It is akin to rock bursts in mines. The unbroken rock below denies a deep-seated fault origin. The very dense compact basal till in the joints is often brittle enough to retain fractures if broken after unloading is completed. None were seen. In other places in the trench till was injected as much as 15 to 20 ft below the surface into small joints with various orientations.

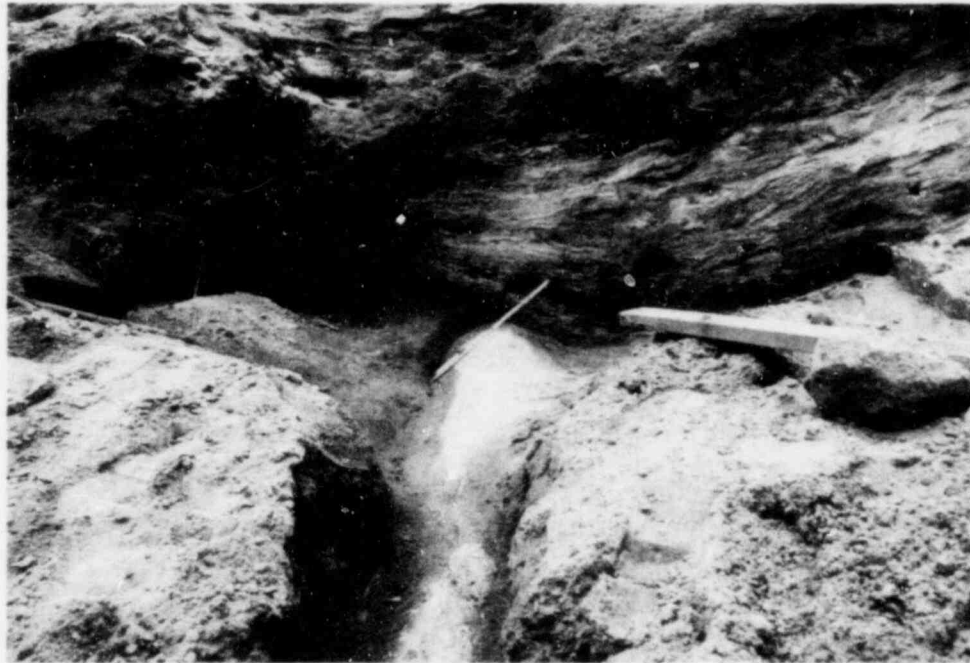
FIGURE 6
ROCK-SOIL CONTACT AT
FAULT 2781, NORTH WALL
MILLSTONE NUCLEAR POWER STATION
UNIT 3

RULER IS ON FAULT SURFACE. NOTE CONTINUOUS GRAY TILL
OVER FAULT

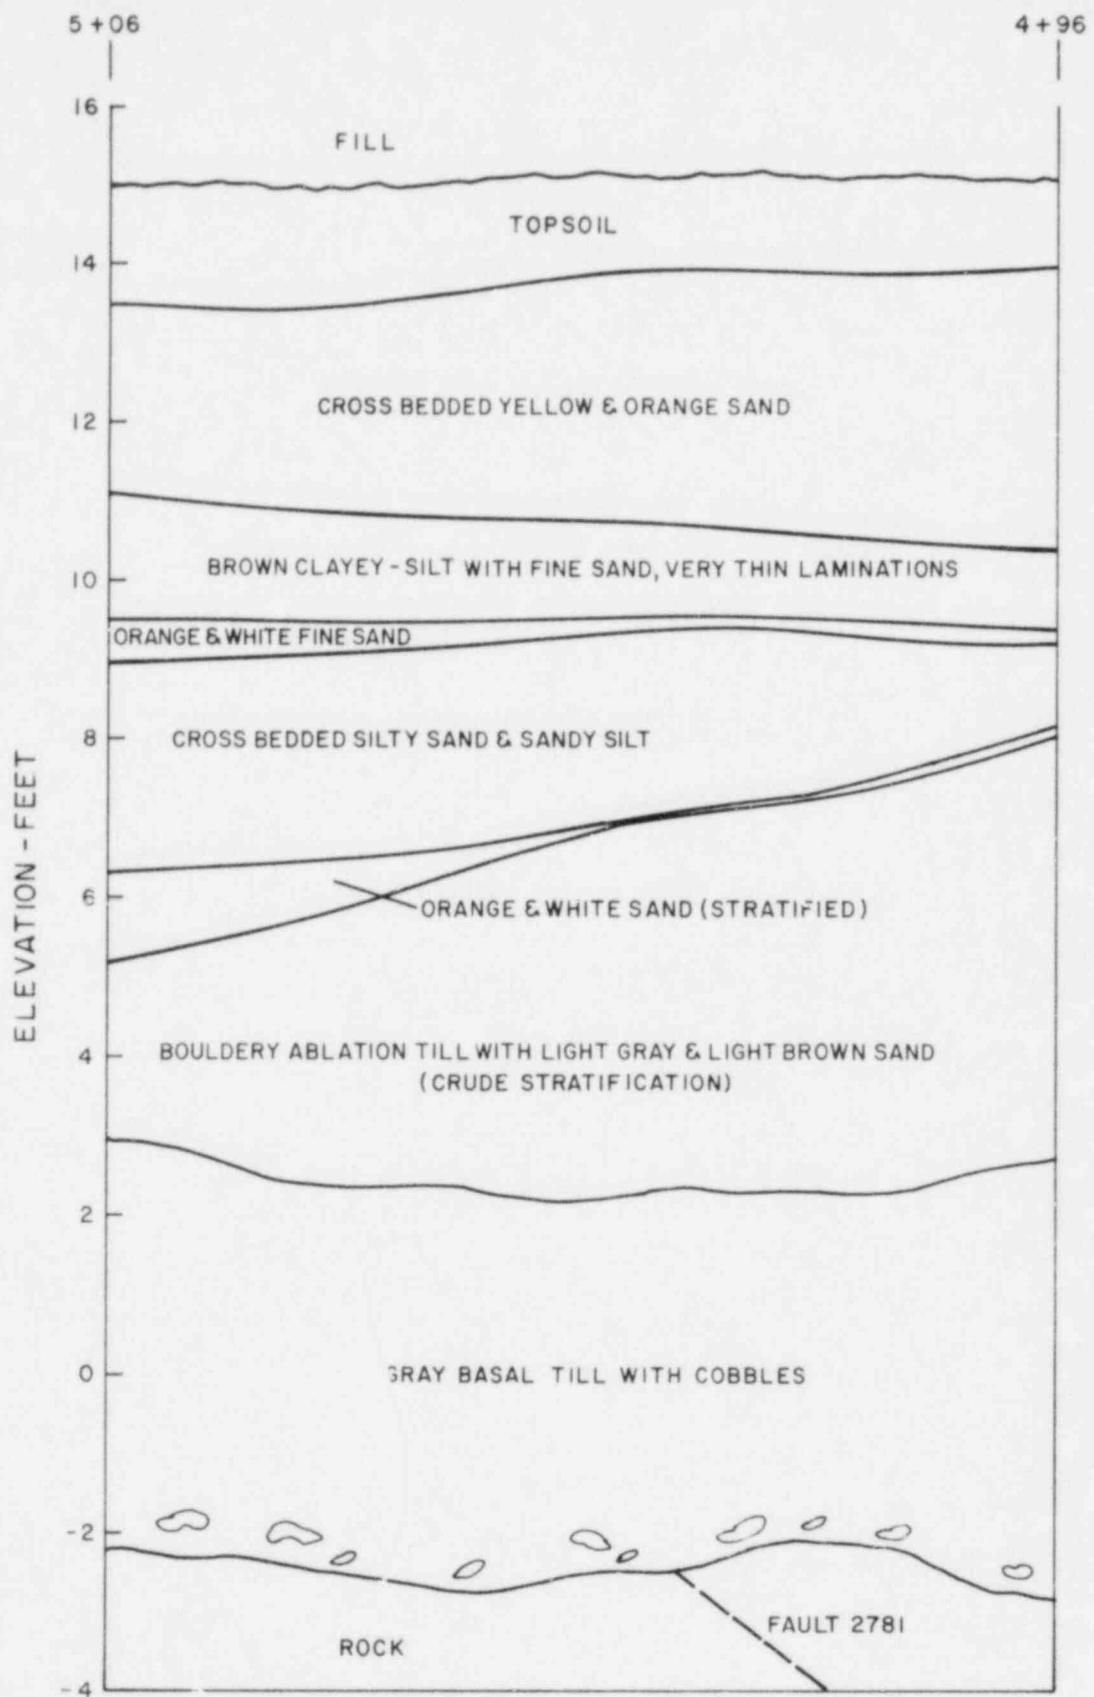
FIGURE 7
 SKETCH OF SOIL STRATIGRAPHY
 OVER FAULT 2781, SOUTH WALL
 MILLSTONE NUCLEAR POWER PLANT
 UNIT 3

At fault 2781 on the south wall, compact bouldery till covers the fault. Its finer portion is similar megascopically to that injected into the joints on the north wall. No breaks were seen in the till.

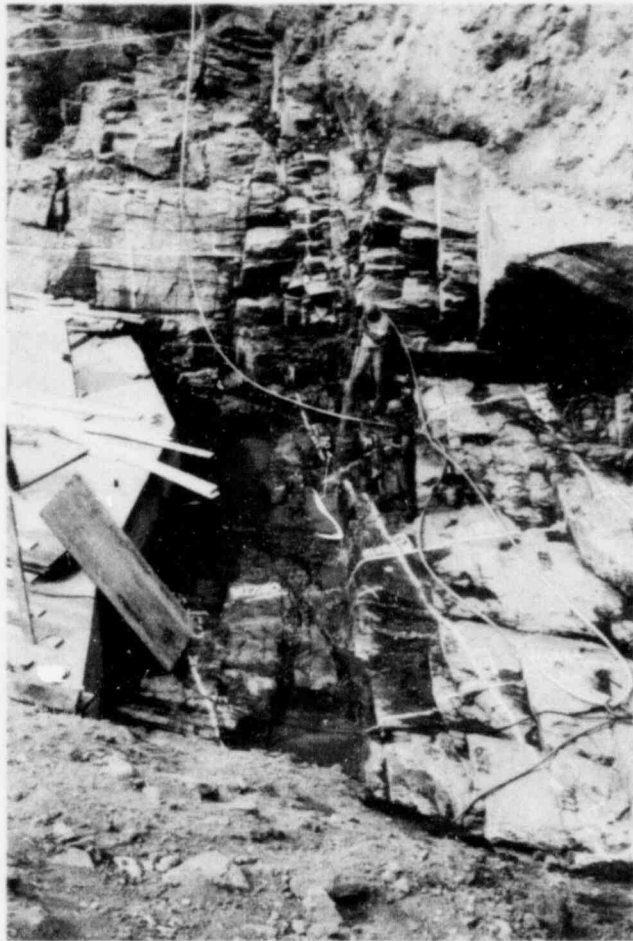
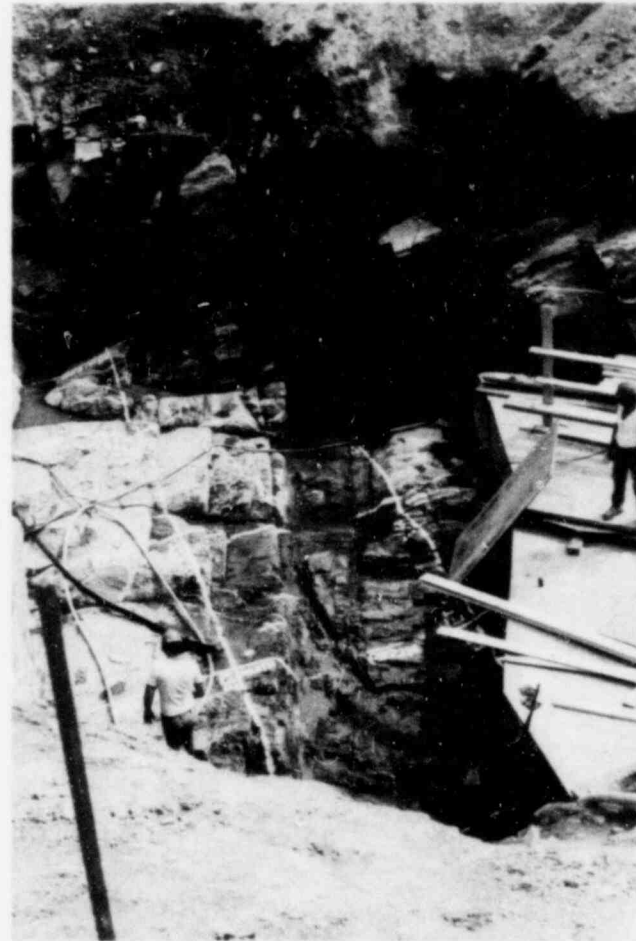
FIGURE 8
FAULTS 2817, 2818, AND 2819
LOOKING NORTH AND SOUTH
MILLSTONE NUCLEAR POWER STATION
UNIT 3

The second fault zone uncovered is larger and more complex than the first and includes faults numbered 2817, 2818, and 2819. (See Figures 1, 3, 4, and 8). The zone strikes between N10-17E and dips 77-82 degrees NW. Measurable left and right lateral offset of pegmatite veins occurs along faults 2817 and 2818 to a maximum of 2.5 ft. Greater displacement is evident on 2819 as no continuity of structures could be identified across the fault in the width of the excavation. The 1.0 in to 1.5 ft wide zone is characterized as containing fractured rock, clay gouge, and drusy secondary quartz with heavy iron staining in some areas. Quartz crystals are found growing into the zone from most fault surfaces and may entirely enclose rock fragments in the zone. Previous studies of quartz crystals from Millstone indicated development at temperatures considerably higher than present surface conditions, meaning they are associated with hydrothermal activity. The last episode of hydrothermal activity in this part of New England is believed to be at least Cretaceous in age (NNECo, 1975).

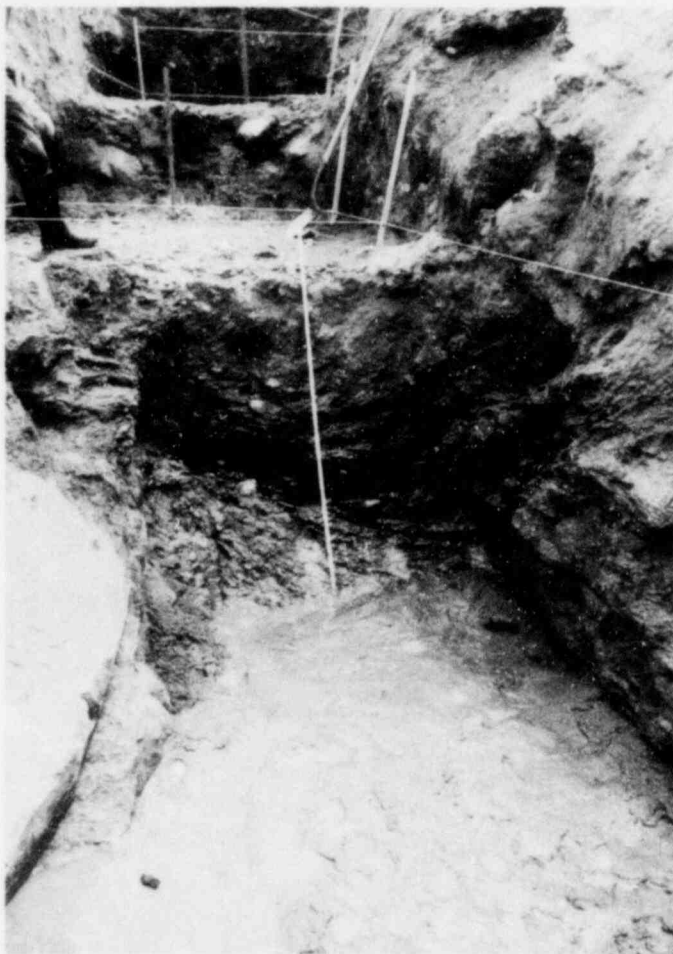
The rock-soil interface above the fault zone has been carefully exposed and documented. (See Figures 9-12). On the south wall, offsets from 1 in. to 15 in. in the unconsolidated outwash material form a small fault-bound depression directly over fault 2819. Close examination of the till directly overlying the fault revealed synclinal but continuous layering within the till. Identification of the layering is enhanced by sand beds providing avenues for seepage of groundwater; these beds have subsequently been heavily iron stained and cemented (See Figures 9 and 10). The till-outwash contact was mapped above the fault zone and is not offset.

The basinal form of the faulted outwash in this area is believed to be the result of melting of a buried ice block with subsequent collapse and slumping of the overlying soil materials into the spaces left by the melting ice (Black, 1982, Appendix B). These features are quite common in glacial ice margin environments and are not of tectonic origin. Spatial correspondence of the soil structures and the bedrock fault is strictly coincidental.

PHOTOS OF SLUMPED SOIL OVER FAULT 2817-2819 ON SOUTH EMBANKMENT. NOTE CONTINUITY OF IRON-STAINED LAYERS OF SOIL

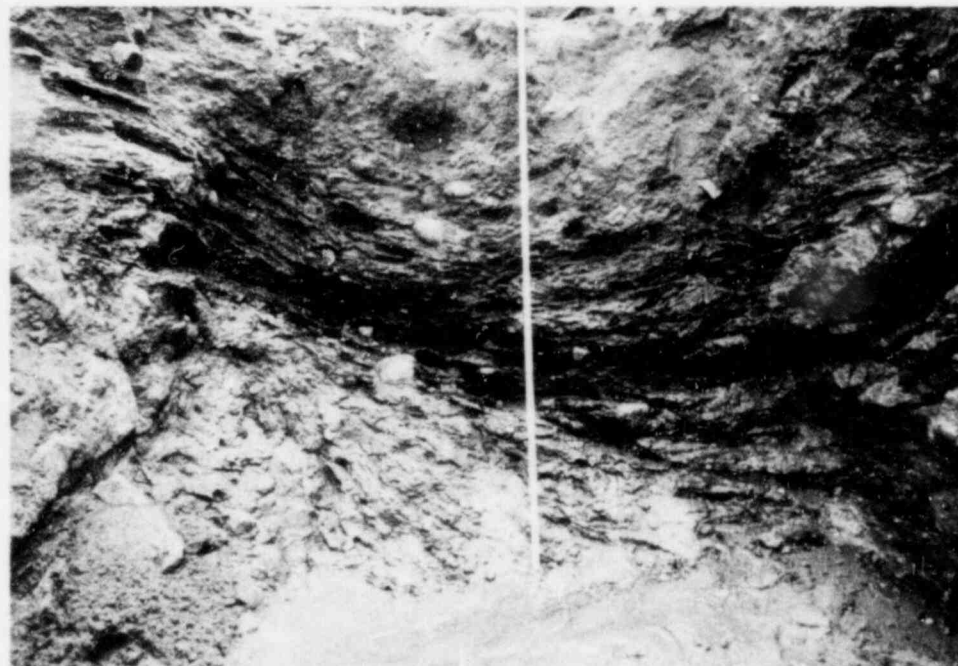
FIGURE 10
SOIL EXCAVATION OVER FAULTS 2817-2819,
SOUTH WALL DISCHARGE TUNNEL
MILLSTONE NUCLEAR POWER STATION
UNIT 3

At fault 2819 on the south wall, compact basal till was seen locally in the fault zone on fractured rock and was covered by stratified deposits. The sag structures in the stratified deposits are typical of those related to the melting out of small buried ice blocks to produce miniature kettles. It seemed reasonably clear in the trench extending southward along the fault that the southward moving ice had plucked irregularly the broken weak rock in the fault zone. The orientations of the sag structures and stratification in the sediments point to a bedrock low farther south. The orientation of the minor faults shows clearly that the sediments immediately over the fault have dropped like a graben. The

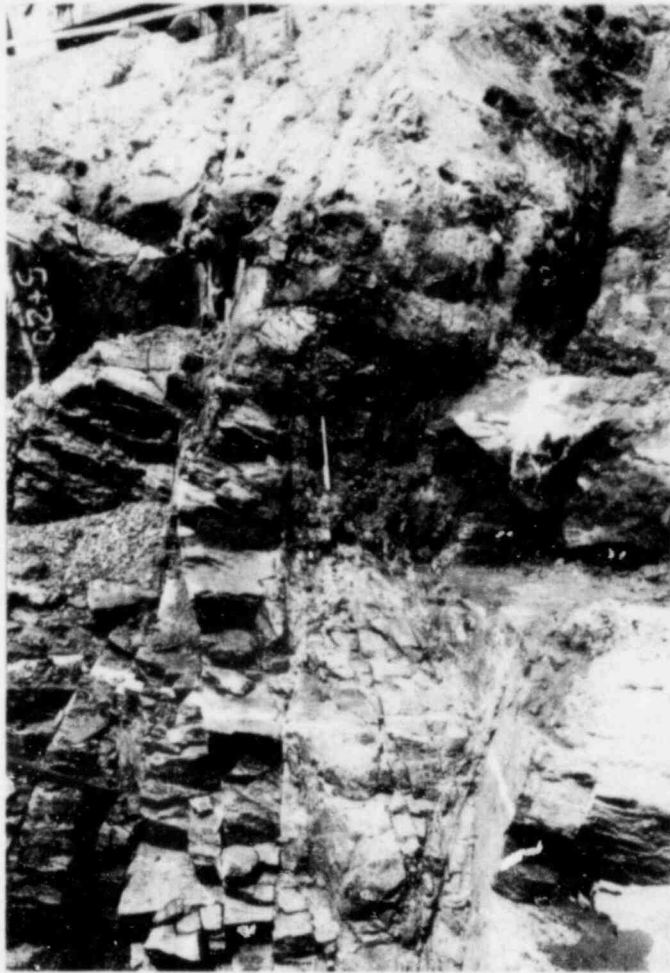
FIGURE 11
ROCK - SOIL CONTACT ABOVE FAULT
ZONE 2817-2819, NORTH WALL
MILLSTONE NUCLEAR POWER STATION
UNIT 3

The rock-soil interface above the north wall is not as well defined due to the more severe weathering and fracturing of the rock in this area. (Figures 11 and 12). No sharp boundary could be drawn where fault material ends and glacial material begins due to the heavy iron staining and abundance of clay from both glacial and tectonic origins. Basal till apparently was not deposited continuously over this area so lack of offset could not be verified. Crude stratification in the overlying flow till is not displaced, however.

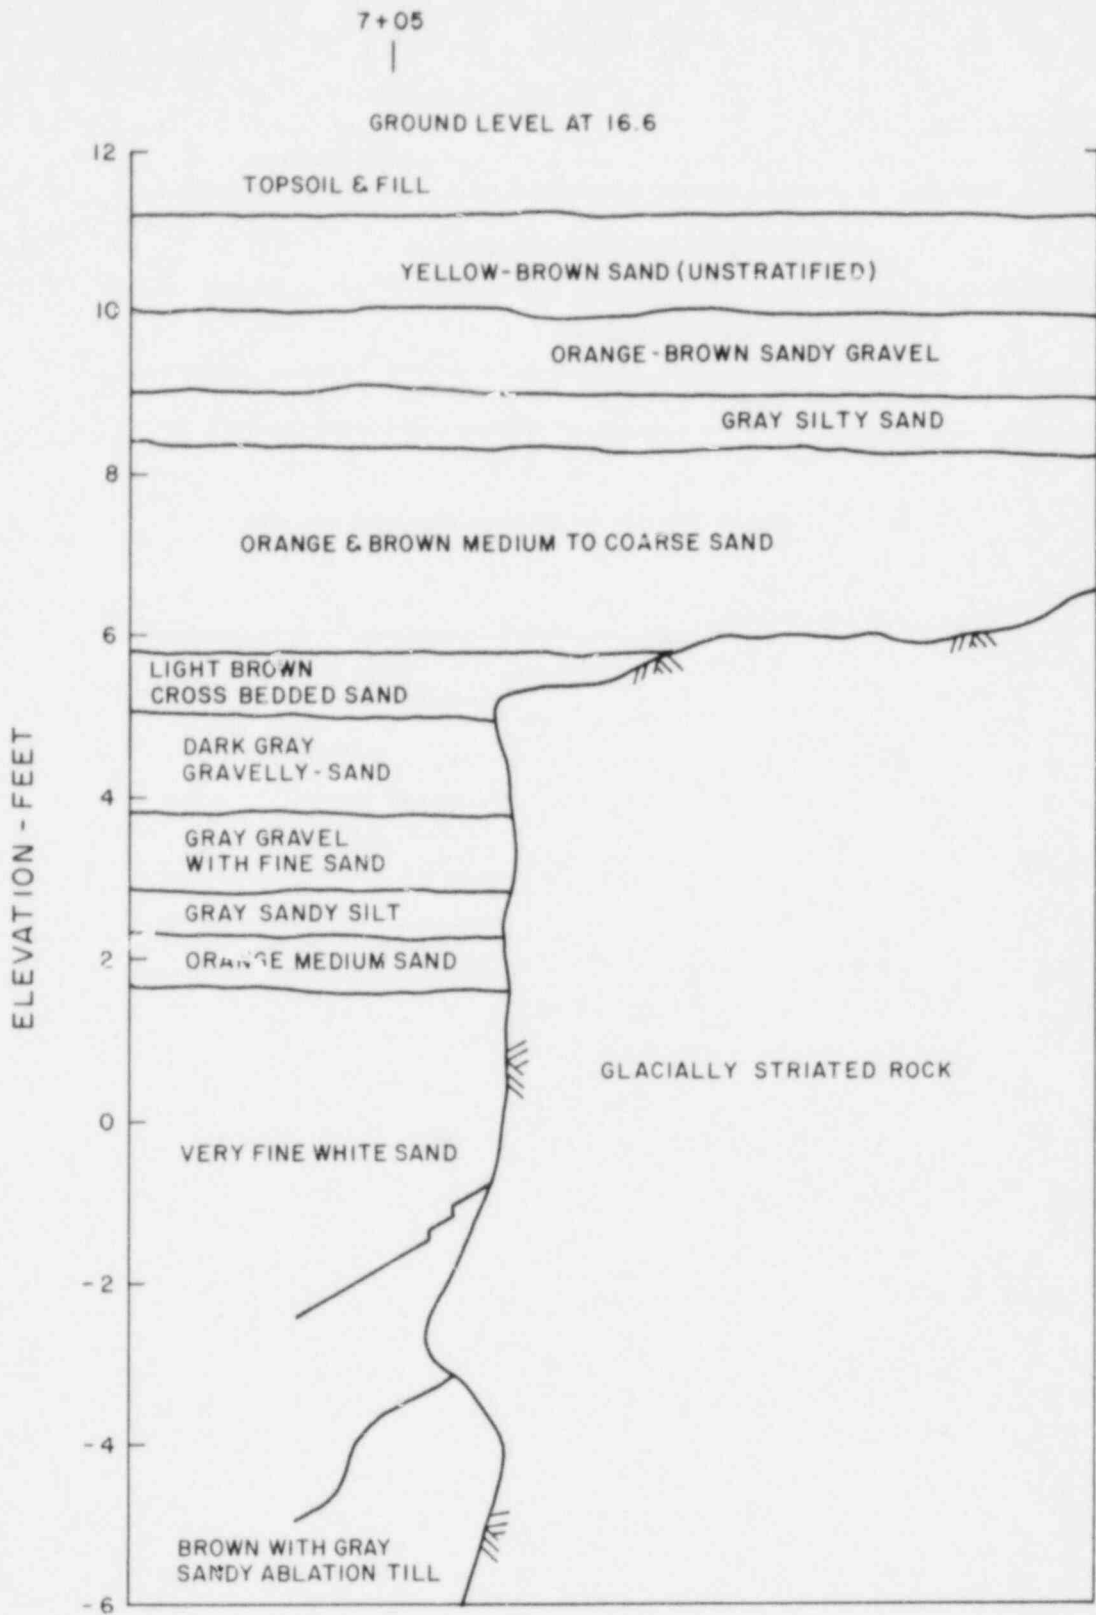
FIGURE 13
ROCK-OUTWASH CONTACT AT
STATION 7+05
MILLSTONE NUCLEAR POWER PLANT
UNIT 3

The bedrock surface drops sharply below tunnel grade near Station 7 + 05. From this point southeastward, the tunnel is primarily founded on till. cursory inspection of the rock-soil contact at this point could possibly be interpreted as a fault contact due to the abrupt truncation of stratified outwash against the large, smooth joint face and the presence of small offset beds in the outwash sands.

Closer inspection reveals a glacially striated joint surface overlain with horizontally bedded deposits (except for cross-bedding) with no evidence of drag on any of the beds at the contact. (See Figure 13). The offsets are confined to particular beds, especially cross-bedded zones, and are not throughgoing. If the joint surface is a fault surface, last movement occurred prior to the formation of striations and deposition of the glacial material.

The stratified drift at the rock contact at station 7+05 has numerous minor structures related to gravity movement and loading during deposition to small displacements related to collapse of piping conduits that formed probably by dewatering during excavation of the trench. Typical downdrag of sediments during compaction and dewatering appear along the rock face. All such structures are strictly normal and widespread in glacial deposits. I saw no reason to refer any of them to bedrock displacements.

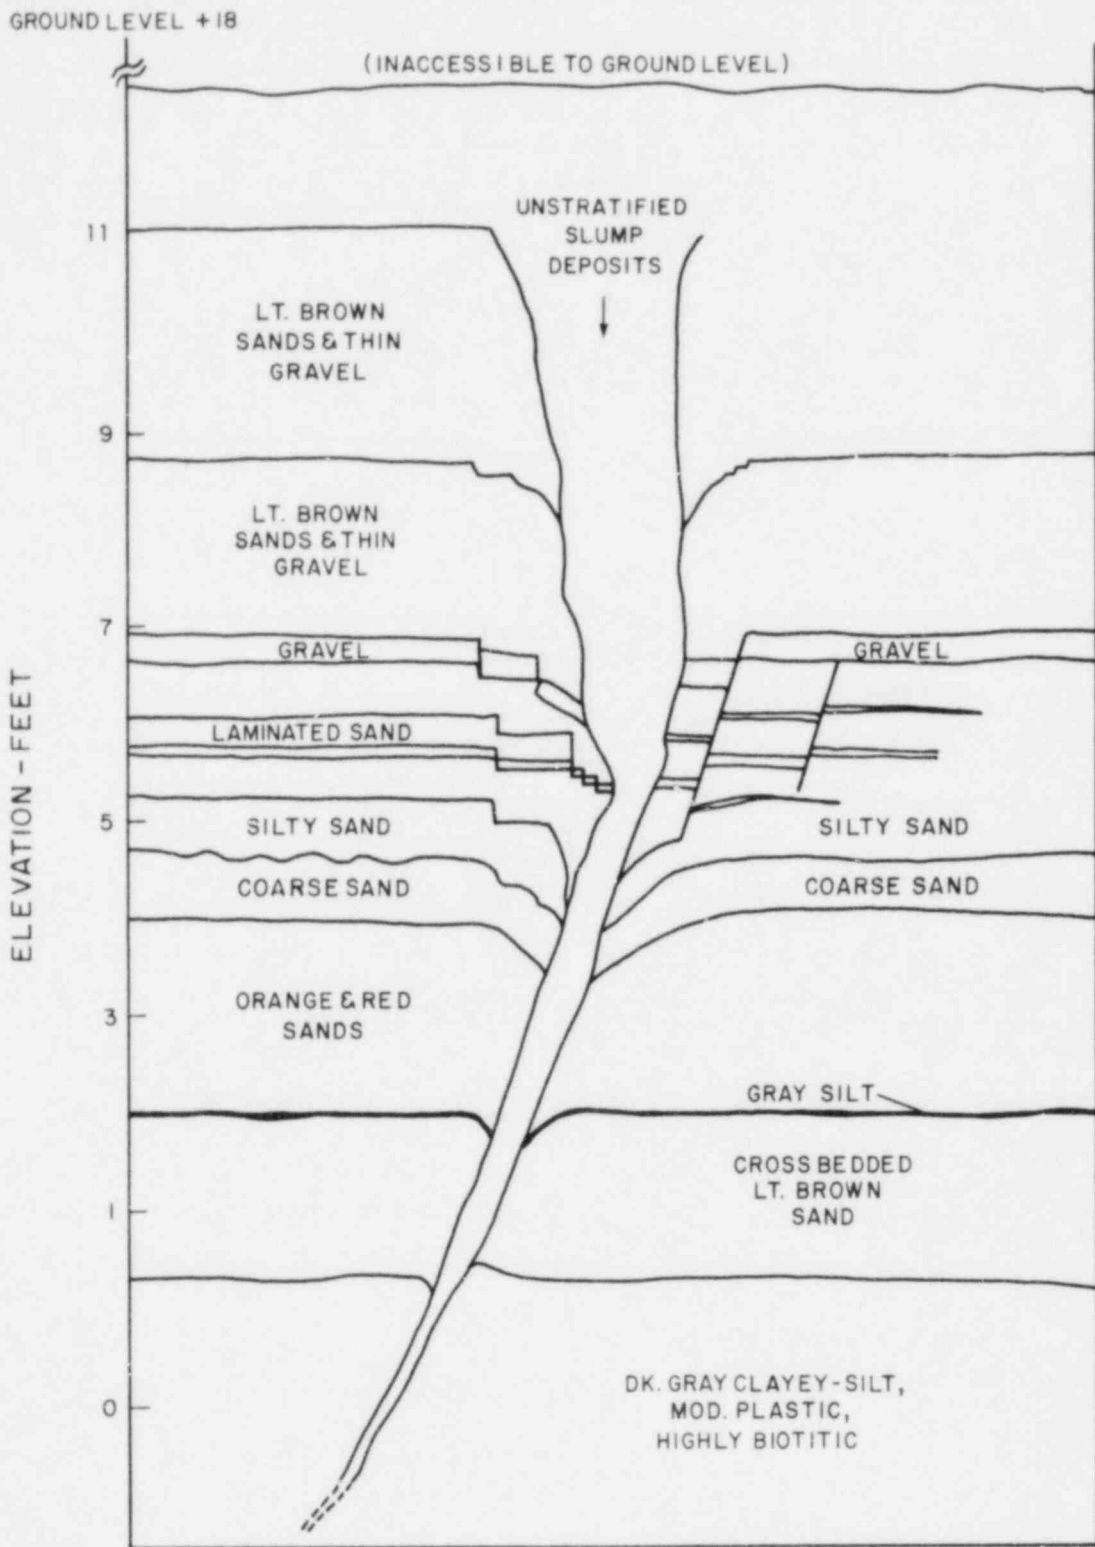
FIGURE 14
 SKETCH MAP OF "PSEUDO" ICE WEDGE
 CAST AT STATION 8+15
 MILLSTONE NUCLEAR POWER PLANT
 UNIT 3

Excavation of the soil-based section of the tunnel uncovered an unusual feature near Station 8 + 15. (See Figure 14 and 15.) It has been identified as an ice-wedge cast (Flint, 1964, p. 279) or a "pseudo" ice-wedge cast (Black, 1982). An ice-wedge cast is the cast of an ice wedge which has been filled with material which slumps and washes in from soil adjacent to the original opening. The original ice-wedge forms as a frost crack at the surface which gradually deepens and widens as more ice develops in the crack. Ice-wedges generally indicate the presence of permafrost during their formation. When the ice melts out as a result of warmer conditions, the hole created fills in with slumped material, creating the ice-wedge cast.

A "pseudo" ice-wedge cast can be formed in temperate climates and are formed by plastic flow of clayey material under differential overburden pressures. The displacement or flow of the subsurface clayey material creates a tension crack in overlying granular material which gradually slumps inward and fills the crack to form a "pseudo" ice-wedge cast. Black (1982) believes the features in Connecticut are of relatively recent origin, are not related to permafrost environments, and are still being formed today. Iron stained layers resulting from former groundwater levels were found to be displaced downward toward the central filled zone of the wedge at Millstone indicating formation after development of static groundwater levels. Whatever the timing of formation, the structure definitely is not of tectonic origin.

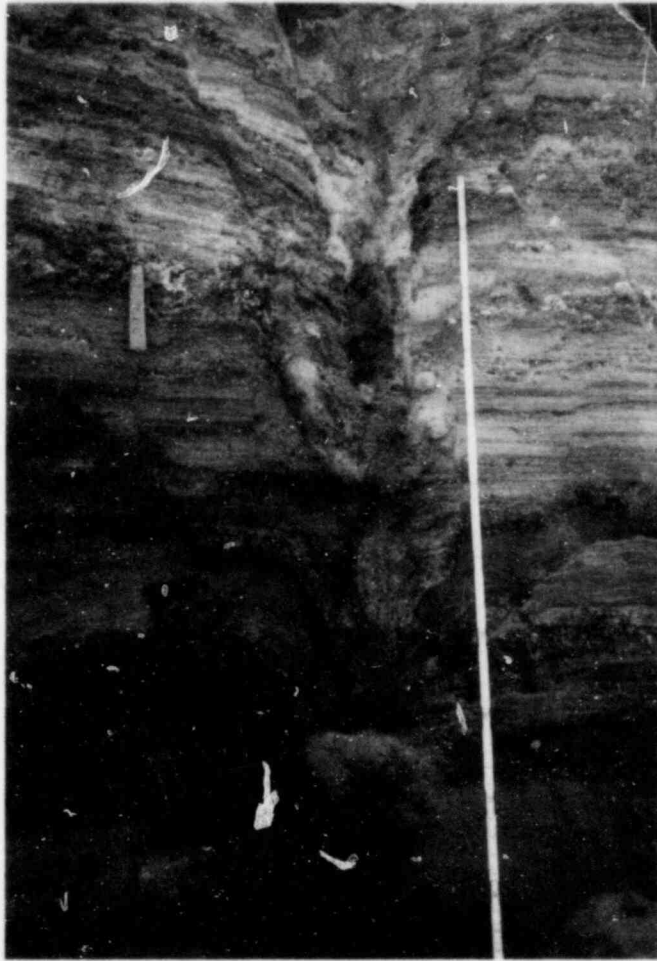
FIGURE 15
"PSEUDO" ICE -WEDGE CAST AT
STATION 8+15 OF DISCHARGE TUNNEL
MILLSTONE NUCLEAR POWER STATION
UNIT 3

The pseudo-ice-wedge cast is a term I have applied to similar features elsewhere in Connecticut. An abstract was published recently (copy attached), and a manuscript has been submitted for publication (a copy can be supplied if needed). In short, the wedge structure is typical of those produced by intermittent tension movements within the sediments. The opening produced allows blocks of stratified sediments on both sides to break loose from the host on small breaks inclined downward toward the apex or for material to simply flow into the void. Many wedges in Connecticut can be traced downward to their apices. The apices are mostly in finer sediments than the upper part or are at or in the water table. Typically, they are in polygonal array around kettles; single wedges commonly parallel topographic discontinuities, such as a stream or shore. Fluctuating water tables, loading, and creep of semi-rigid material over plastic material in the groundwater zone lead to their formation. Near Storrs, Connecticut, they are especially abundant in the upper part of kame terraces along streams where sediments are many tens of feet thick and are creeping intermittently toward a stream. The wedges disappear in the vicinity of the water table. In the one in the trench, the upper part of the wedge cuts dark brown iron-stained horizons and is younger than the oxidation. Near the apex, the iron stains swing out horizontally from the wedge into the sediments. The lowermost part of the wedge is in plastic fine sediments. Seemingly, the wedge has been extending itself downward as it widens. Movements are probably going on slowly but intermittently today. I see no reason why this wedge should be related to bedrock movements, nor do I know of any in Connecticut that are.
