U. S. NUCLEAR REGULATORY COMMISSION

Report No. 50-483/94004(DRP)

Facility Name: Callaway Plant, Unit 1

Inspection from January 23, 1994 through March 12, 1994 (Report No. 50-483/94004(DRP))

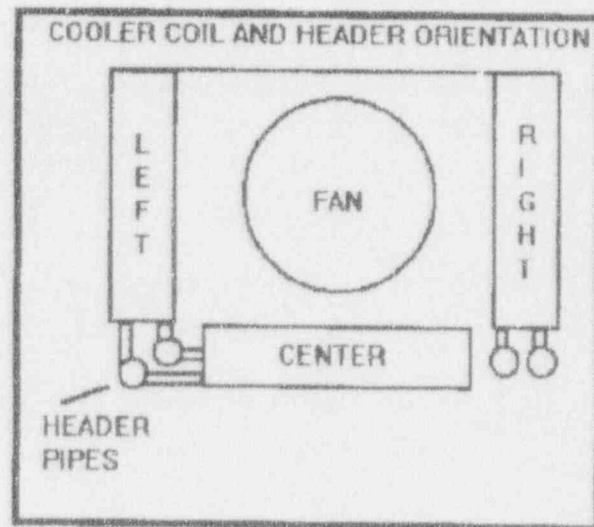
Figure 1

There are four containment coolers, two coolers are in each train. "A" and "C" coolers are in the "A" train and "B" and "D" coolers are in the "B" train. The arrangement of each cooler, as seen from above, is as shown in figure 1. Each of the left, center, and right portions of the coolers contain four heat exchanger coils, each stacked on top of the other, for a total of 12 coils per cooler. Each heat exchanger coil contains copper tubes of three-eighths of an inch in diameter. These tubes are the smallest diameter tubes contained within the ESW system. A fan in the center of the cooler draws air across the heat exchanger coils. Each heat
