PRAIRIE ISLAND NUCLEAR GENERATING PLANT  
Docket Nos. 50-282 License Nos. DPR-42  
50-306 DPR-60

Auto-start of No. 121 Cooling Water Pump on Low Header  
Pressure While Aligned for Safeguards Operation

LICENSEE EVENT REPORT (LER)

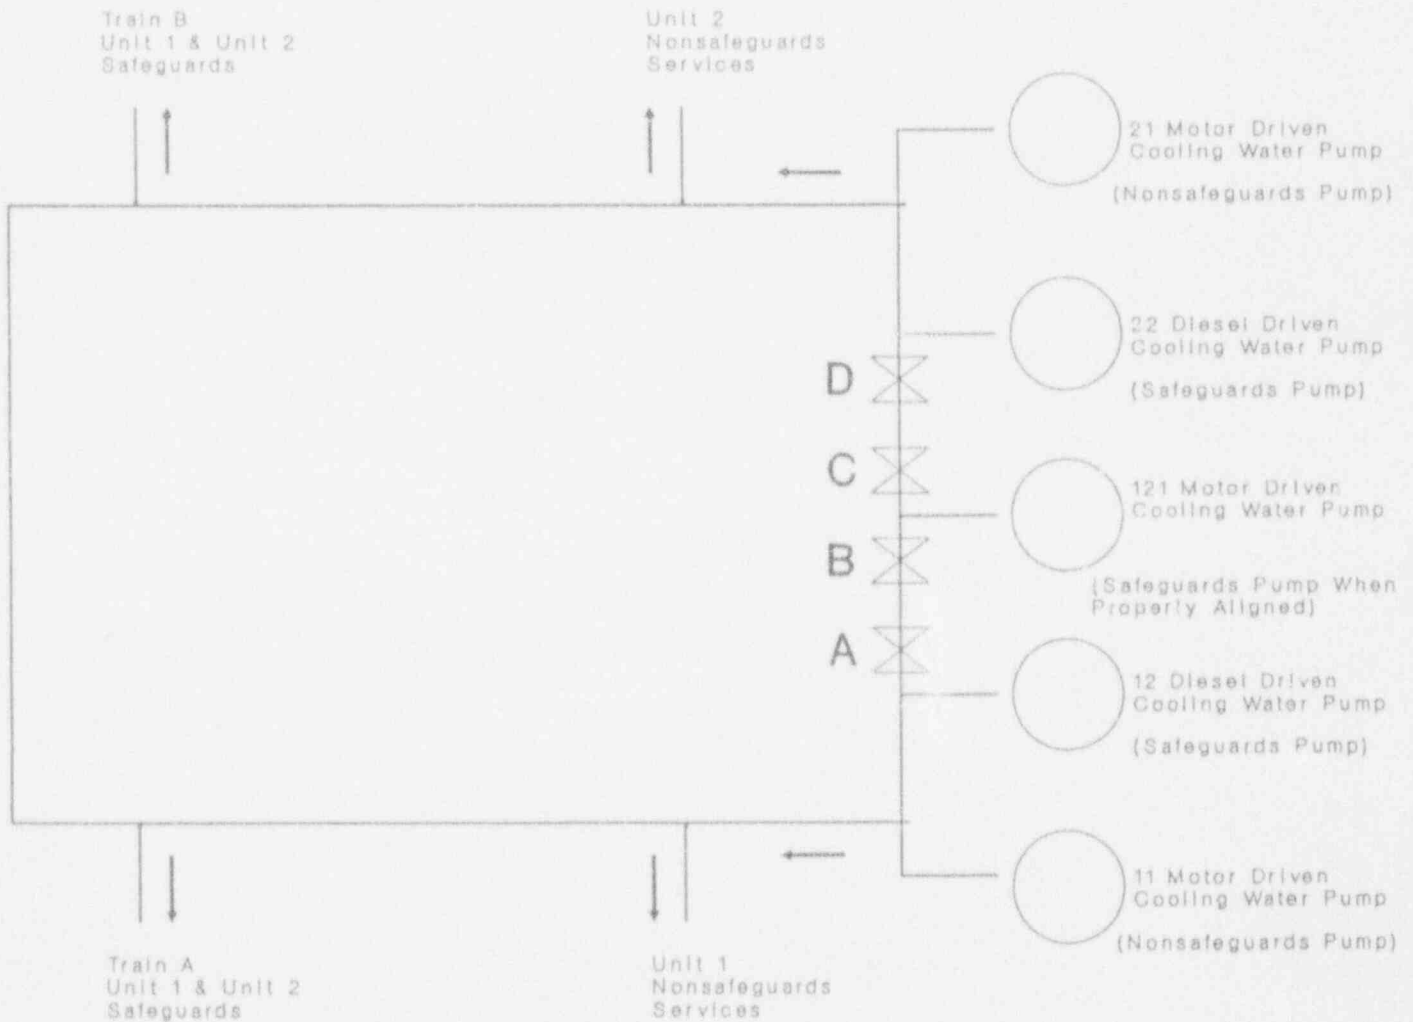
FIGURE ONE

On March 1, 1994, both units were at 100% power. No. 11 Motor-driven Cooling Water Pump was running and supplying all cooling water loads. See Figure One. Technical Specifications allow a diesel cooling water pump to be removed from service with no Limiting Condition for Operation entry, provided that No. 121 Cooling Water Pump is aligned to supply the affected header. No. 121 Cooling Water Pump had been aligned for safeguards operation (valves C and D closed) in accordance with Technical Specification 3.3.D.1.a., in order to isolate No. 12 Diesel Cooling Water Pump for repair of a leaking lube oil fitting. After the repair was made, No. 12 pump was started locally to verify the leak had been fixed. The discharge valve for No. 11 pump was then slowly closed to allow No. 12 pump to gradually assume the header load, and No. 11 pump to be unloaded and shut down. After No. 12 pump had been run for 1 hour, No. 11 pump was restarted to assume the header load and No. 12 pump was shut down. When No. 12 pump was shut down locally, No. 11 pump did not pick up the header loads quickly enough, and the resultant decrease in header pressure was sufficient to cause No. 121 pump to start automatically at 1408 hours. This was a nonsafeguards actuation of an ESF component.

Cause of the event was inadequate procedures. Neither the work package nor the system operating procedure addressed the potential for auto-start of No. 121 Cooling Water Pump when swapping pumps. As a result of the previously reported auto-start (Unit 1 LER 93-006), the routine surveillance procedures and annual PM procedures were revised; the system operating procedure was not revised. Post-maintenance testing required only that integrity of the lube oil system piping be verified; the surveillance procedure was not required to be performed to prove operability. No. 12 pump was tested using the normal system operating procedure.

The system operating procedure has been revised.

Feasibility of applying a time delay to the start circuitry for No. 121 Cooling Water Pump will be considered.
