Subject: Main Feedwater System

MAINE YANKEE ATOMIC POWER STATION FEEDWATER EVENT

On January 25, 1983, Maine Yankee experienced a feedwater line steam-water hammer event that caused the feedwater line adjacent to a steam generator to crack through and leak. This report describes the plant systems and components related to the event, its causes and consequences, the repairs and modifications that were made or planned, and provides a justification for continued power operation. Most of the material contained herein was presented to the NRC at a meeting held at their offices on February 9, 1983. It has been supplemented by commentary reflecting some of the technical comments made during the oral presentation.

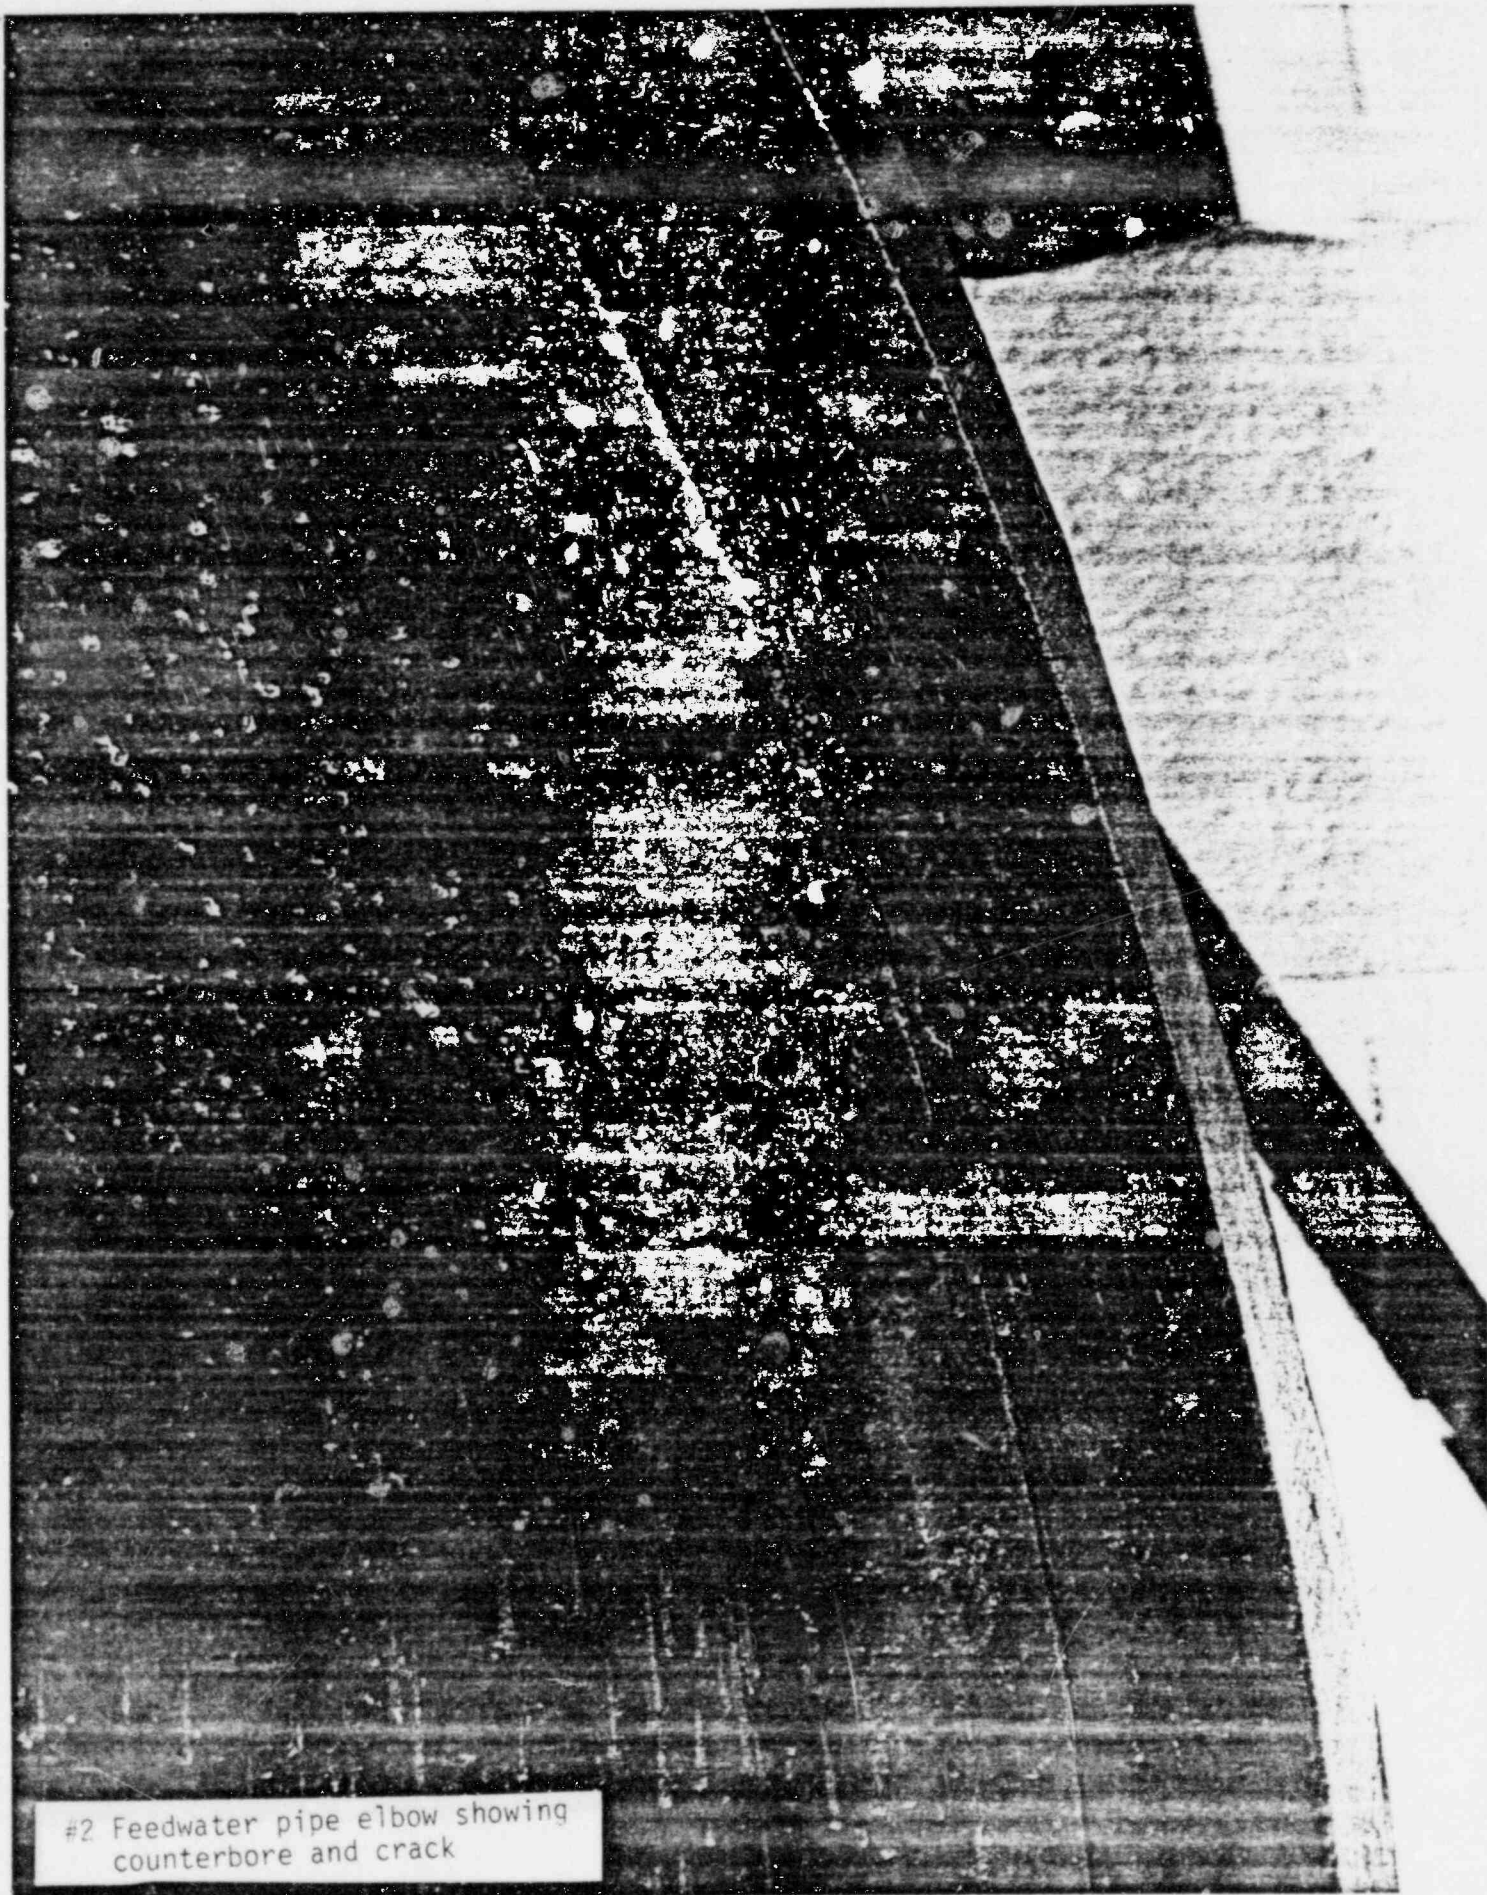
1. #2 Feedwater pipe elbow showing counterbore and crack.
2. #2 elbow showing through wall crack at outside.
3. #2 elbow showing crack.
4. #2 elbow showing crack and ruler
5. #2 SG nozzle, safe end, 20° elbow, short horizontal pipe section, and 90° elbow to vertical. Also shown: pipe cotter in place and chem addition line.
6. #3 Feedwater line horizontal support.

#2 Feedwater pipe elbow showing counterbore and crack

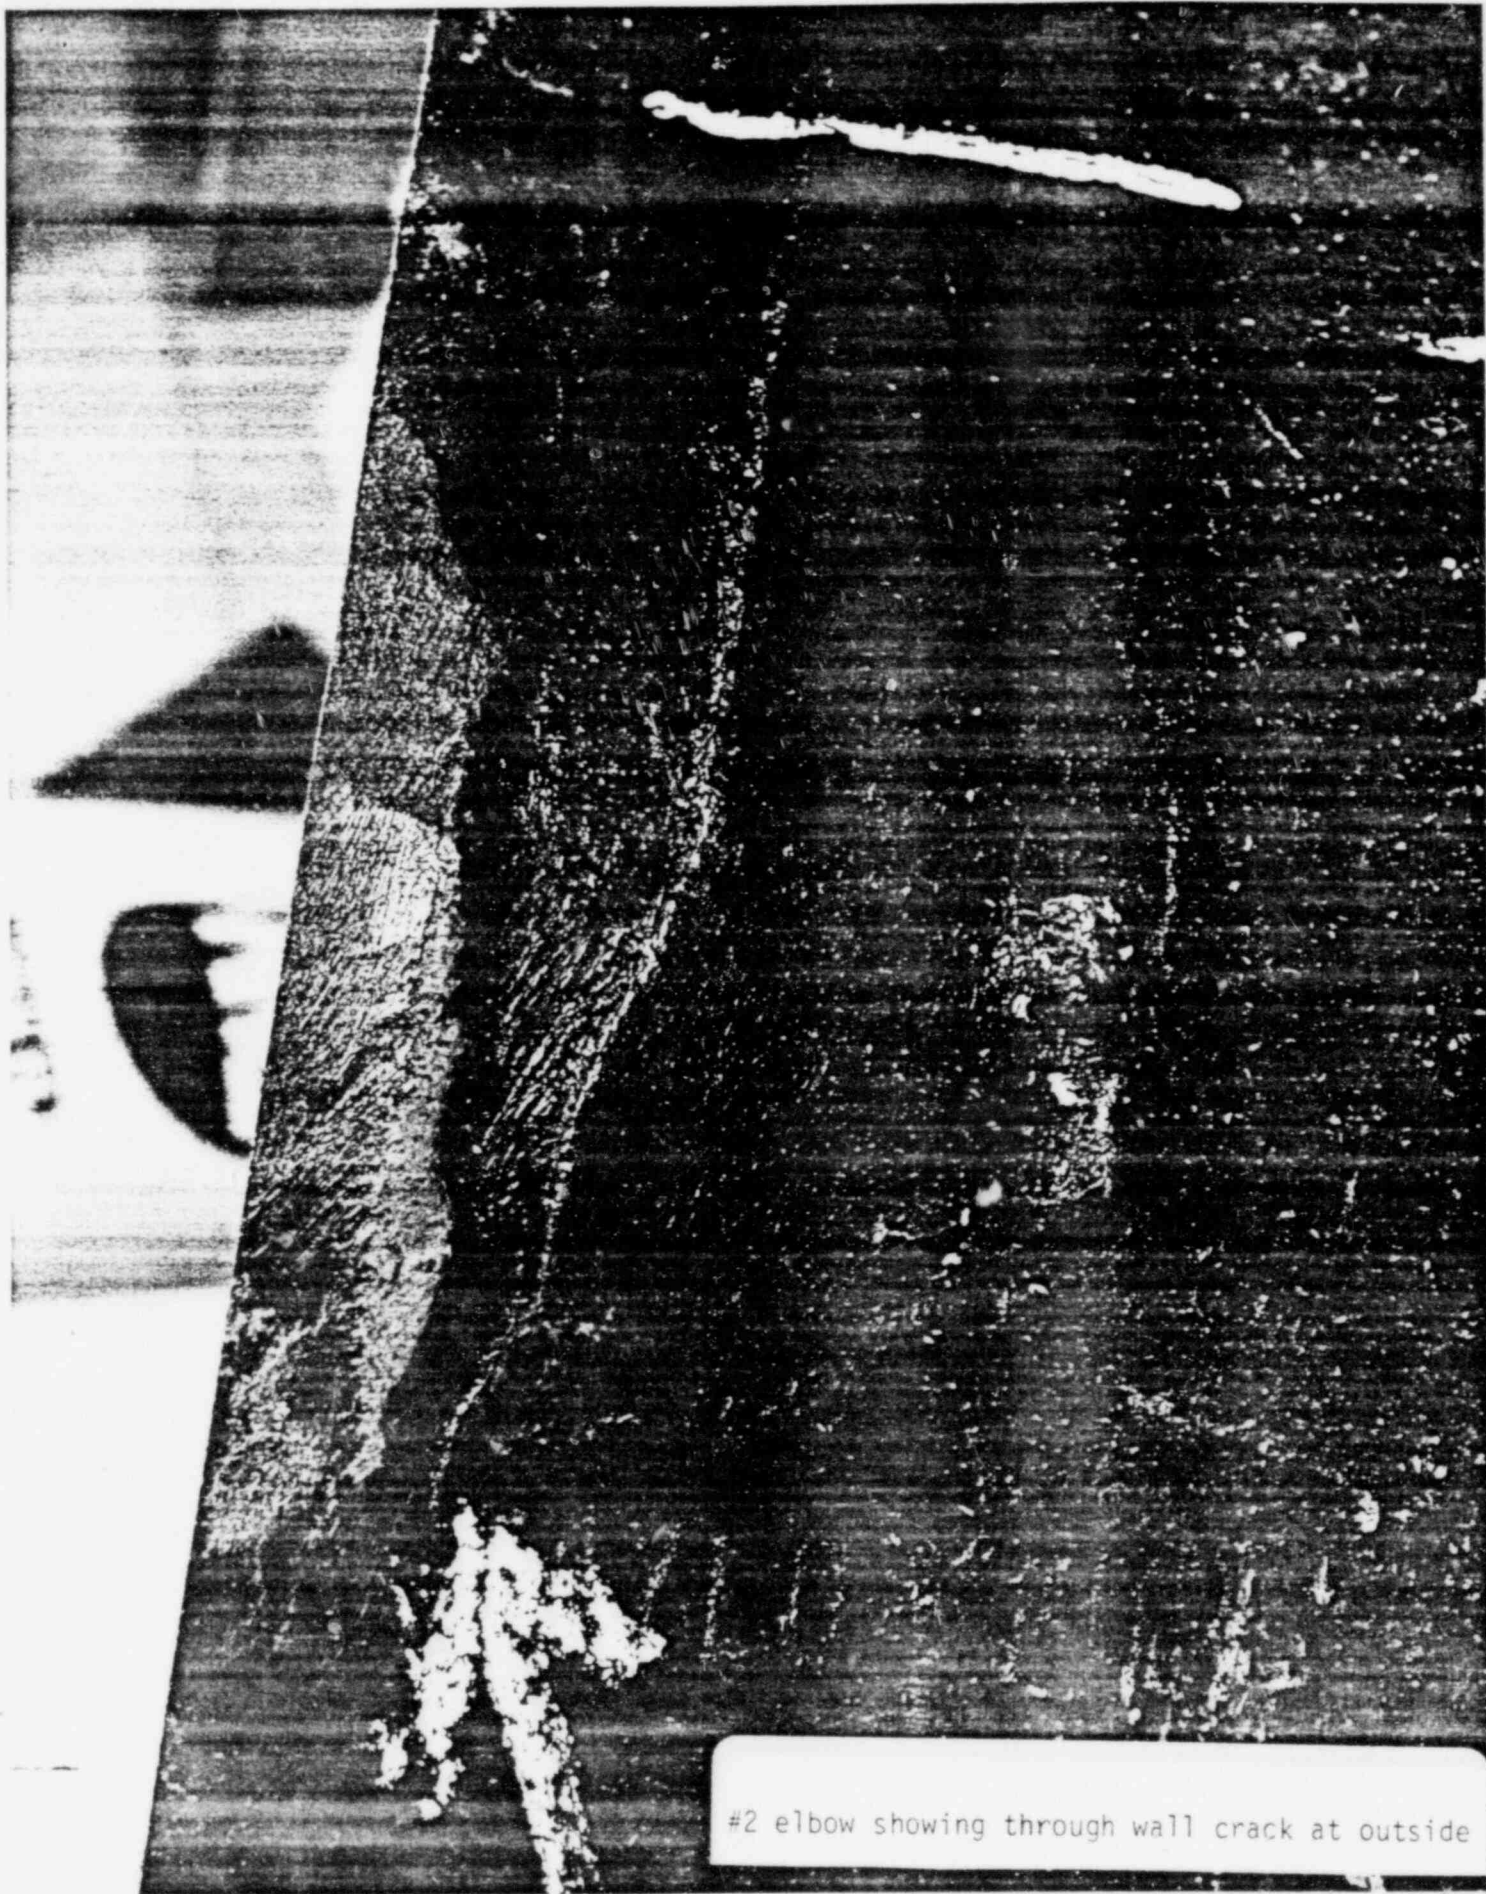
#2 elbow showing through wall crack at outside

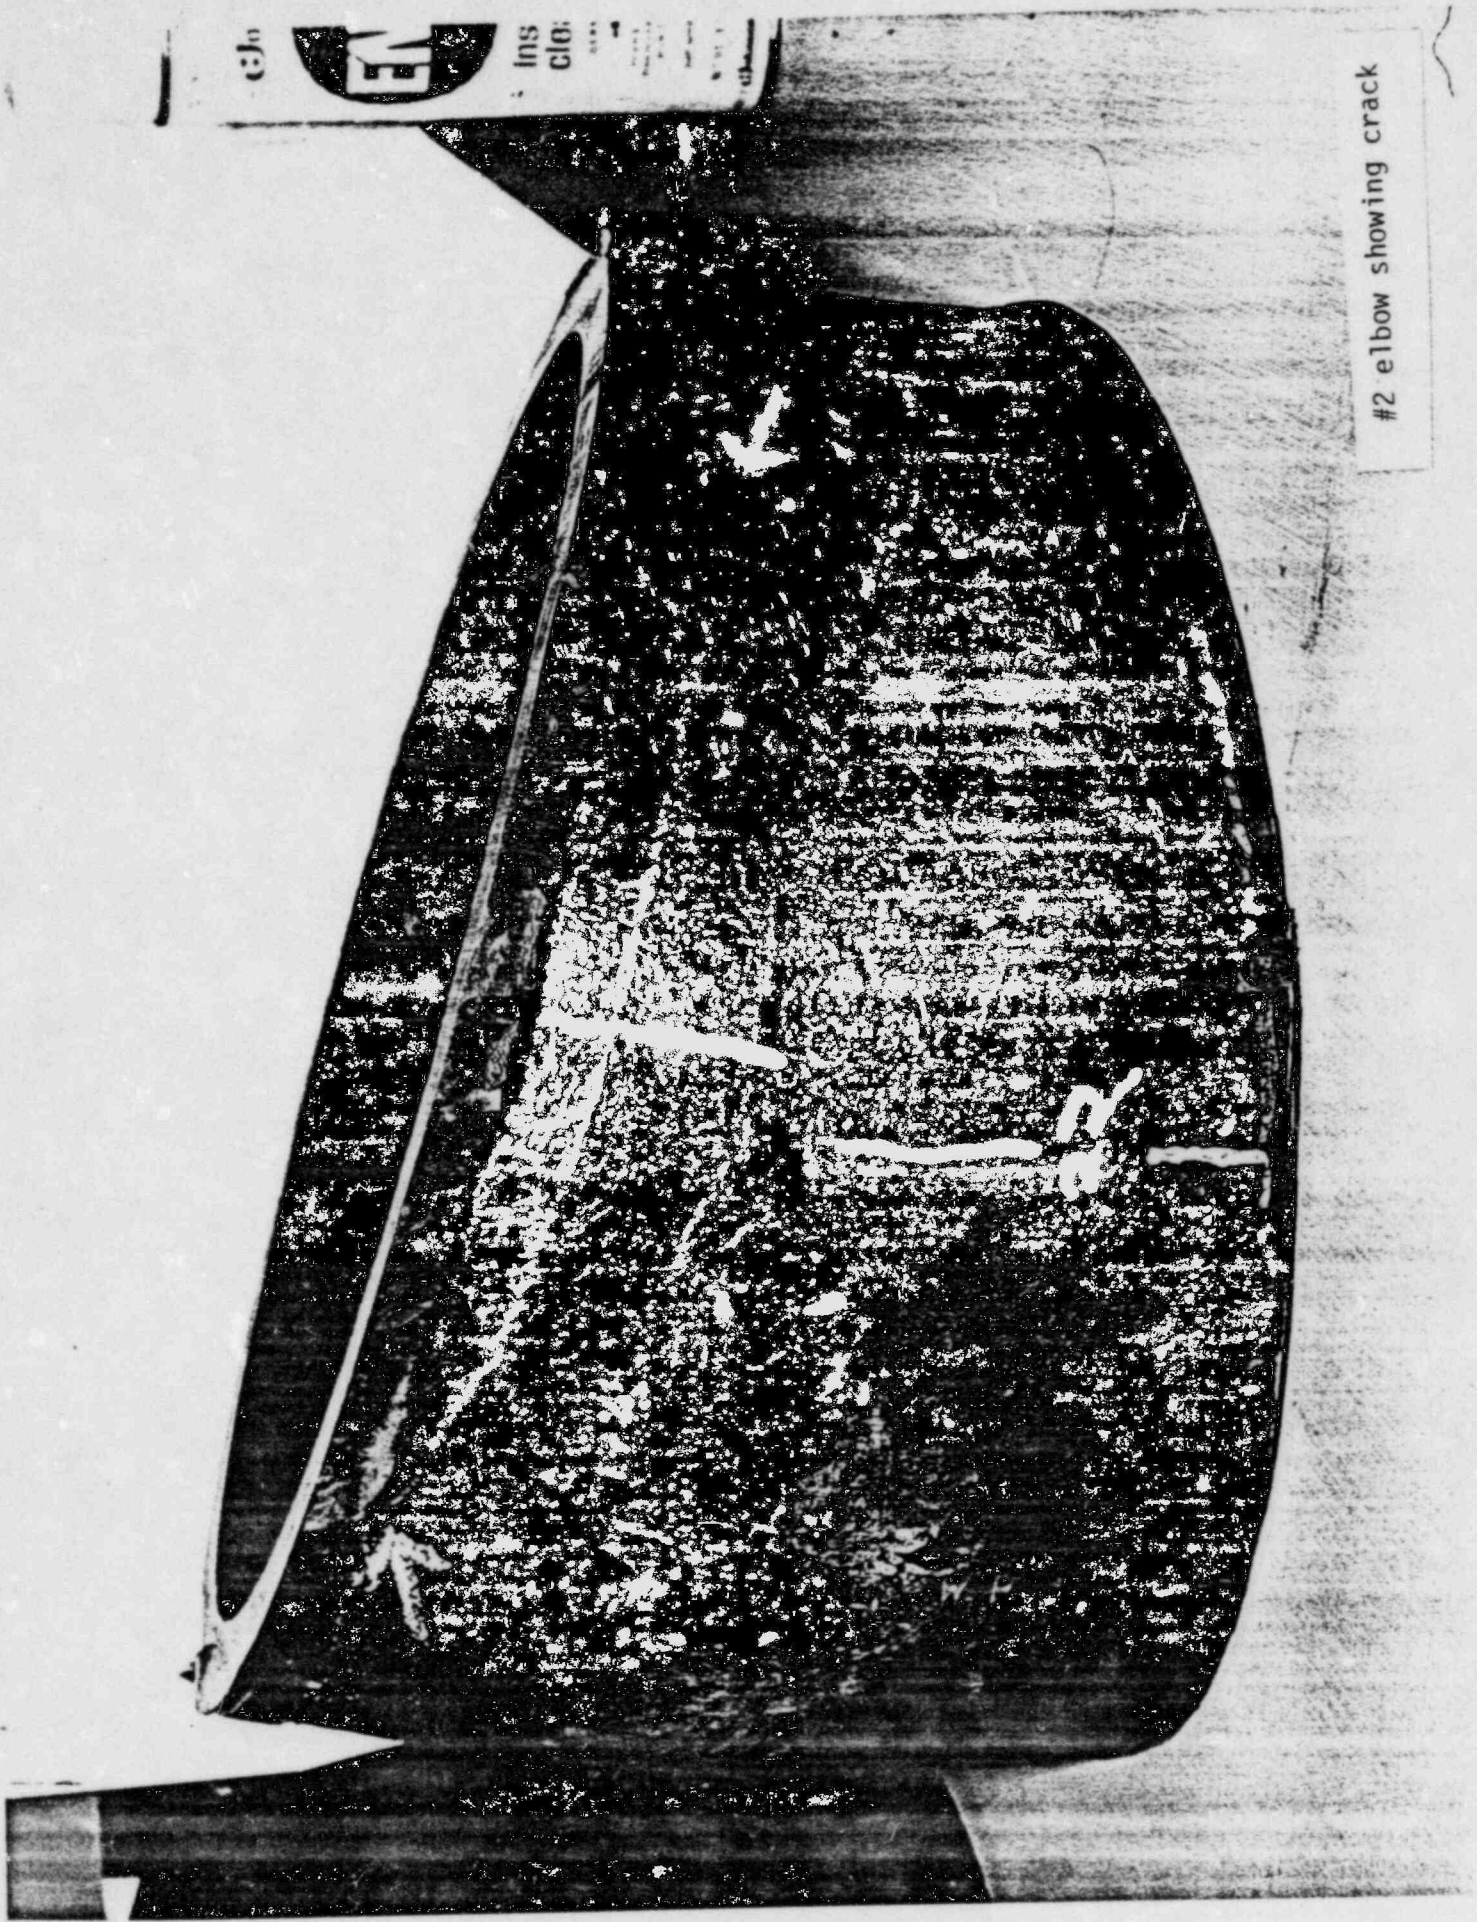
#2 elbow showing crack

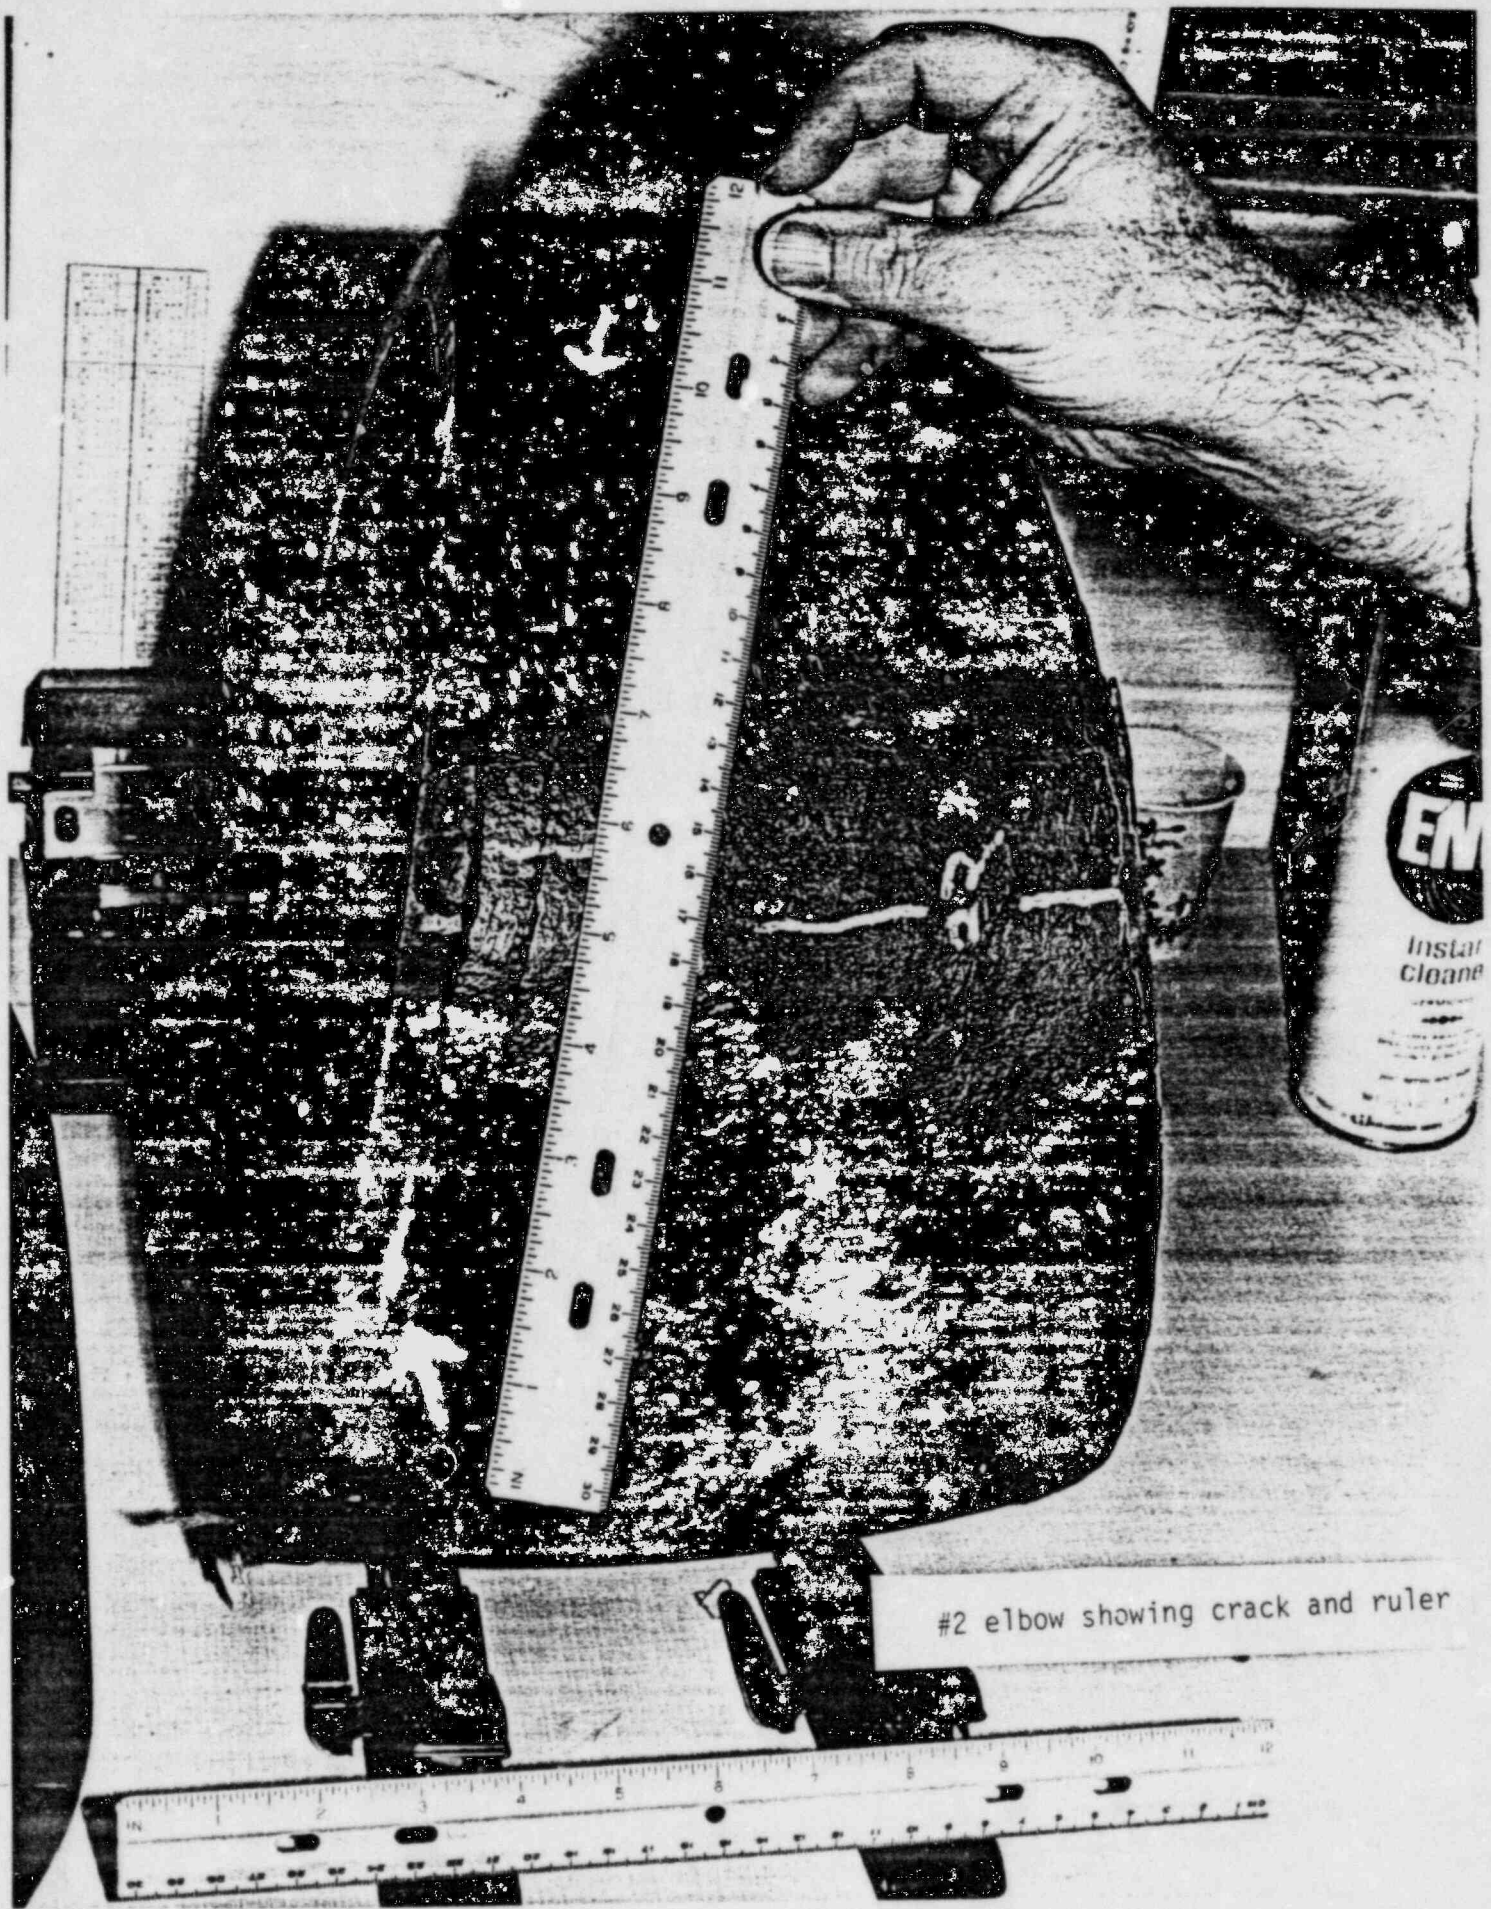
#2 elbow showing crack and ruler

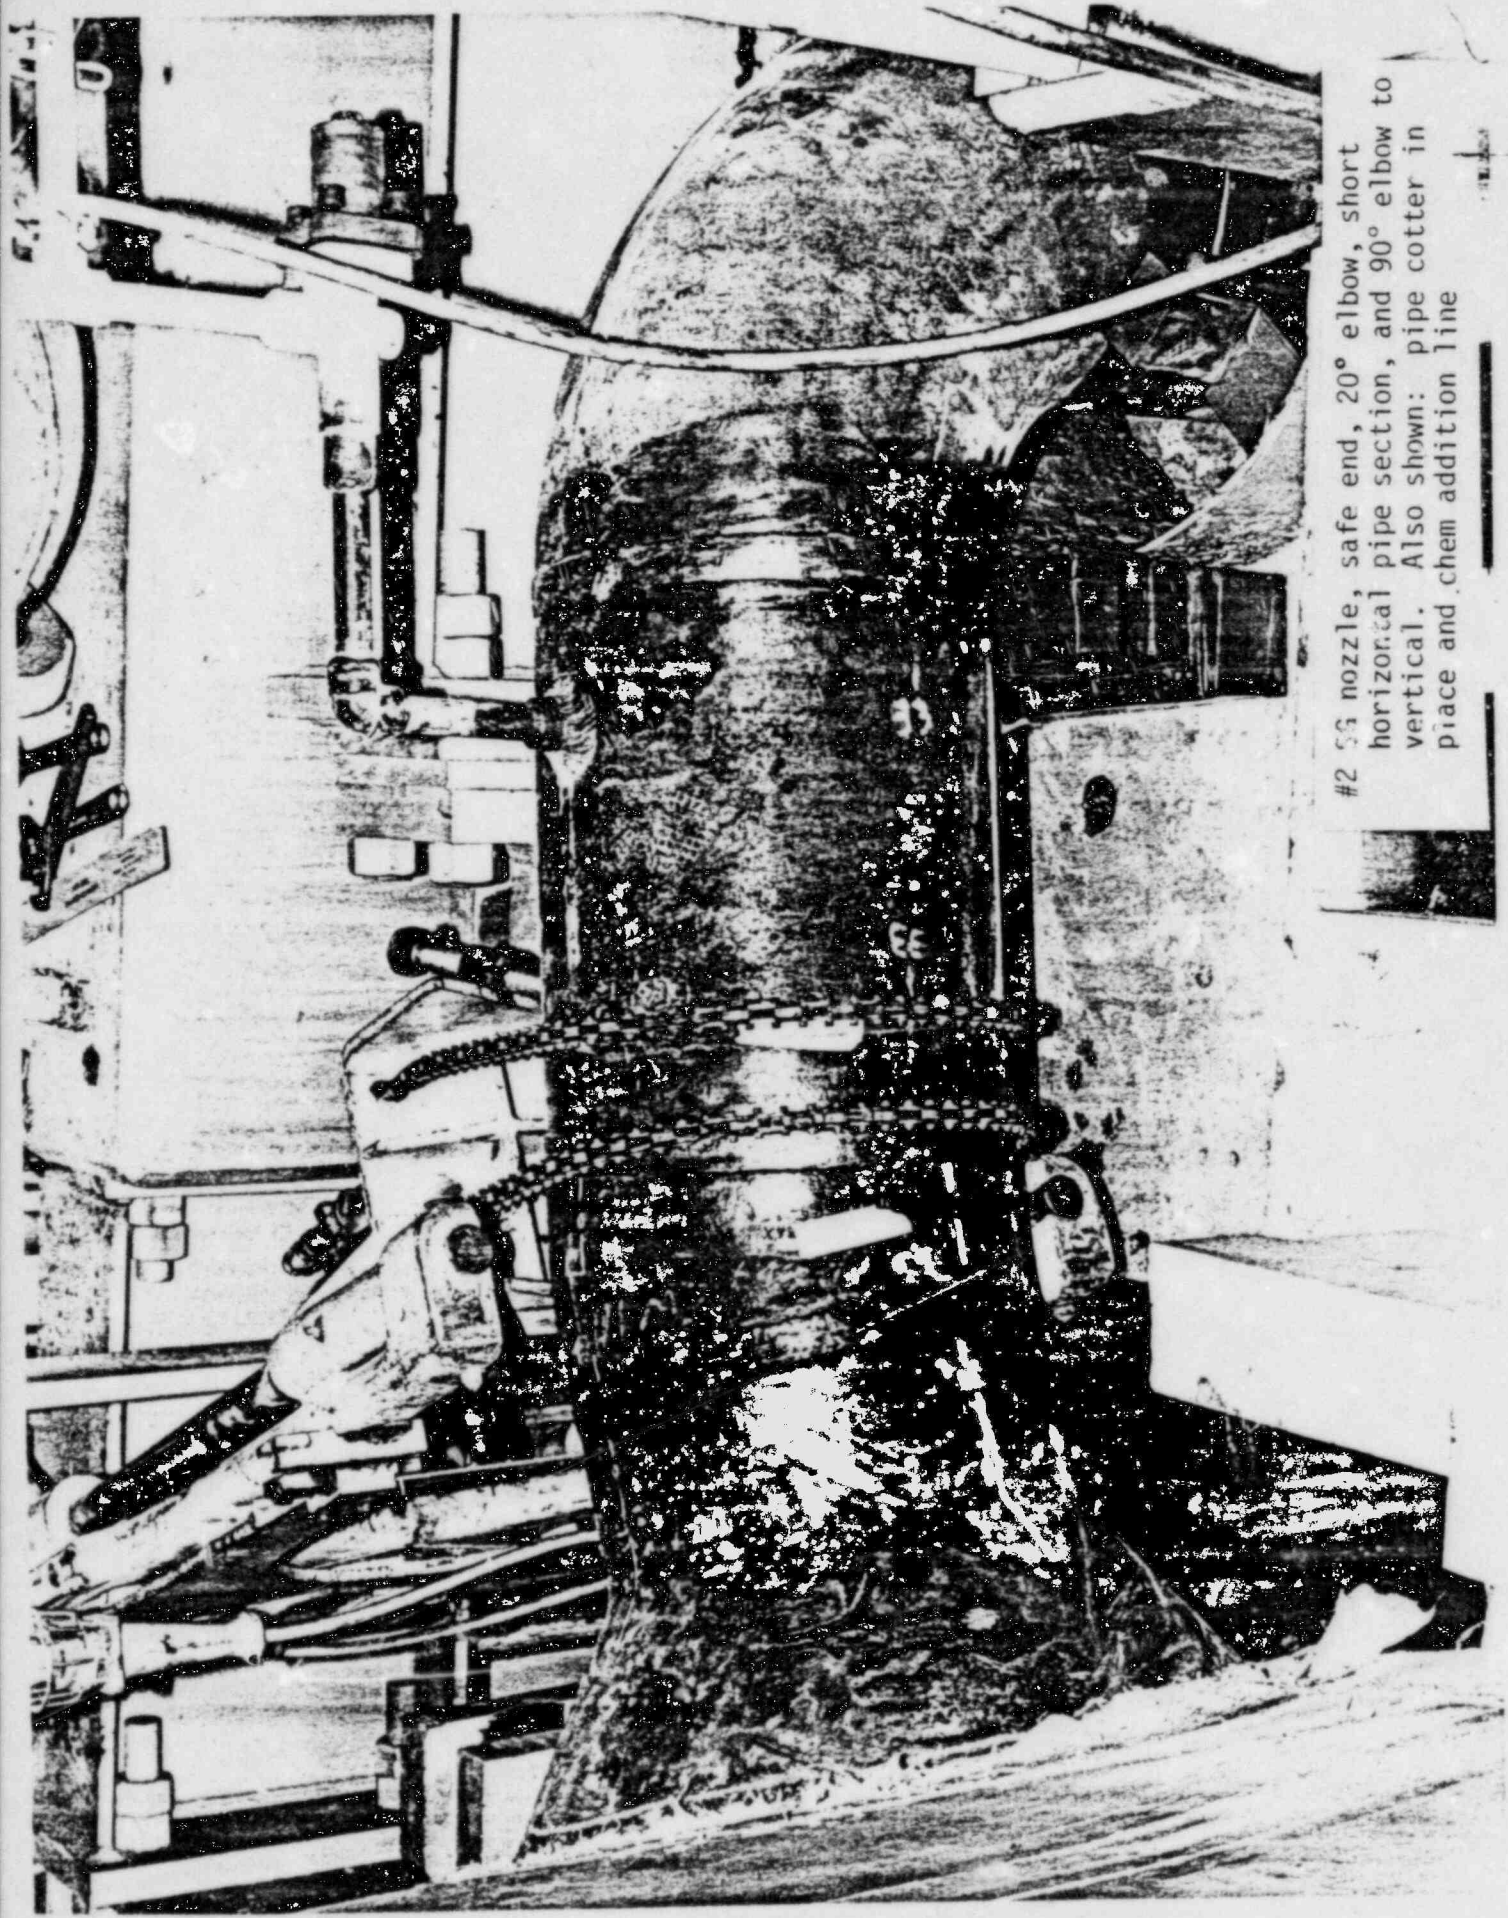
#2 56 nozzle, safe end, 20° elbow, short horizontal pipe section, and 90° elbow to vertical. Also shown: pipe cotter in place and chem addition line

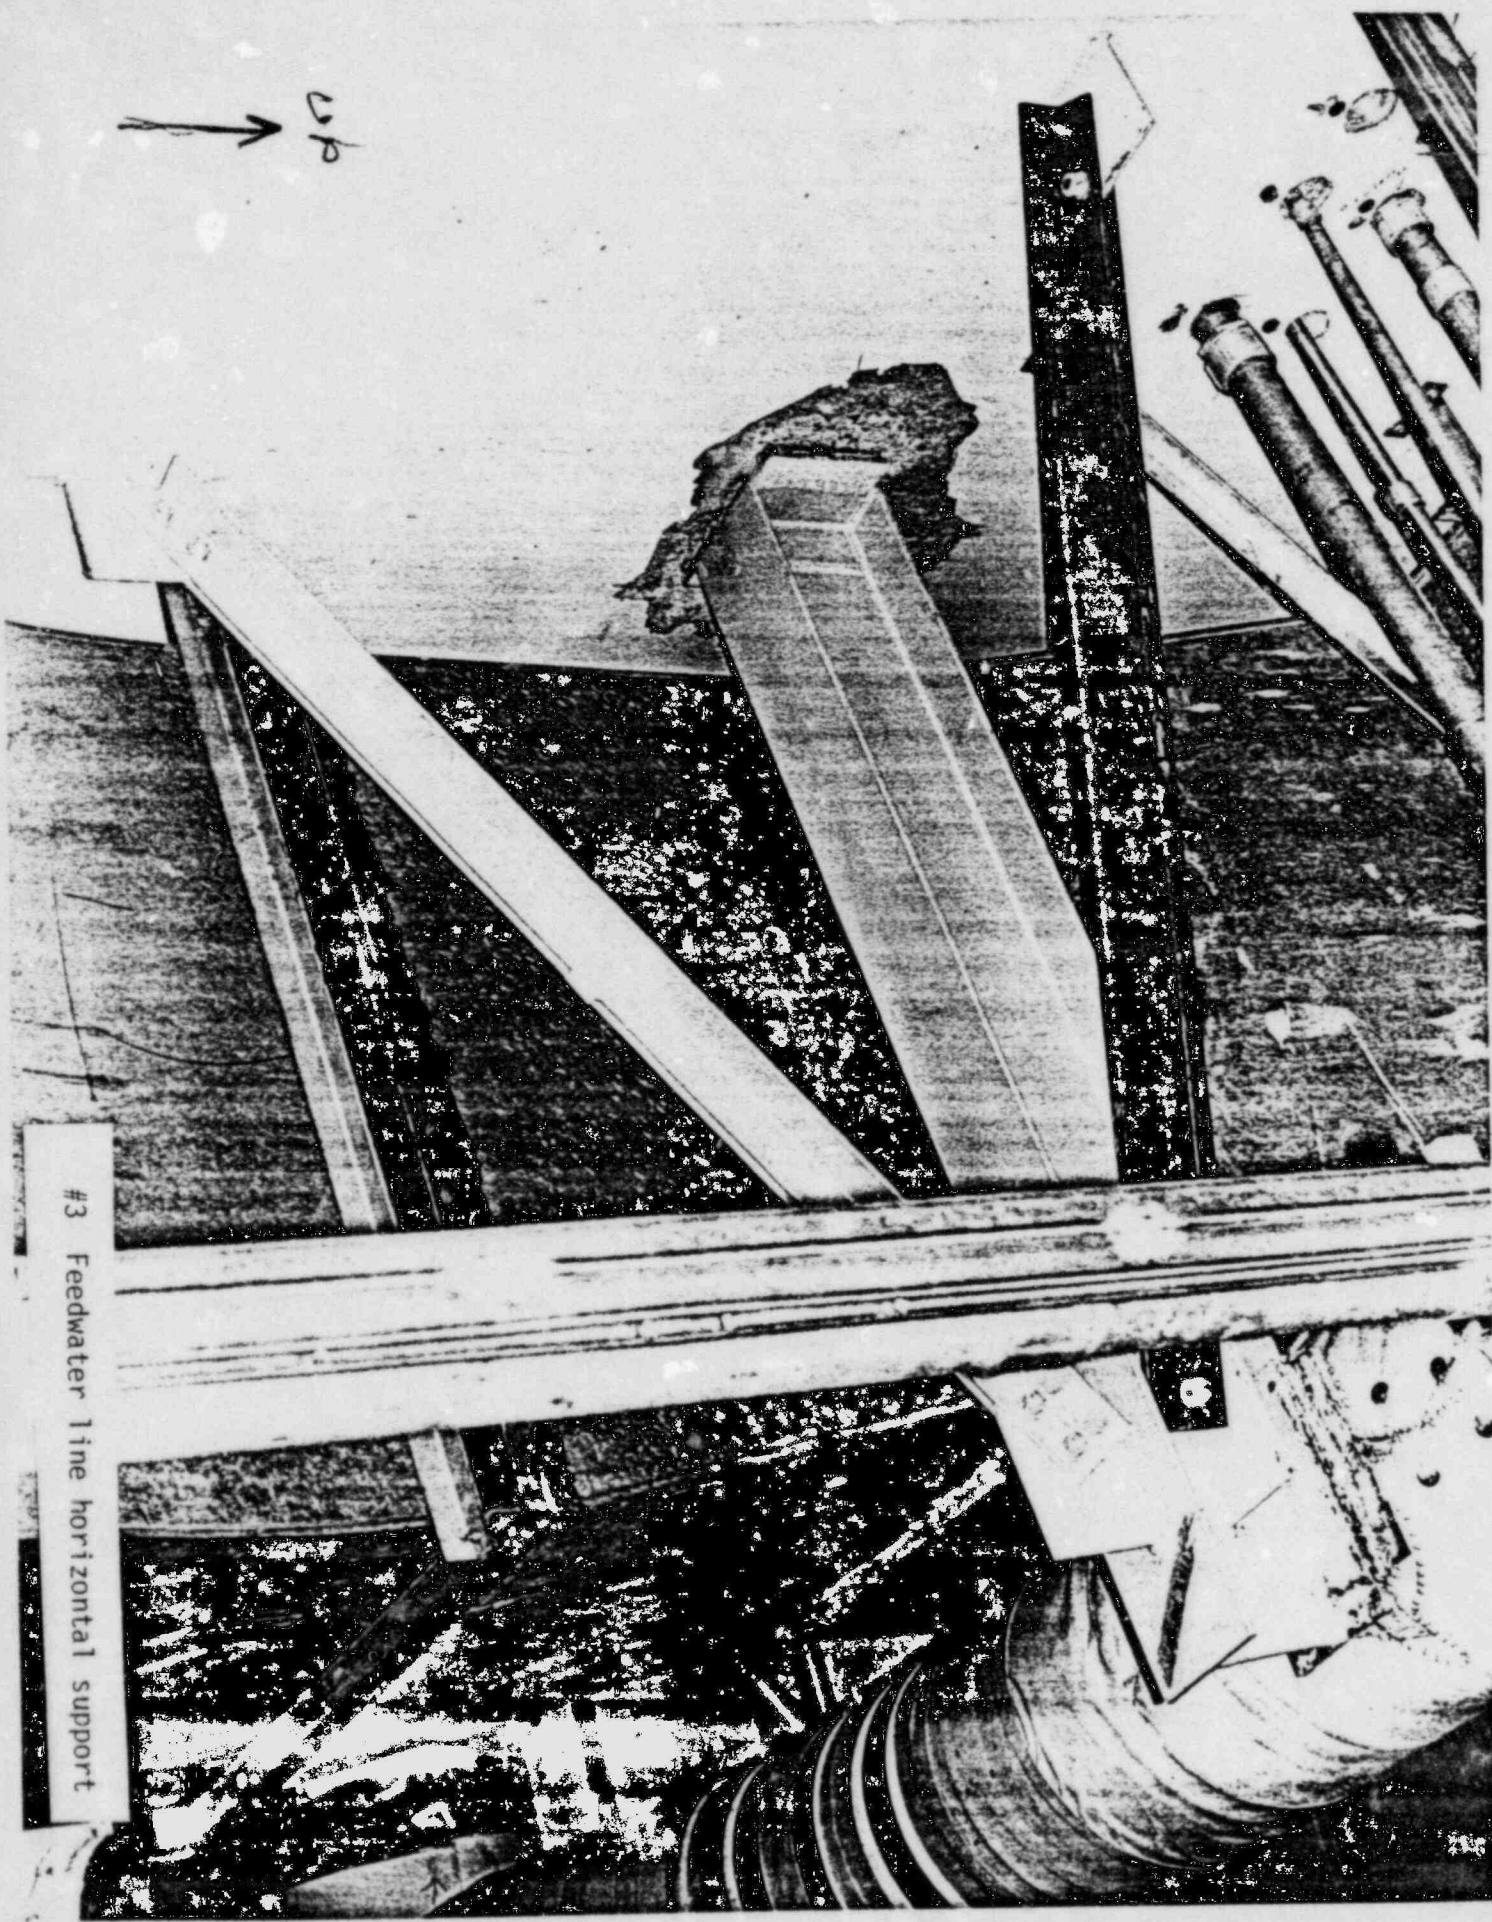
#3 Feedwater line horizontal support

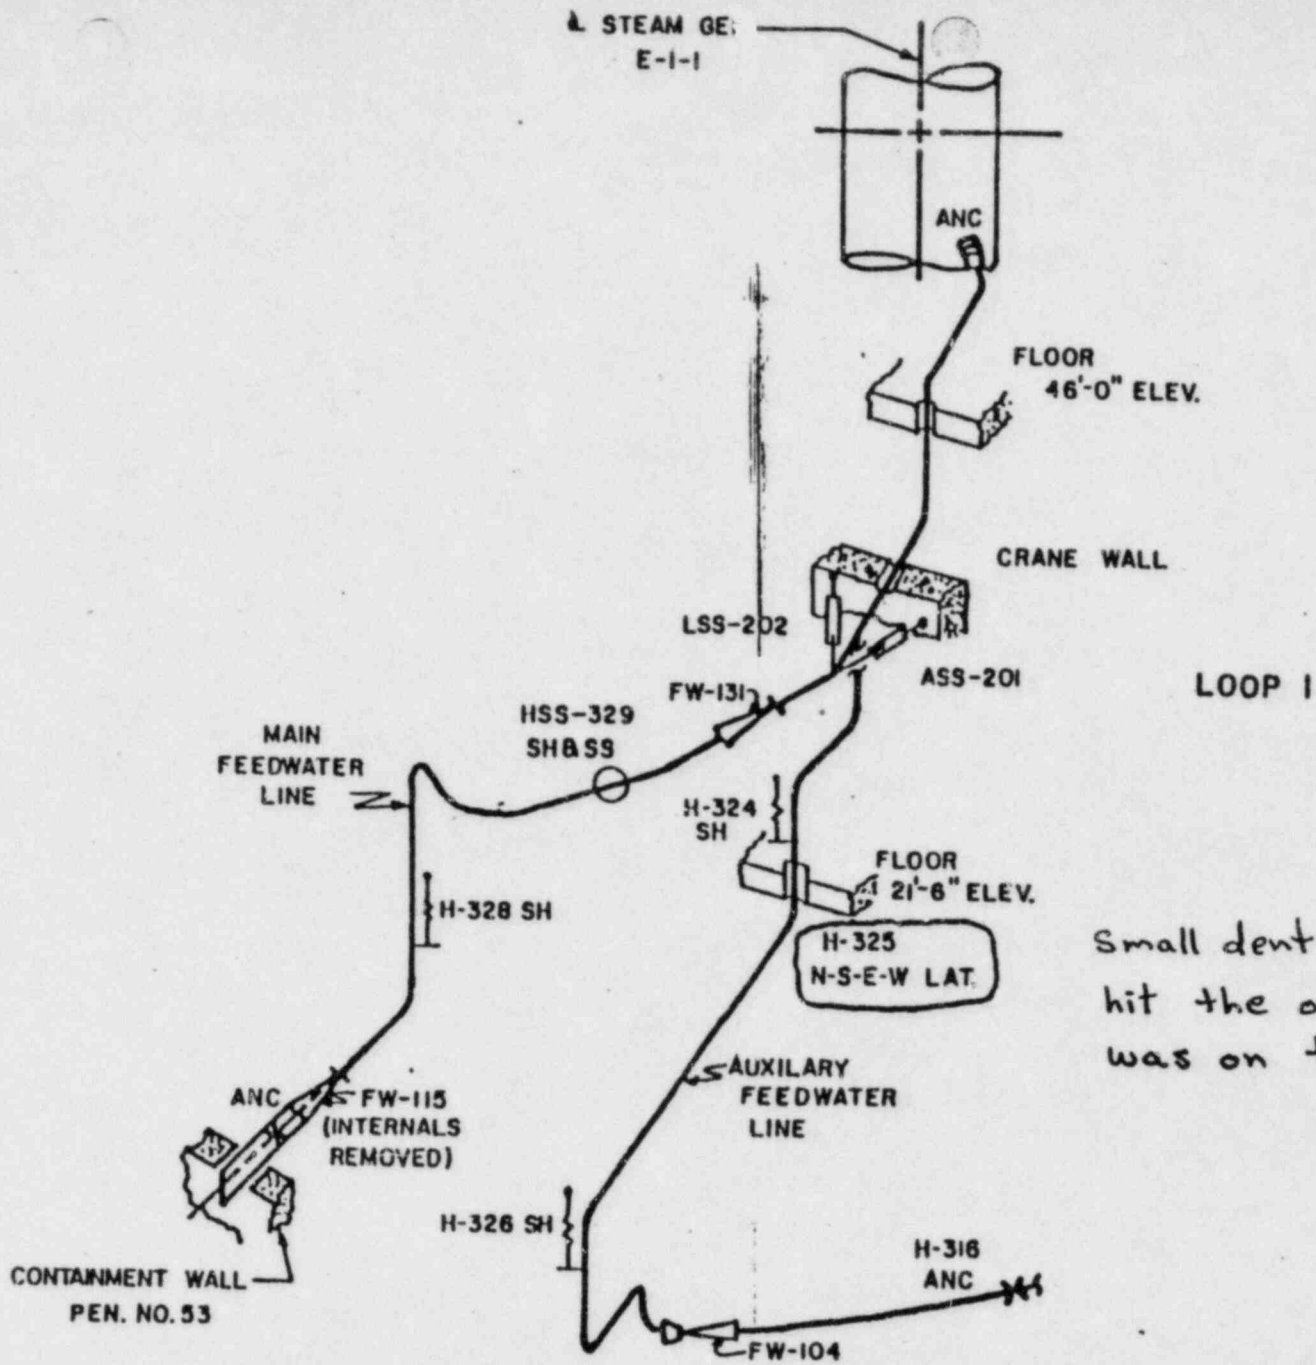
Small dent where the pipe lug hit the outer support. The dent was on the steam generator side.

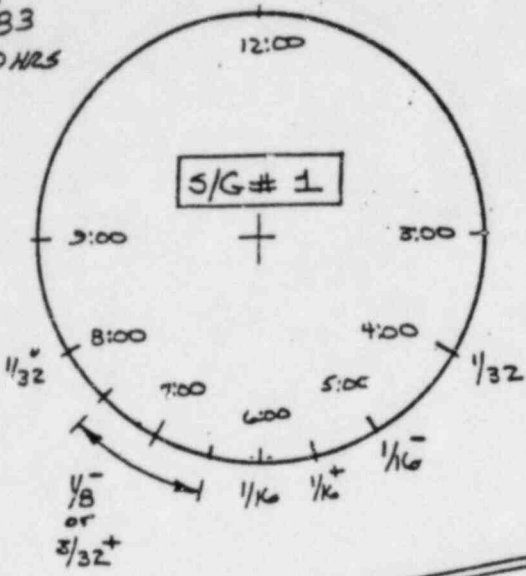
2/4/83
100 HRS

1. NO APPRECIABLE METAL REMOVAL FROM 9:00-3:00
2. POROSITY PER ATTACHED SHEET
3. APPEARS DEEPEST BETWEEN 6:30 & 7:30. GROOVE BLENDED & FLAPPER WHEELED. DEEPEST PART $\approx 1/4"$ RAD.

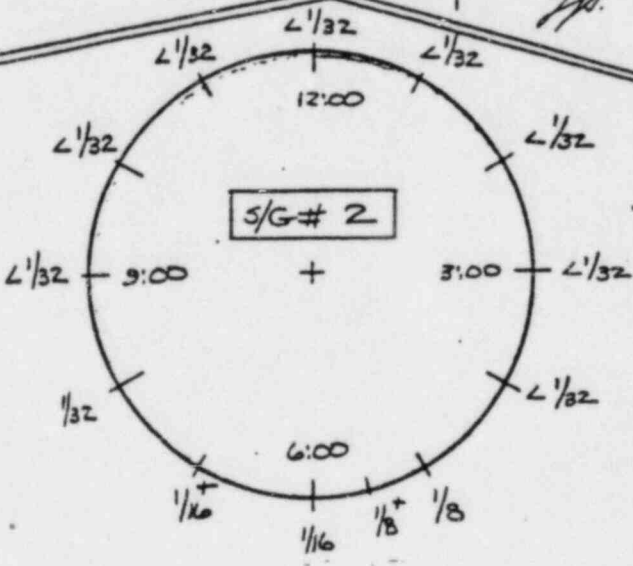
2/4/83
1300 HRS

NO MATERIAL REMOVED

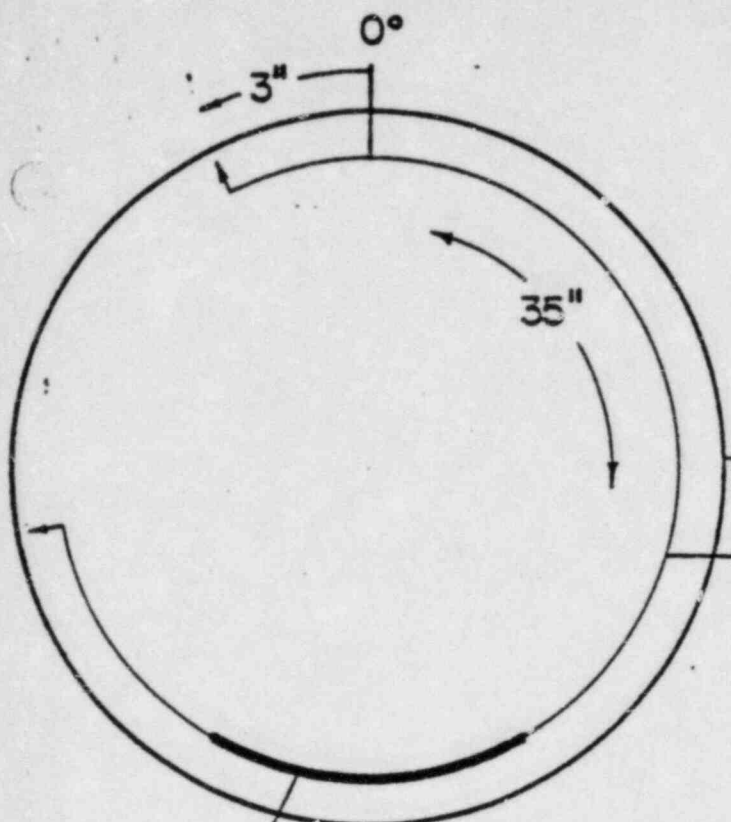
#1 EL

HEAVIEST
INDICATION

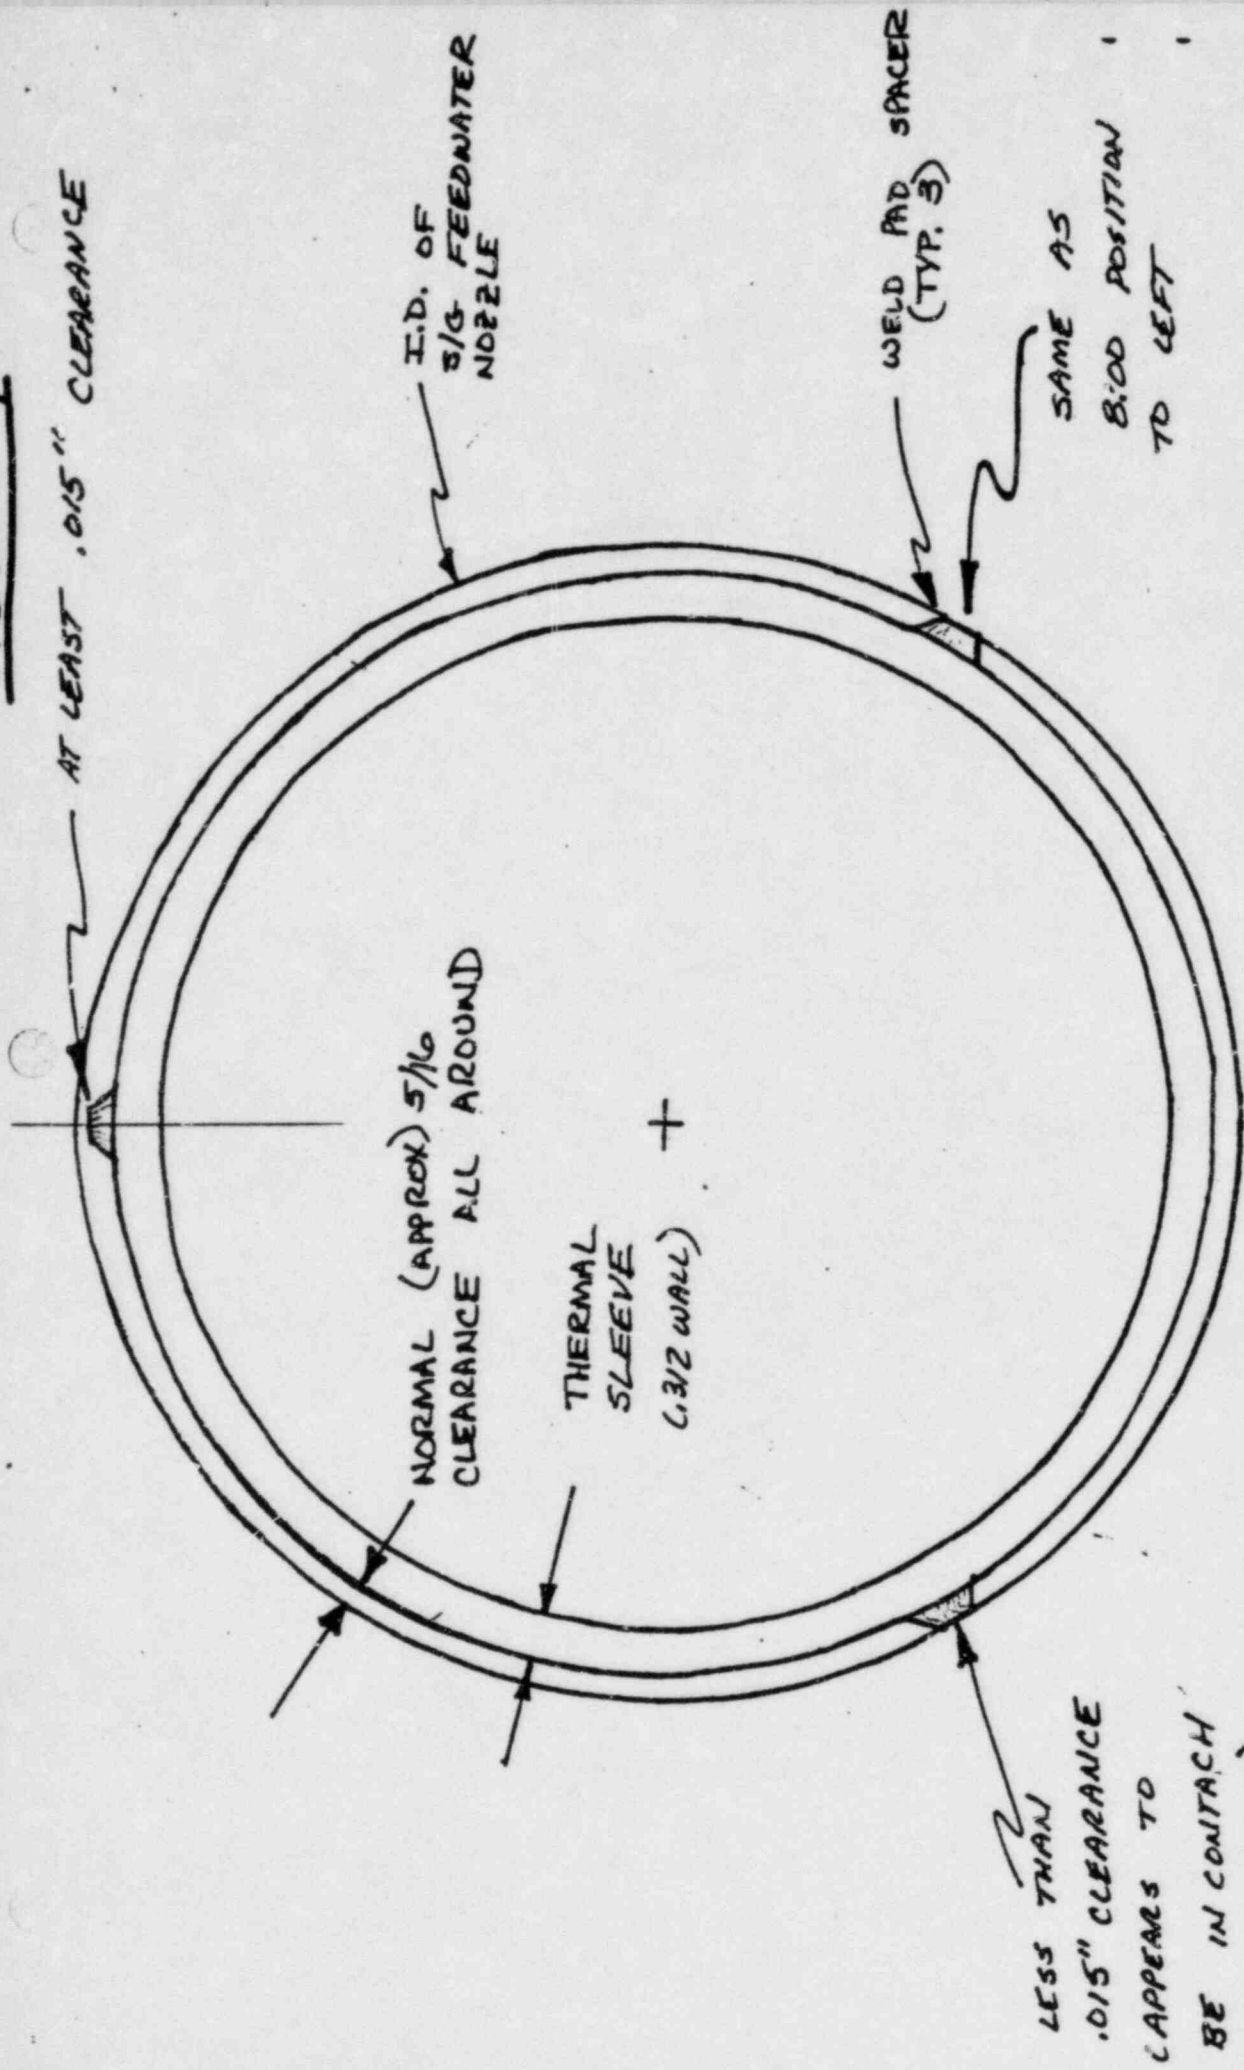
FIGURE 4

NOTE: MANY TACK WELDS BROKEN

NOTE:
ALL U BOLT NUT
TACK WELDS
STILL INTACT
