Subject: Main Feedwater System

MAINE YANKEE ATOMIC POWER STATION FEEDWATER EVENT

On January 25, 1983, Maine Yankee experienced a feedwater line steam-water hammer event that caused the feedwater line adjacent to a steam generator to crack through and leak. This report describes the plant systems and components related to the event, its causes and consequences, the repairs and modifications that were made or planned, and provides a justification for continued power operation. Most of the material contained herein was presented to the NRC at a meeting held at their offices on February 9, 1983. It has been supplemented by commentary reflecting some of the technical comments made during the oral presentation.

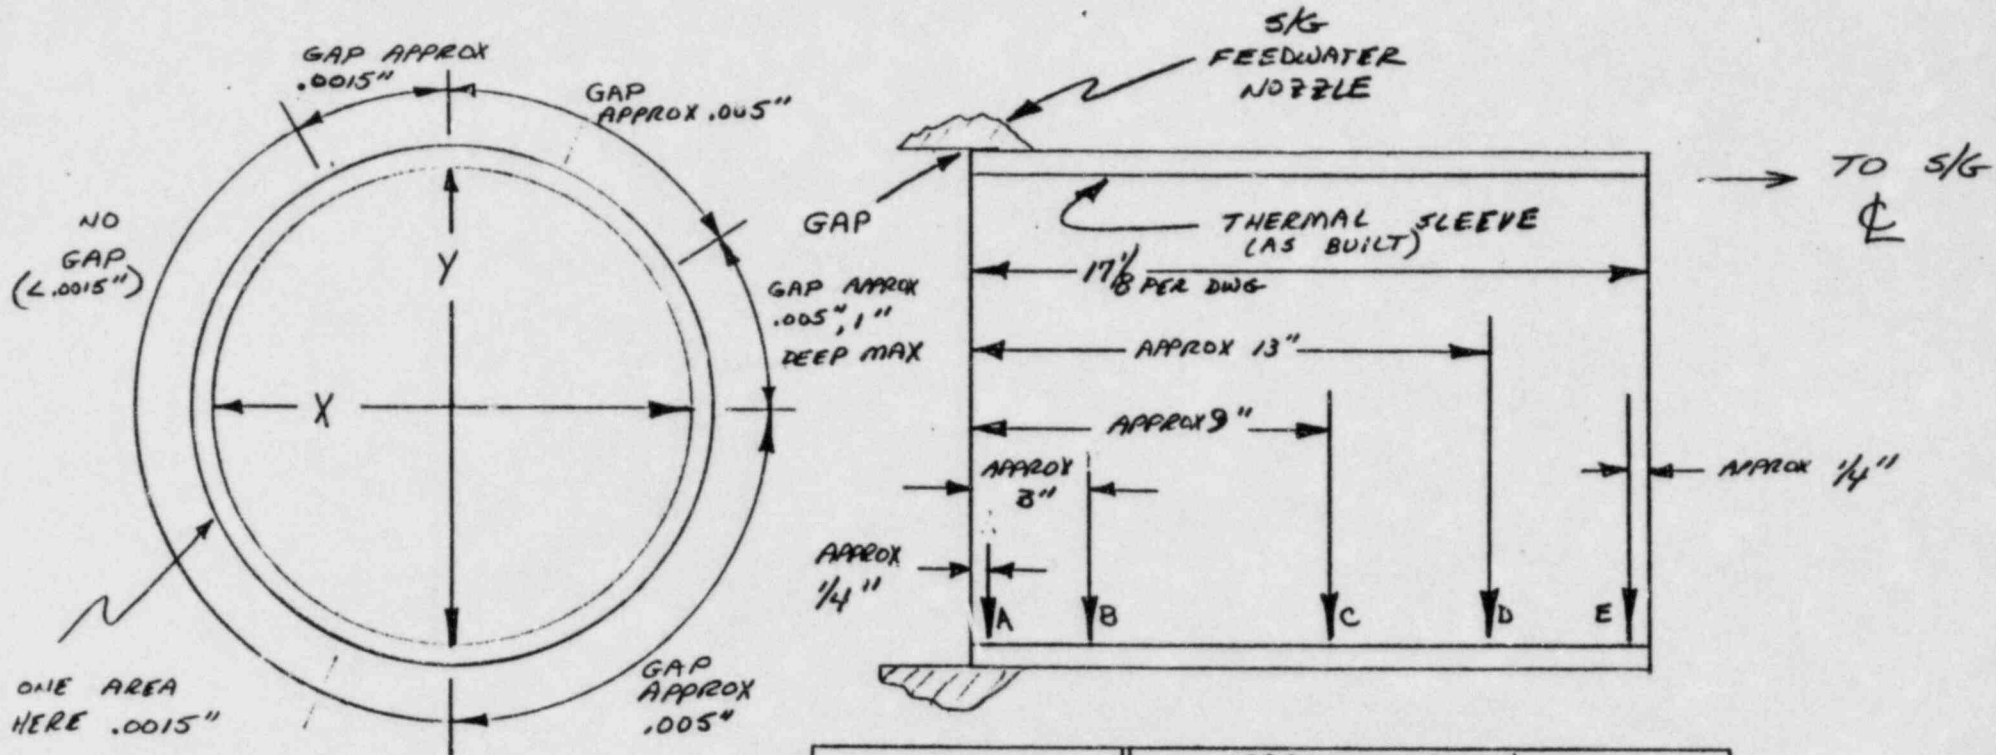
SK # 1
 DATE 1/31/82
 BY W. Martel Jr.
 CE

NOTE- THIS SECTION TAKEN THRU WELD PADS. ONE-HALF WAY FROM 5/8 WALL TO INSIDE END OF SLEEVE THE BULGE WAS GREATER THAN THE (PROJECTED) I.D. OF THE FEEDWATER NOZZLE, SEE ELEVATION VIEW & OUTER DASHED LINE ON THIS SKETCH.

ONE AREA
 HERE .0015"
 WENT IN
 ABOUT 1 1/2"

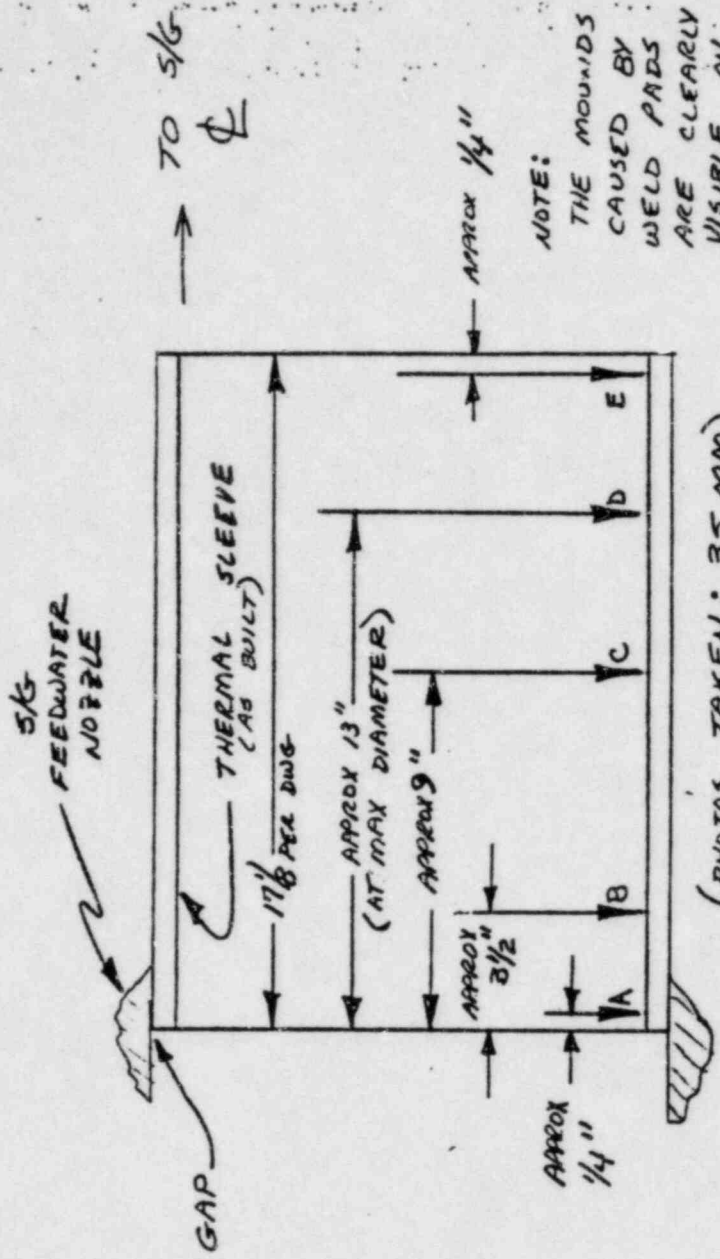
SA # 3
 DATE 1/31/83
 BY Wm. R. W...
CE

NOTE: MOST OF THE OUTWARD BULGE MORE THAN THE (PROJECTED) I.D. OF THE NOZZLE (I.E. AT LOCATION D) IS AT THE TOP

NOTE: THE MOUNDS CAUSED BY WELD PADS ARE CLEARLY VISIBLE ON SLEEVE I.D.
