U.S. NUCLEAR REGULATORY COMMISSION  
REGION I  
INSPECTION REPORT

Report No. 030-06156/94-001

Facility Name: Hewlett-Packard Company  
Avondale Division

Inspection Summary: Closeout Inspection on February 15, 1994 (Inspection No. 030-06156/94-001)

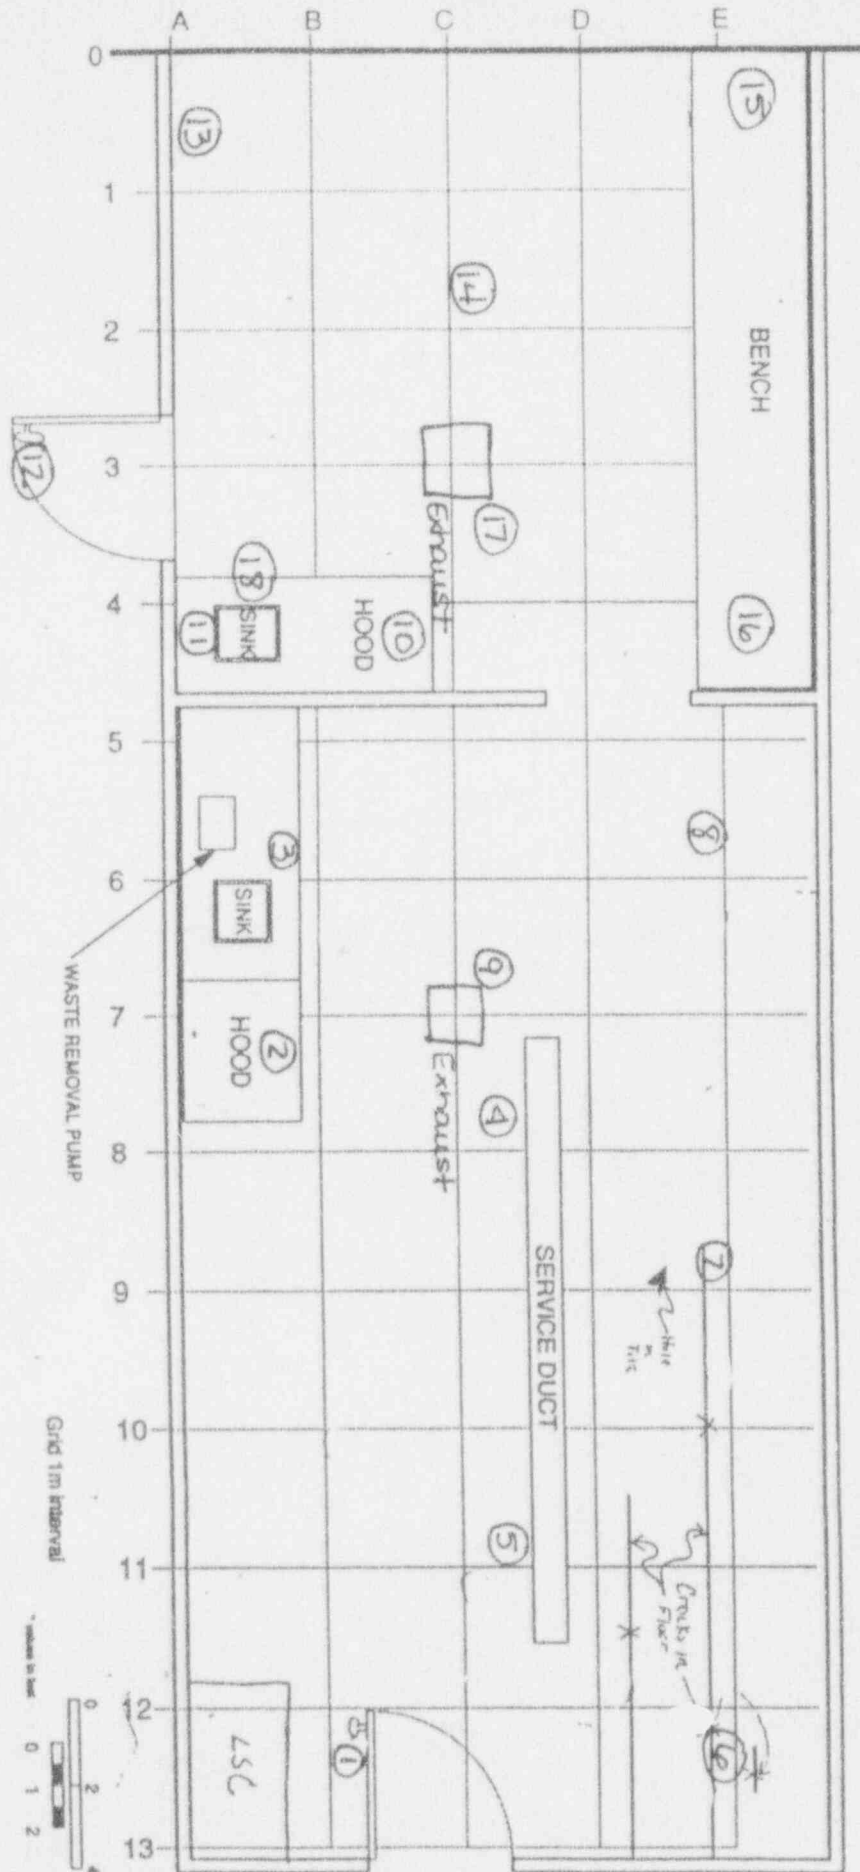
# Attachment A

Areas of 100 square centimeters were tested at eighteen locations throughout the facility. A diagram showing the locations of the wipes is included as Attachment A to this report. A complete list of the wipe results is included as Attachment B to this report. Contamination exceeding the acceptable removable contamination levels was found on an exhaust air vent in the Hot Lab.

<u>Location</u>	<u>Nickel 63 (dpm/wipe)</u>
1. Door knob	< LLD
2. Floor where fume hood was	< LLD
3. Floor where sink was	< LLD
4. Floor where work bench was	< LLD
5. Floor where work bench was	< LLD
6. Crack in floor	103
7. Floor	< LLD
8. Floor	< LLD
9. Exhaust air vent	< LLD
10. Floor where hood was	23
11. Floor where sink was	< LLD
12. Door knob	< LLD
13. Floor	19
14. Floor	< LLD
15. Floor where work bench was	< LLD
16. Floor where work bench was	< LLD
17. Exhaust air vent	1082
18. Sink line	< LLD
