U.S. NUCLEAR REGULATORY COMMISSION
REGION IV

Inspection Report: 50-285/94-08

Facility Name: Fort Calhoun Station

Areas Inspected: Special, announced inspection of the consequences of a supervisory relay failure in the engineered safety features system (ESF).

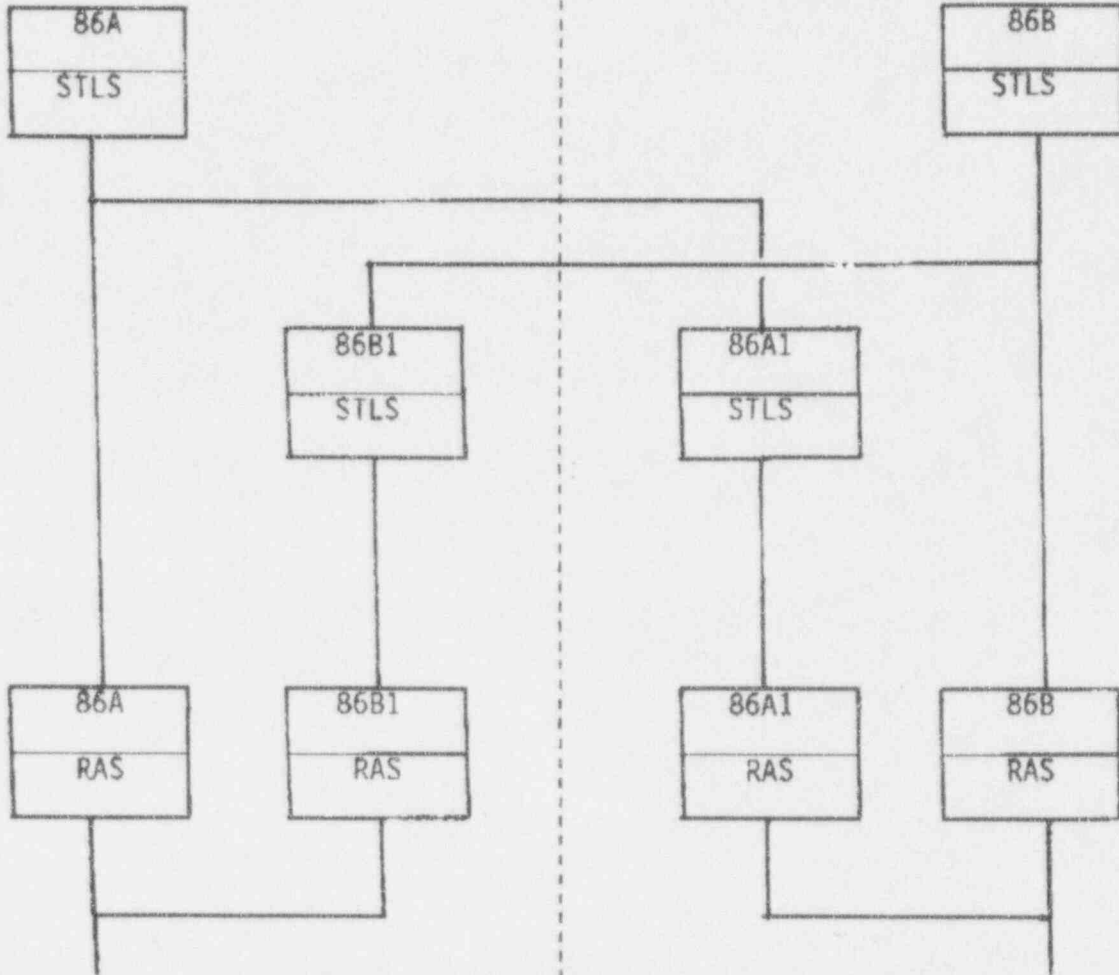
ATTACHMENT 2

Attachments 2 - 4 depict the RAS relay logic for Train A. The Train B logic would be identical except for the component designators.

Inadvertent lockout relay actuations during design basis events were identified which resulted in failure to achieve a minimum level of engineered safeguard performance acceptable for the design basis accident. A failure of Supervisory Relay 86A/STLSS caused by a short circuit of a relay coil could result in an actuation of Lockout Relay 86A/STLS. If this occurred during a design basis accident with either a low pressurizer pressure signal present or a CHPS present, the lockout relay actuation would result in the initiation of a RAS with the following results:

- Safety Injection and Refueling Water Tank Discharge Valves LCV 383-1 and LCV 383-2 would close.
- Containment Sump Suction Valves LCV 383-3 and LCV 383-4 would open.
- Both low pressure safety injection pumps would trip.
- Both high pressure safety injection pumps' minimum recirculation header isolation valves (HCV-385 and HCV-386) would close.

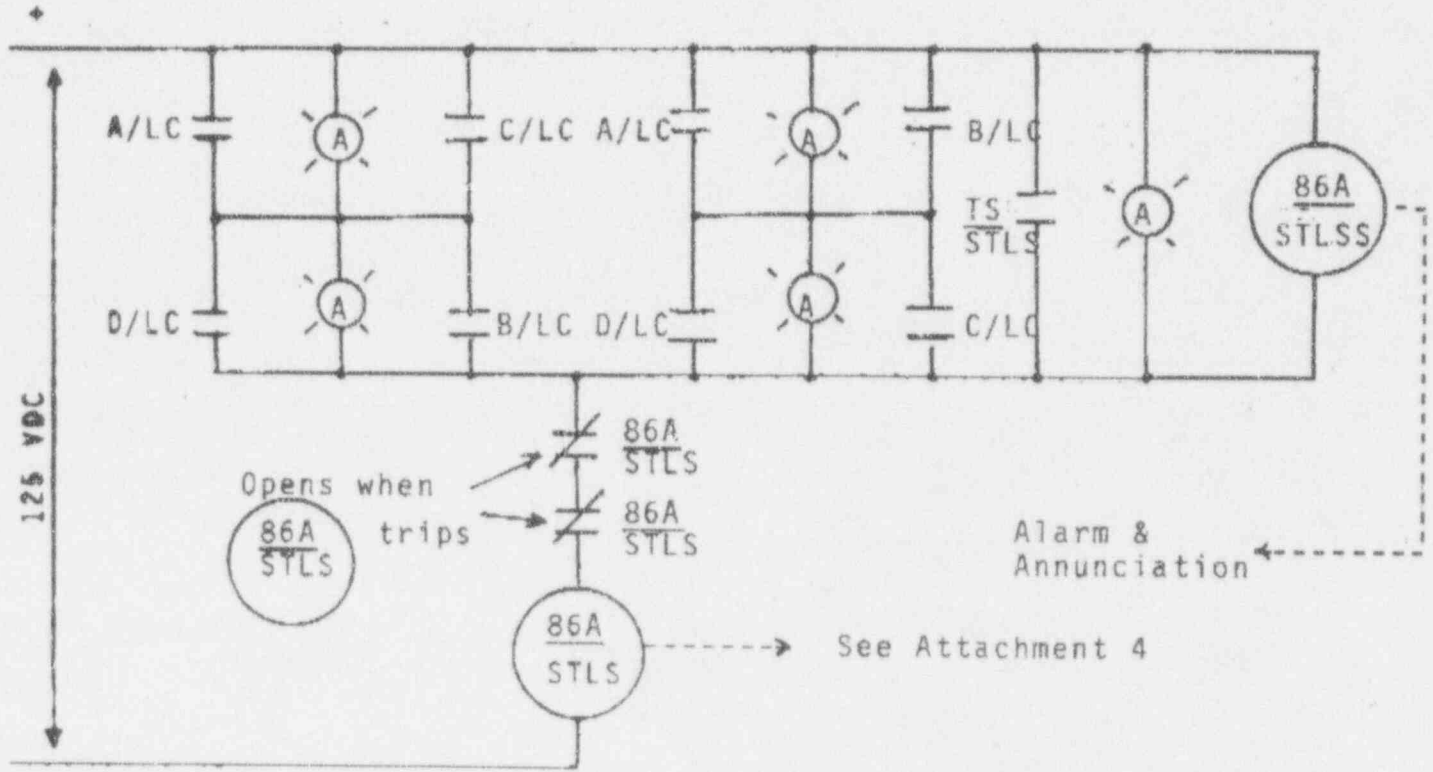
ATTACHMENT 3

The typical ESF supervisory circuit consists of a high coil resistance relay and indicating light wired in parallel and then connected in series with the lockout relay coil. For example, in the safety injection and refueling water low signal (STLS) scheme, each train (A and B) has a redundant set of four channel level switches (A/LC, B/LC, C/LC, and D/LC). This allows the closing of any two contacts to initiate an STLS. On each redundant set, a 2-out-of-4 logic exists. Should an actual STLS occur, a 2-out-of-4 matrix is actuated which shorts out the supervisory relay and then actuates the lockout relay. A small amount of current is allowed to travel through the supervisory and lockout relays. This current is enough to pick up the supervisory relay, but not enough to actuate the lockout relay. If power is lost to the circuit, or the lockout relay coil fails in the open condition, the supervisory relay drops out and an alarm and annunciator is actuated to alert control room operators that the lockout relay is not operable. In addition, normally the amber light associated with the supervisory relay is dimly lit verifying that the circuit's power is available and the lockout relay coil has not open circuited. Should power be lost or the lockout relay coil open the indicating light will go out.

It was also concluded that under certain MSLB, SGTR, or small break LOCA conditions high pressure safety injection pump damage could occur due to dead heading. This condition could be caused by either failure of Supervisory Relay 86A/STLSS or three other supervisory relays in the Train A RAS logic: Supervisory Relays 86A/RASS, 86A1/RASS, or 86A1/STLSS.

The licensee installed Temporary Modification TM 94-014 on February 18, which lifted one of the leads from Supervisory Relays 86A/STLSS and 86B/STLSS and electrically removed these from the logic circuit. This modification eliminated the single failure concern reported on February 18, since a short circuit of the supervisory relay could no longer occur.

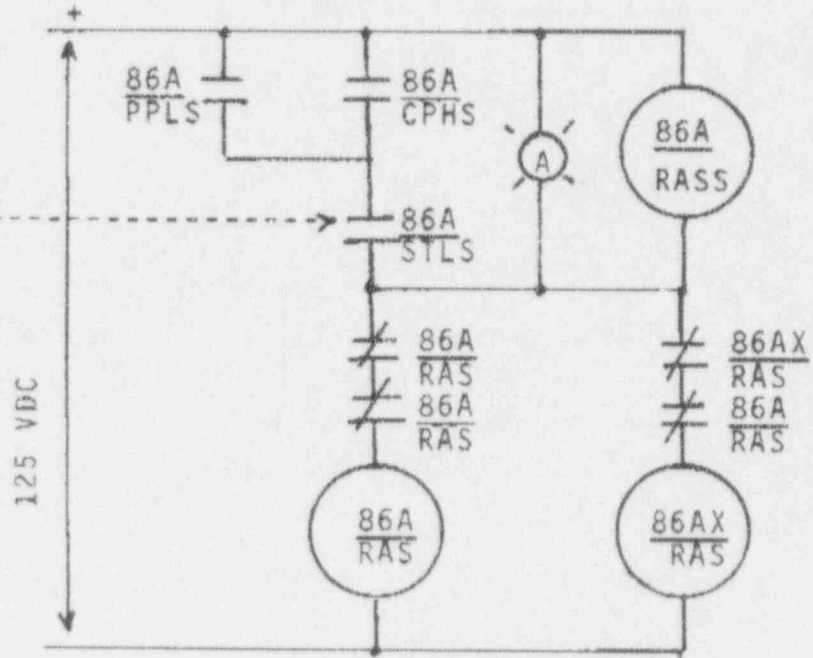
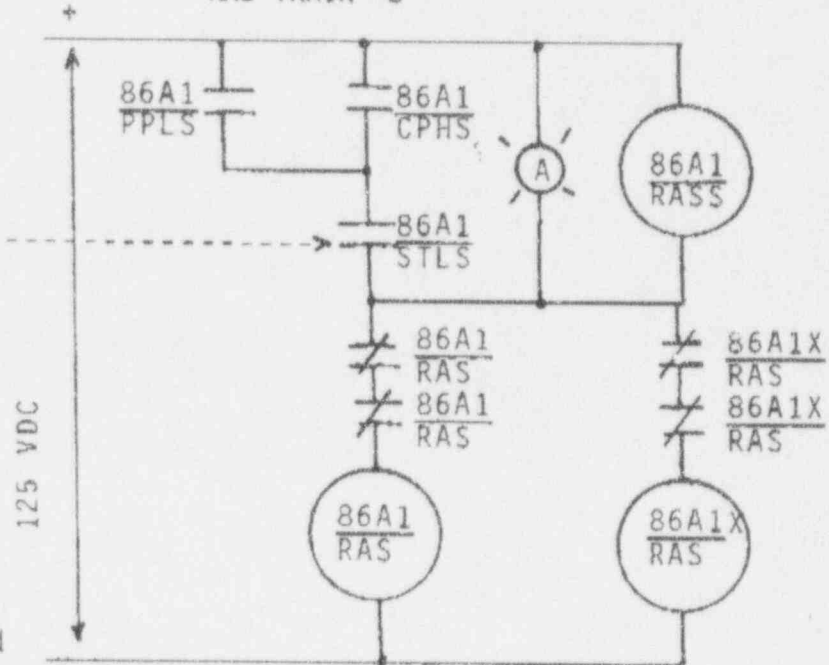
ATTACHMENT 4

Train A RAS actuation causes an automatic swap to the recirculation mode for both trains of safety injection and containment spray. If the failure was timed so that the RAS actuation was premature, there would be insufficient net positive suction head for the running pumps. The high pressure safety injection pumps for both trains would be vulnerable to damage. The

The above described logic sequence would be identical for the Train B logic. A similar failure of Supervisory Relay 86B/STLSS would result in the actuation of Lockout Relays 86B/STLS, etc. Train B RAS actuation also causes the automatic swap to the recirculation mode for both trains of high pressure injection and containment spray.

In addition, the licensee reviewed the other supervisory relays in the RAS logic circuit. The licensee installed Temporary Modification TM 94-015 on February 19, to lift a similar lead from six other supervisory relays, as a precautionary measure until the engineering analysis was completed.
