Public Service Company of Colorado

September 15, 1982
Fort St. Vrain
Unit No. 1
P-82394

SUBJECT: Status of Cracked Fuel Element Webs

The purpose of this letter is to update the status of the cracked fuel element webs discovered as a result of the Segment 2 nondestructive examination program. The letter also presents PSC's reasons for believing that these cracked webs do not constitute a significant hazard to public health and safety and briefly describes current plans for further evaluation of the cracks.

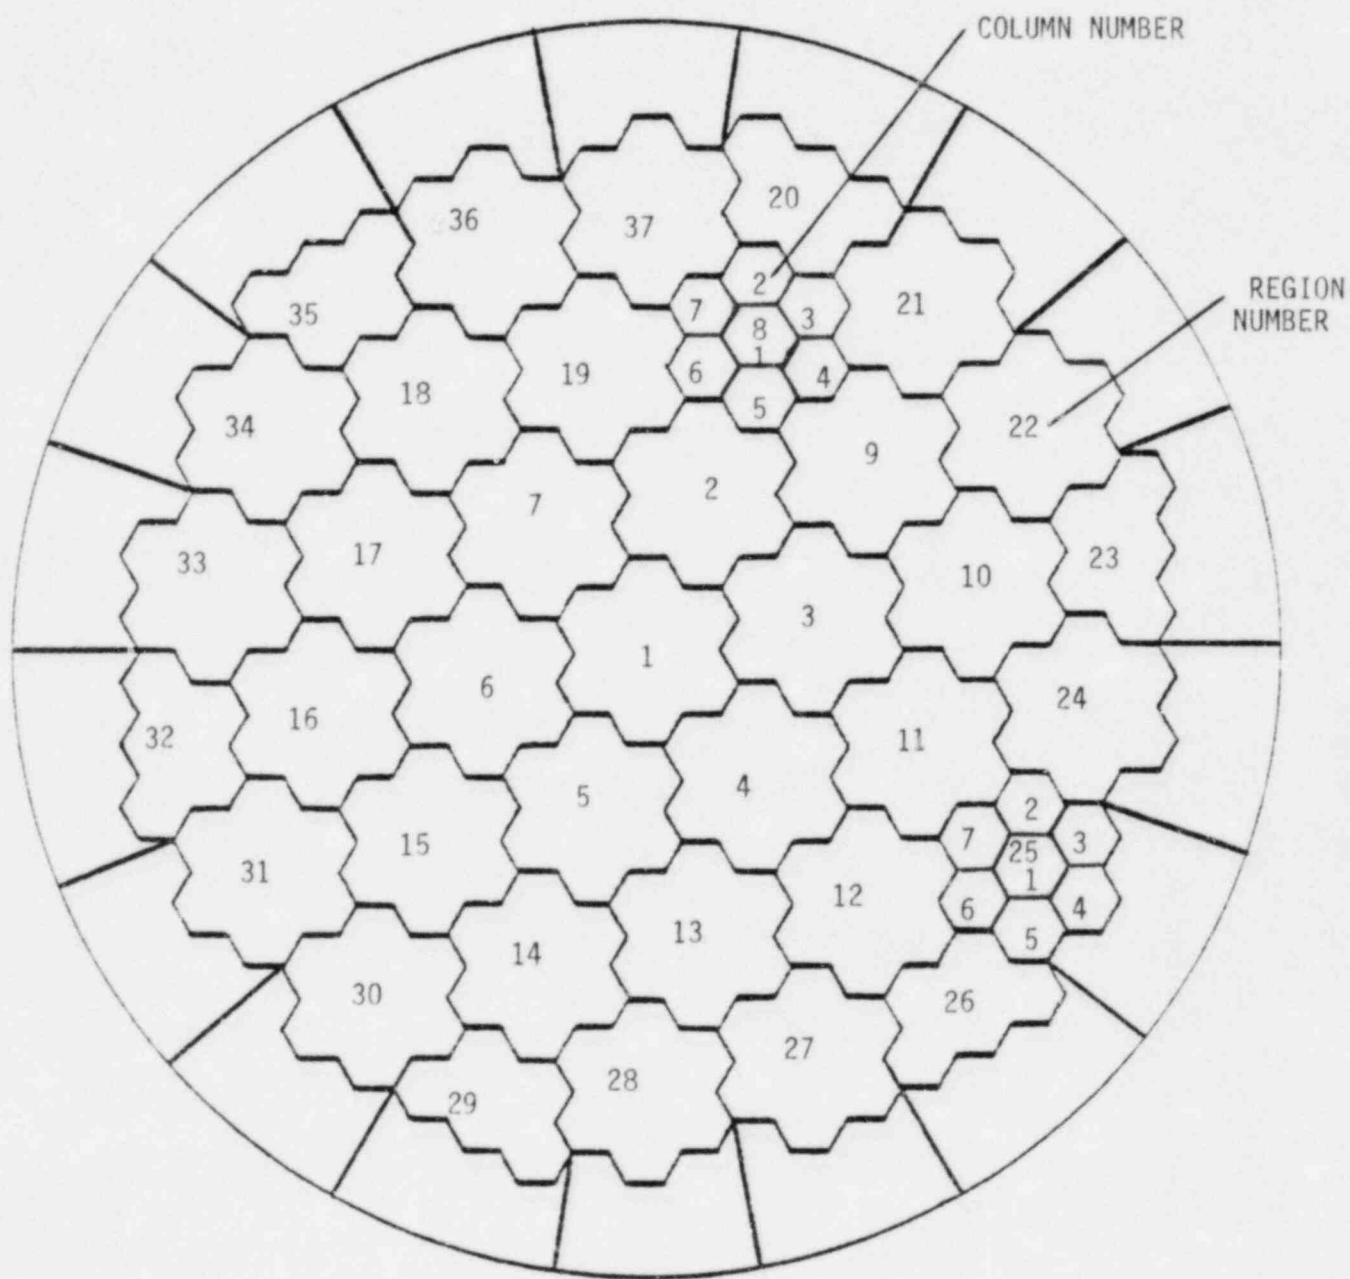
FIGURE 1. CORE POSITION OF ELEMENTS
(Shipped To GAC)

Based upon later review by General Atomic Company (GAC) of the video tapes made during the examinations, it was determined that a similar, but thinner crack might also exist on the corresponding face of fuel element 1-0172. (Fuel element 1-0172 was located in the initial core directly under fuel element 1-2415.) In order to determine conclusively whether a crack also occurred in fuel element 1-0172, it, along with 1-2415 and three other fuel elements, were sent to San Diego for closer examination in the GAC Hot Cells. The core location of these elements is shown in Figure 1.

ELEMENT	REGION	COLUMN	ACTIVE CORE LAYER
1-2415	8	5	3
1-0172	8	5	4
1-0108	8	6	3
2-2693	8	1	3
5-0801	25	3	4

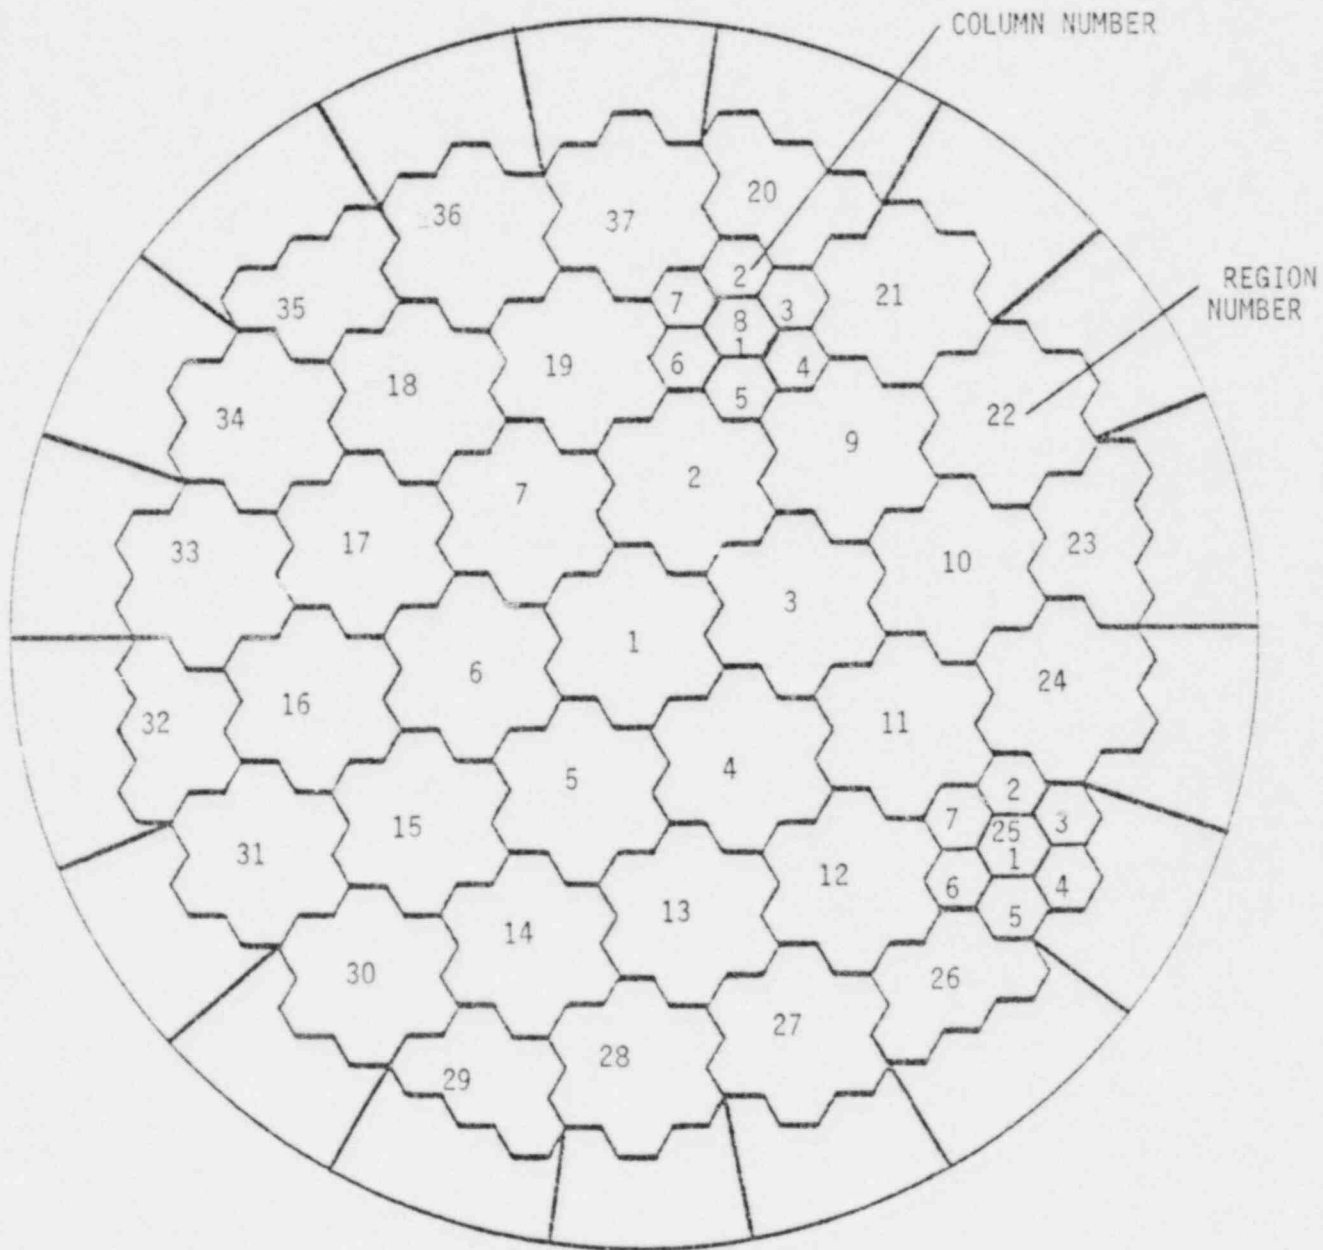
FIGURE 1 CORE-POSITION OF ELEMENTS
(Shipped To GAC)

Based upon later review by General Atomic Company (GAC) of the video tapes made during the examinations, it was determined that a similar, but thinner crack might also exist on the corresponding face of fuel element 1-0172. (Fuel element 1-0172 was located in the initial core directly under fuel element 1-2415.) In order to determine conclusively whether a crack also occurred in fuel element 1-0172, it, along with 1-2415 and three other fuel elements, were sent to San Diego for closer examination in the GAC Hot Cells. The core location of these elements is shown in Figure 1.

ELEMENT	REGION	COLUMN	ACTIVE CORE LAYER
1-2415	8	5	3
1-0172	8	5	4
1-0108	8	6	3
2-2693	8	1	3
5-0801	25	3	4
