SUBJECT: LOSS OF OFFSITE POWER RESULTING FROM A LACK OF
PREVENTIVE MAINTENANCE AND INADEQUATE PERSONNEL
TRAINING

NRC INFORMATION NOTICE NO. 89-XX: LOSS OF OFFSITE POWER RESULTING FROM A
LACK OF PREVENTIVE MAINTENANCE AND
INADEQUATE PERSONNEL TRAINING

AEOD/E90-02

CROSBY LOW PRESSURE RELIEF VALVES
NOZZLE RING PROBLEMS

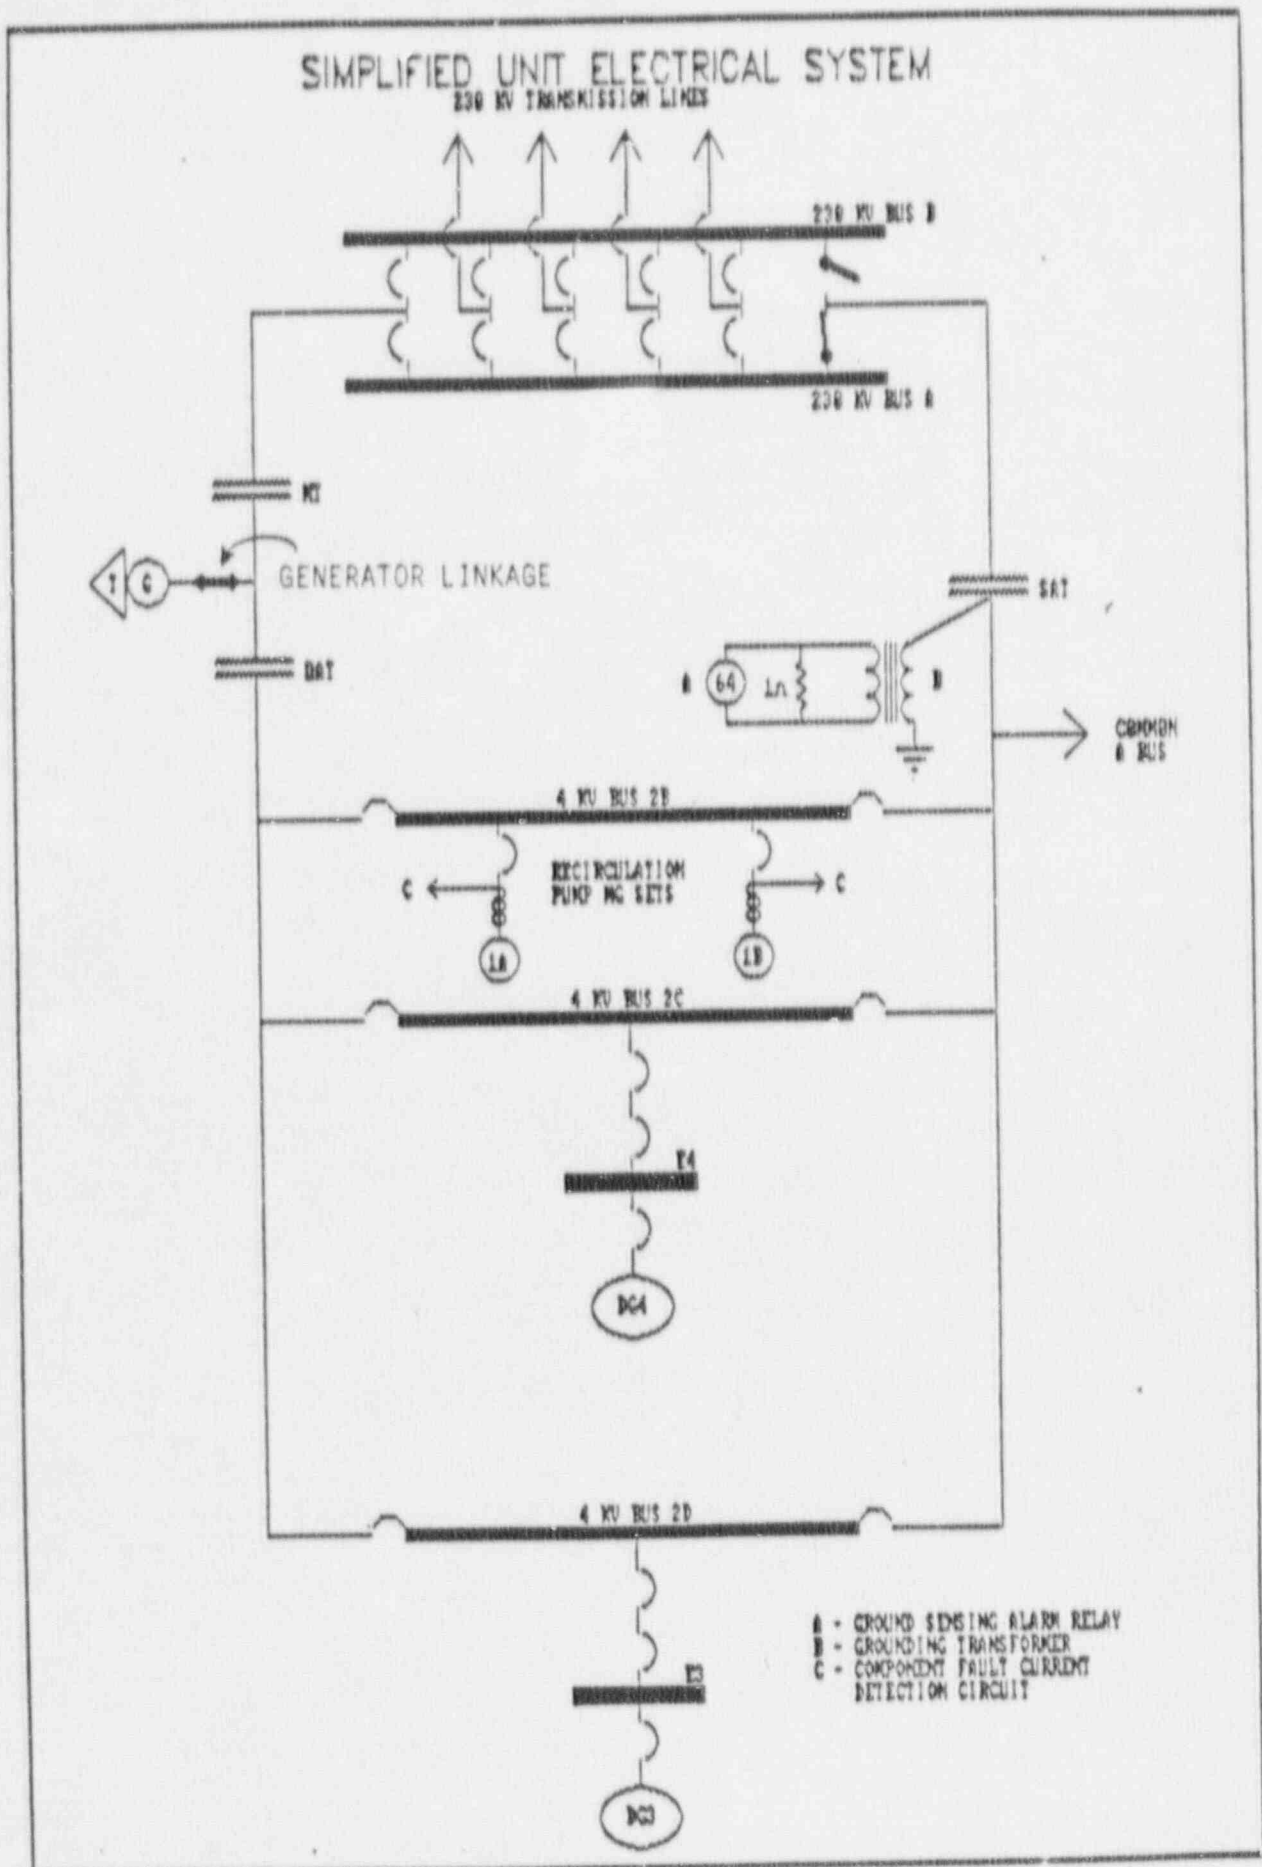
FIGURE 1

2. The licensee has provided training to the appropriate plant personnel on the ground detection and clearing methods.
3. Since the restoration of the offsite power source by backfeeding through the main transformer involves removal of the main generator linkage and takes about 9 hours (see Figure 1 attached), the licensee will establish appropriate procedures and a time limit for restoring offsite power, after the loss of the SAT, to satisfy General Design Criterion (GDC)-17. (GDC-17 requires that the time to restore offsite power should be less than the time required to assure specified acceptable fuel design limits and design conditions of the reactor coolant pressure boundary.)

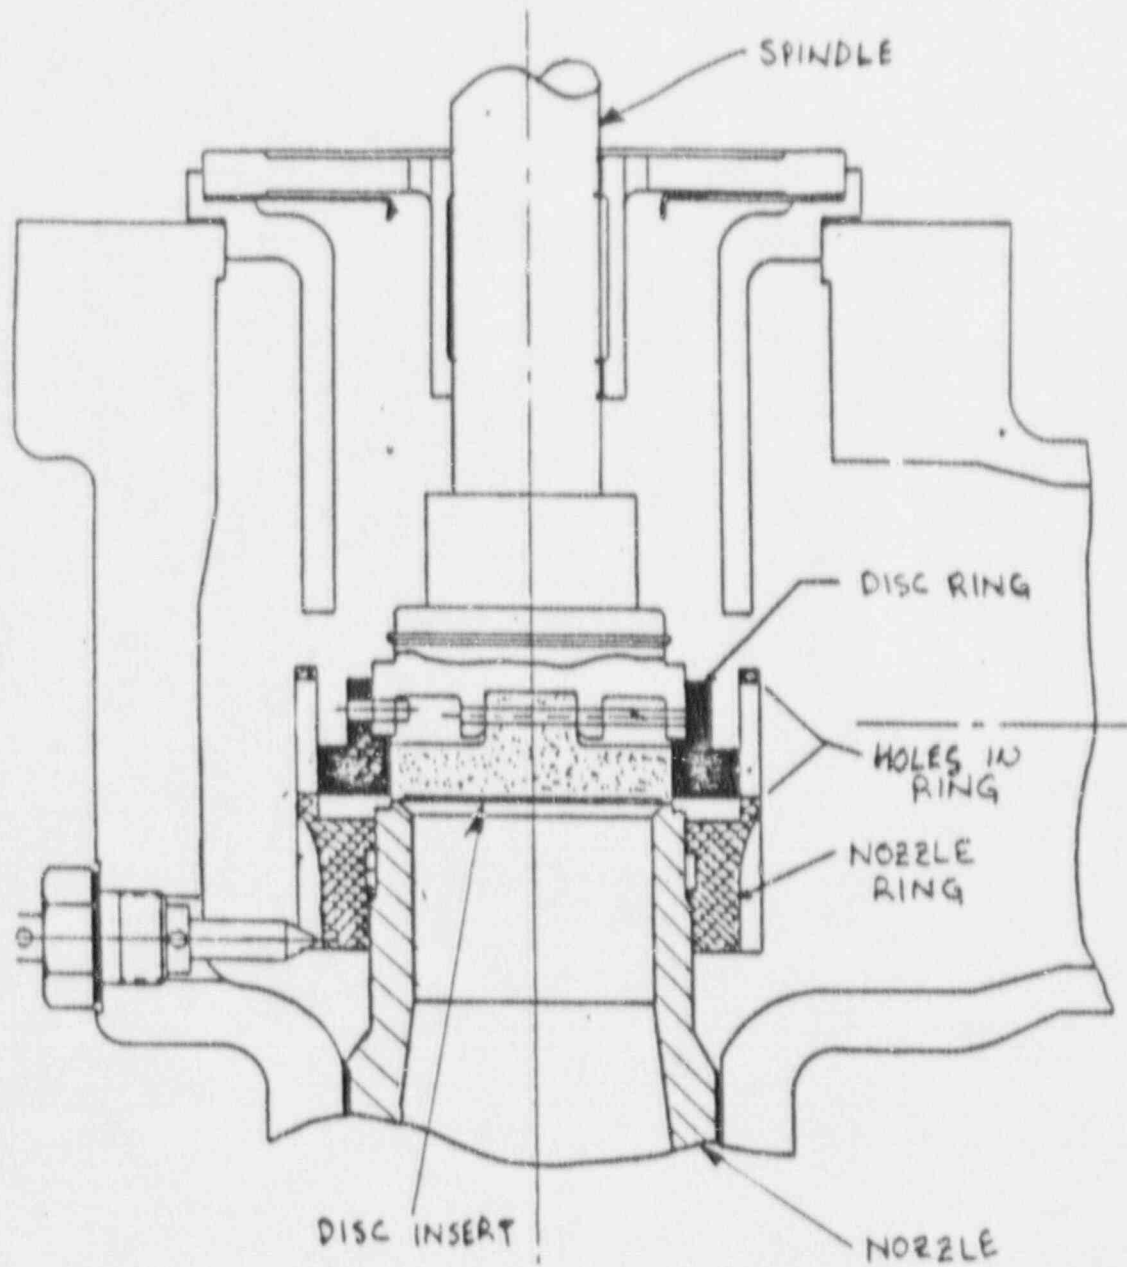
FIG. 1 VALVE CUTAWAY

All of the valves involved in the referenced events were Crosby relief valves, Model JB-35-TD-WR-B, which is used in a number of nuclear plants in the U.S. As shown in Fig. 1, the valve nozzle (about 1.5 to 2 in. diam.), which forms the valve seat, is surrounded by a ring that is screwed on the nozzle. The valve disc insert, connected to the spindle by an insert pin, is surrounded by a disc ring that is also held in place by the insert pin. The spindle is spring loaded to push the disc insert against the valve nozzle. The nozzle ring is sufficiently long to guide the disc assembly when the valve is actuated. A bellows surrounds the spindle above the disc assembly to negate the impact of back pressure on the valve lift point.

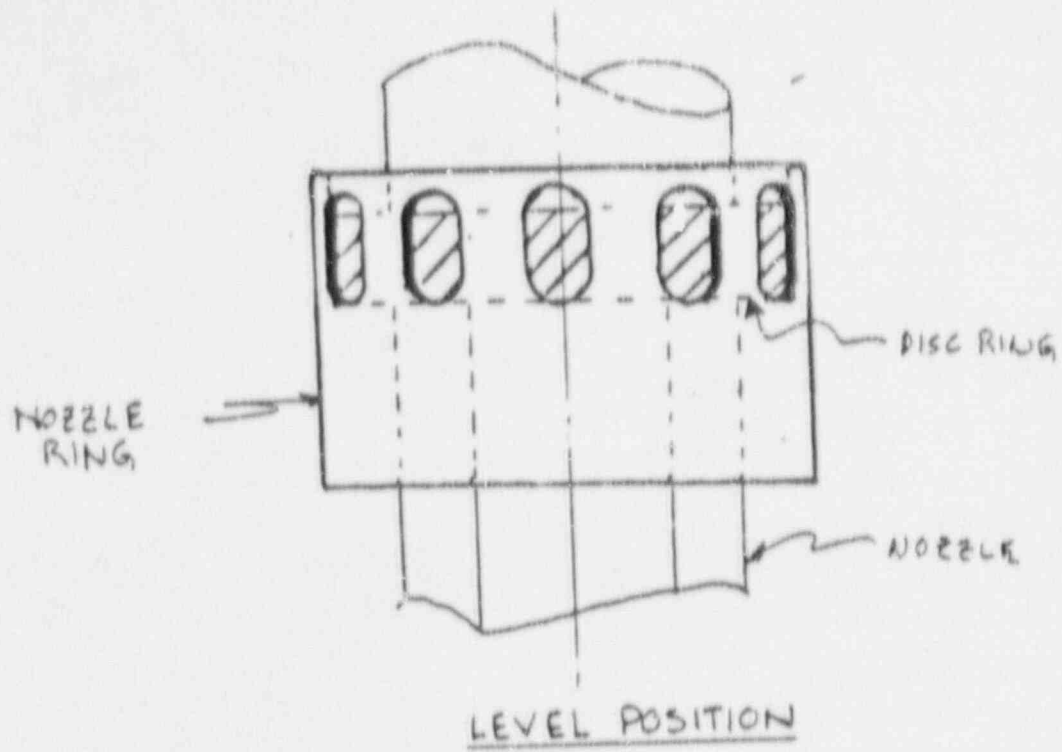
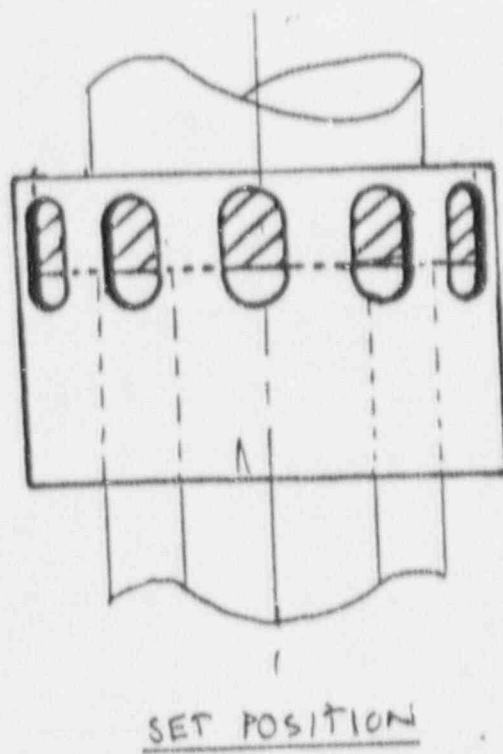
FIG. 2 RING SETTING

Based on the manufacturer's test reports for the Braidwood valves, the nozzle ring position should be set about 105 notches below a level position which is about 230 notches below the highest locked position. The highest locked position for the nozzle ring is determined by rotating the ring until there is contact between the ring and the bellows protector located above the nozzle. Backing off about 230 notches from this position should result in the lower edge of the holes in the nozzle ring being at the elevation of the nozzle surface as shown in Fig. 2. This is designated the level position. The proper ring position is about 105 notches lower than the level position so the holes in the nozzle ring straddle the nozzle surface as shown in Fig. 2. The nozzle ring is rotated by using a screw driver through a hole in the back side of the valve to move notches around the ring circumference. There are 18 to 30 notches around the nozzle ring for the valves of interest. There are about 24 turns per inch.

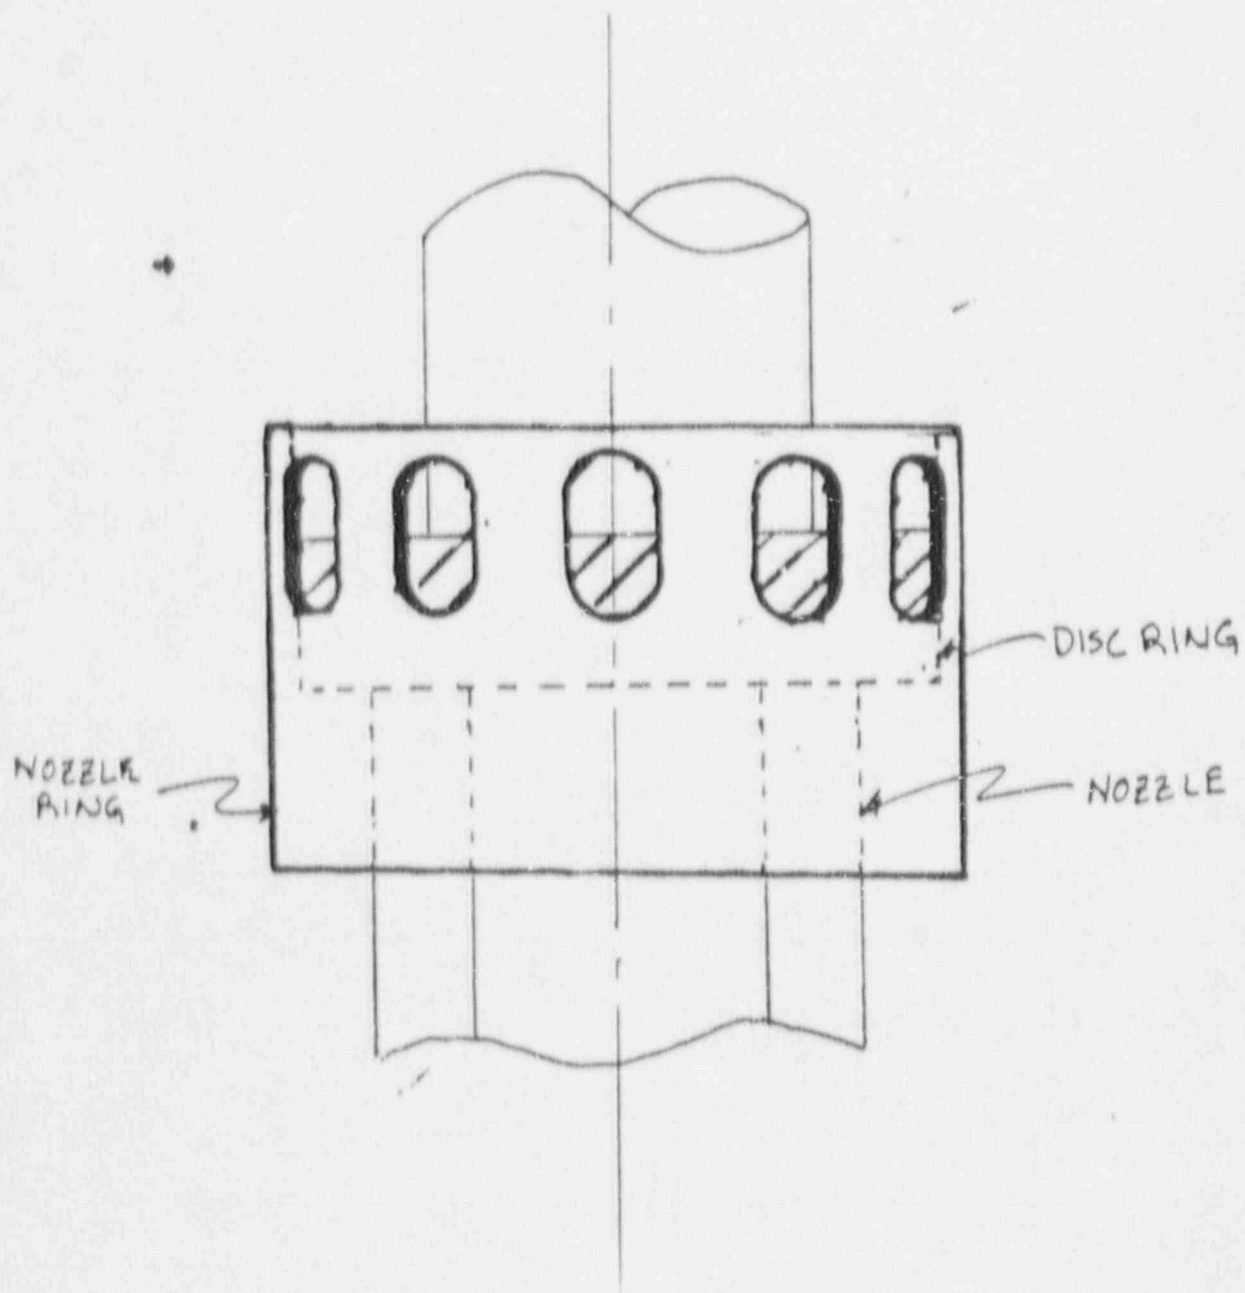
FIG. 3 RING SETTING
TOO HIGH

An incorrect nozzle ring setting on a relief valve adversely affects the valve's characteristics and can result in uncontrolled leakage or discharge from the valve as noted in the above discussion. A low setting may produce valve chatter and ultimate valve failure leading to uncontrolled leakage. A very high nozzle setting may eliminate the ventilation area at the nozzle surface provided by the holes in the nozzle ring as indicated in Fig. 3. Under these conditions, the valve reseal may be significantly delayed because of the cushion of water trapped under the valve disc assembly.
