ENVIRONMENTAL RISK ASSESSMENT SURVEY OF  
FOOTE MINERAL COMPANY FACILITY  
AT CAMBRIDGE, OHIO  
A SUBSIDIARY OF NEWMONT MINING CORPORATION

Versar Job No. 879

Versar Inc.  
6850 Versar Center  
Springfield, Virginia 22151  
1-800-283-7727

May 28, 1985

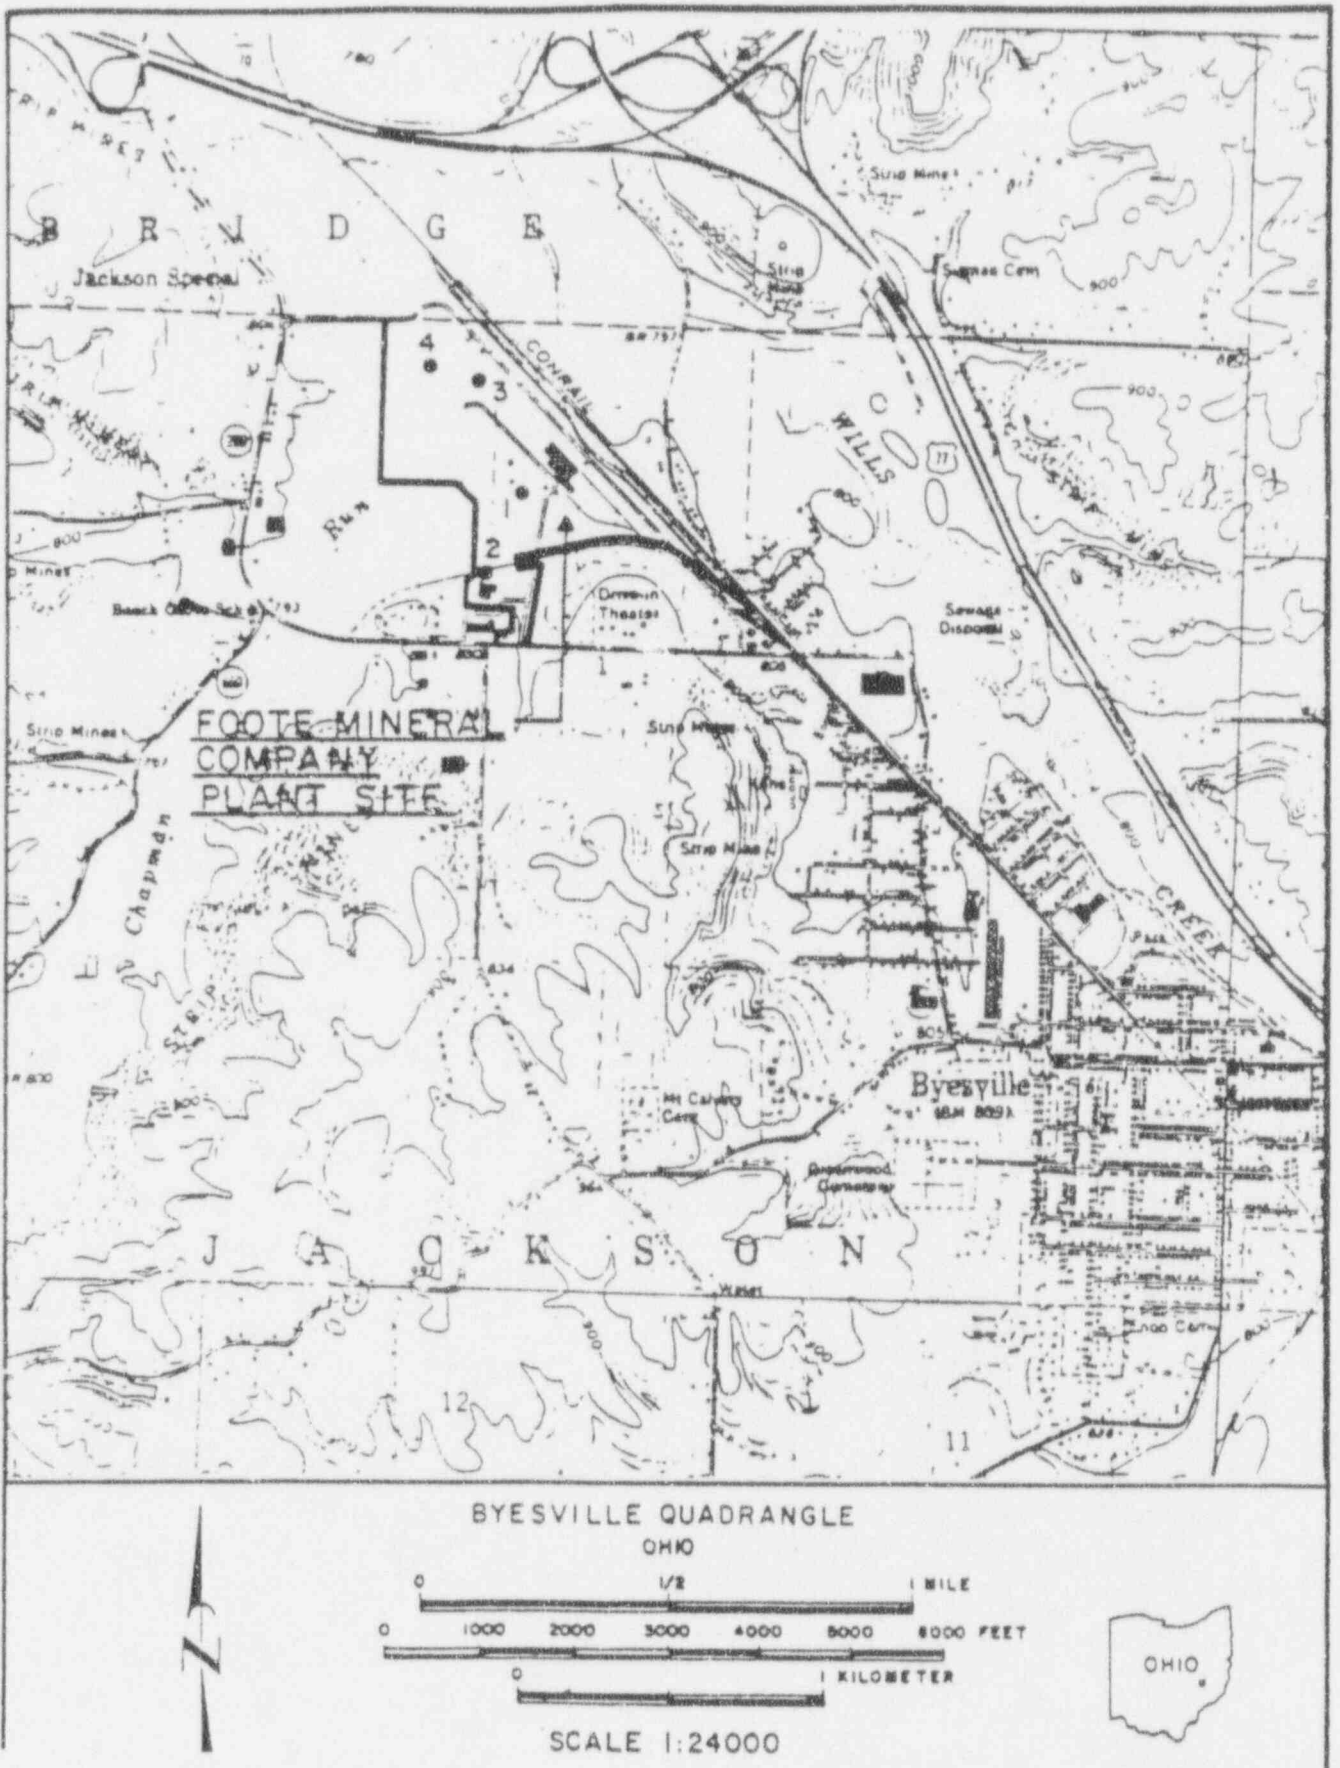
Figure 1.5-1. Location of Monitoring Wells

Monitoring well number 2 is downgradient of the chemical production facility building; monitoring well number 1 is downgradient of the furnace building, but not the raw materials stockpiles. Monitoring well number 4 is upgradient of the slag dump; it is not located directly between the dump and Chapman's Run, but is 200 yards northwest (upgradient) of a direct line between the slag dump and Chapman's Run. A "septic odor" was noticed in the first 8 feet of soil samples taken here, and was attributed to possible leakage of a nearby sanitary sewer line.

This well is screened in the uppermost sandy water-bearing layer. Monitoring well number 3 is screened in a relatively impermeable clay strata from 31 to 61 feet deep. Directly above this clay strata is a wet sand lens from 28 to 31 feet; however, this sand lens is protected from surface leachate contamination by an overlying gray clay layer from 16 to 26 feet deep. The vulnerable surficial water-bearing strata at the location of well number 3 is a wet sand lens from 12 to 16 feet. The monitoring well is not screened in this strata. Monitoring well number 3 is located along the northeast border of the site and is probably upgradient of the groundwater flowing beneath the site.

- 85-1. Potential groundwater contamination from the sources detailed above should be monitored in a program which (a) establishes local groundwater flow patterns from field survey data; (b) places an adequate number of monitoring wells downgradient of potential contaminant sources; (c) samples at least the surficial water bearing permeable strata at risk of contamination.
- 85-2. Leachate seeps around the base of the landfilled area appear to have differing chemical make-ups, due to the variety of colors of the seepage observed. The various leachate seeps should be sampled and analyzed for all reasonable chemical constituents, including organic chemicals, toxic metals, including vanadium and vanadium compounds, and radionuclides.
- 85-3. The landfill leachate impacts on the adjacent wetlands and stream sediments and biota should be assessed.
