Commonwealth Edison

LICENSEE EVENT REPORT (LER)

Facility Name (1) Zion Unit 2	Docket Number (2) 0 5 0 0 0 3 0 4	Page (3) 1 of 0 3
----------------------------------	--------------------------------------	----------------------

Title (4)
Actuation of Unit 2 Station Blackout Loads During Restoration of Buses 147/247 to Offsite Power.

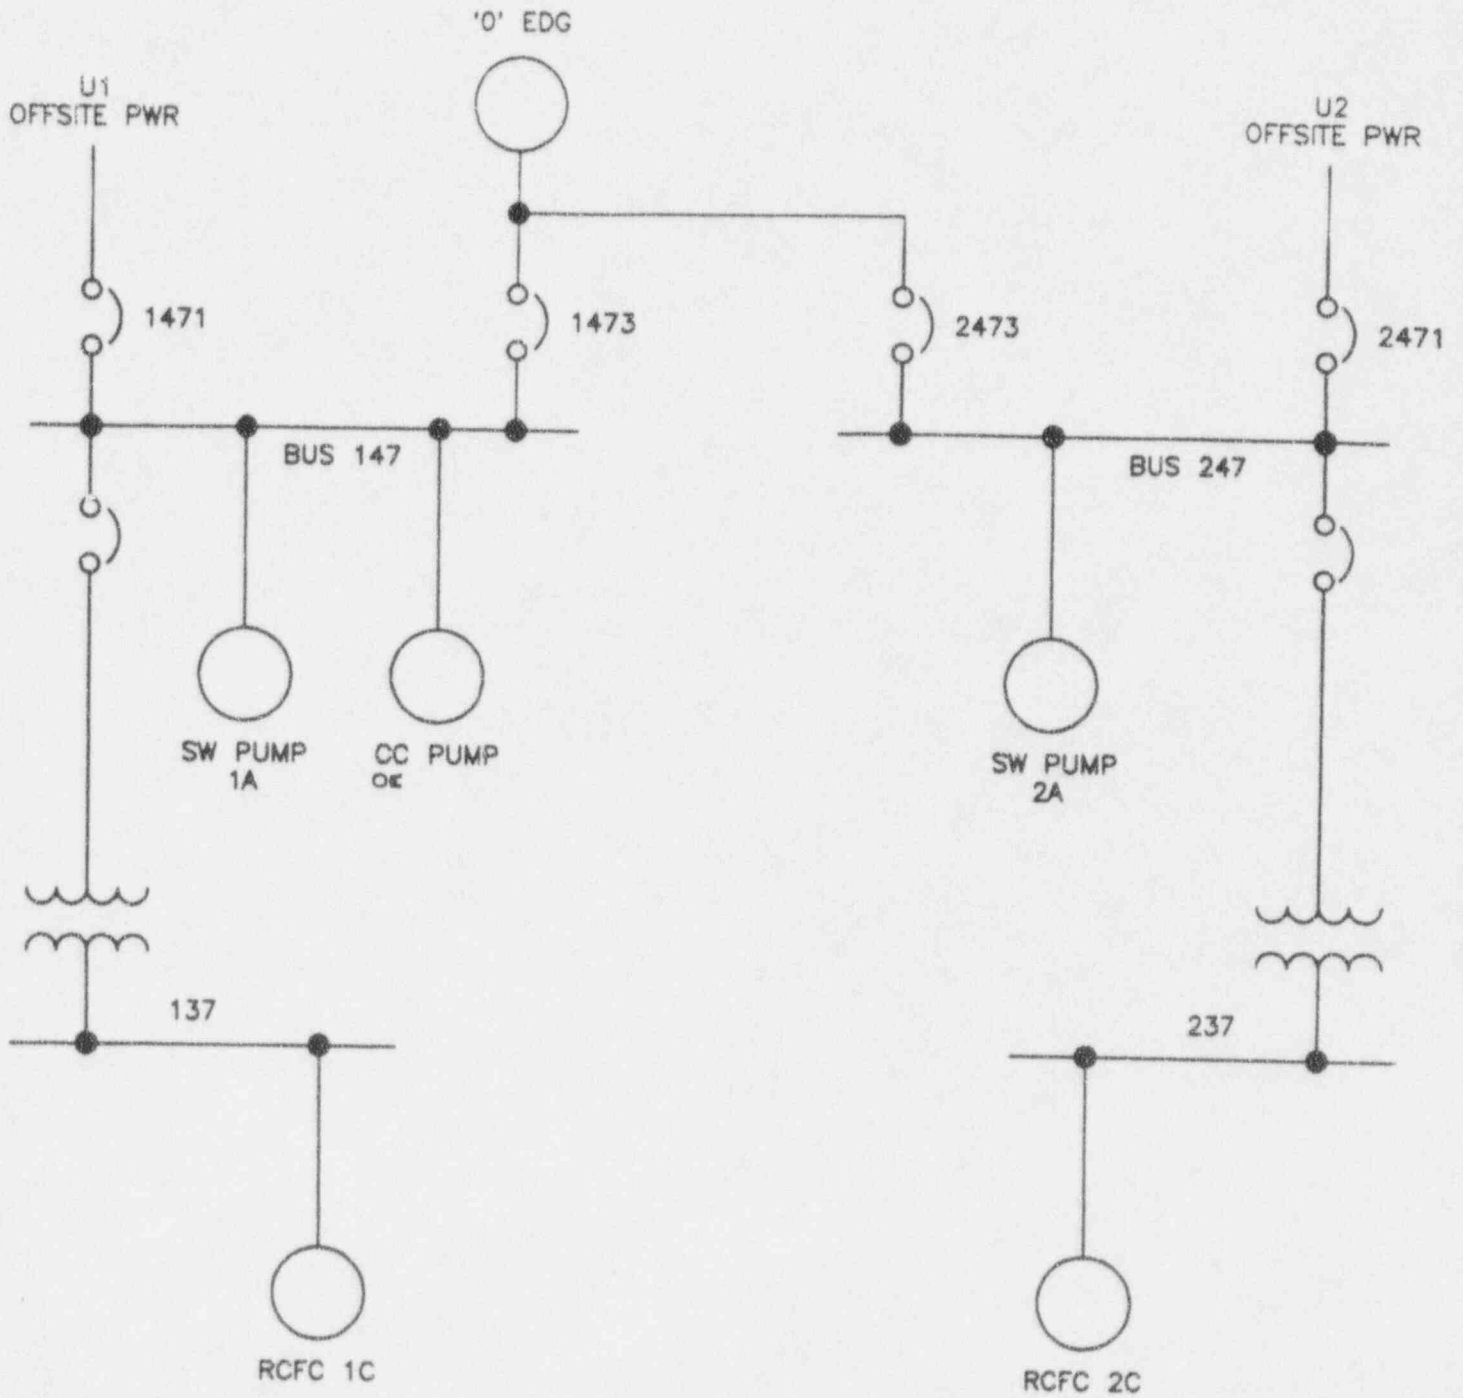
ATTACHMENT 1

On 03/02/94, Technical Staff Special Procedure (TSSP) 44-93, was being performed on the 0 Emergency Diesel Generator (EDG) [EK] following a modification that had been installed on the 0 EDG to allow it to supply power to Essential Service (ESS) Buses 147 and 247 (Attachment 1). The purpose of this testing was to verify that 0 EDG could maintain its frequency and voltage requirements while supplying power for the Station Blackout loads for both ESS buses 147 and 247. The Station Blackout loads for ESS bus 147 are the 1A Service Water (SW) [BI] pump, the 0E Component Cooling Water (CC) [CC] pump, and the 1C Reactor Containment Fan Cooler (RCFC) [BK]. The Station Blackout loads for ESS bus 247 are the 2A SW pump and the 2C RCFC.
