U. S. NUCLEAR REGULATORY COMMISSION

Report No. 50-320/82-08

Facility Name: Three Mile Island Nuclear Station, Unit 2

Inspection Conducted: July 6 - August 7, 1982

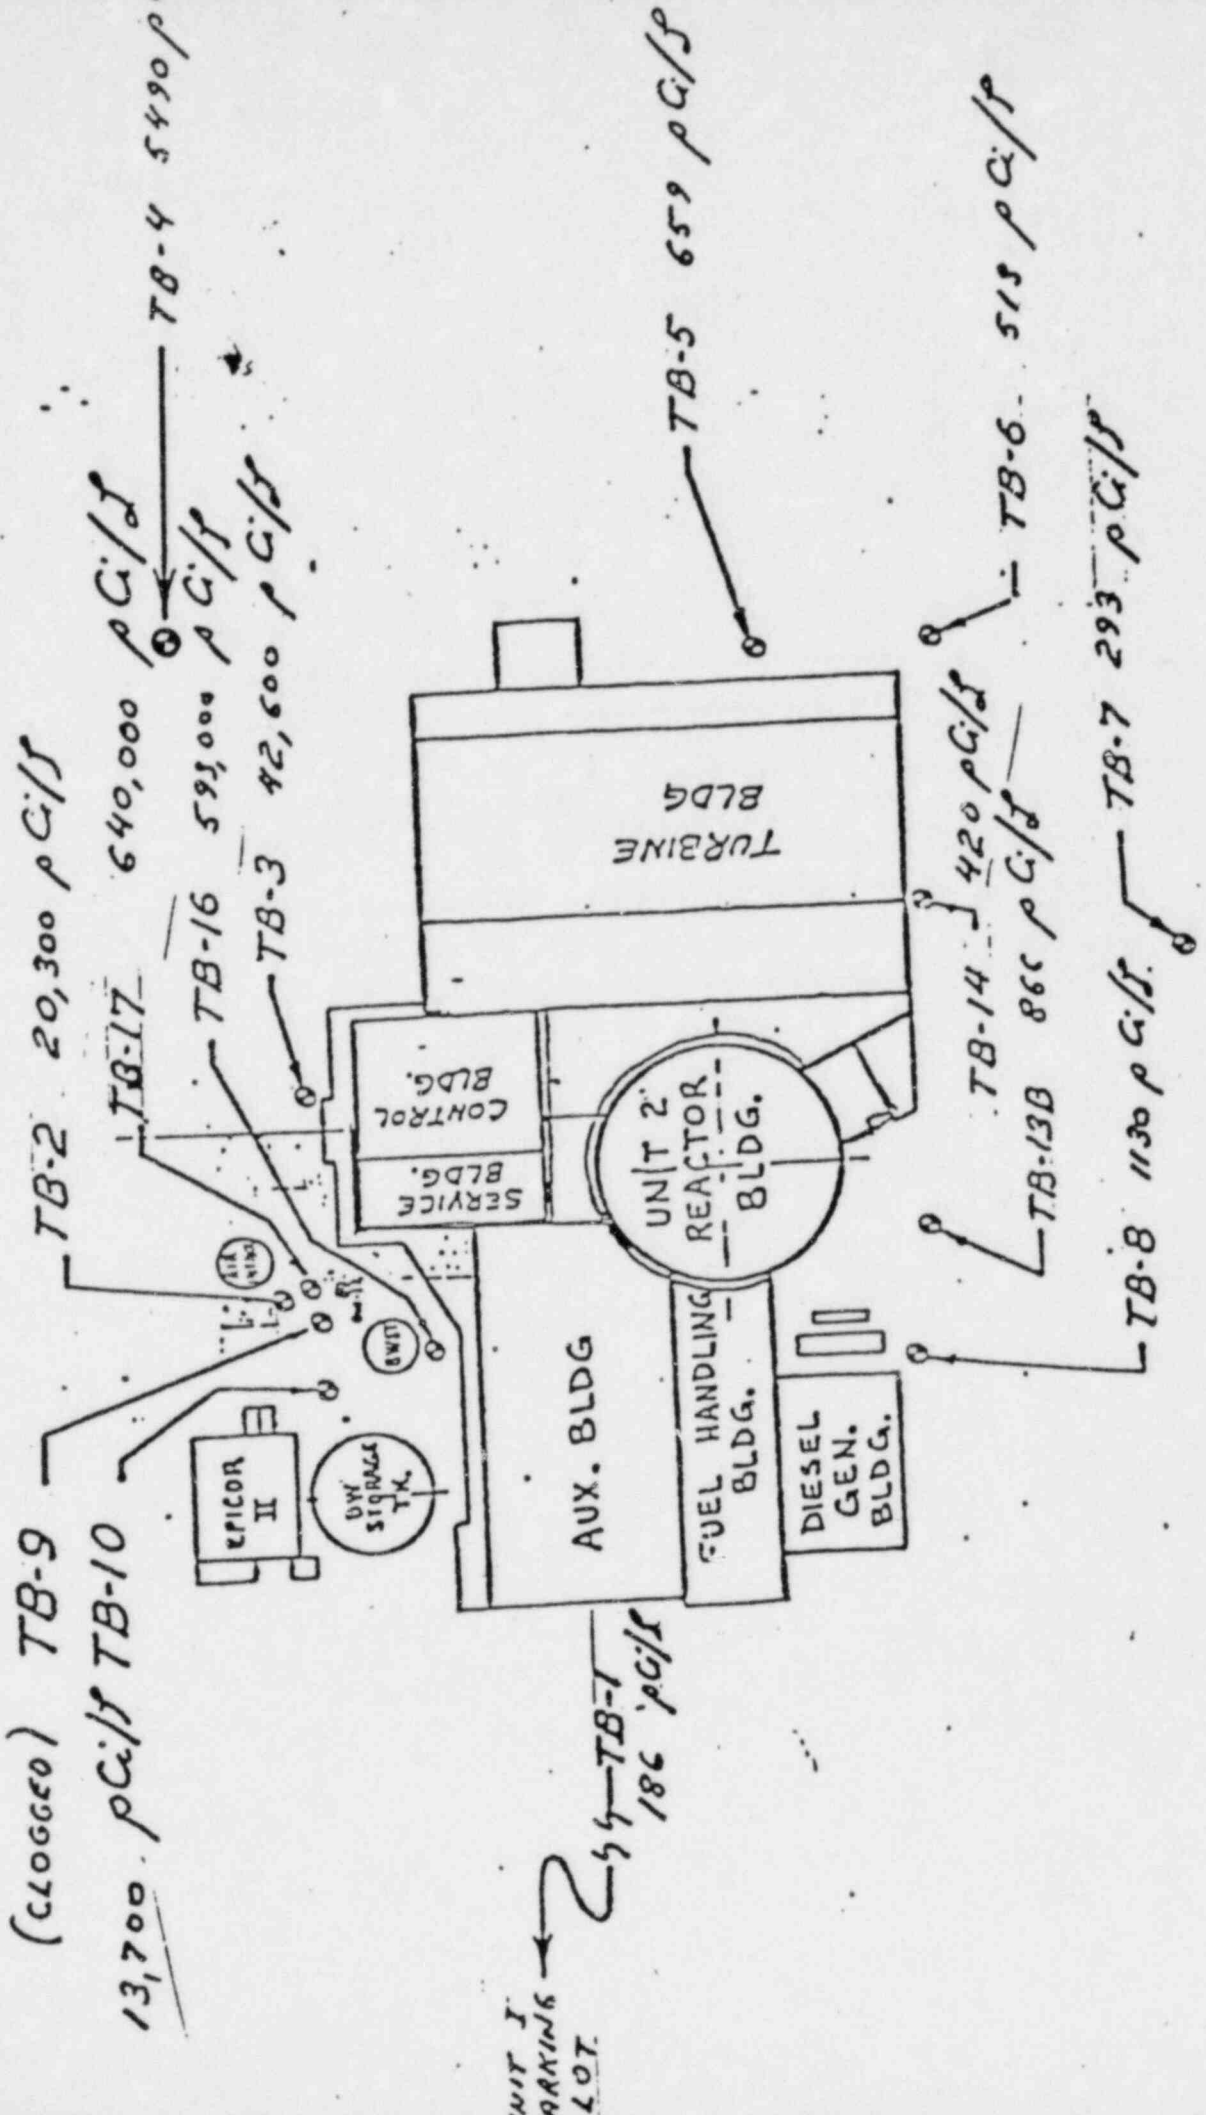
TEST BORING H³ CONCENTRATIONS

1. Groundwater Monitoring Program. The licensee samples onsite groundwater by means of test borings (see Figure 1). Weekly water samples are taken from borings 1, 2, 3, 10, 16, and 17. The other test borings are sampled monthly except test boring 9 which is clogged. During April, 1982, the licensee reported analytical results for groundwater samples taken from onsite test borings in February and March of 1982. Changes in tritium concentrations were noted for test borings 2, 3, and 17. A sample taken from test boring 17 on March 23, 1982, contained a tritium concentration of 1,100,000 pCi/l. The previous highest reading for test boring 17 was 678,000 pCi/l, for a sample taken February 25, 1982. Test boring 2, was reported as 954,000 pCi/l, for a sample taken February 12, 1982. More recent samples from test boring 2 showed reduced levels of tritium, down to 30,900 pCi/l for a sample taken March 23, 1982. The tritium levels for test boring 3 went from about 2,400 pCi/l on March 9, 1982, to 24,700 pCi/l on March 23, 1982. The licensee instituted a systematic program to identify the source of the tritium. The NRC independently analyzed water samples taken from these test borings on April 8, 1982.

The maximum permissible concentration (MPC) of tritium in unrestricted areas, as required by 10 CFR Part 20, is 3,000,000 pCi/l. The increased concentrations have remained below MPC. The increased tritium concentrations were only noted in the test borings near the Borated Water Storage Tank. The samples from aquatic environment in the TMI area did not indicate any apparent increase in tritium concentrations.

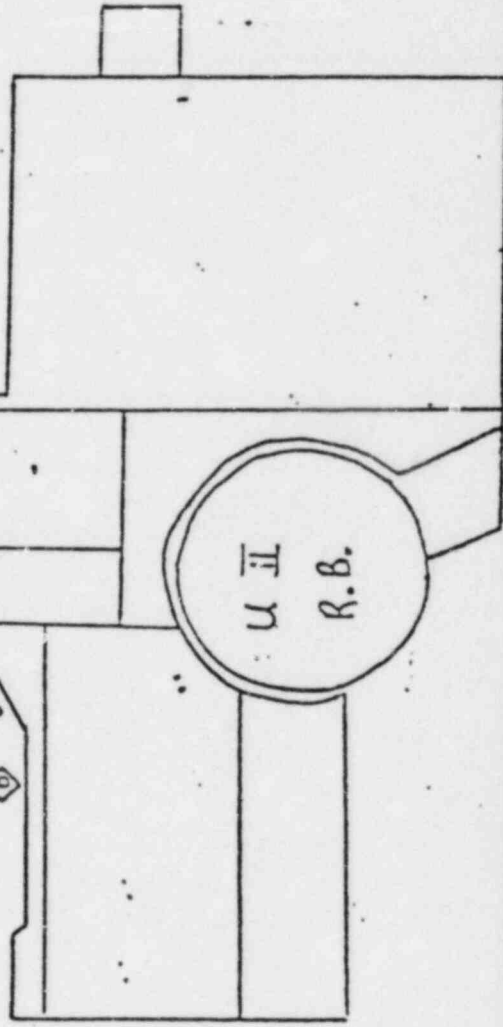
FIGURE 2 -7-

4. Special NRC Sample Program. During March and April 1982, the NRC sampled various onsite locations (Figure 2) to assess BWST leakage/cleanup, and the licensee monitoring program. Soil and liquid samples were tested by the Analytical Chemistry Laboratory, Idaho Operations Office, DOE. The results of these analyses are reported in the following table.
