UNITED STATES
NUCLEAR REGULATORY COMMISSION
REGION II
101 MARIETTA ST., N.W., SUITE 3100
ATLANTA, GEORGIA 30303

Report No. 50-321/82-27

Facility Name: E. I. Hatch Unit I

5. LER 50-321/82-60 Followup (92700)

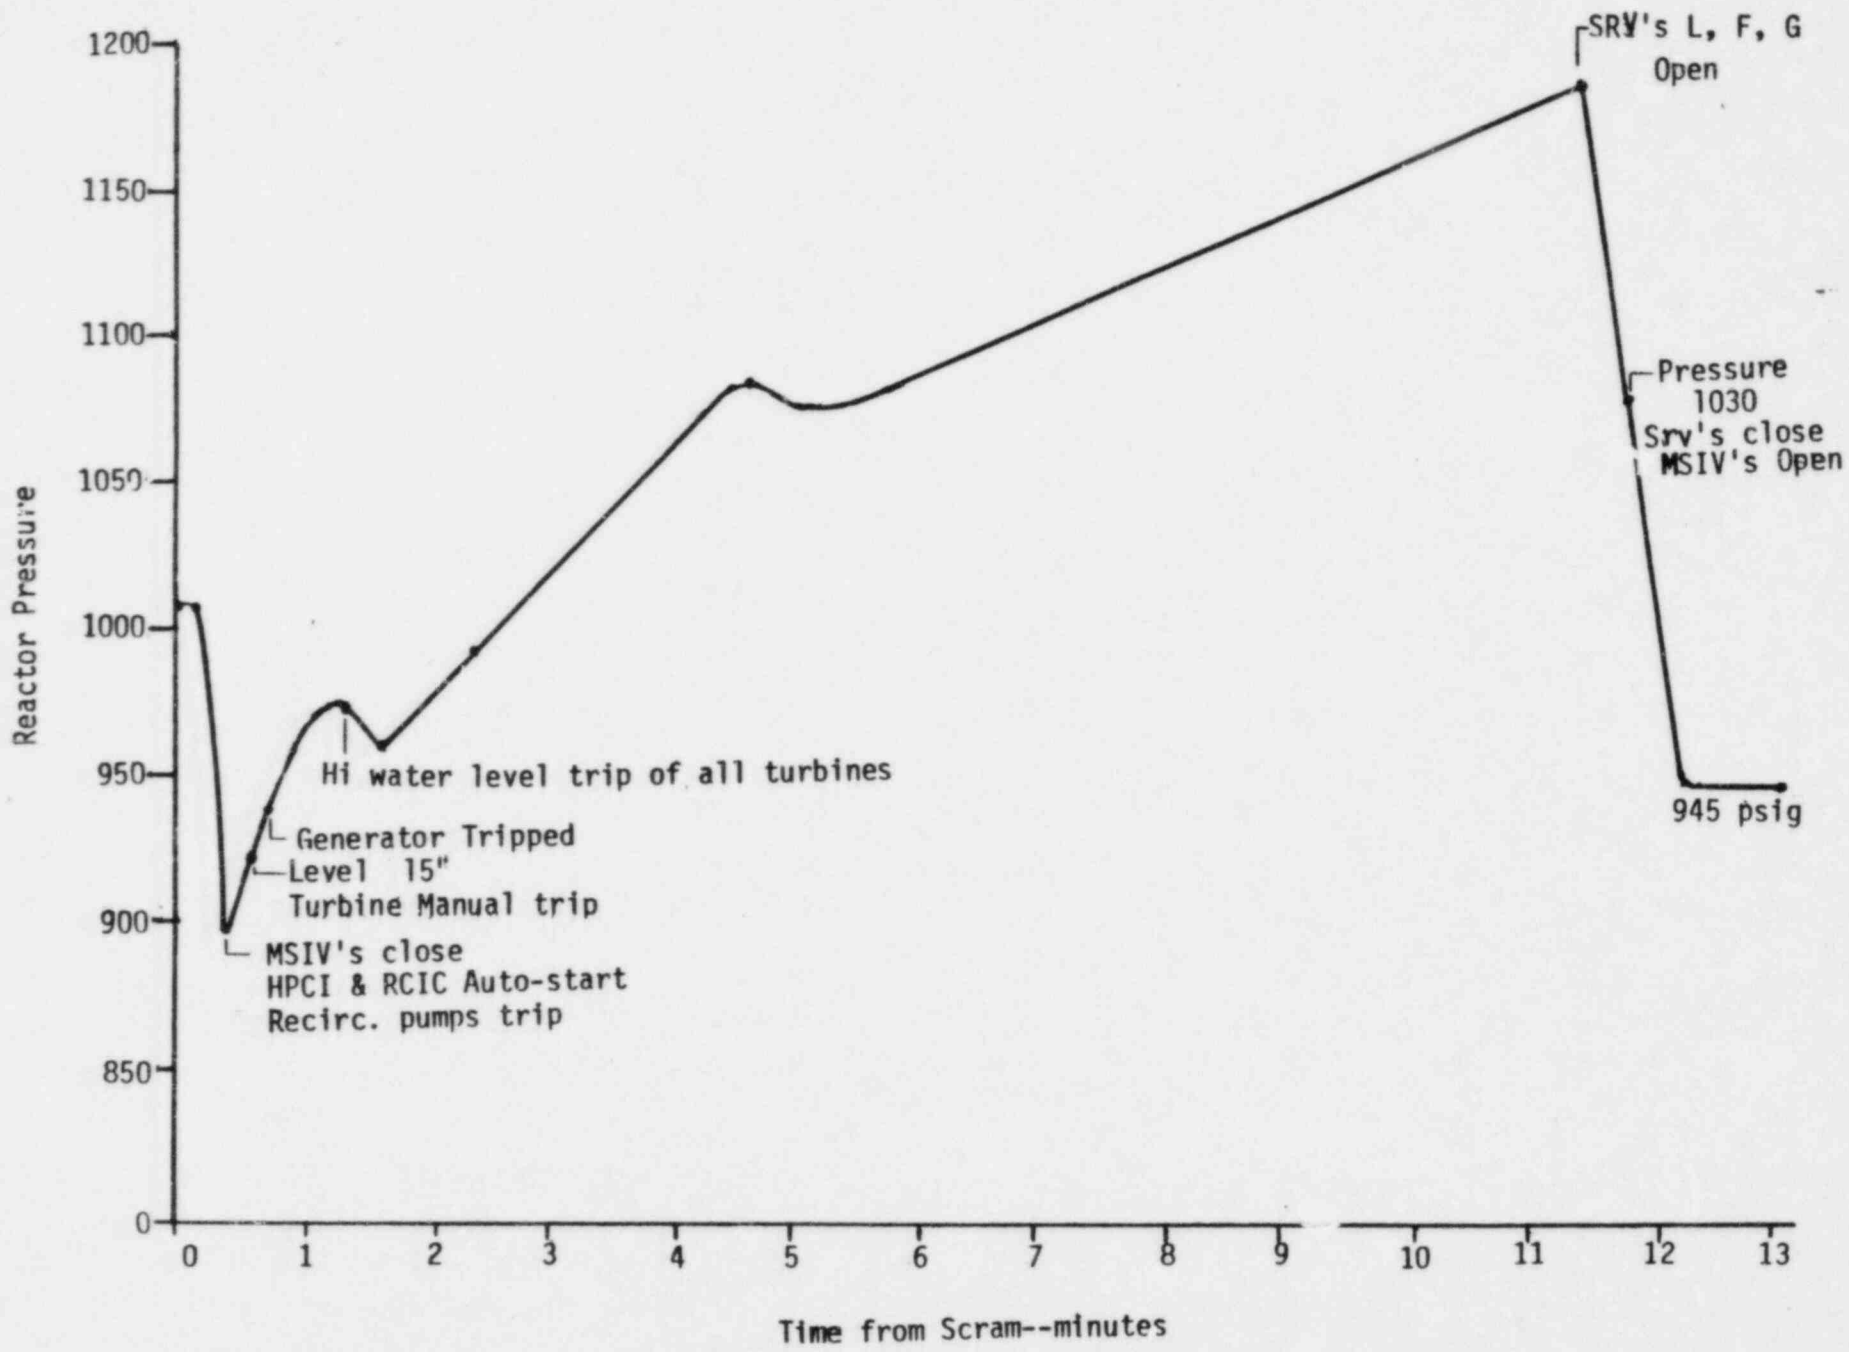
Figure 1 Primary Pressure Transient

Reactor pressure began increasing with the MSIV's closed (see Fig. 1 for primary pressure transient). The wide range pressure records indicated a maximum pressure of about 1180 psig. The operator elected to display the GEMAC pressure indicator on the process computer digital display. This indicator displayed a maximum of 1200 psig. Two other pressure indicators also displayed a maximum of 1200 psig.

Safety relief valves L, F and G automatically opened 11 minutes and 59 seconds after the reactor trip. Pressure decreased to 945 psig and the MSIVs were manually opened at this time. Pressure control was then taken by the EHC system and normal recovery was initiated by the operators.

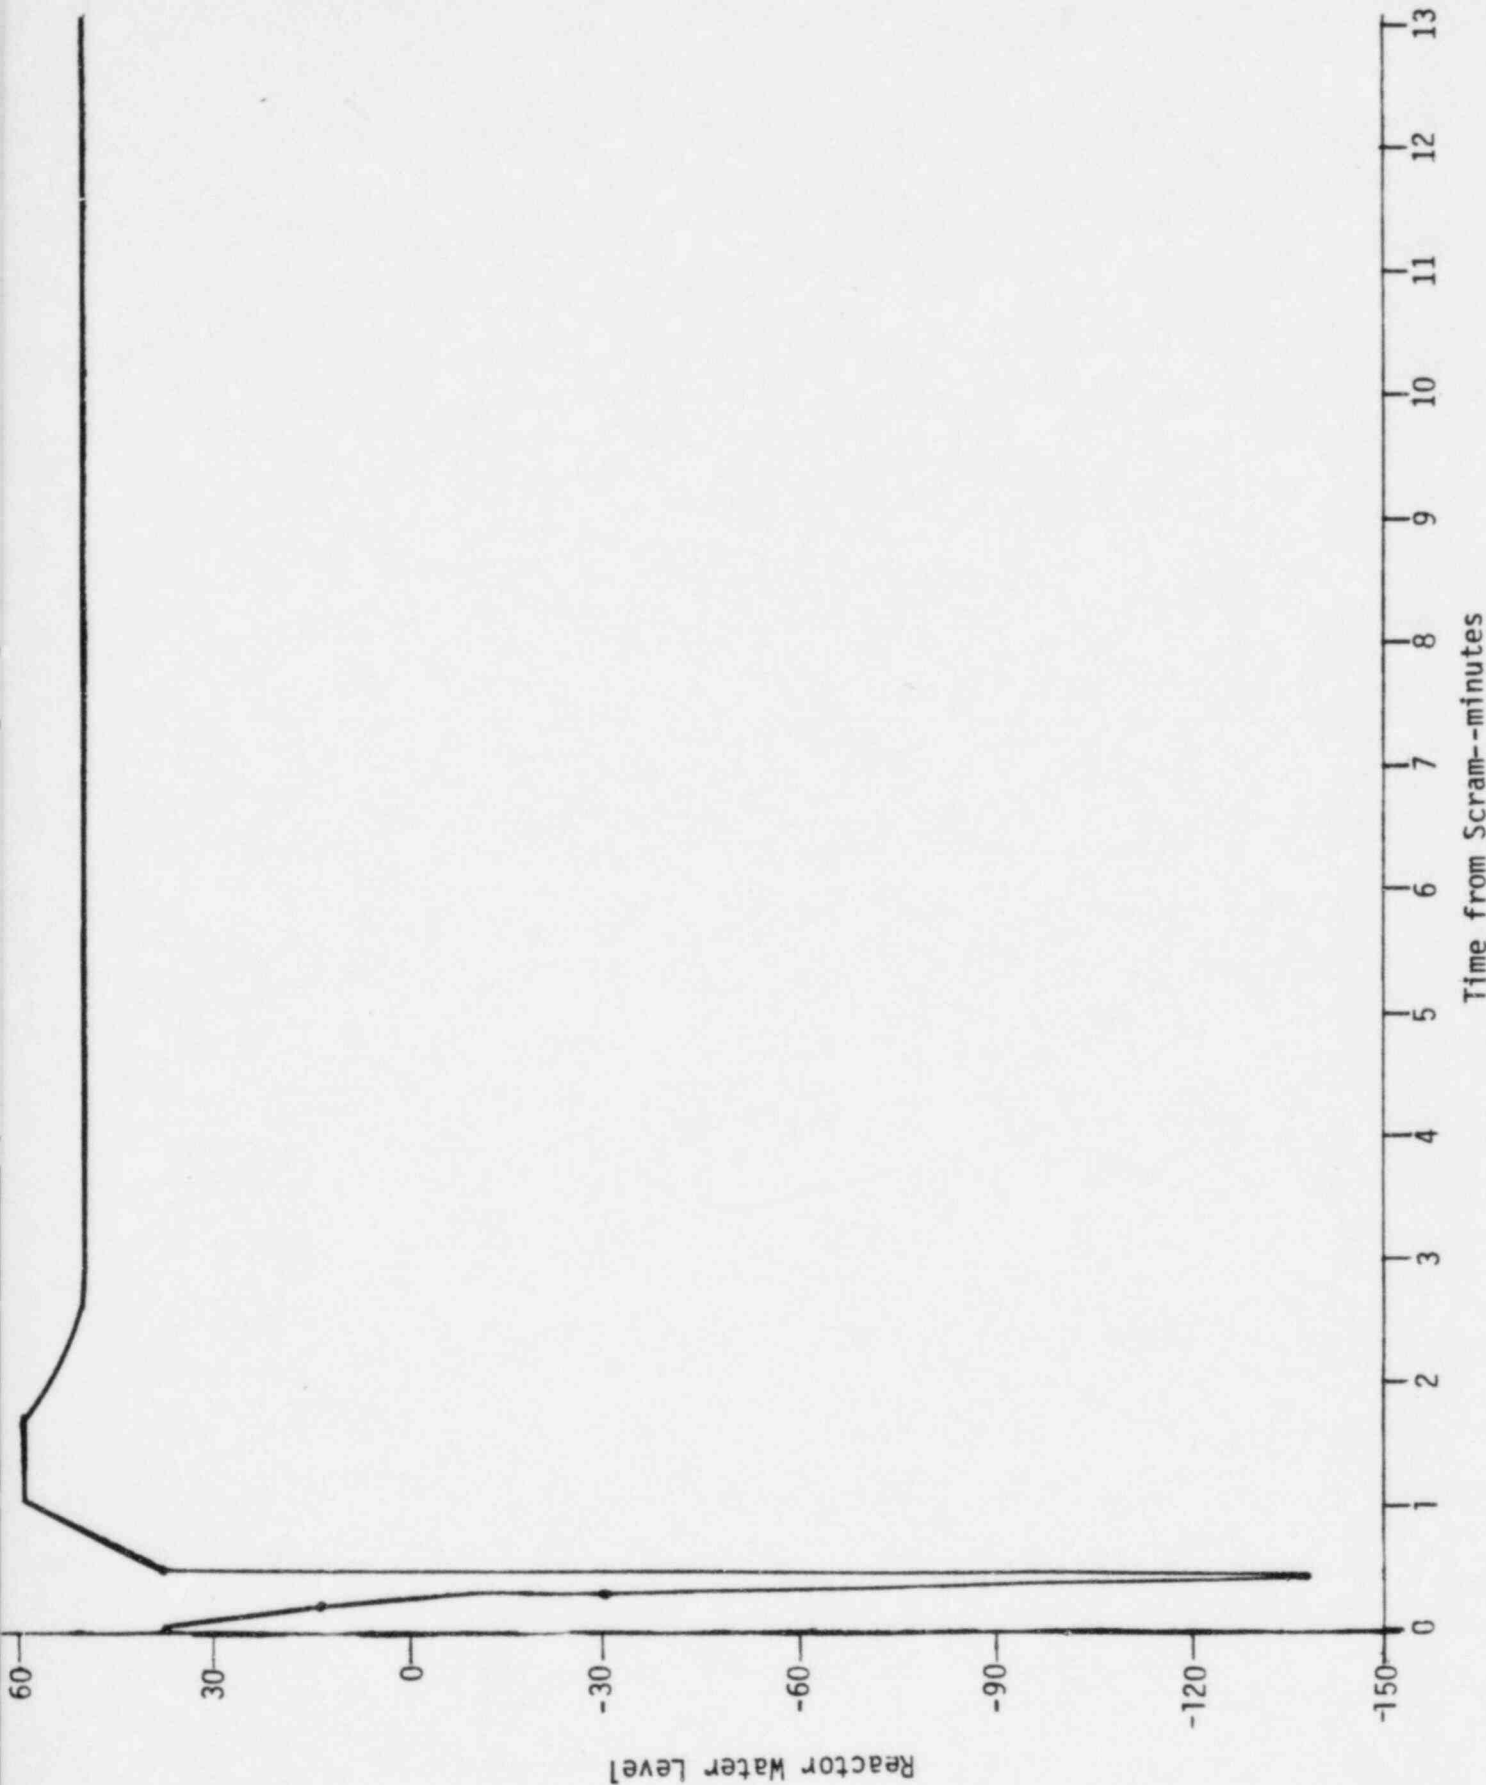
Figure 2 Water Level Transient

Reactor water level decreased to the low level setpoint of 15 inches soon after the trip and continued to decrease since the main turbine had not yet been tripped off (see Fig. 2 for water level transient). The MSIVs closed automatically when reactor water level decreased to minus 30 inches, HPIC and RCIC started automatically. The recirc pumps tripped off automatically. Reactor water quickly recovered and, upon reaching the high level trip setpoint, the HPIC and RCIC turbines tripped off.

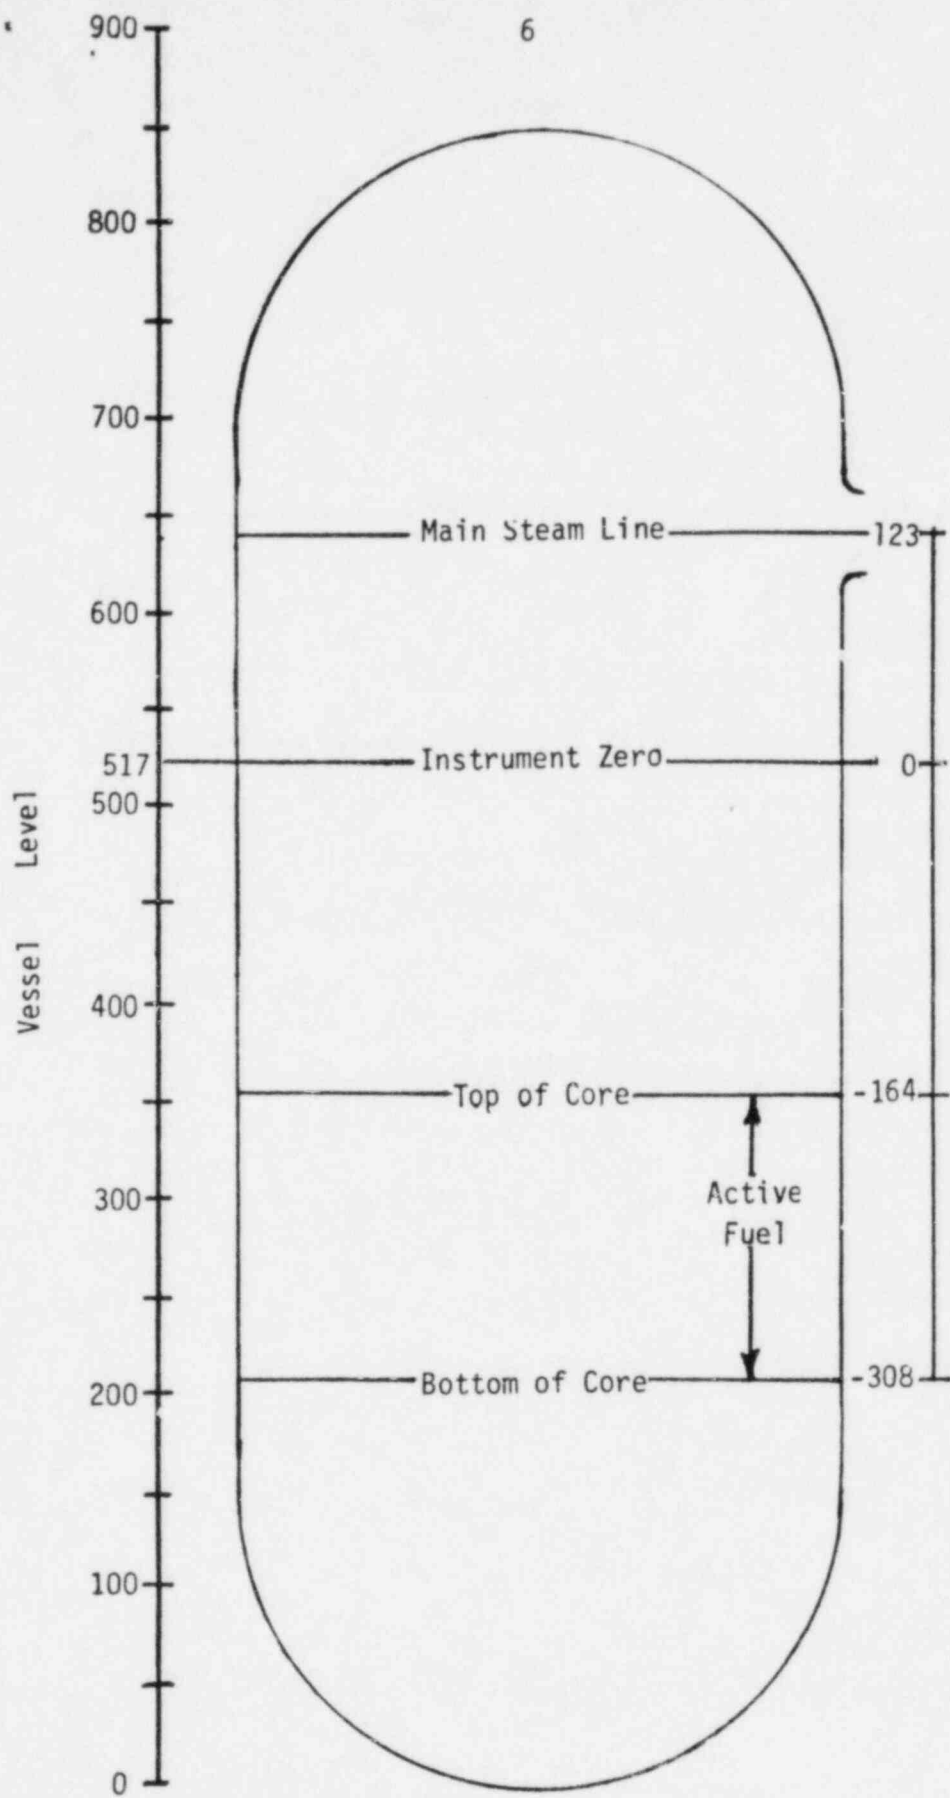
Figure 3 Reactor Vessel Water Level

073703 CST, MSIV's closed due to Group 1 isolation as a result of reactor water level decrease to -30 inches (See Fig. 3 for water level reference). The HPCI and RCIC started automatically and the recirc pumps tripped off.
