**An Engineering Geologic Evaluation
of the PSA Flight 1771 Crash Site Near
Paso Robles, California**

October 1, 1989

D. W. Carpenter, J. C. Chen, G. S. Holman

Prepared for
U. S. Nuclear Regulatory Commission

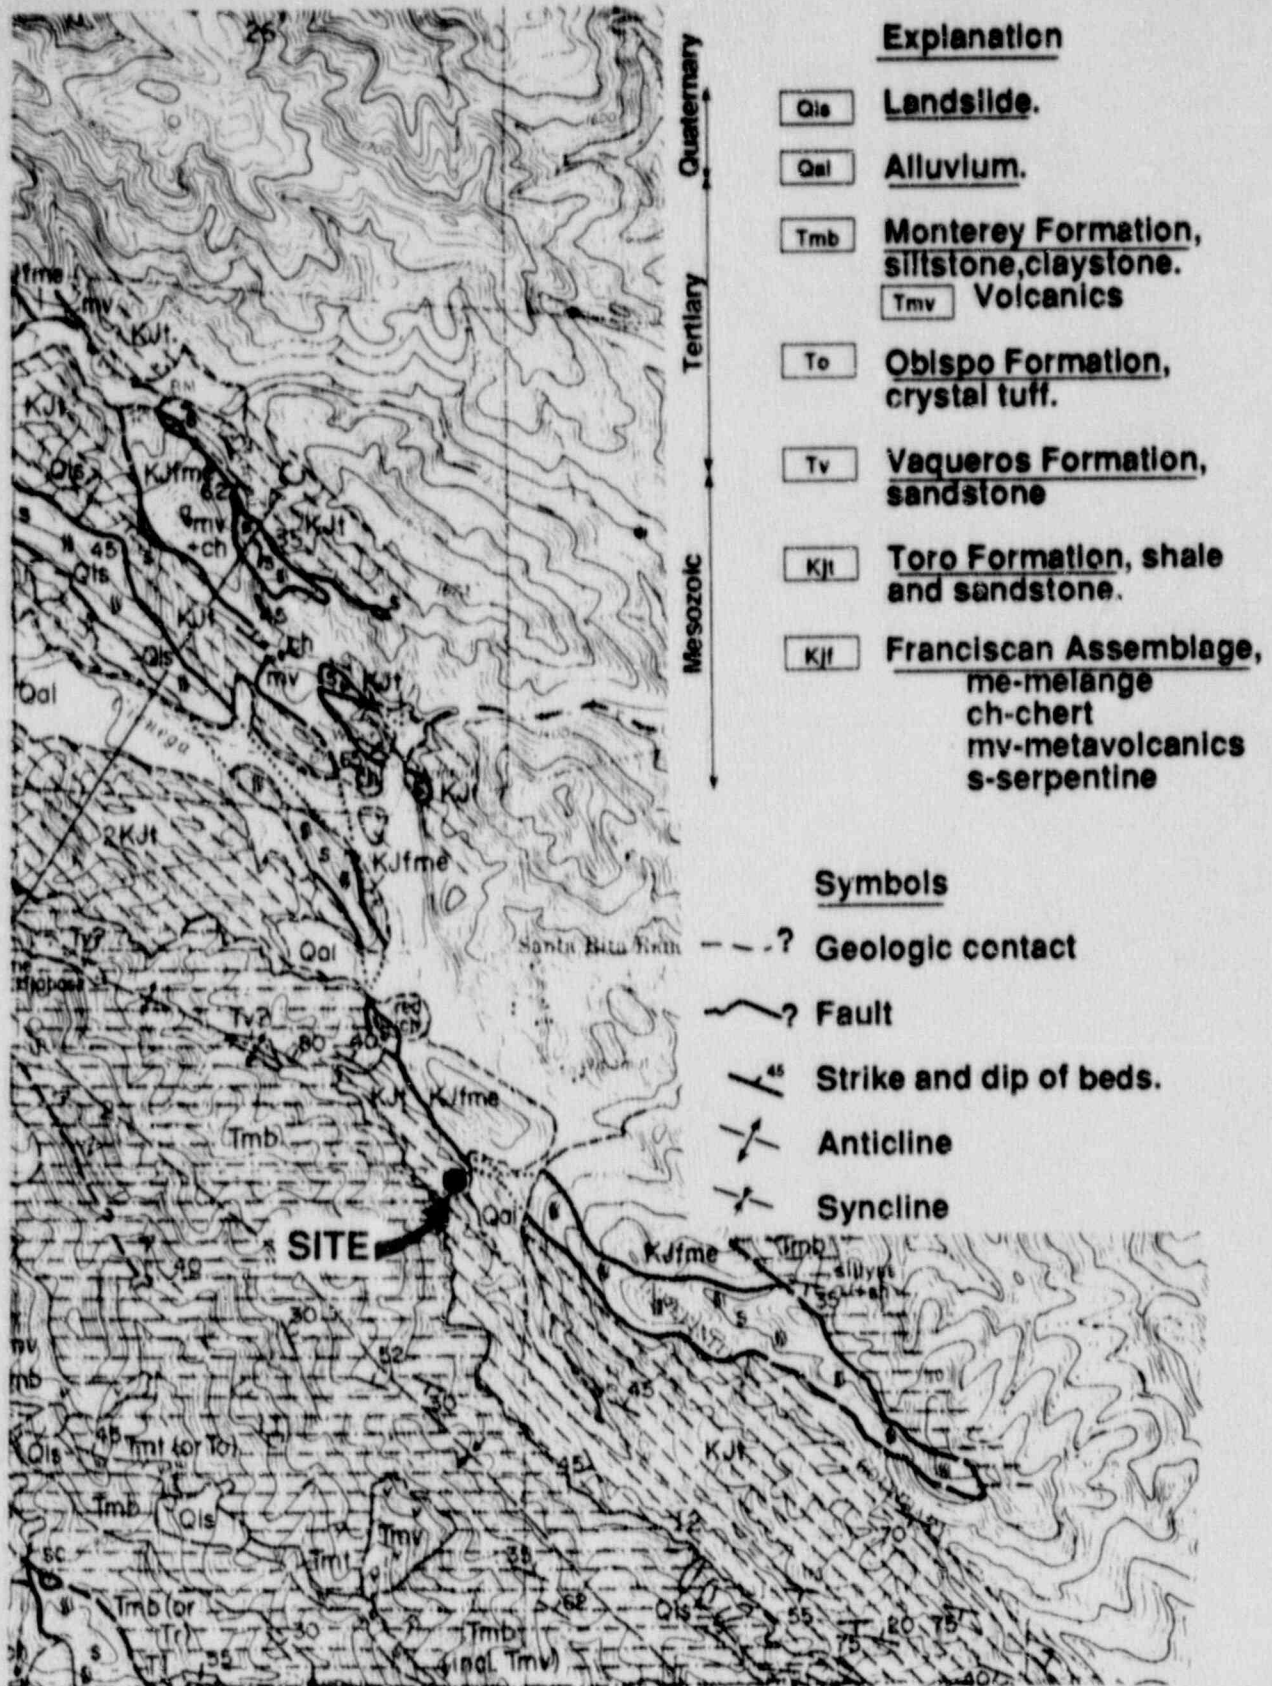
Fig. 4. Regional geologic map, PSA Flight 1771 crash site, adapted from Hall, 1974.

Figure 4 is a geologic map of the area surrounding the PSA Flight 1771 crash site. As shown in Fig. 4, the crash site and near vicinity are underlain by marine sedimentary rocks of the late Mesozoic Toro Formation (Ref. 5). These rocks are a portion of the Great Valley Sequence. Franciscan melange, chert and serpentine are exposed northeast of the crash site (Fig. 4). These rocks are separated from the marine sedimentary rocks present in the vicinity of the crash site by a branch of the Oceanic Fault zone (Ref. 5) which in turn is a portion of the regional Sur-Nacimiento Fault system (Ref. 3). The Sur-Nacimiento Fault system was an important tectonic feature during the late Mesozoic and early Cenozoic eras of earth history but has not been active in geologically recent times (Ref. 6).

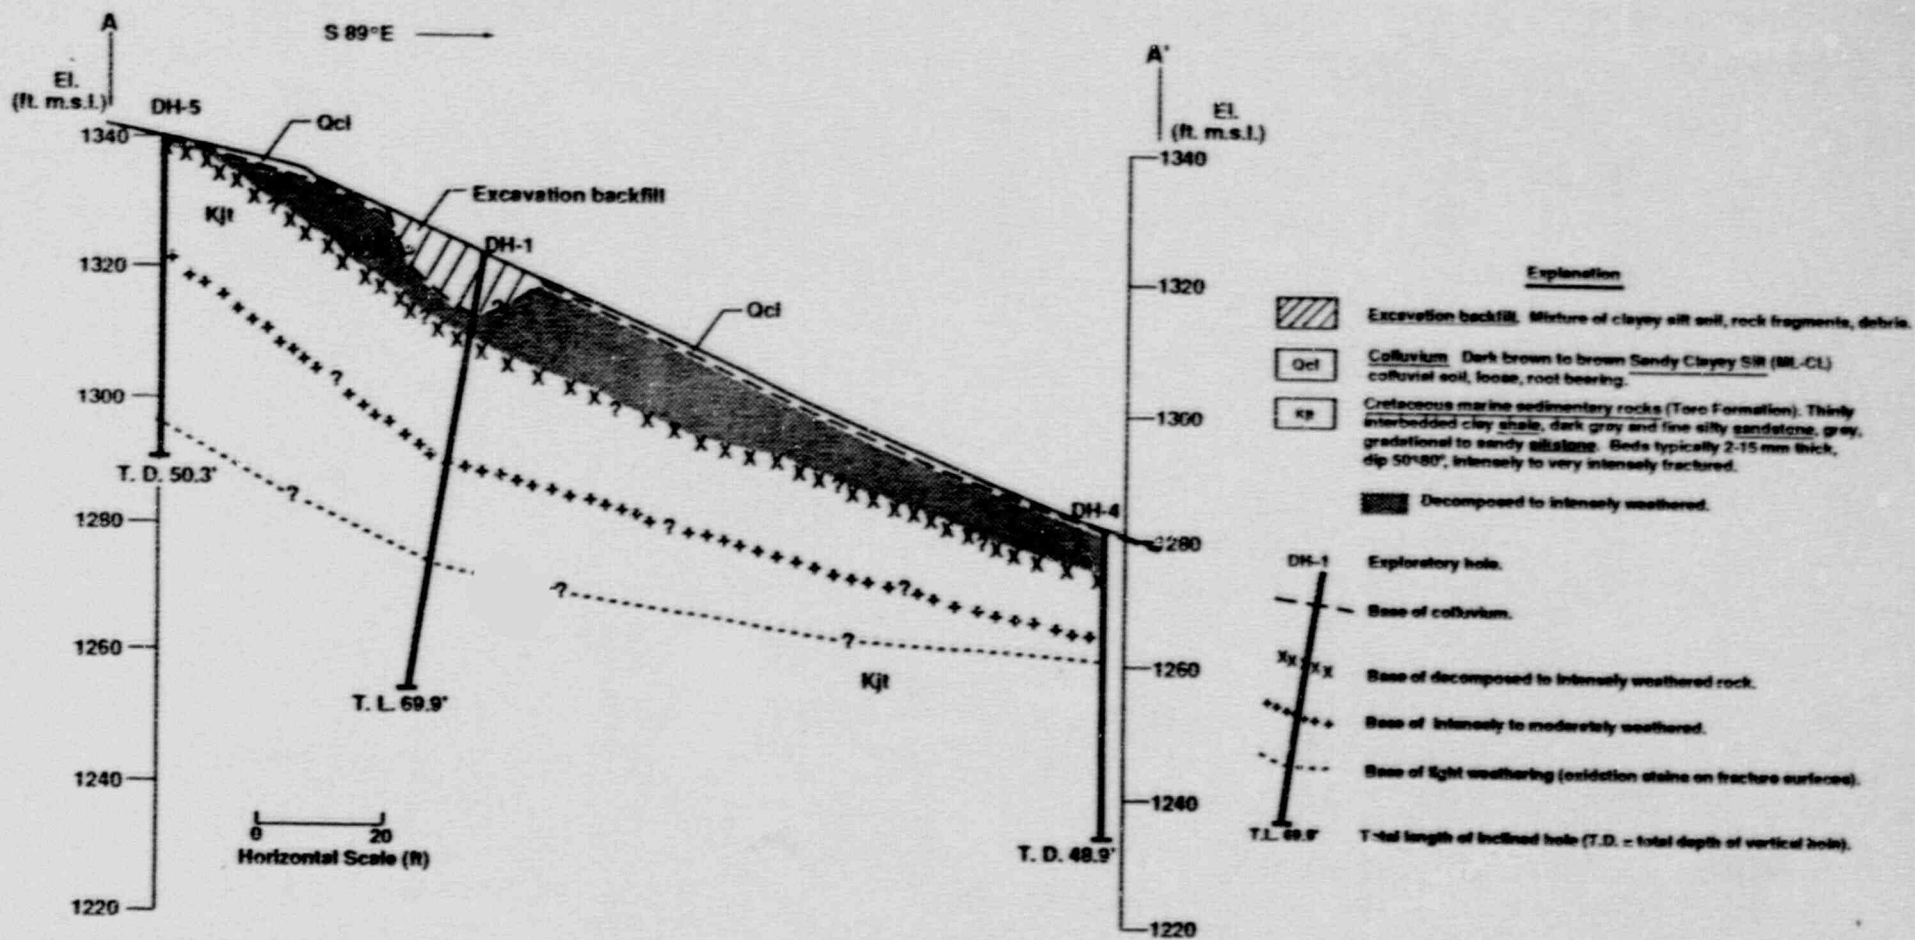
Fig. 6. Geologic Cross-Section A-A'.

Surface geology of the PSA Flight 1771 crash site is shown on the site geologic map, Fig. 5. Subsurface conditions, revealed by five exploratory holes drilled at and near the crash site, are inferred on geologic cross-sections A-A' and B-B', shown as Fig. 6 and Fig. 7, respectively.

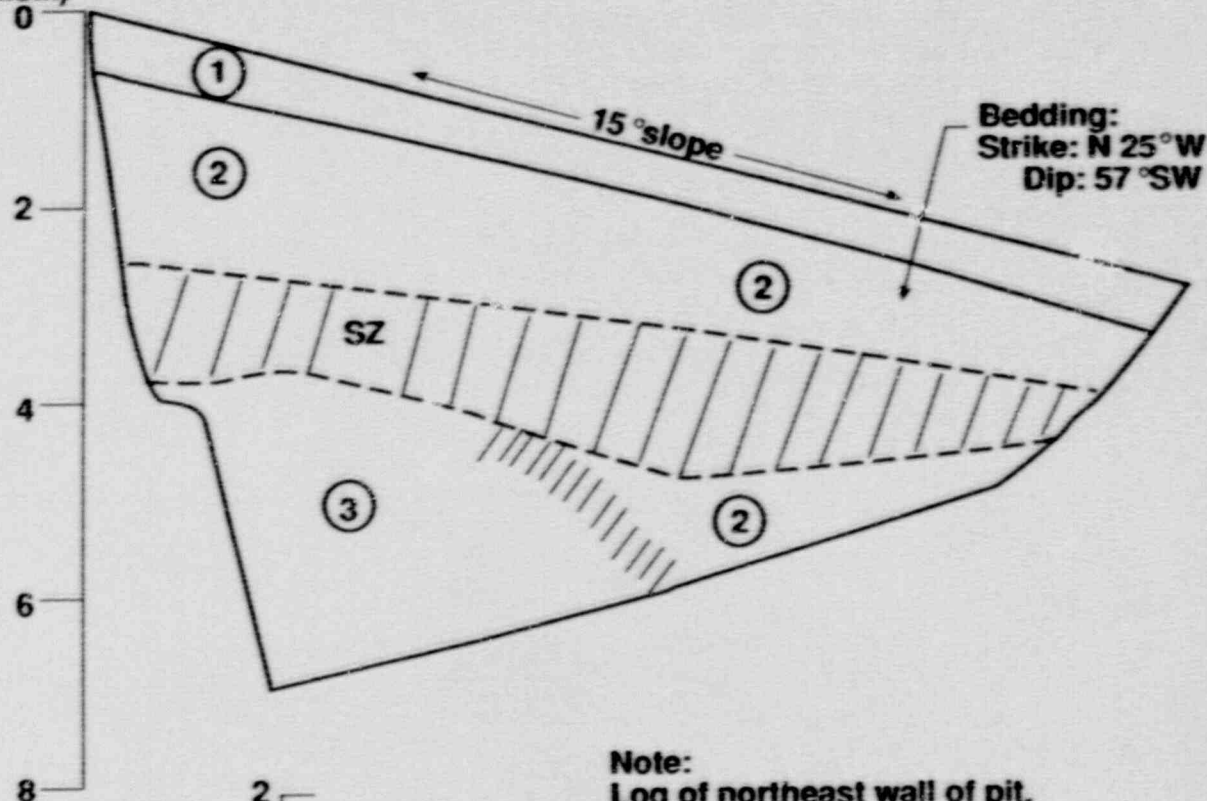
Log of test pit LLNL-2.

- ① Mixture of rock fragments and silty clay soil. Fill.
- ② Interbedded Shale and Sandstone. Intensely weathered, fragments crush in hands. Shale dominant, olive brown with abundant Mn oxide stains. Sandstone very fine grained, silty, present as thin interbeds weathered to dense silty sand, brown.
- ③ Interbedded Shale and Sandstone. Moderately weathered. Shale dominant, hard, greenish gray to gray with abundant Fe & Mn oxide stains. Sandstone oxidized throughout, brown.

SZ Shear zone: Dark brown, moist sandy clay along near-vertical fracture. Several similar fractures, 1"-3" wide visible on NW face of pit.

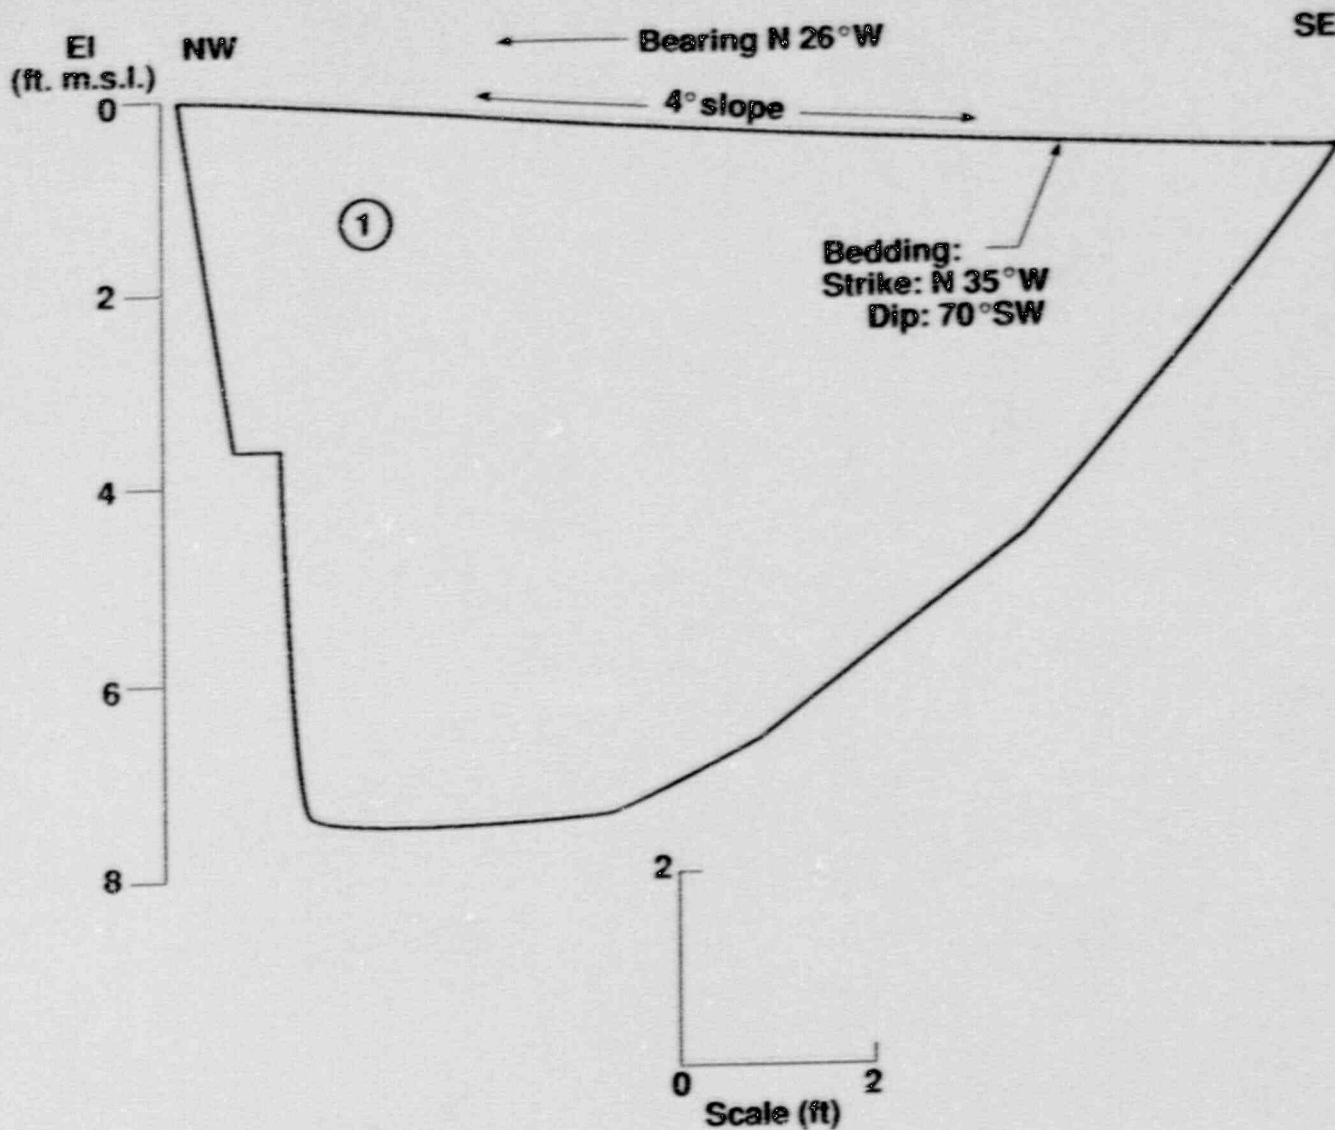
Log of test pit LLNL-3.

- ① **Interbedded Shale and Sandstone:** Intensely weathered with some moderately weathered lenses on NW wall of pit. Shale dominant, gray brown to greenish gray, abundant Fe & Mn oxide stains on fractures along which rock breaks easily. Sandstone beds to 1/2" thick, very fine grained, silty, oxidized brown throughout. Some soil on fracture surfaces.

Log of northeast wall of pit. Penetrator entered toward northwest along southwest wall at approximate mid point of pit.

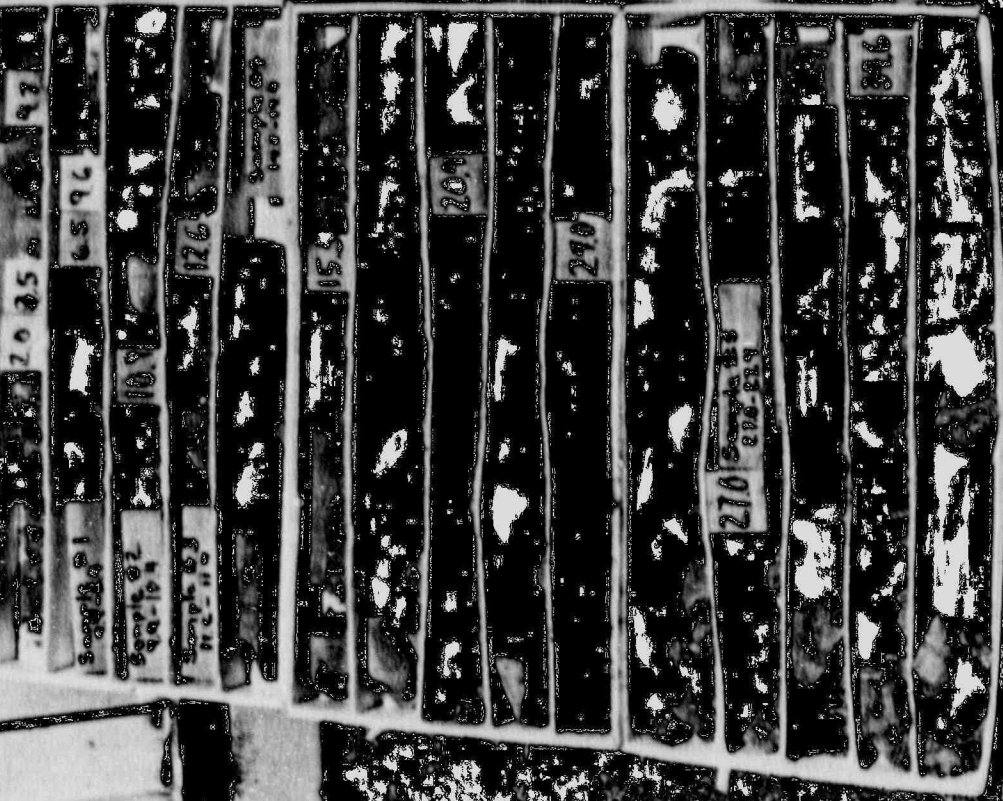
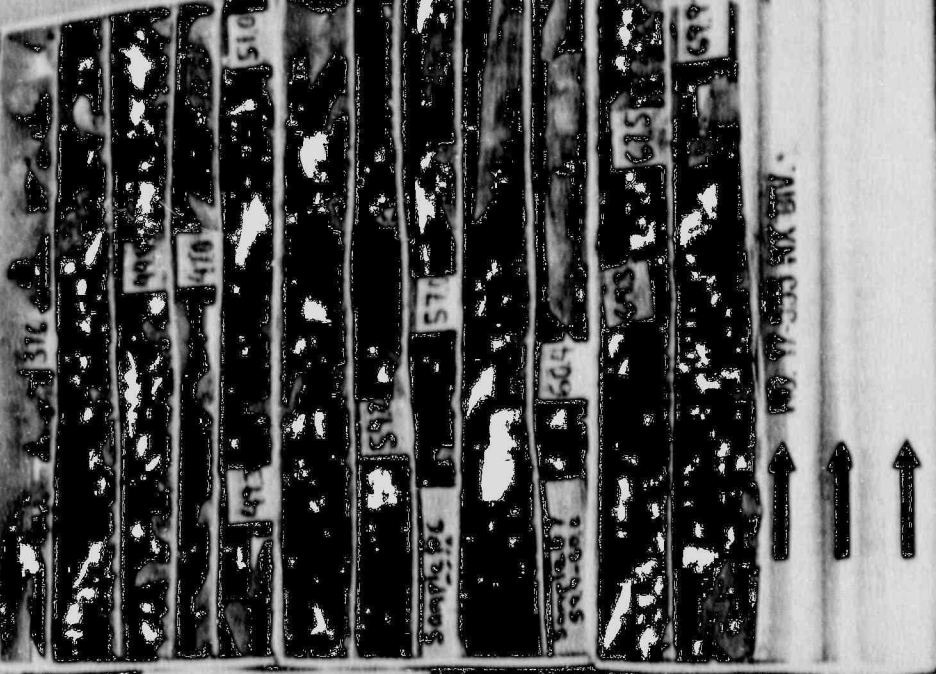
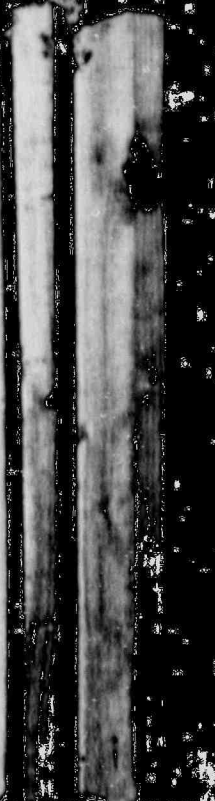
As discussed previously, DH-1 penetrated a highly sheared zone at depth and the average RQD for this hole is lower than for the other holes drilled during the investigation. However, this increased degree of fracturing does not appear to be the result of rock damage resulting from the PSA Flight 1771 crash.

RQD values for near-surface rocks penetrated by DH-1 (geotechnical zones 1 and 2) do not materially differ from those obtained for geotechnical zones 1 and 2 in the other holes drilled during the project (see Table 3). It seems reasonable to presume that had the PSA Flight 1771 crash caused shearing of moderately weathered to unweathered rocks at depths of 30 feet and greater, the more weathered rocks between the bottom of the crater and the sheared strata would have been severely affected.

Jet fuel stains were noted along a fracture at a depth of about 21 feet in core recovered from DH-1. This is believed to reflect the local availability of jet fuel rather than an increase in openness of fractures as a result of the crash. This belief is supported by the observation that fluid losses were experienced during the drilling of all of the core holes completed as part of the site investigation. Fluid losses were greater in the upper portions of the core holes than at depth in most cases and fluid losses similar to those in DH-1 were experienced while drilling the upper portions of DH-2 and 3, located in similarly weathered and fractured rocks but outside the crater area.

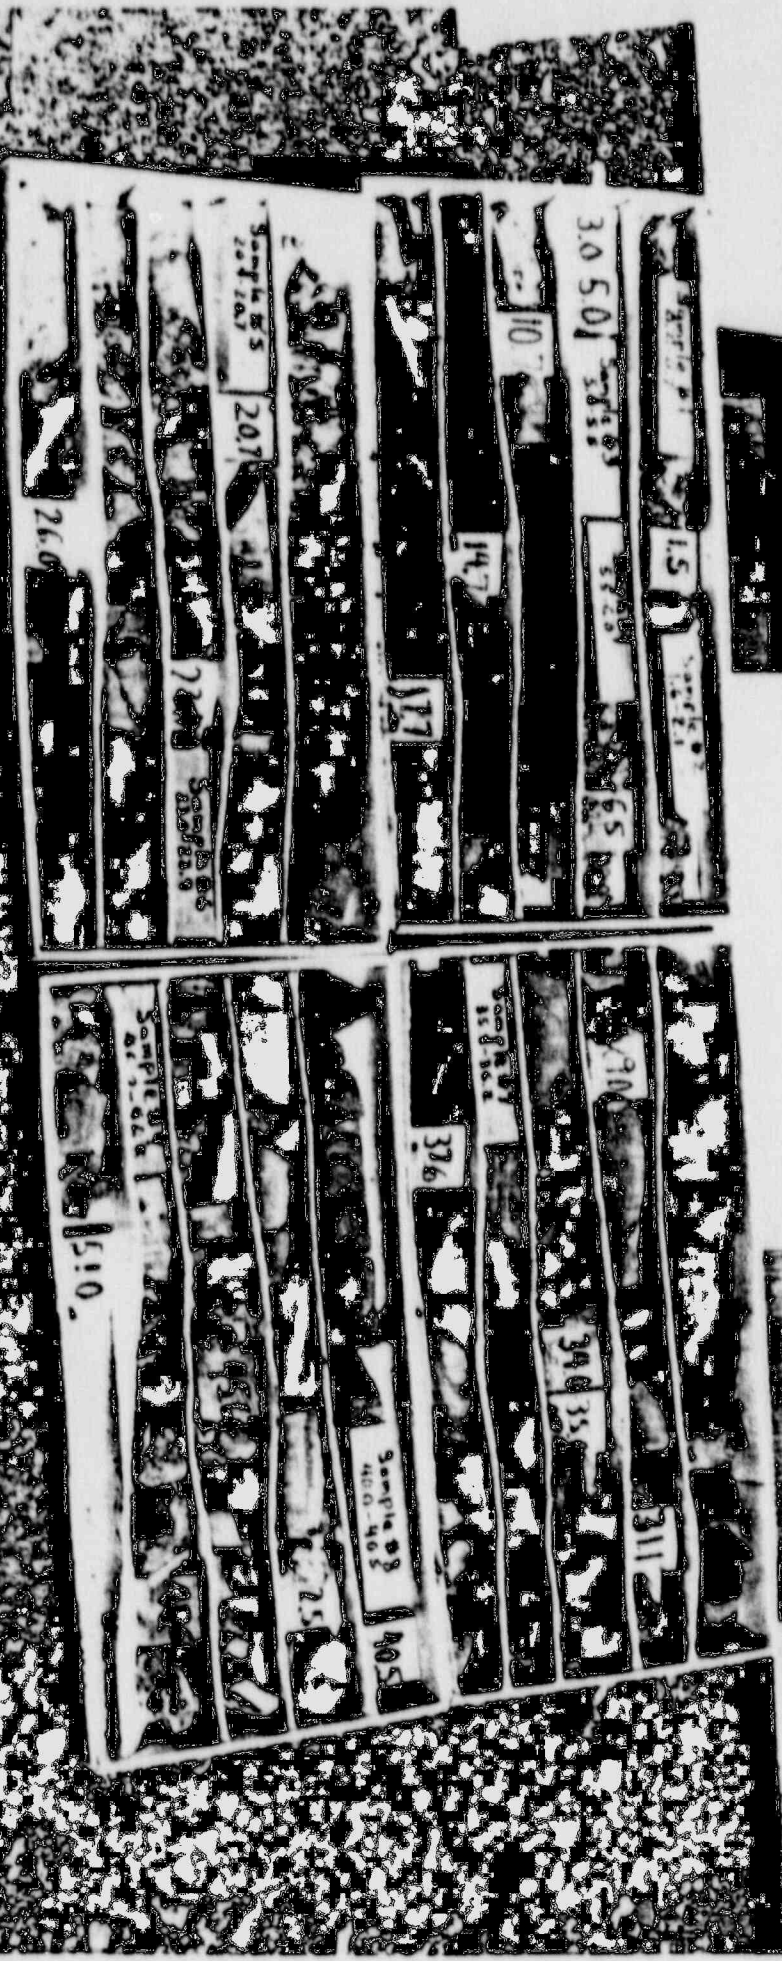
PATC
DH-3

23 5-25.8 Very intensely fractured, recovered as fragments. Visible fractures heavily Fe- and Mn-oxide stained, inclined 30° and 60°-70° (parallel and normal to bedding). Core loss zone, possibly sheared.

25 8-35.0 Intensely fractured, recovered as short cores and fragments broken on Fe-oxide stained fractures inclined 45° and 70°-80° (parallel and normal to bedding). Some gray and orange-brown stained clay on fracture surfaces.

25 0-42.7 Moderately fractured, recovered mainly as cores broken on fractures inclined 30°-45°, 60° (normal to bedding), and 80° (parallel to bedding), slight Fe-oxide staining on some fractures, partial carbonate healing.

42 7-46.0 Intensely fractured, recovered as short cores and fragments, fractures inclined 25°, 55°, and 80° (normal to bedding), slight Fe-oxide stains 42 7-43.5.

46 0-46.9 Moderately fractured, mechanically broken. At 43.5' 1/2" thick Fe-oxide stained carbonate veinlet inclined 60°.

46 9-51.0 Shear zone, partial carbonate healing, recovered as fragments, some gray clay. Visible fractures inclined 30-45° and 70°-85°, bedding disrupted. Core loss zone.

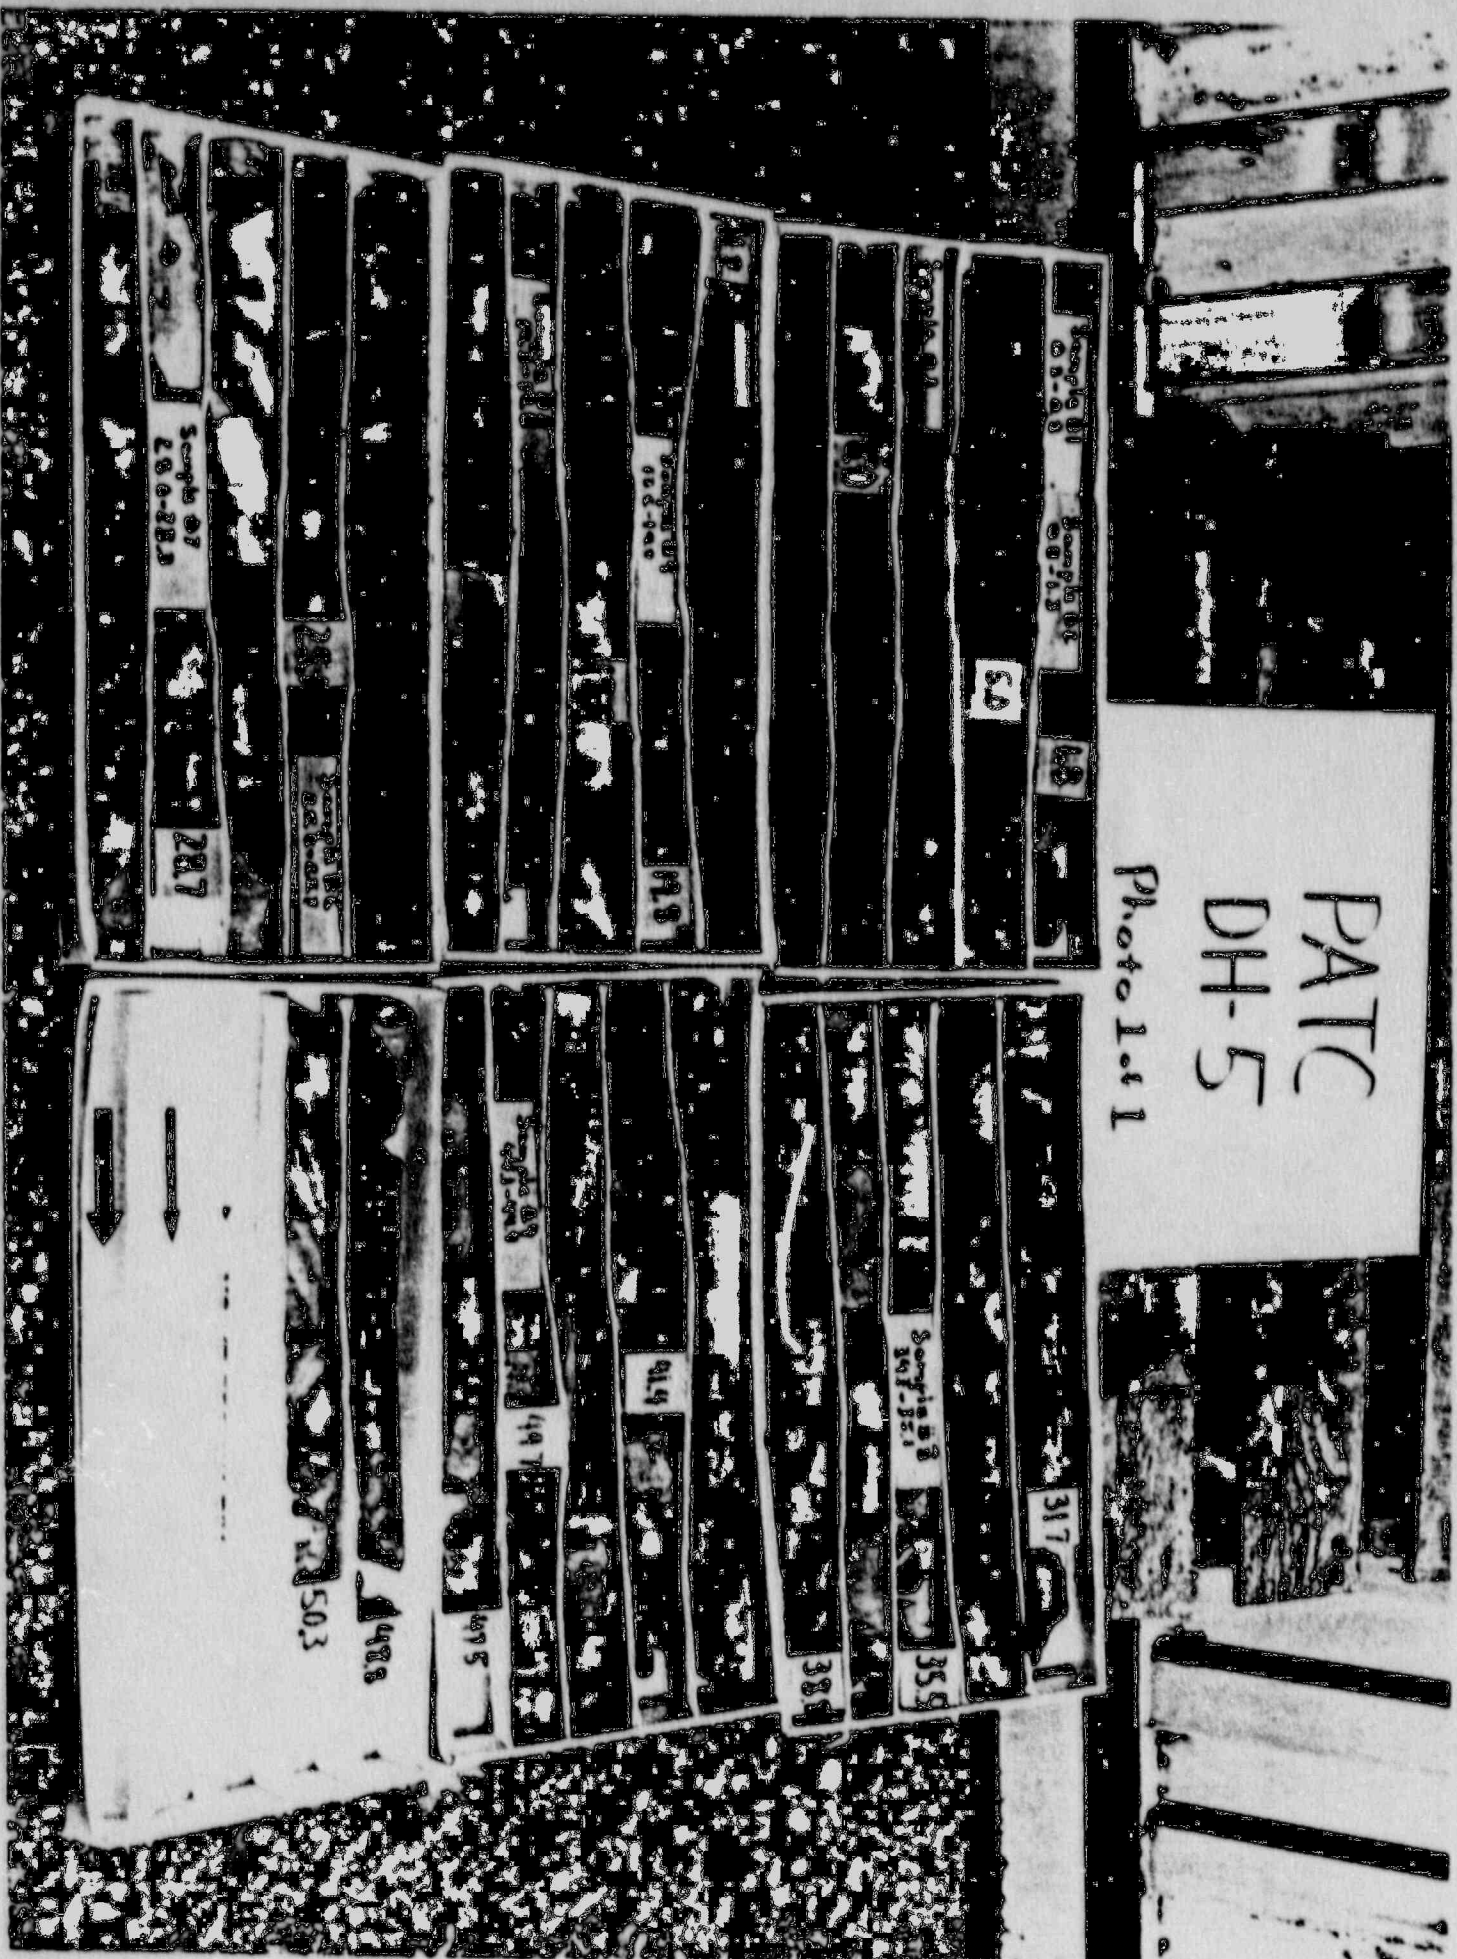
PATC
DH-5

It should be noted that RQD values for core obtained from DH-5, located on a hilltop west of the impact point, average higher than those for core obtained from the other holes drilled during the investigation. This suggests that the rock mass properties of the DH-5 area are better than average for the crash site as a whole. If so, the geophysical measurements made by Endacott and Associates, using DH-5 may have yielded seismic velocities that are on the high side relative to the crash site as a whole.

21 4-25 3. Mostly moderately fractured, fractures mostly spaced 0.2'-0.1'. Fe-oxide stains and some carbonate coatings, dip 20°-65° and 60°-80°.
29 1-29 9. Very intensely fractured.

31 7-33 1. Intensely fractured, core broken on Fe-oxide stained fractures with 35°-65°, 50°-60°, and 70° dips.

35 5-37 2. Intensely fractured, recovered as cores broken on Fe-oxide stained fractures with 65°, 60°, and 70°-80° dips.
37 2-41 9. Very intensely fractured, recovered as fragments, some orange clay, visible fractures dip as 35.5°-37.2° interval.
39 3-40 4. Variably intensely fractured to sheared, core broken on Fe-oxide stained fractures with 65°-80° and 70°-90° dips, crushed zones with gray brown clay gouge.
41 9-50 1. Mostly moderately fractured, fractures mostly spaced 0.3'-1.0', some mechanical breaks. Fe-oxide stains to 44.5', carbonate and pyrite on some fractures. Dips 30°-65°, 70°-80° (normal to bedding), and 60°-65° (parallel to bedding).

47 5-47 8. Very intensely fractured, core splintered on intersecting fractures with 50° and 80° dips.

50 1-50 3. Shear zone, recovered gray clay gouge, fracture at 50.1' dips 40°.
