U. S. NUCLEAR REGULATORY COMMISSION

Report No. 50-206/90-27

Facility Name: San Onofre Nuclear Generating Station Unit 1

Inspection Conducted: July 10 - September 14, 1990

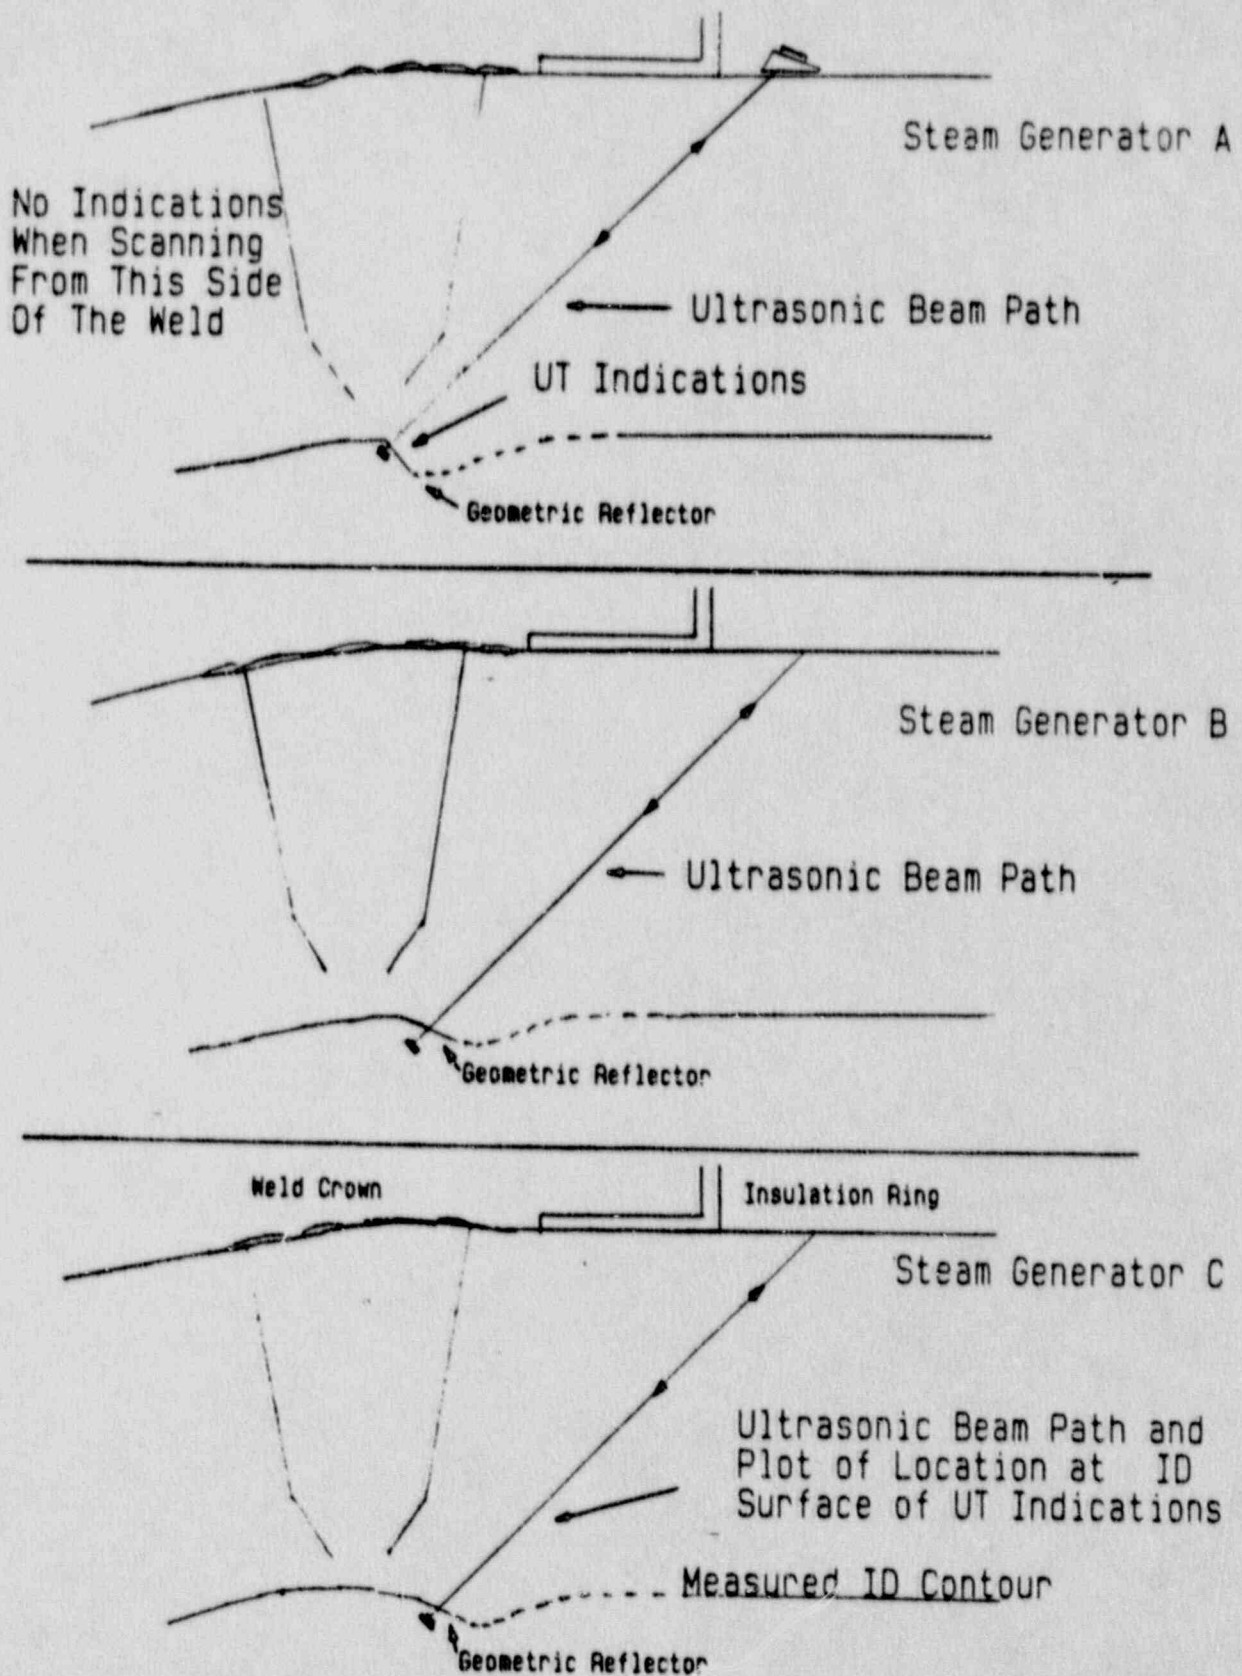
Several indications recorded above 50% DAC were located at the ID surface of the weld in all three steam generators. On all three generators the indications were recorded only from one side of the weld. From UT thickness measurements and contour profiling of the ID surface, the indications were determined to be generated by geometric reflectors at the ID surface and not from cracks at that surface. An actual ID profile measurement was made on the C generator at the location of an indication with a profile gauge. A plot of the cross section of the welds at the indications as generated by Robert W. Pechacek of Combustion Engineering in 4-1-1986, are shown in Figure 1. The plots of the UT indications shown for the three welds were made by Mr. Pechacek who did an independent evaluation of the indications for Southern California Edison in 1986.

Therefore, it is my conclusion that the UT indications are not from cracks since indications were not recorded from both sides of the weld, and the recorded indications are consistent with the geometry of the ID surface plotted in Figure 1.

Figure 1. Cross Sectional Plots of the Ultrasonic Beam Location and UT Indications with respect to the ID Surface Contour of San Onofre Unit 1 Steam Generator Welds.

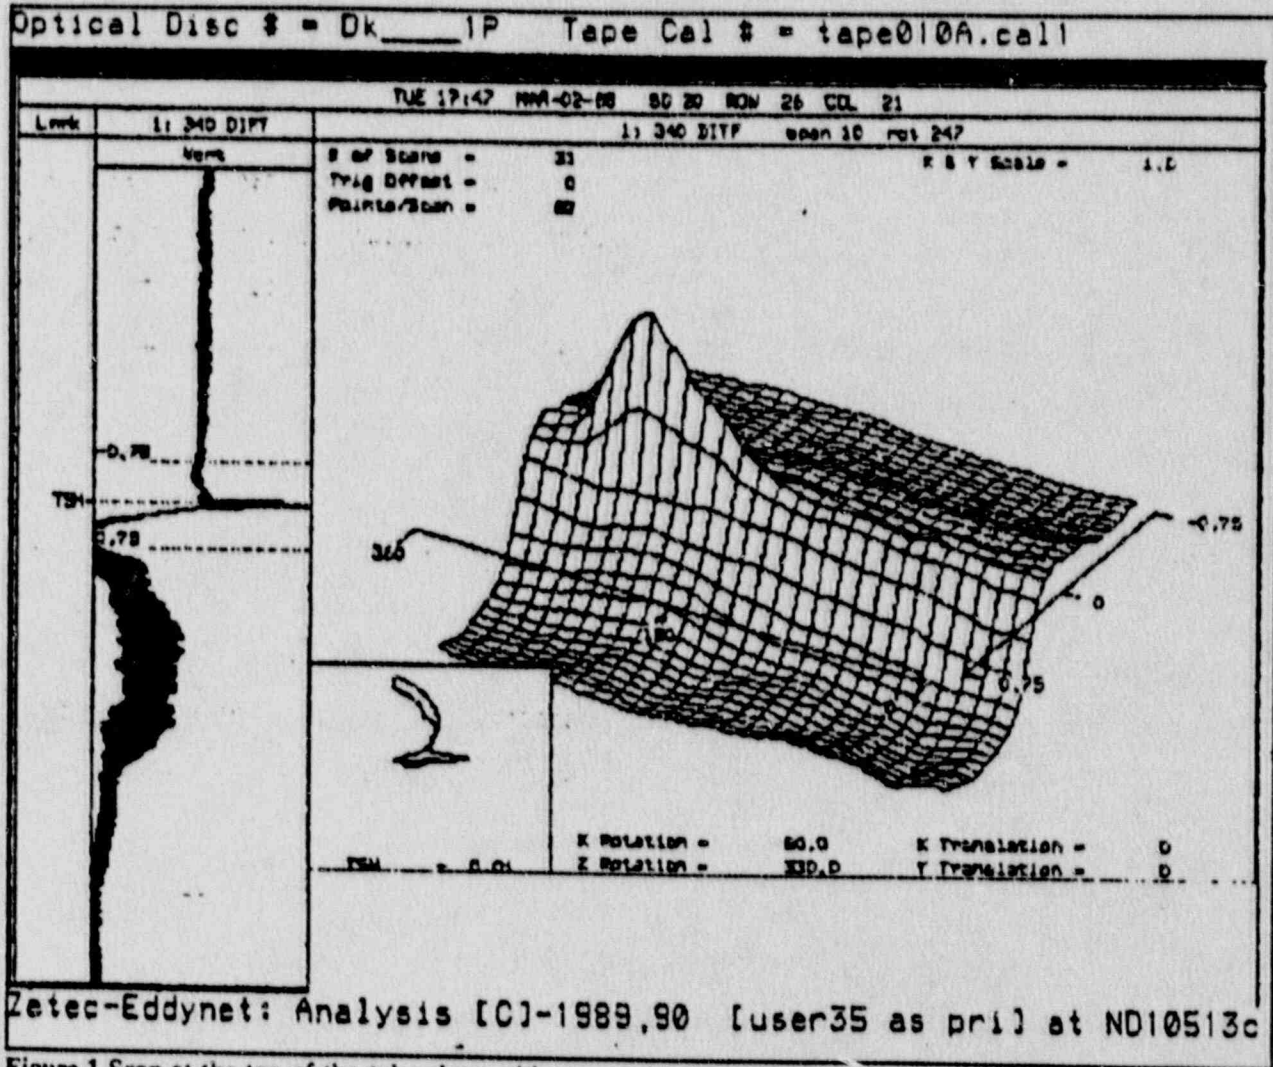
We established on the basis of our review that the 1988 RPC indication reported by the licensee can be described as a planar indication within the cross-sectional plane of the tube, very much like a circumferential crack. It is our experience that the development of relatively sharp cracks in regions of IGA involvement is not at all unusual. The RPC crack-like indication appears to measure between 50% and 70% through-wall. Because of its circumferential orientation, we do not find it at all unexpected that the bobbin coil could not detect this indication.

One crack-like defect was detected at the top of the tube sheet with the rotating pancake probe, as shown in Figure 1. This defect was missed with the bobbin probe. The defect was present on a review of the 8X1 inspection made in 1985, but not called at the time. This emphasizes the need to scan at least a sampling of the tubes at the top of the tube-sheet with the rotating pancake probe. About 600 tubes can be scanned in a day with the rotating pancake probe. The rotating pancake probe is about half the size of the pancake probe in the 8X1 array and therefore has a better response to small defects. The lift-off compensation technique used for the pancake probes by Zetec is outdated and interferes

Figure 1 Scan at the top of the tube sheet with a motorized rotating pancake probe.

with the measurement of the defect depth. Therefore, no calibration of the defect depth is made. I would recommend that the lift-off compensation method be updated and that the defect depth be measured. The depth of the defect in Figure 1 measures between 50 to 70 %.

We believe RPC probe inspections to be a key element of an inspection program which will ensure the reliable detection of IGA and associated cracks. We recommend that RPC inspections be included on part of future inspections for IGA. Bobbin coil inspections, in our view, have not been demonstrated to be adequately effective for the reliable detection of IGA and associated cracking in excess of the 50% plugging limit.
