REPORTED TURBINE COMPONENT DAMAGE
AT BVPS UNIT 1 RELATED TO CONDUCT OF
OPERATIONAL SURVEILLANCE TEST (OST) 1.26.1

DUQUESNE LIGHT COMPANY
Beaver Valley Power Station

A review of unusual steam flow distribution patterns, steam pressure changes and load disturbances occurring during OST 1.26.1, leading to turbine component damage.

August 26, 1988

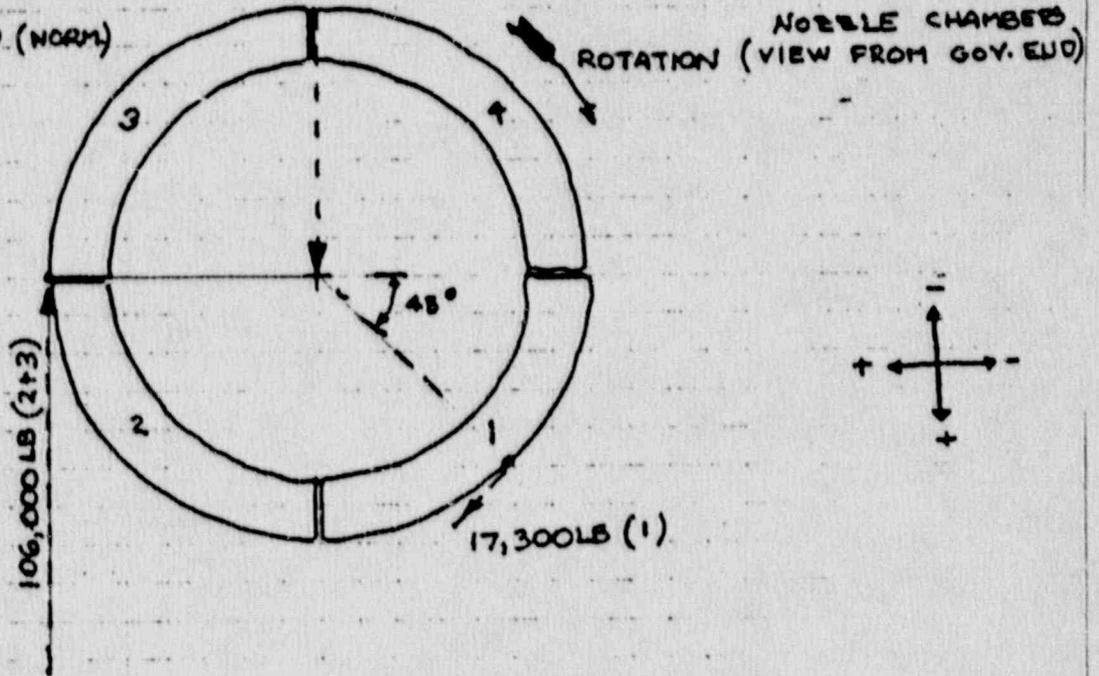
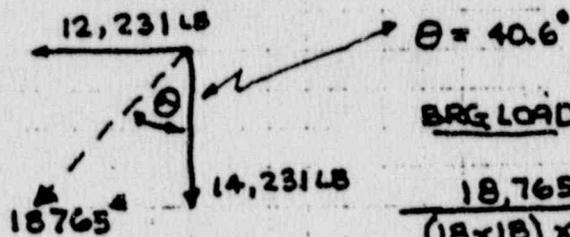
FIGURE NO. 43

Appendix A provides a method for calculating the resultant forces acting on the HP rotors. These steam forces are relatively very large compared to the HP rotor weight. For example, the static weight of the HP rotor between Bearings No. 1 and No. 2 equals 108,000 lbs., while a situation may exist (-670 MW) when Governor Valves No. 2 and No. 3 are completely open (Valves No. 1 and No. 4 being closed) where the resultant steam forces developed (106,000 lbs.) almost equals the static weight of the rotor, but in the upward direction. Whenever that or similar situations develop in the HP turbine, the rotor bearings become very lightly loaded. Figure A3 represents the actual initial condition (95% load) required to perform the governor valve surveillance test. Under these conditions, it can be observed that not only are Bearings No. 1 and No. 2 very lightly loaded (less than 30 psi), but the resultant bearing contact angle is about 40° from the 6 o'clock position, suggesting that the bearings are operating in a region of dynamic instability.

108,000 LB (WT. OF ROTOR BETWEEN BRGS 1 & 2)
 ROTOR OVERHANG NOT CONSIDERED

OBSERVATION: BRGS (1 & 2) BECOME VERY LIGHTLY LOADED - PERHAPS UNSTABLE

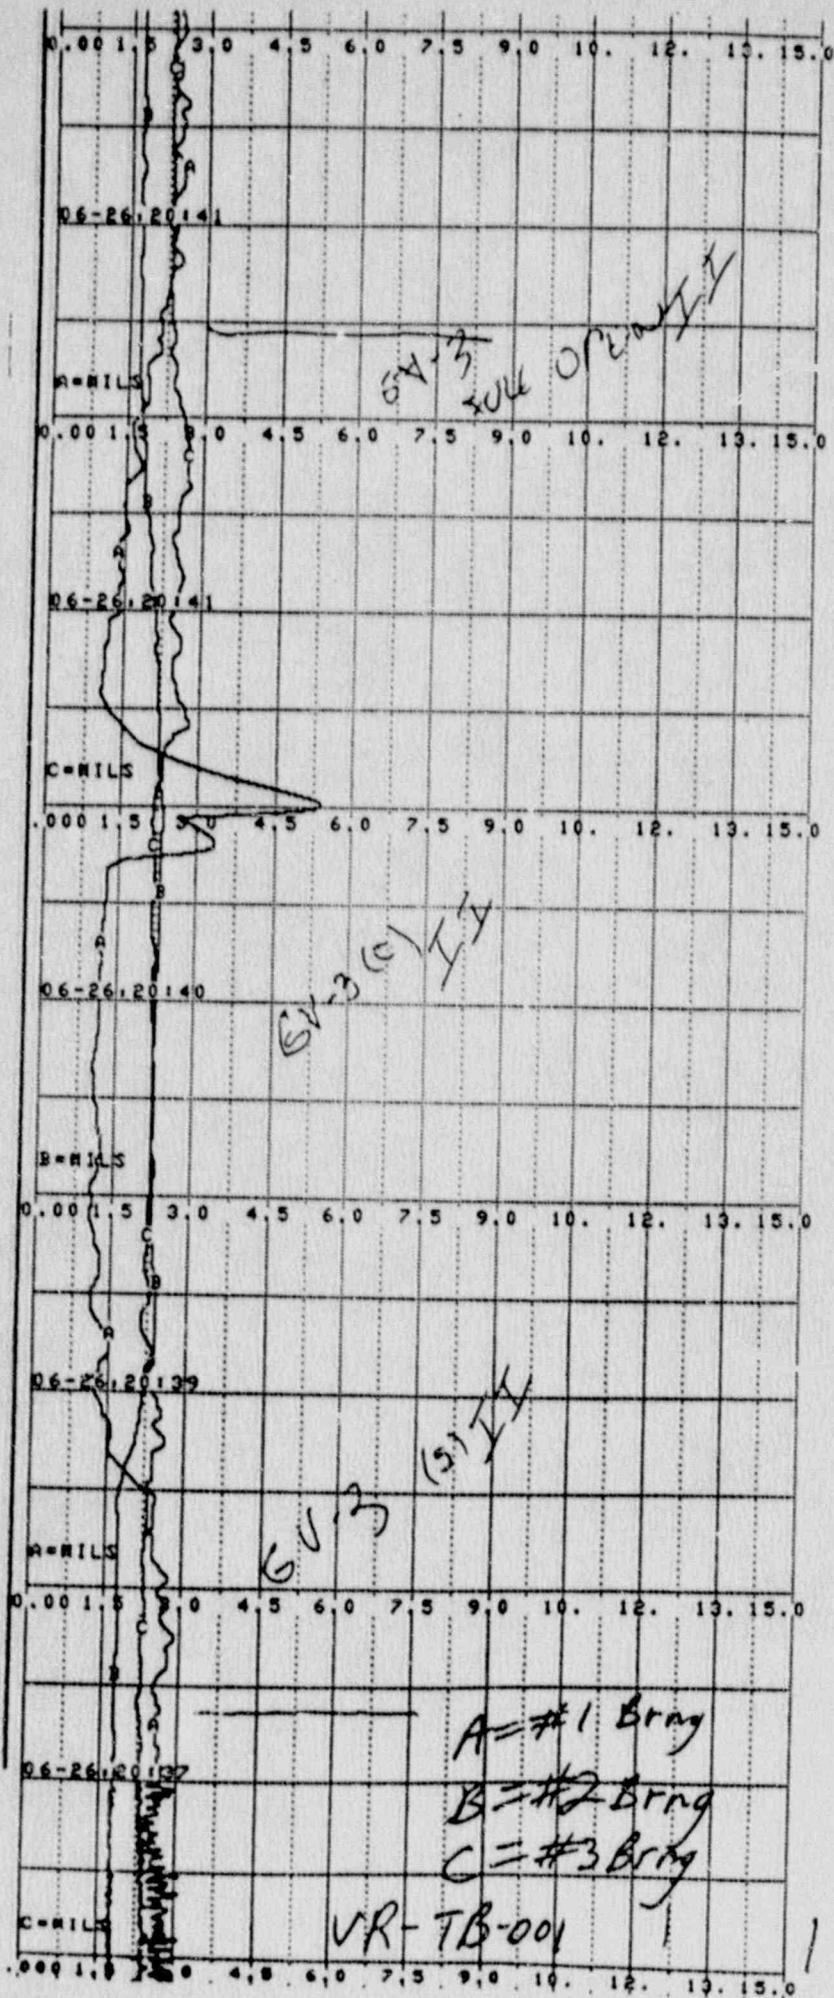
FIGURE NO. A4

The large rotor bearing displacements occurring at Bearing No. 1 were first observed by the plant operators while performing the governor valve surveillance tests per OST 1.26.1. The typical bearing vibration patterns observed are shown on portions of the Control Room strip chart recorder, reproduced in Figures A4, A4.1 and A4.2. Additional engineering analysis, supported by supplementary field data, clearly confirmed that movement was occurring within the No. 1 bearing. Figure 5A records the relative position of Bearing No. 1 center-line during the governor valve test. It is noteworthy to observe that the greatest bearing motion occurs during the governor Valve No. 3 testing interval. This is in agreement with calculated predictions.

TYPICAL RESPONSE OF GV-3
DURING OST 1.26.1 ON HP
ROTAR DISPLACEMENT

As noted above, in order to eliminate the HP rotor dynamic instability and to decrease the HP rotor displacements during the governor valve testing intervals, tilting pad type bearings should replace the original sleeve type bearings. Tilting pad bearings will permit high bearing contact angles to be accepted without introducing "oil whip", "rotor whirl", or other similar instabilities. Observations at BVPS Unit 2 during valve testing appears to confirm this fact.

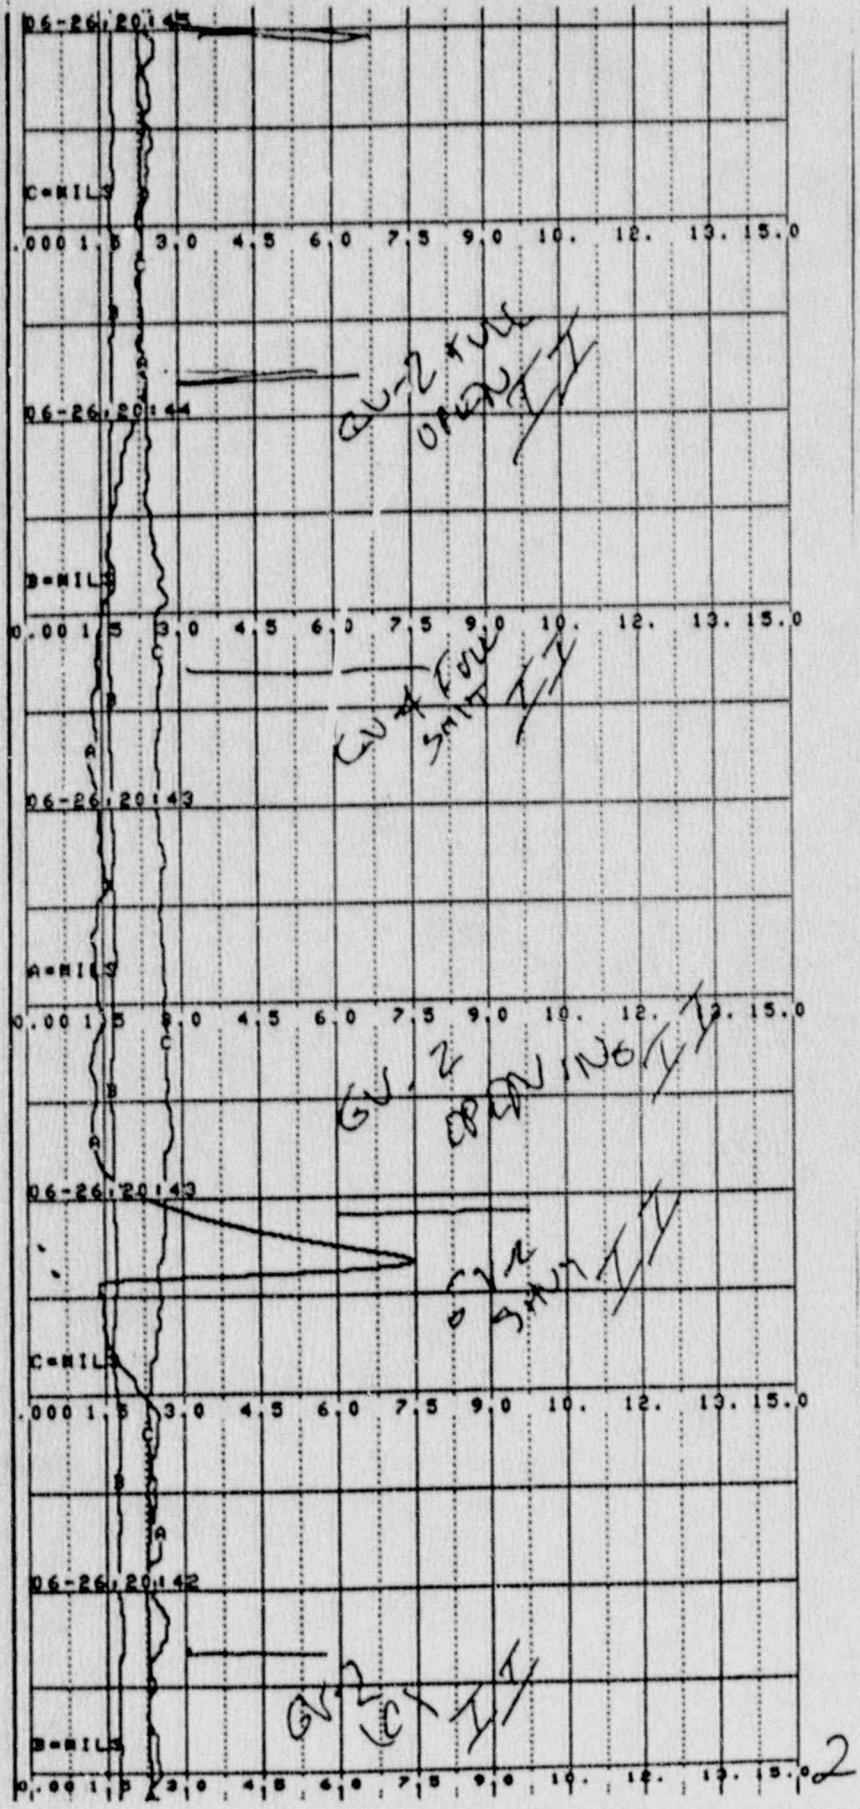
FIGURE NO. A4.1

TYPICAL RESPONSE OF GV-2
DURING OST 1.26.1 ON HP
ROTOR DISPLACEMENT

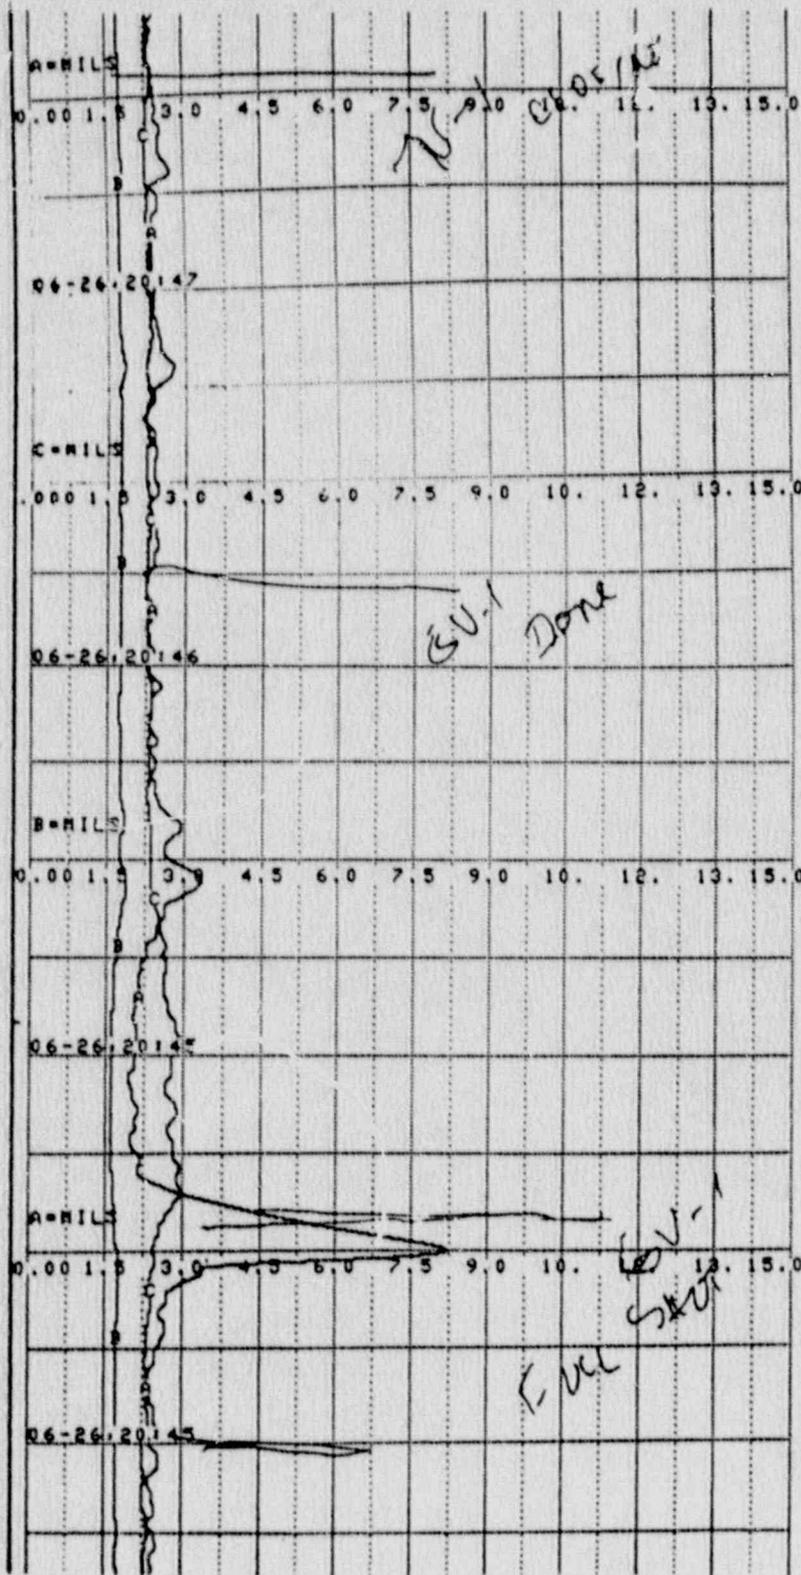
FIGURE NO. A4. ?

TYPICAL RESPONSE OF GV-1
DURING OST 1.26.1 ON HP
ROTOR DISPLACEMENT

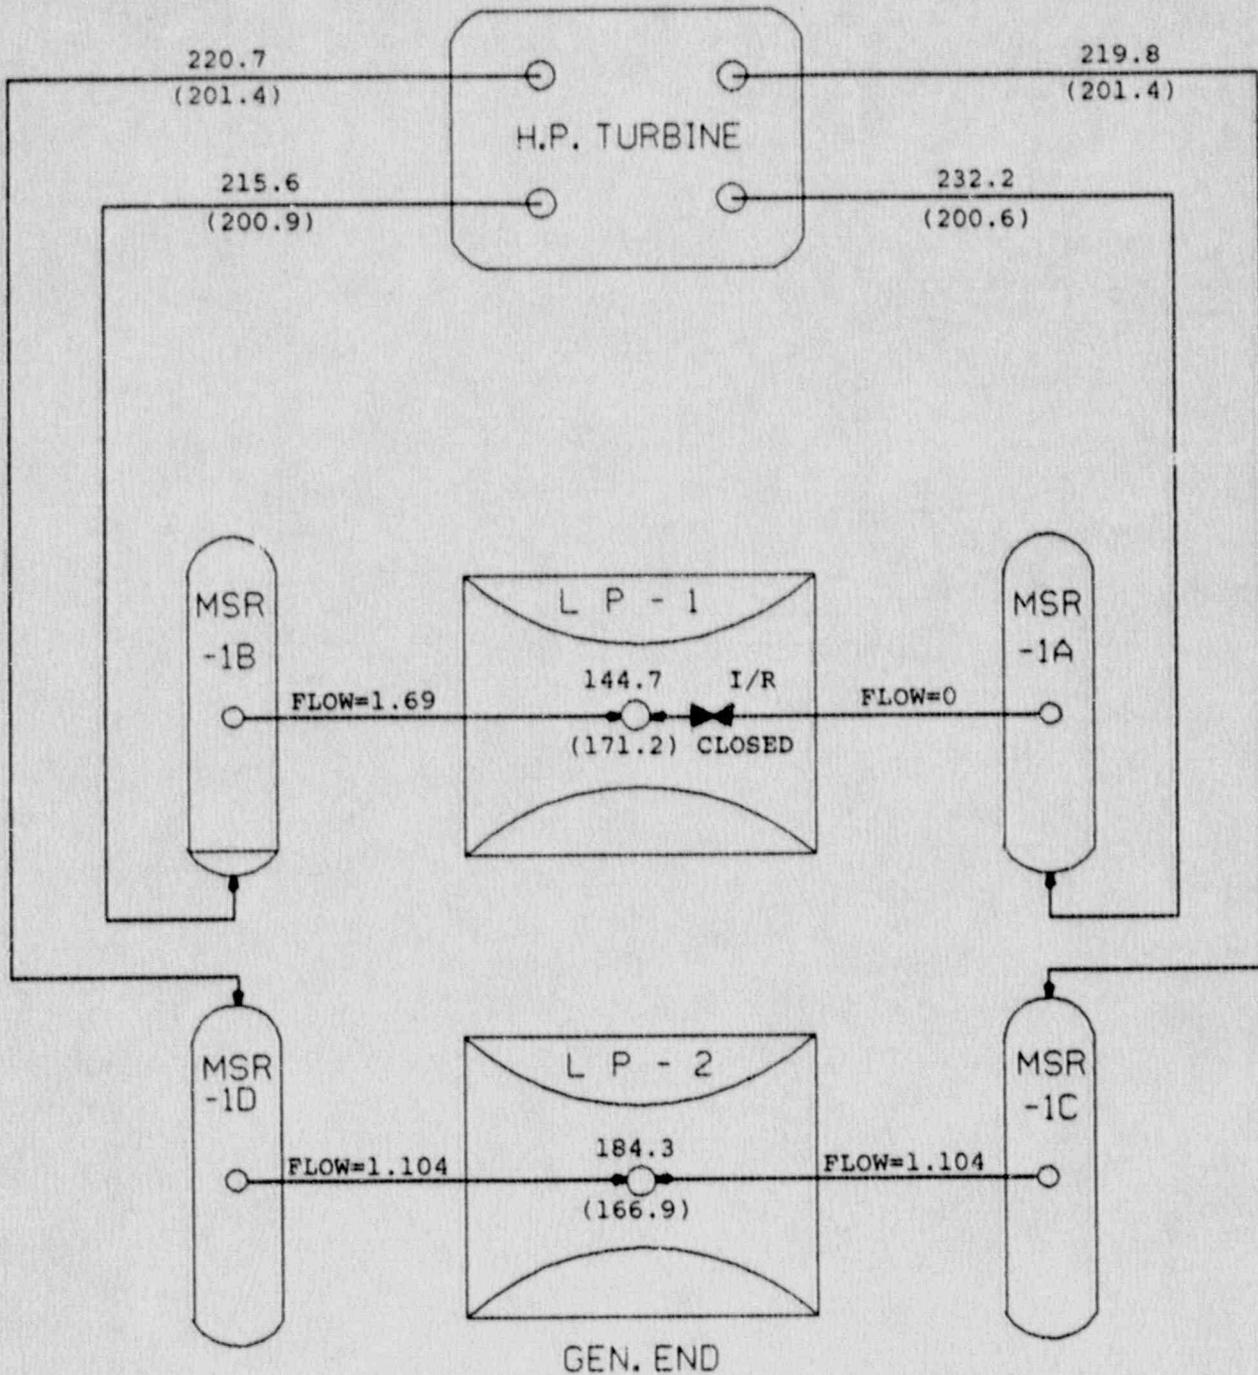
FIGURE C1.1

An examination of the above test results clearly show that during the intercept and reheat stop valve testing interval, the turbine crossover (X-0) pipe flows patterns undergo significant changes. The tabulation below indicates the maximum individual relative pipe flows are achieved whenever one (1) set of IV/RSV are closed. The maximum X-0 flow increases are about X1.76 normal and appear in the opposite side X-0 pipe feeding the same low pressure turbine. For example, when the intercept and reheat stop valves in X-0 pipe -1A are closed, the maximum flow appears in the opposite X-0 pipe -1B.

This increases in steam flows, steam velocities and pressure drops during this test are a direct precursor of the premature failures in the MSR shellside closure plates. The following tabulation demonstrates the fact that there are large forces to absorb during valve testing:

CROSS - OVER & CROSS - UNDER PIPE ARRANGEMENT
 RELATIVE CROSS - OVER PIPE FLOW DURING
 VALVE TESTING (TEST 11RL)

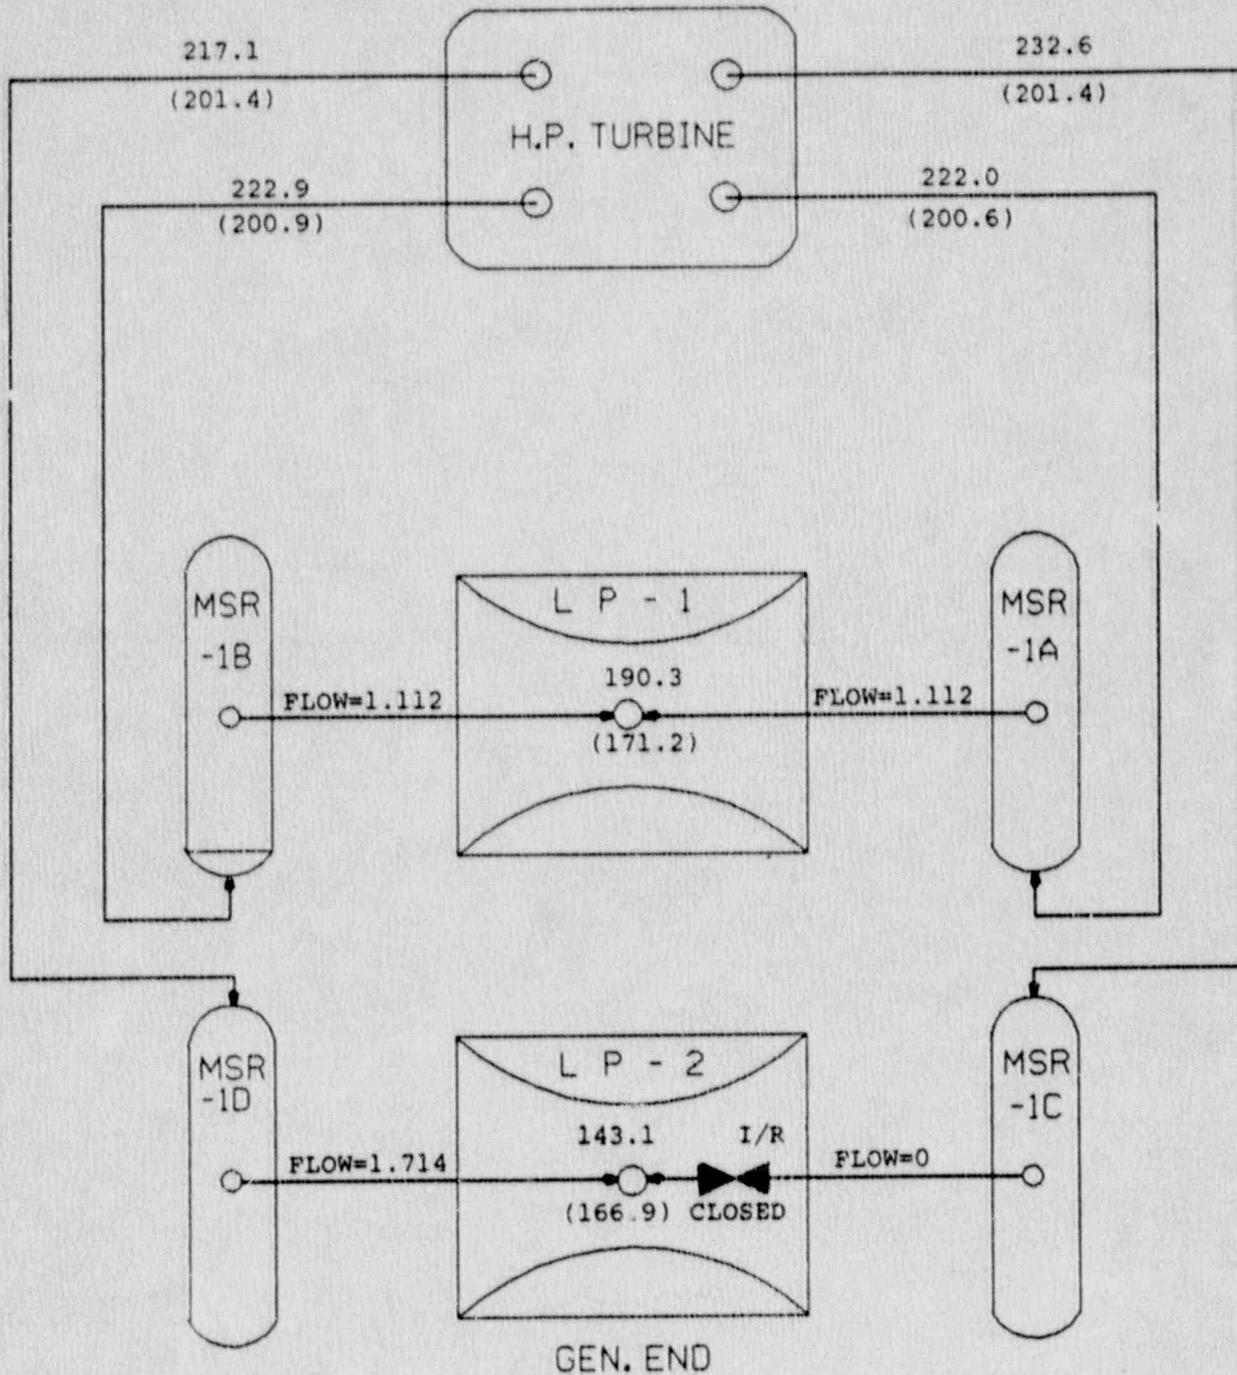
FIGURE C1.2

CROSS - OVER & CROSS - UNDER PIPE ARRANGEMENT
 RELATIVE CROSS - OVER PIPE FLOW DURING
 VALVE TESTING (TEST 21RL)

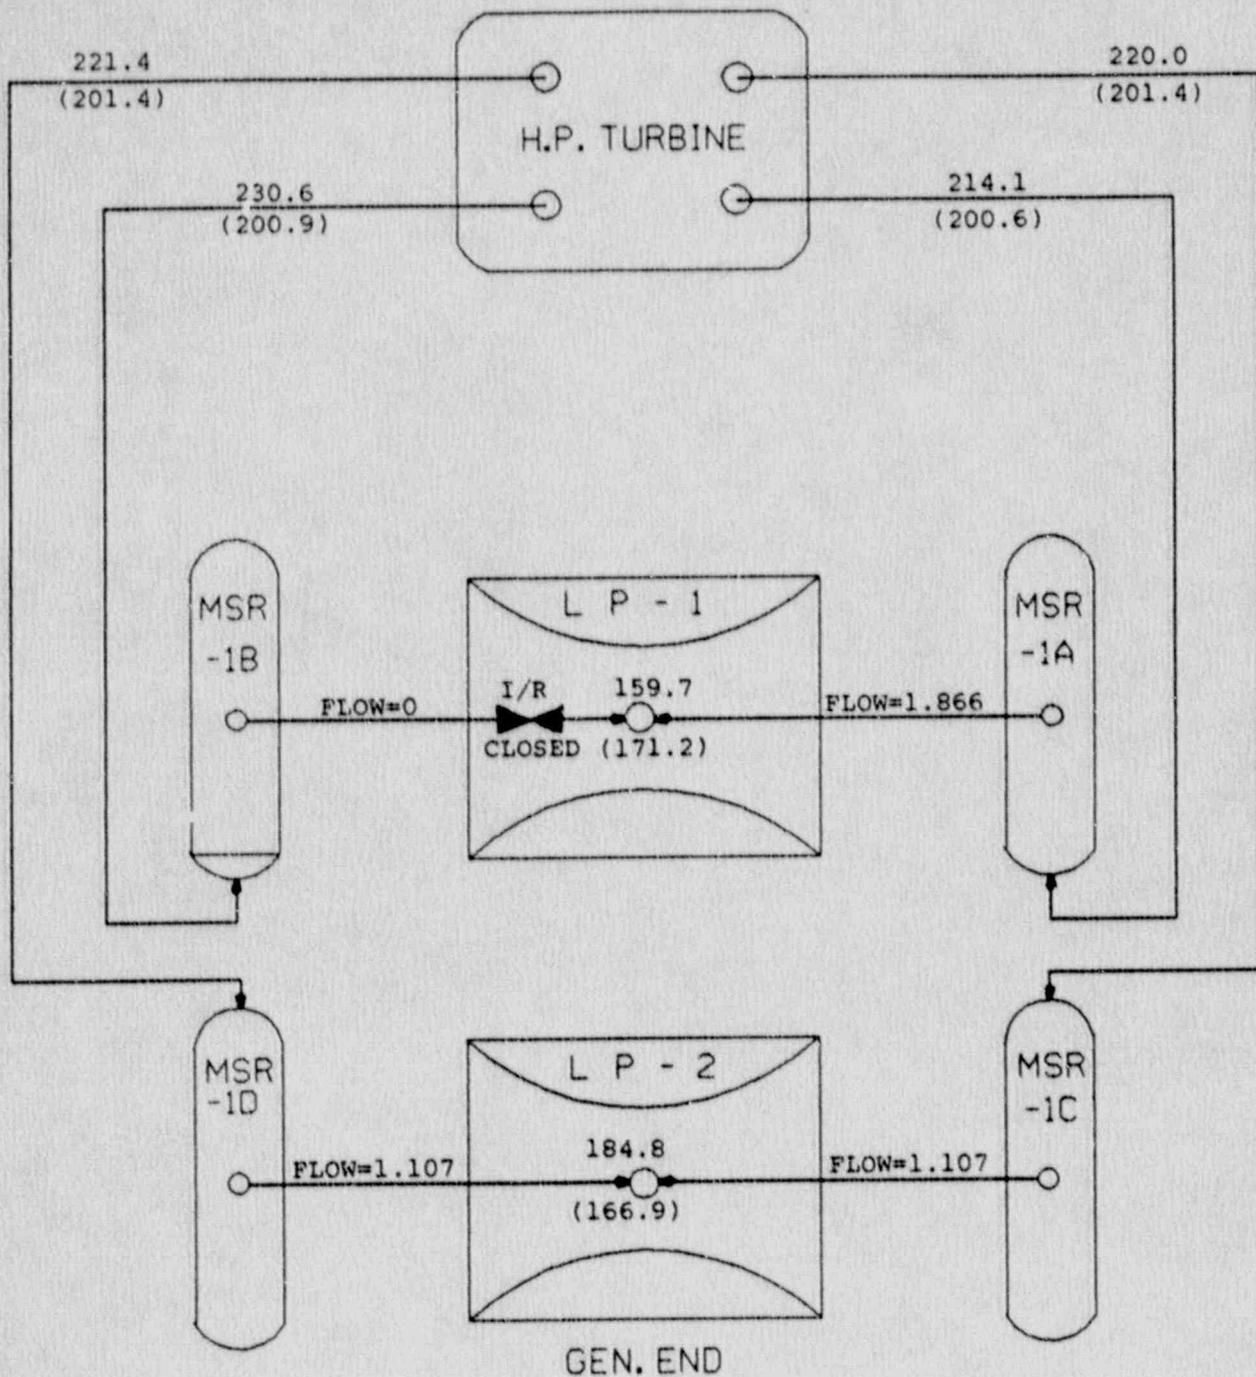
FIGURE C1.3

CROSS - OVER & CROSS - UNDER PIPE ARRANGEMENT
 RELATIVE CROSS - OVER PIPE FLOW DURING
 VALVE TESTING (TEST 1IRR)

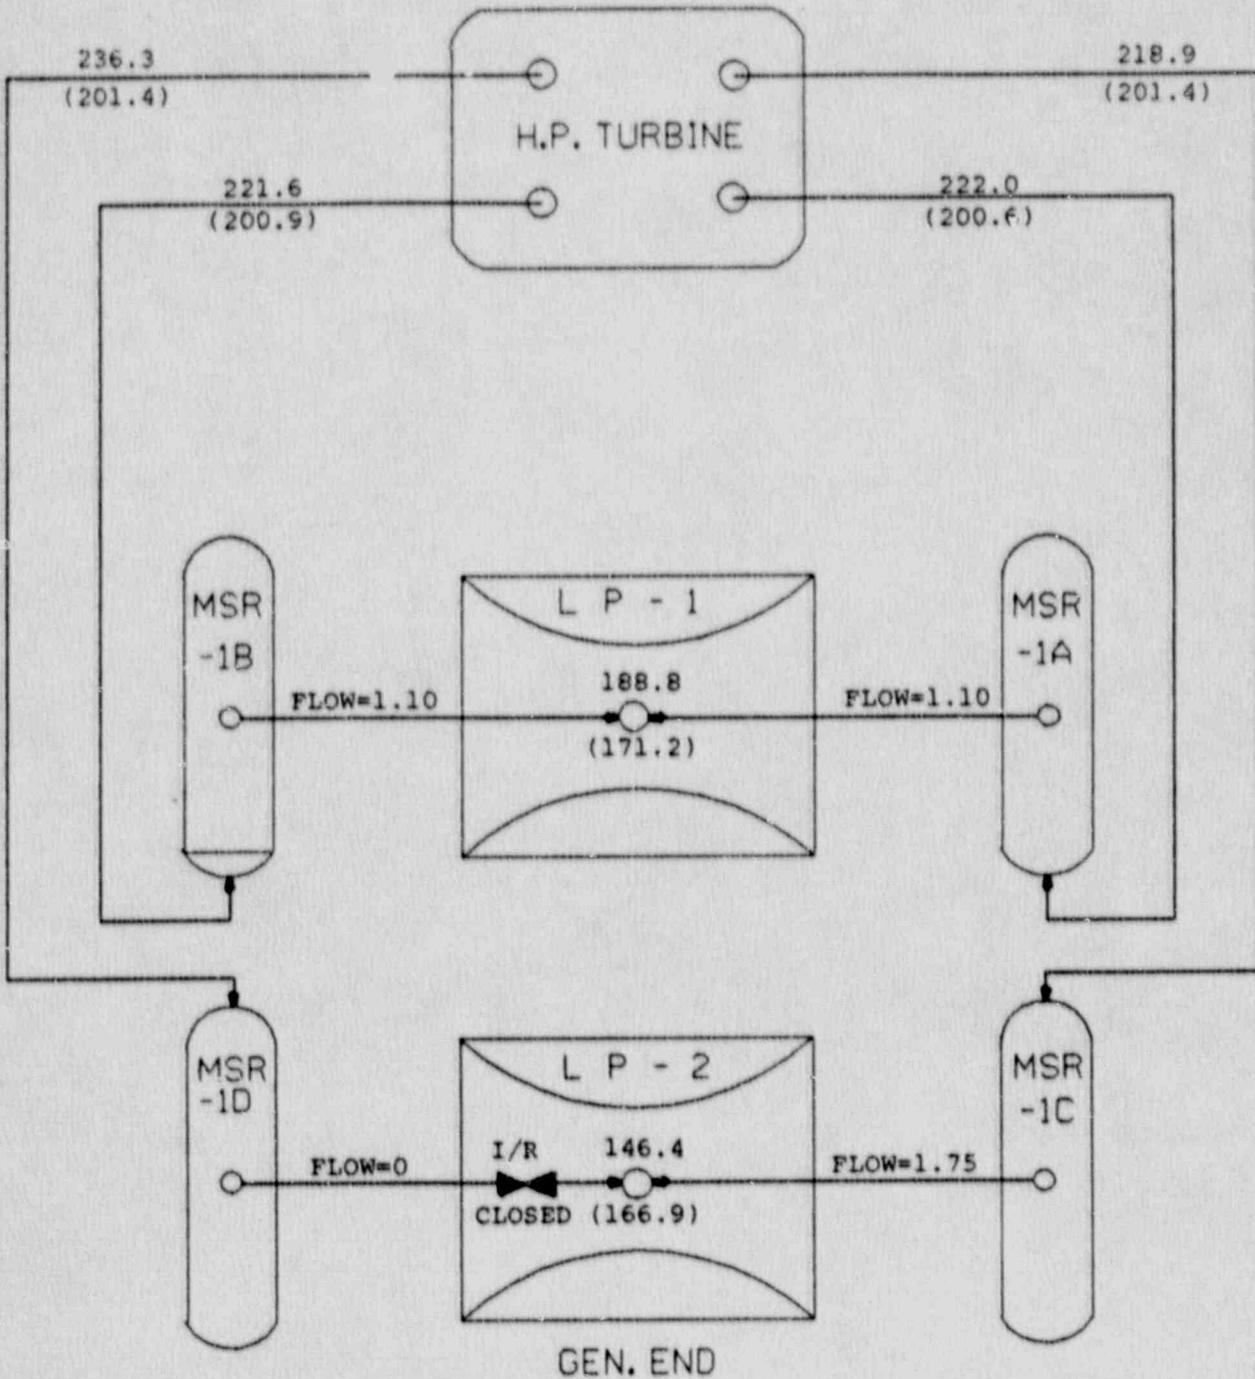
FIGURE C1.4

CROSS - OVER & CROSS - UNDER PIPE ARRANGEMENT
 RELATIVE CROSS - OVER PIPE FLOW DURING
 VALVE TESTING (TEST 2IRR)

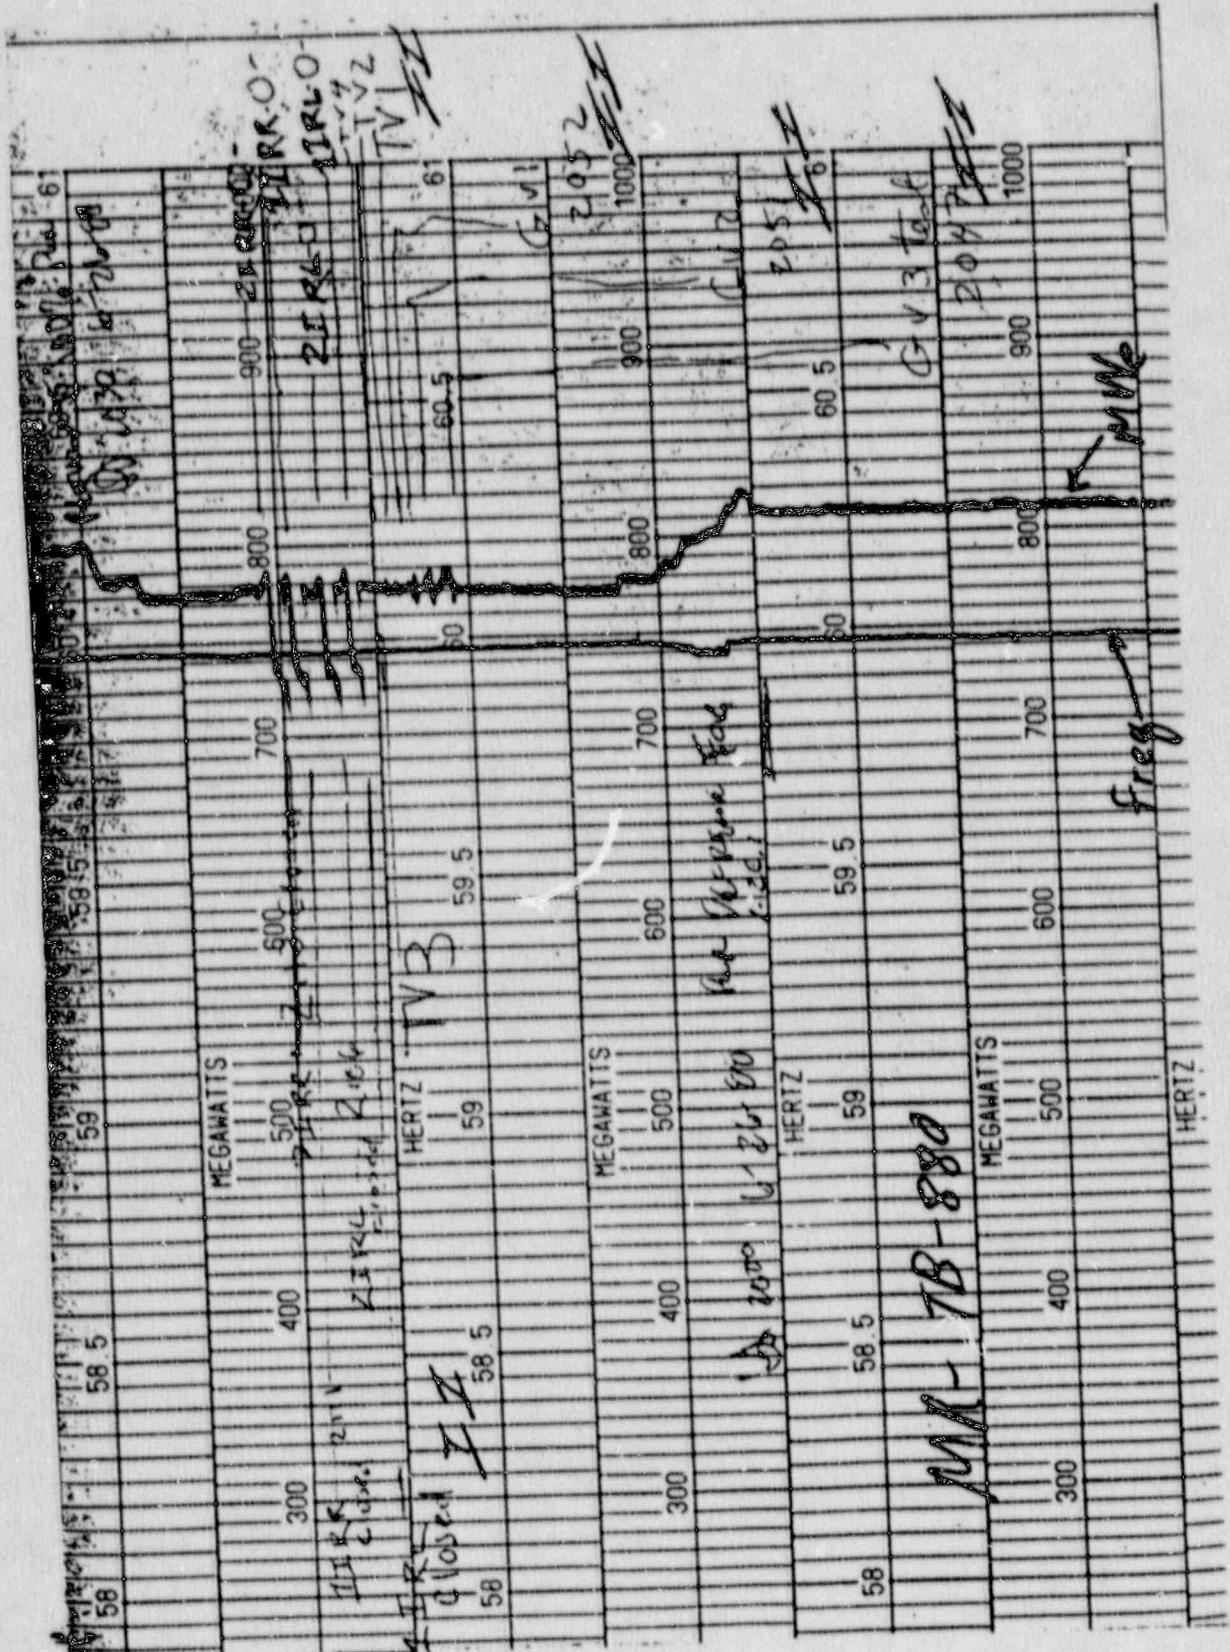
FIGURE NO. C2

The reach of effects from intercept and reheat stop valve testing is very wide. For example, the generating capability of the unit fell from about 780 MW to 720 MW (See Figure C2) as each valve was exercised. At the same time, total steam flows to one (1) LP turbine increased by 10-11%. By reference to Figure C1.1, it was observed that during TEST 11RL, the steam flow to LP-2 increased by a factor of X1.104. As a result of this increase, the LP last row blading in LP-2 experienced a load increase of 5% above the normal levels. Note this increase is after the load had been reduced 5% in order to conduct OST 1.26.1. Continuing with TEST 11RL, the pressure in the -1A cross-under and cross-over piping (no flow/valves closed) increased to 232.2 PSIG or within about 18 PSIG of challenging the MSR relief valve. Finally, the pressure distribution at the HP turbine exhaust region creates a pressure and thrust unbalance that causes the rotor position to move in one direction and then in the other direction.

TYPICAL RESPONSE OF ELECTRICAL OUTPUT (MW) DURING OST 1.26.1
FROM INTERCEPT AND REHEAT STOP VALVE TESTING

The propensity for serious turbine component damage is clearly present during the conduct of this test. Recommendations are to avoid, defer or decrease the frequency of this testing until the results of this testing are better understood, or an alternative to testing is developed.
