**Northeast  
Nuclear Energy**

# LICENSEE EVENT REPORT (LER)

FACILITY NAME (1) Millstone Nuclear Power Station Unit 2	DOCKET NUMBER (2) 05000336	PAGE (3) 1 OF 6
---	-------------------------------	--------------------

TITLE (4)  
Failure to Meet Acceptable Isolation For Class 1E Protection Instrument Channels

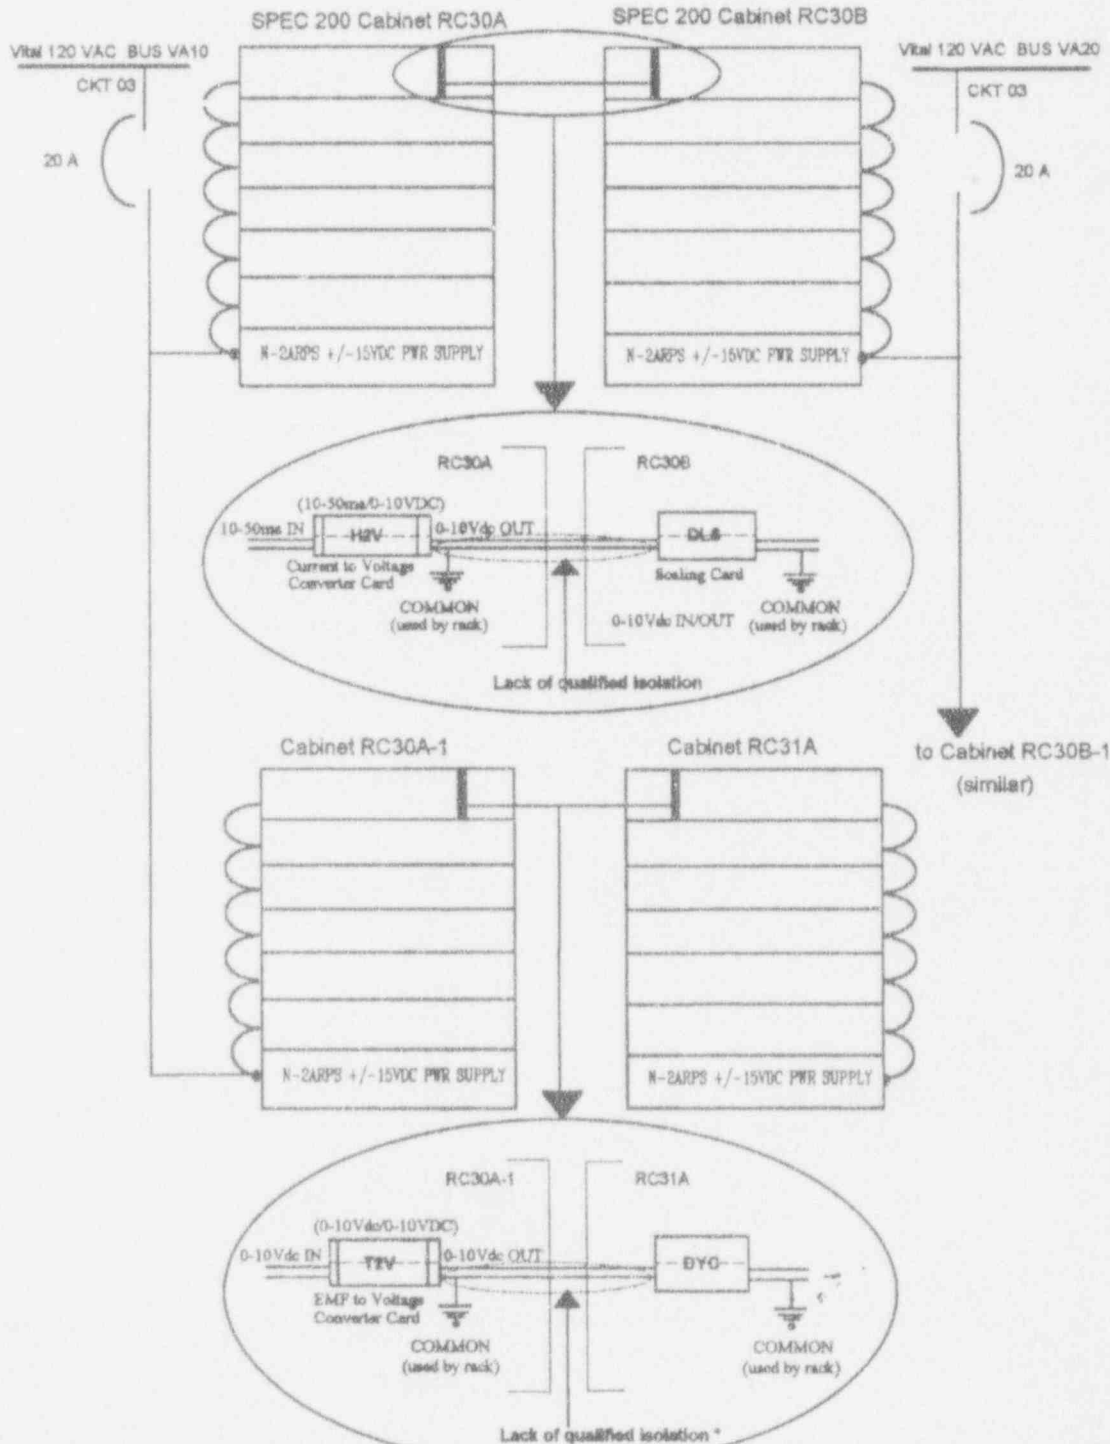
The wiring permits the pressurizer (0-10Vdc) low voltage control signal to pass from cabinet RC30A to RC30B via an isolated current to voltage (H2V) converter card. The common leg of both cabinets became connected due to the wiring configuration of the H2V card (refer to the attached figure). If a catastrophic fault in the form of a voltage surge from the 120VAC feed or +15/-15 Vdc power supply, or a ground fault were to occur the fault could affect both cabinets. Each cabinet power supply also feeds an independent channel of safety related (Class 1E) reactor protection system (RPS)/Engineered Safety Features Actuation System (ESFAS) instrument loop. Therefore, the wiring deficiency could affect the safety related instrument loops if the fault were to cause failures of the +15/-15 Vdc power supply units in each cabinet.

At approximately 0900 hours on March 10, 1994, during the follow-up instrument channel isolation review, it was determined that inadequate isolation exists between the 1E cold leg temperature (Tcold) inputs into the non-1E feedwater regulating system single element control. The concern is that a fault in the non-safety grade Spec 200 instrument cabinets, RC31A or RC31B, could propagate to, and compromise the safety grade Spec 200 protection instrument cabinets of RC30A-1 or RC30B-1 as a result of the inadequate isolation scheme (refer to the attached figure).

The wiring permits the (0-10Vdc) low voltage Tcold control signal to pass from cabinet RC30A-1 (and RC30B-1) to non-1E cabinet RC31A (and RC31B) via an isolated "EMF t, voltage" converter (T2V) card. The common leg of the 1E and non 1E cabinets become connected due to the output wiring of the T2V card (which only provides input wiring isolation).

\*NOTE: Similar for RC30B-1 to RC31B interface

As corrective action, design changes will be completed in the near future to provide isolation for the two pressurizer pressure channels and Tcold inputs to single element feedwater control in order to maintain a design basis consistent with the FSAR description.
