TENNESSEE VALLEY AUTHORITY

TENNESSEE VALLEY AUTHORITY - SEQUOYAH NUCLEAR PLANT UNIT 2 - DOCKET NO.
50-328 - FACILITY OPERATING LICENSE DPR-79 - LICENSEE EVENT REPORT (LER)
50-328/90012

LICENSEE EVENT REPORT (LER)

TITLE (4) Gas accumulation in centrifugal charging pump suction piping as result of gas stripping in miniflow line orifices

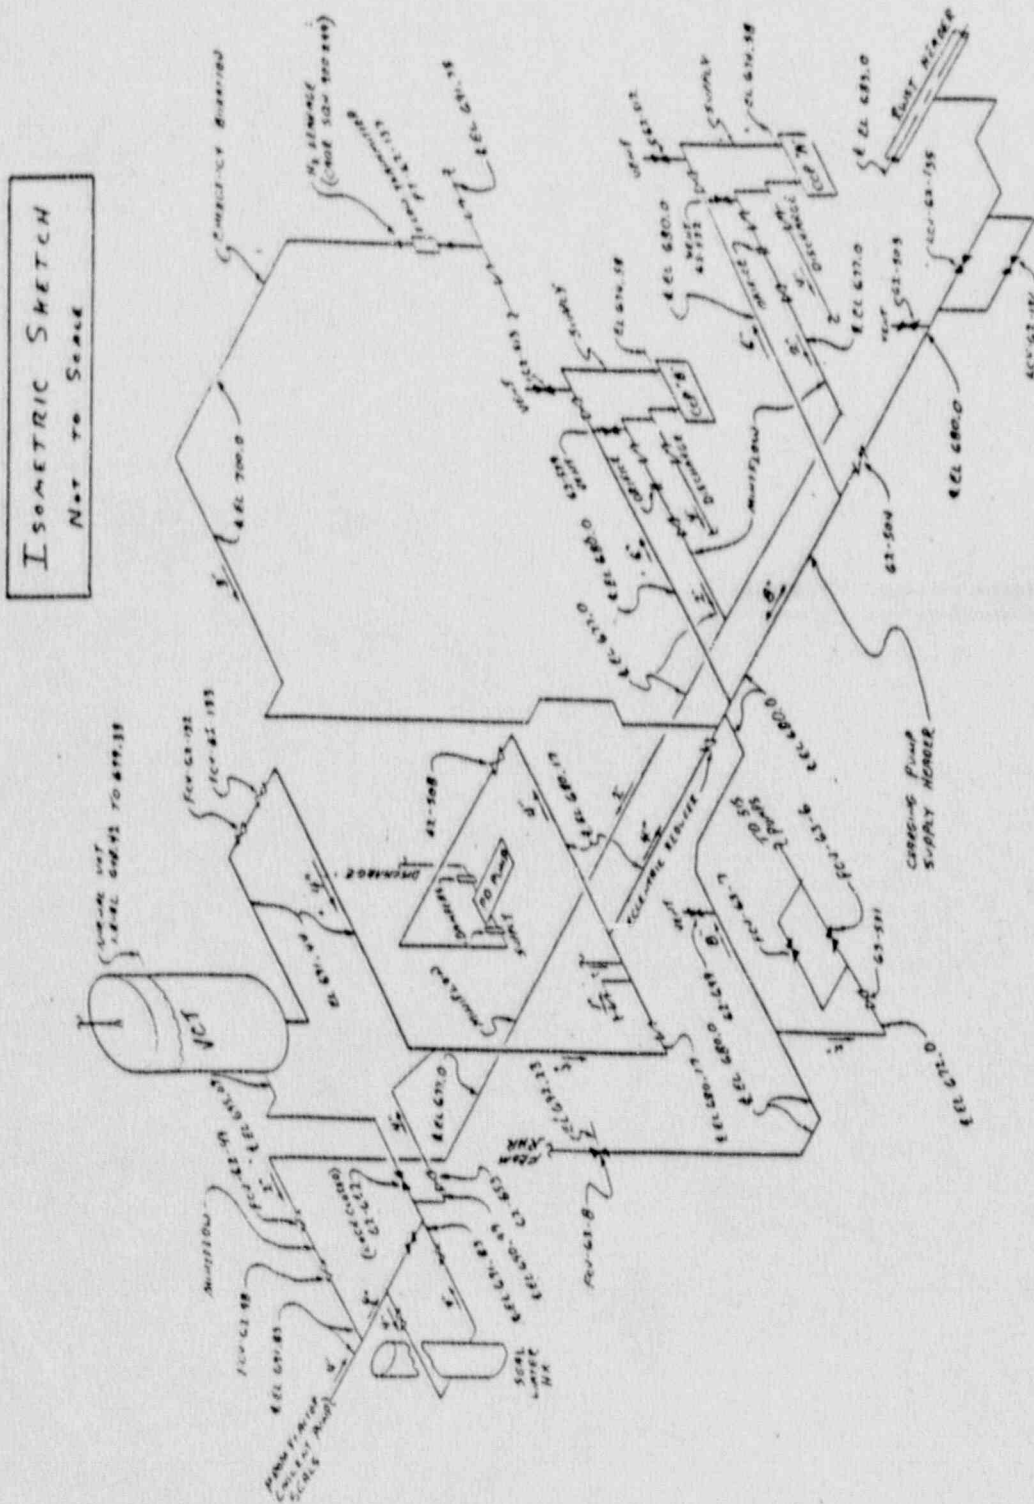
At 1635 EDT on August 20, 1990, while preparing to perform Surveillance Instruction (SI) 40, "Centrifugal Charging Pump," an attempt was made to change operation from the 2A-A to the 2B-B CCP. When the 2B-B CCP was started and run in parallel with 2A-A CCP, no anomalies were observed. However, when the 2A-A CCP was stopped, the operator observed fluctuations in pump flow and motor current on 2B-B and secured the pump after returning 2A-A to service. After venting the pump casing and discharge piping, the pump was restarted at 1954 EDT. Similar fluctuations in pump flow and current were observed, and the pump was again stopped. At 2130 EDT, the pump casing and discharge piping were again vented. The pump suction piping was also vented without complete success at Valve VLV-62-513, which is on the 2B-B CCP suction line. The venting operations continued, and at 0215 EDT on August 21, 1990, a length of piping from the 2A-A residual heat removal (RHR) heat exchanger (EIIIS Code BP) discharge to the CCP suction header was vented at Valve VLV-62-699. The 2B-B CCP was started and normal operating parameters were observed. The pump was subsequently tested using SI-40. Vibration diagnostics, pump flow, and discharge pressure indicated acceptable pump performance. However, nonintrusive ultrasonic testing indicated that a small pocket of gas was present in the horizontal section of suction piping from the RHR discharge to the CCPs and that the vertical section up to Valve 2-FCV-63-8 was void. FCV-63-8 is located on the vertical section of the RHR discharge to the CCP suction header at an elevation above VLV-62-699, i.e., the section up to FCV-63-8 cannot be vented by VLV-62-699, and no additional vent exists in this line up to FCV-63-8. See attached sketch and Updated Final Safety Analysis Report, (UFSAR) Figure 6.3.2-1.

An evaluation of the event was completed on August 22, 1990, which concluded that hydrogen gas was coming out of solution and accumulating in certain pipe locations. In consultation with Westinghouse Electric Corporation, it was determined that continued operation was acceptable provided that the gas volume does not exceed six cubic feet in the suction piping to the CCPs. The condition was verified to exist on both units with ultrasonics. Shiftily venting of the piping at VLV-62-699 was specified on both units until the gas accumulation rate could be quantified and an appropriate venting frequency could be determined. Subsequently, the Unit 2 piping was vented at 2015 EDT on August 22, 1990. Based on a volume control tank (VCT) level drop of approximately two percent during that venting, it was concluded at 2234 EDT, that the piping may have had approximately 10 cubic feet of gas vented in addition to that trapped in the vertical section up to FCV-63-8. Because this condition would represent more than the six cubic feet of gas allowed, the NRC Operations Center was notified at 2317 EDT of a potentially unanalyzed condition on Unit 2.

The physical phenomenon causing the hydrogen gas to come out of solution is believed to be primarily gas stripping at the CCP miniflow line flow restricting orifices. In the original plant design, the CCP miniflow returned to the VCT rather than to the pump suction line. However, as a result of a Westinghouse generic letter concerning the potential for overflowing the VCT after swapover from the VCT to the refueling water storage tank (RWST), the miniflow was rerouted to the CCP suction line downstream of the VCT outlet valves.

The immediate actions taken were to evaluate the gas accumulation problem and to maintain pump operability by venting the suction piping periodically. Operation of the PDCPs was initiated on both units to avoid the gas stripping mechanism. Arrangements were made for temporary alterations to leave vent hoses installed to facilitate venting. In addition, a method was developed for installing a vent valve below Valve FCV-63-8 to vent the gas trapped in the vertical section of piping. Required engineering documentation for this modification was initiated.

The long-term corrective action plans are still being developed. The plan currently underway is to install vent valves above and below FCV-63-8 to vent the vertical sections of piping. These permanent vents are expected to be installed on both units by the end of October 1990. Potential future modifications include a continuous vent system from piping high points to the VCT. SQN plans to continue operating the PDCPs as the preferred charging source, to continue periodically venting the CCP suction headers, and to continue monitoring the gas accumulation rate. Long-term modifications may include returning the CCP miniflow path to the VCT, or installing multistage orifices in the CCP miniflow lines to reduce gas stripping.
