SUBJECT: Arkansas Nuclear One - Unit 1
Docket No. 50-313
License No. DPR-51
Licensee Event Report No. 50-313/90-010-00

LICENSEE EVENT REPORT (LER)

TITLE (4) Inoperable Control Room Habitability Systems Due to Leakage in Air Supply System to Control Room Isolation Dampers Caused by Failure to Adequately Test and Maintain System Following Modification

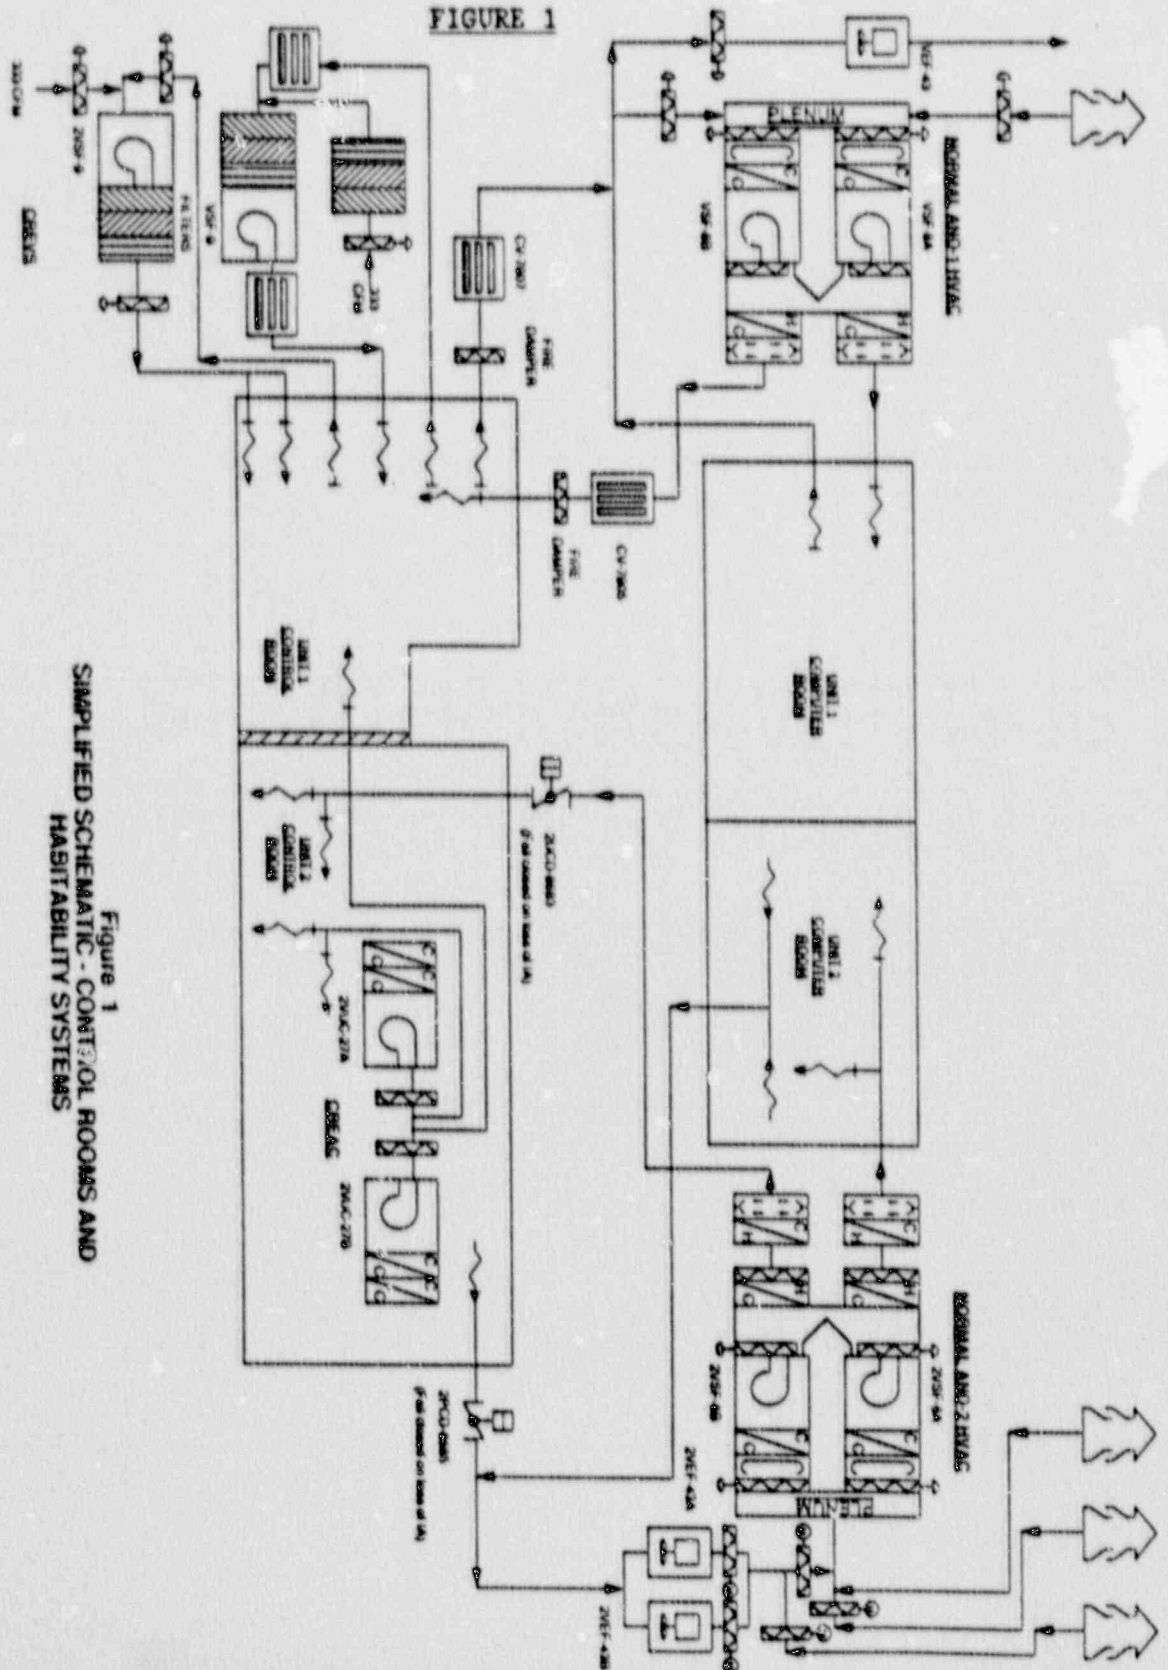
Figure 1
SIMPLIFIED SCHEMATIC - CONTROL ROOMS AND
HABITABILITY SYSTEMS

The ANO-1 and ANO-2 control rooms are located adjacent to each other and are separated by a wall containing louvered openings to provide for air flow between the rooms. The two rooms form a common control room envelope [NA] which is provided with systems designed to ensure habitability of the envelope during normal plant operation and following a postulated accident on either unit (see Figure 1). The habitability systems include:

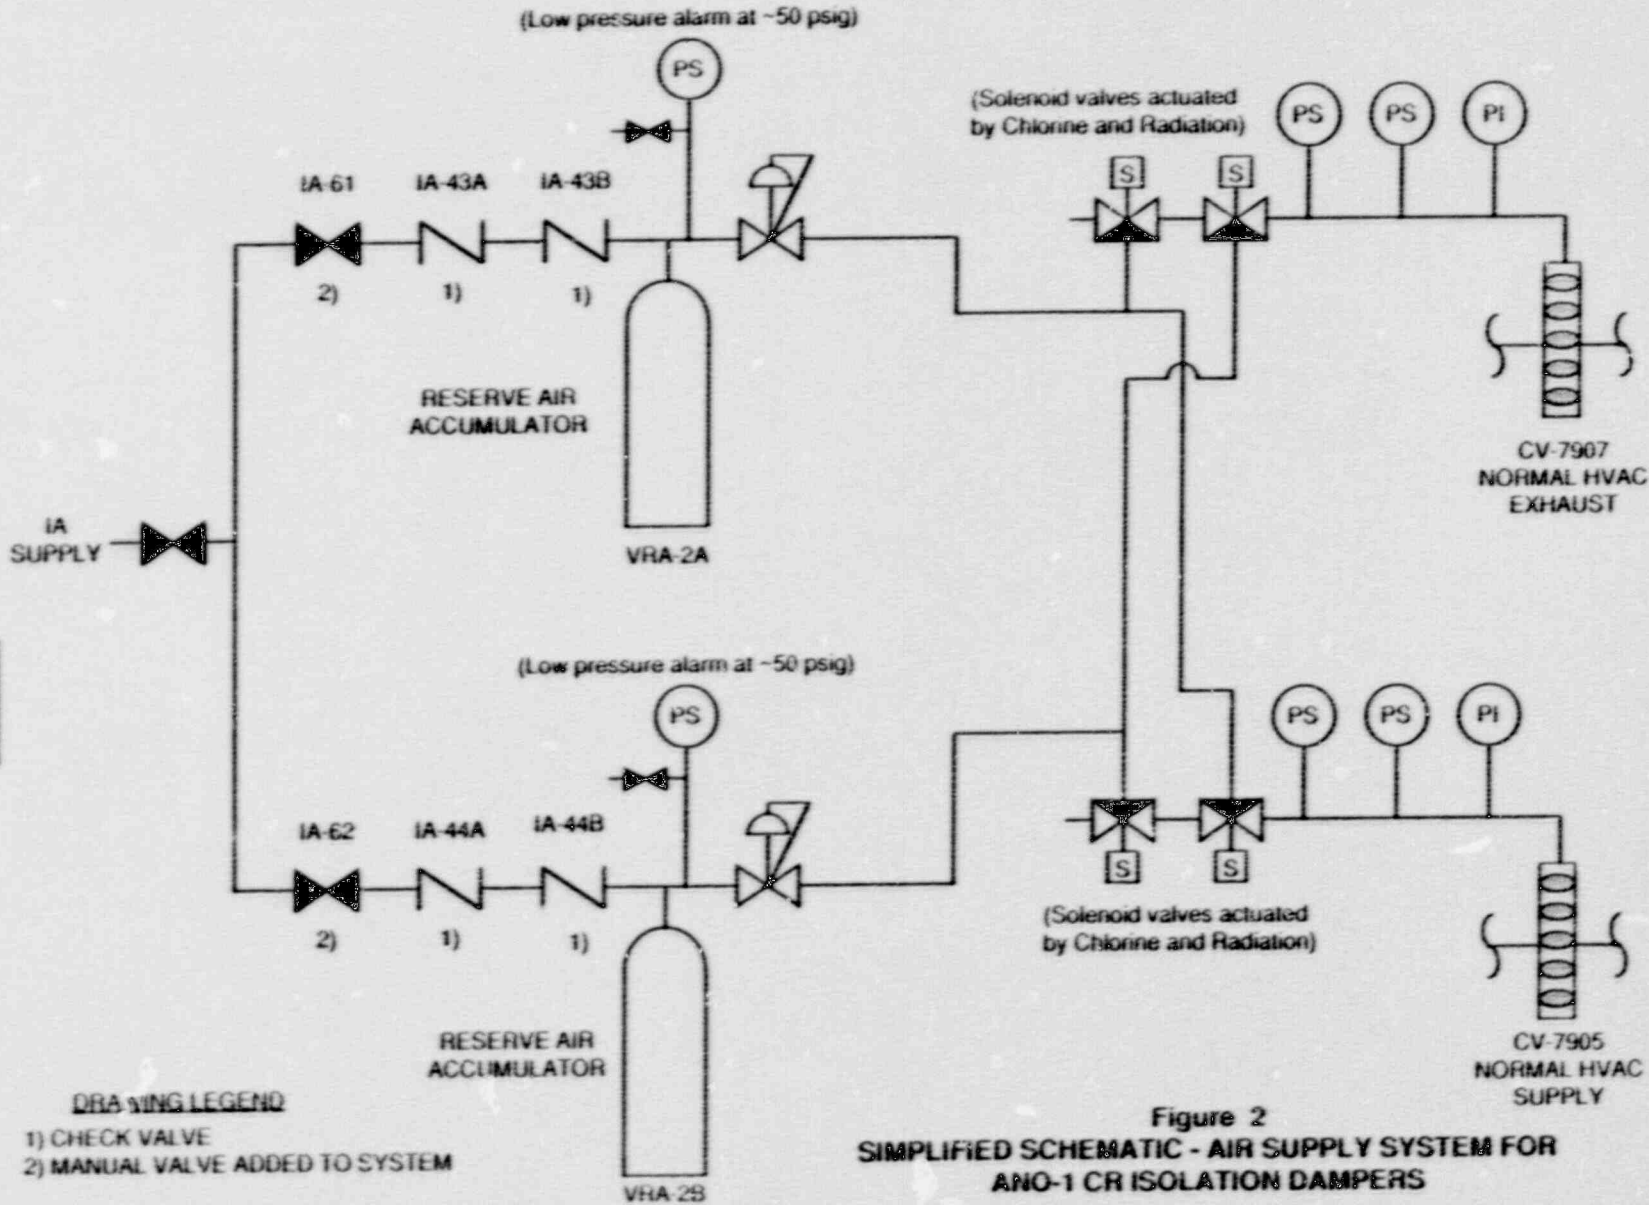
Figure 2
SIMPLIFIED SCHEMATIC - AIR SUPPLY SYSTEM FOR
ANO-1 CR ISOLATION DAMPERS

In September 1990, during the course of an NRC inspection, an inspector requested information related to previous leak testing of four (4) check valves in the air supply piping to the two (2) isolation dampers (CV-7905 and CV-7907) [DMP] located in the normal HVAC system supply and exhaust ductwork for the ANO-1 control room (see Figure 2). The isolation dampers are normally open, pneumatic valves (bladder type valves) requiring air pressure for inflation to provide isolation of the normal HVAC system. Air supply to the dampers is normally provided by the plant's non-safety related instrument air (IA) [LD] system. The air supply system also incorporates the use of two redundant

reserve air accumulators (VRA-2A and VRA-2B) [RVR] which serve to provide a backup reservoir of closing air for actuating and/or maintaining the dampers in a closed position following a postulated loss of instrument air system. The check valves in the air supply piping upstream of the accumulators provide isolation of the accumulators to ensure this air source is not depleted due to depressurization of the instrument air system.

An investigation was conducted by System Engineering personnel to determine if previous testing of the check valves had been performed. On September 15, 1990, it was concluded that testing of the check valves had not been conducted. The results of previous surveillance testing indicated that the capability to close the dampers and isolate the ANO-1 control room within 10 seconds as required by the Technical Specifications could be achieved; however, the capability of the check valves to prevent a loss of accumulator or system air pressure due to backleakage to a depressurized instrument air system which could result in the damper reopening was unknown at this time.

Following discovery on September 21, 1990, that the check valves and other components of the system leaked excessively immediate corrective actions included repair of piping joints, threaded connections and solenoid valve leakage. The four check valves were removed and replaced with new valves. However, due to the unavailability of a better designed valve, it was necessary to utilize check valves with a similar design. Bench testing of the new valves for leakage prior to installation indicated that due to their design, i.e., bronze seats and disc, little improvement in minimizing leakage was obtained by this replacement. In order to resolve this problem, the system was modified by adding a manual isolation valve in each line directly upstream of the check valves. By maintaining the manual valves in a closed position, positive isolation of each accumulator from the IA system could be achieved. Results of system leak testing with the manual valves closed indicated leakage was significantly reduced. Conservative calculations based on final leakage rates in this configuration indicated the isolation dampers could be closed and maintained in a closed position for a minimum time period of approximately 72 hours under worst case conditions. Routine recharging of the accumulators from the IA system can be accomplished by periodically cycling the manual valves. Appropriate procedure changes were completed requiring maintaining the manual valves normally closed and opening them periodically for recharging of the accumulators. Remote monitoring of air supply system pressure is provided by pressure switches which initiate a control room annunciator alarm if system pressure decreases to approximately 50 psig.
