LICENSEE EVENT REPORT (LER)

FACILITY NAME (1) Calvert Cliffs, Unit 1	DOCKET NUMBER (2) 0 5 0 0 0 3 1 1 7	PAGE (3) 1 OF 0 8
---	--	----------------------

TITLE (4)
Tilted Excure Detectors Caused by Inadequate Procedural Guidance

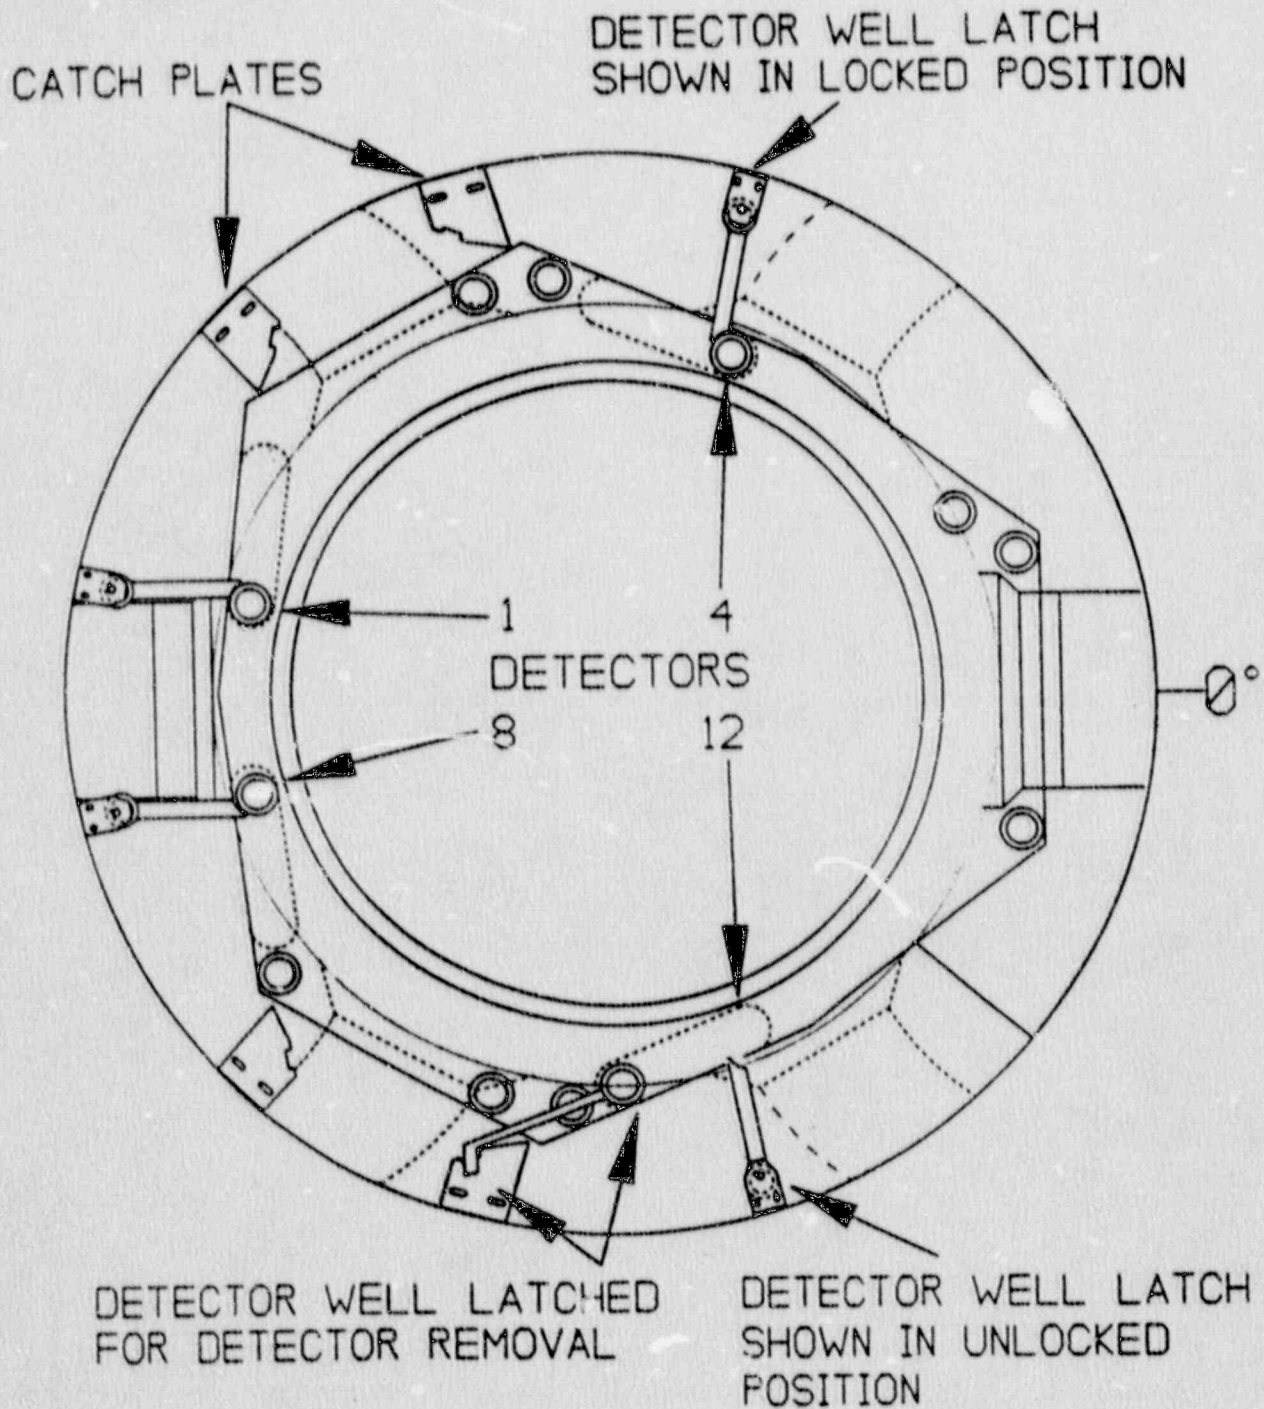
FIGURE 1

There are four Excore Power Range NI channels (A, B, C, and D) that provide input to the Reactor Protection System (RPS). The detectors for channels A and B are fixed in place. The detectors for channels C and D are mounted in swing wells. As shown in Figure 1, there are four swing wells (1, 4, 8, and 12) for each Calvert Cliff, Unit. Wells 1 and 4 are spares which contain no detectors. The detectors for channels C and D are mounted in wells 8 and 12, respectively.

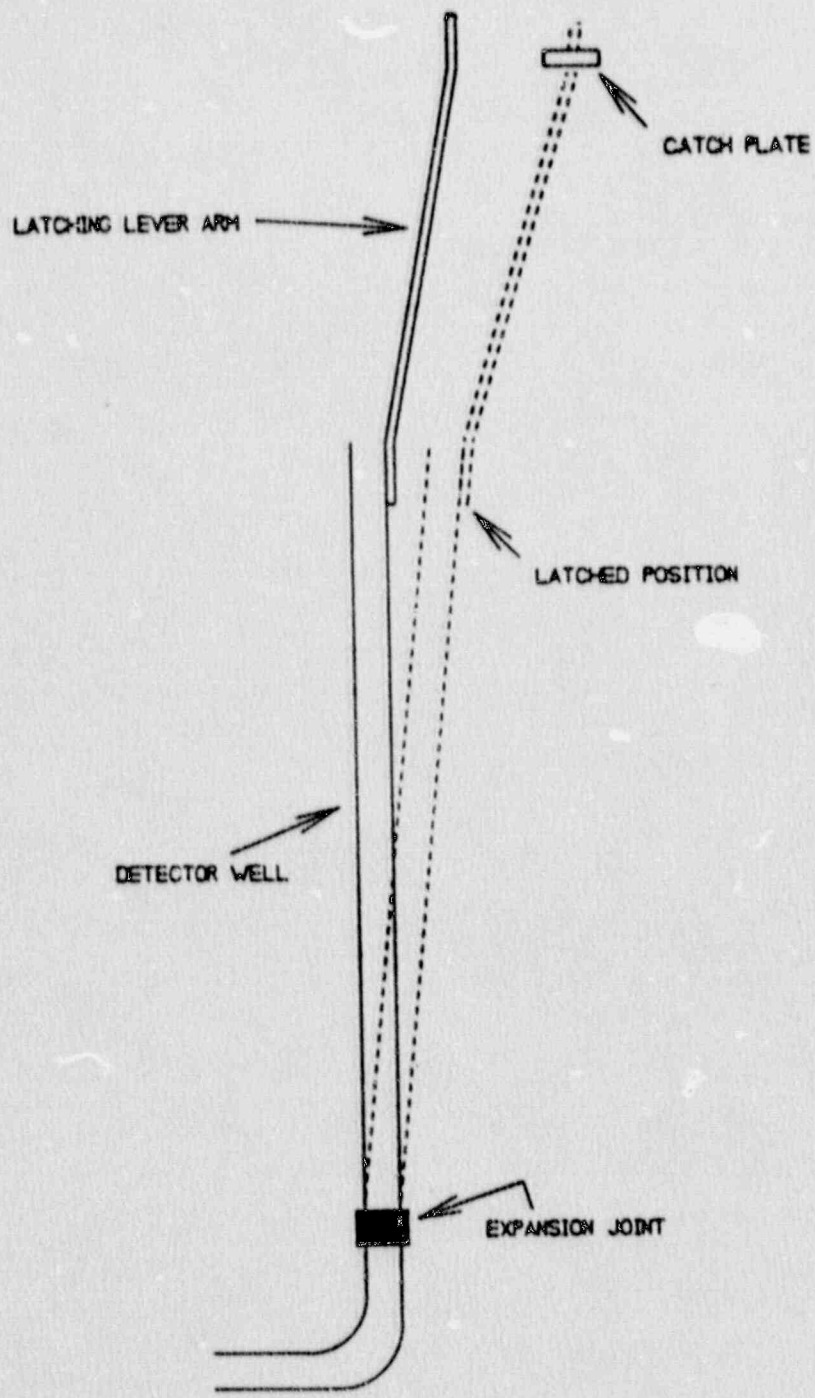
FIGURE 2

These detectors cannot be inserted or removed vertically since they are located under pipes entering the reactor vessel. Therefore, these detectors are each mounted on a hinge-type expansion joint (see Figure 2). A locking mechanism holds the detector well vertical. When released, the detector (see Figure 1), is tilted using its latching lever arm which attaches to a catch plate to hold the detector in the tilted position.

- A. The tilted detectors in both units were placed in a vertical position and correctly locked in place using the locking mechanism.
- B. Power ascension for Unit 1 was held at 30 percent power to perform excore ASI calibrations. We also stopped to calibrate excore ASI between 85 and 90 percent power as part of our normal startup process following an extended outage. This process will be repeated during Unit 2 startup.
- C. Procedures RV-24A/B are being revised to provide explicit guidance on the operation of the swing wells.

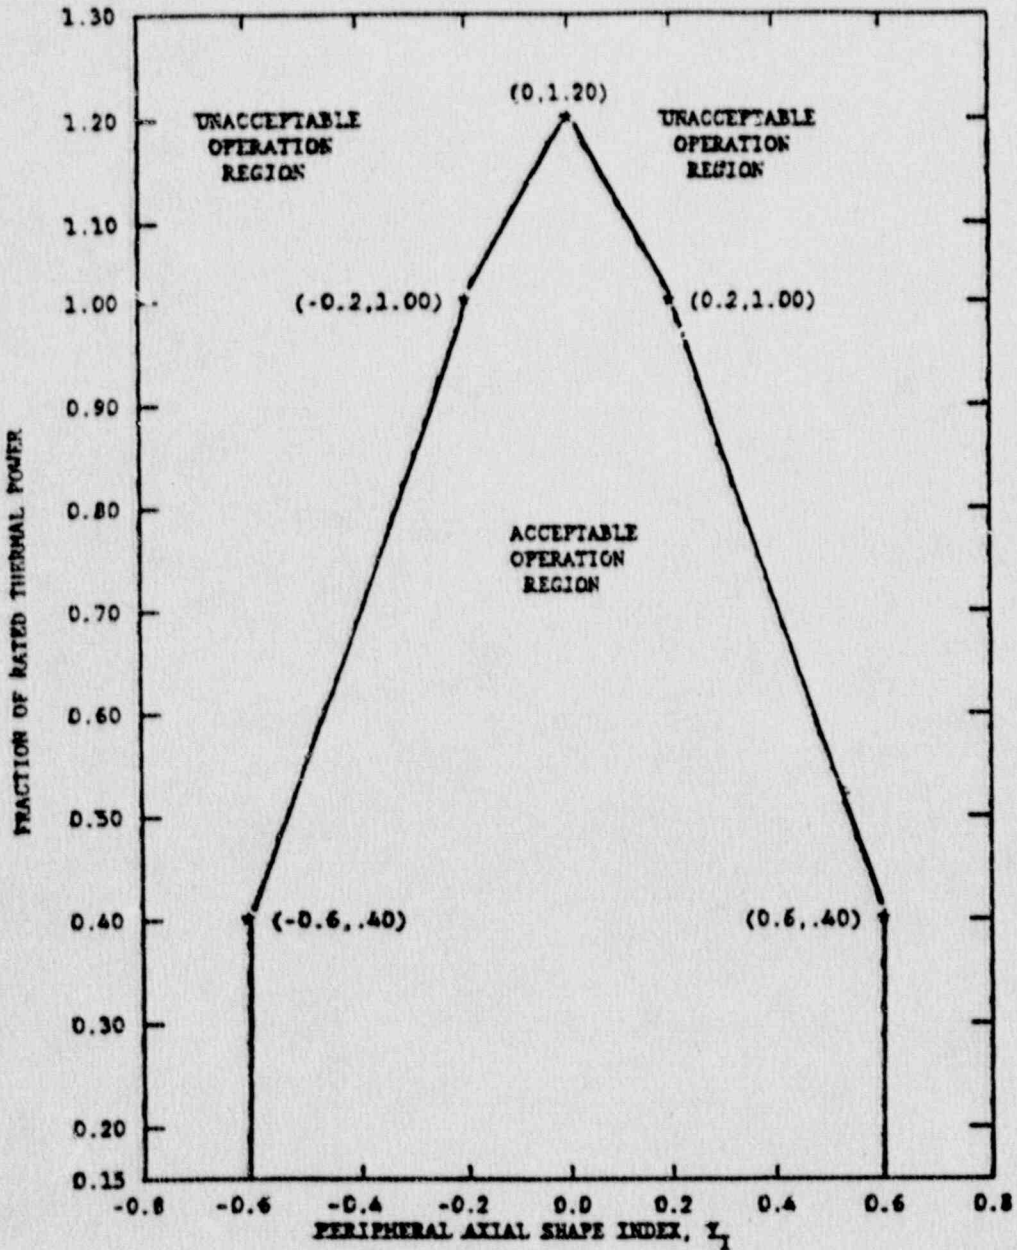
Figure 2.2-1
Peripheral Axial Shape Index, Y_1 vs Fraction of Rated Thermal Power

ASI is measured by incore detectors to assure operation within TS Limiting Condition for Operation (LCO) for Linear Heat Rate and Departure from Nucleate Boiling. The limits of these LCOs are more conservative than the setpoint for the APD Trip, specified in TS Figure 2.2-1 (Figure 3).
