SUBJECT: SUMMARY OF THE OPERATING REACTOR EVENTS MEETING  
ON JULY 8, 1981

SUBJECT: TRIP REPORT TO NORTH ANNA-2 - FAILURE OF B PHASE  
MAIN TRANSFORMER AND SUBSEQUENT FIRE IN THE TRANSFORMER  
AREA

SUBJECT: UPDATE ON TRANSFORMER FIRE AT NORTH ANNA POWER STATION,  
JULY 3, 1981

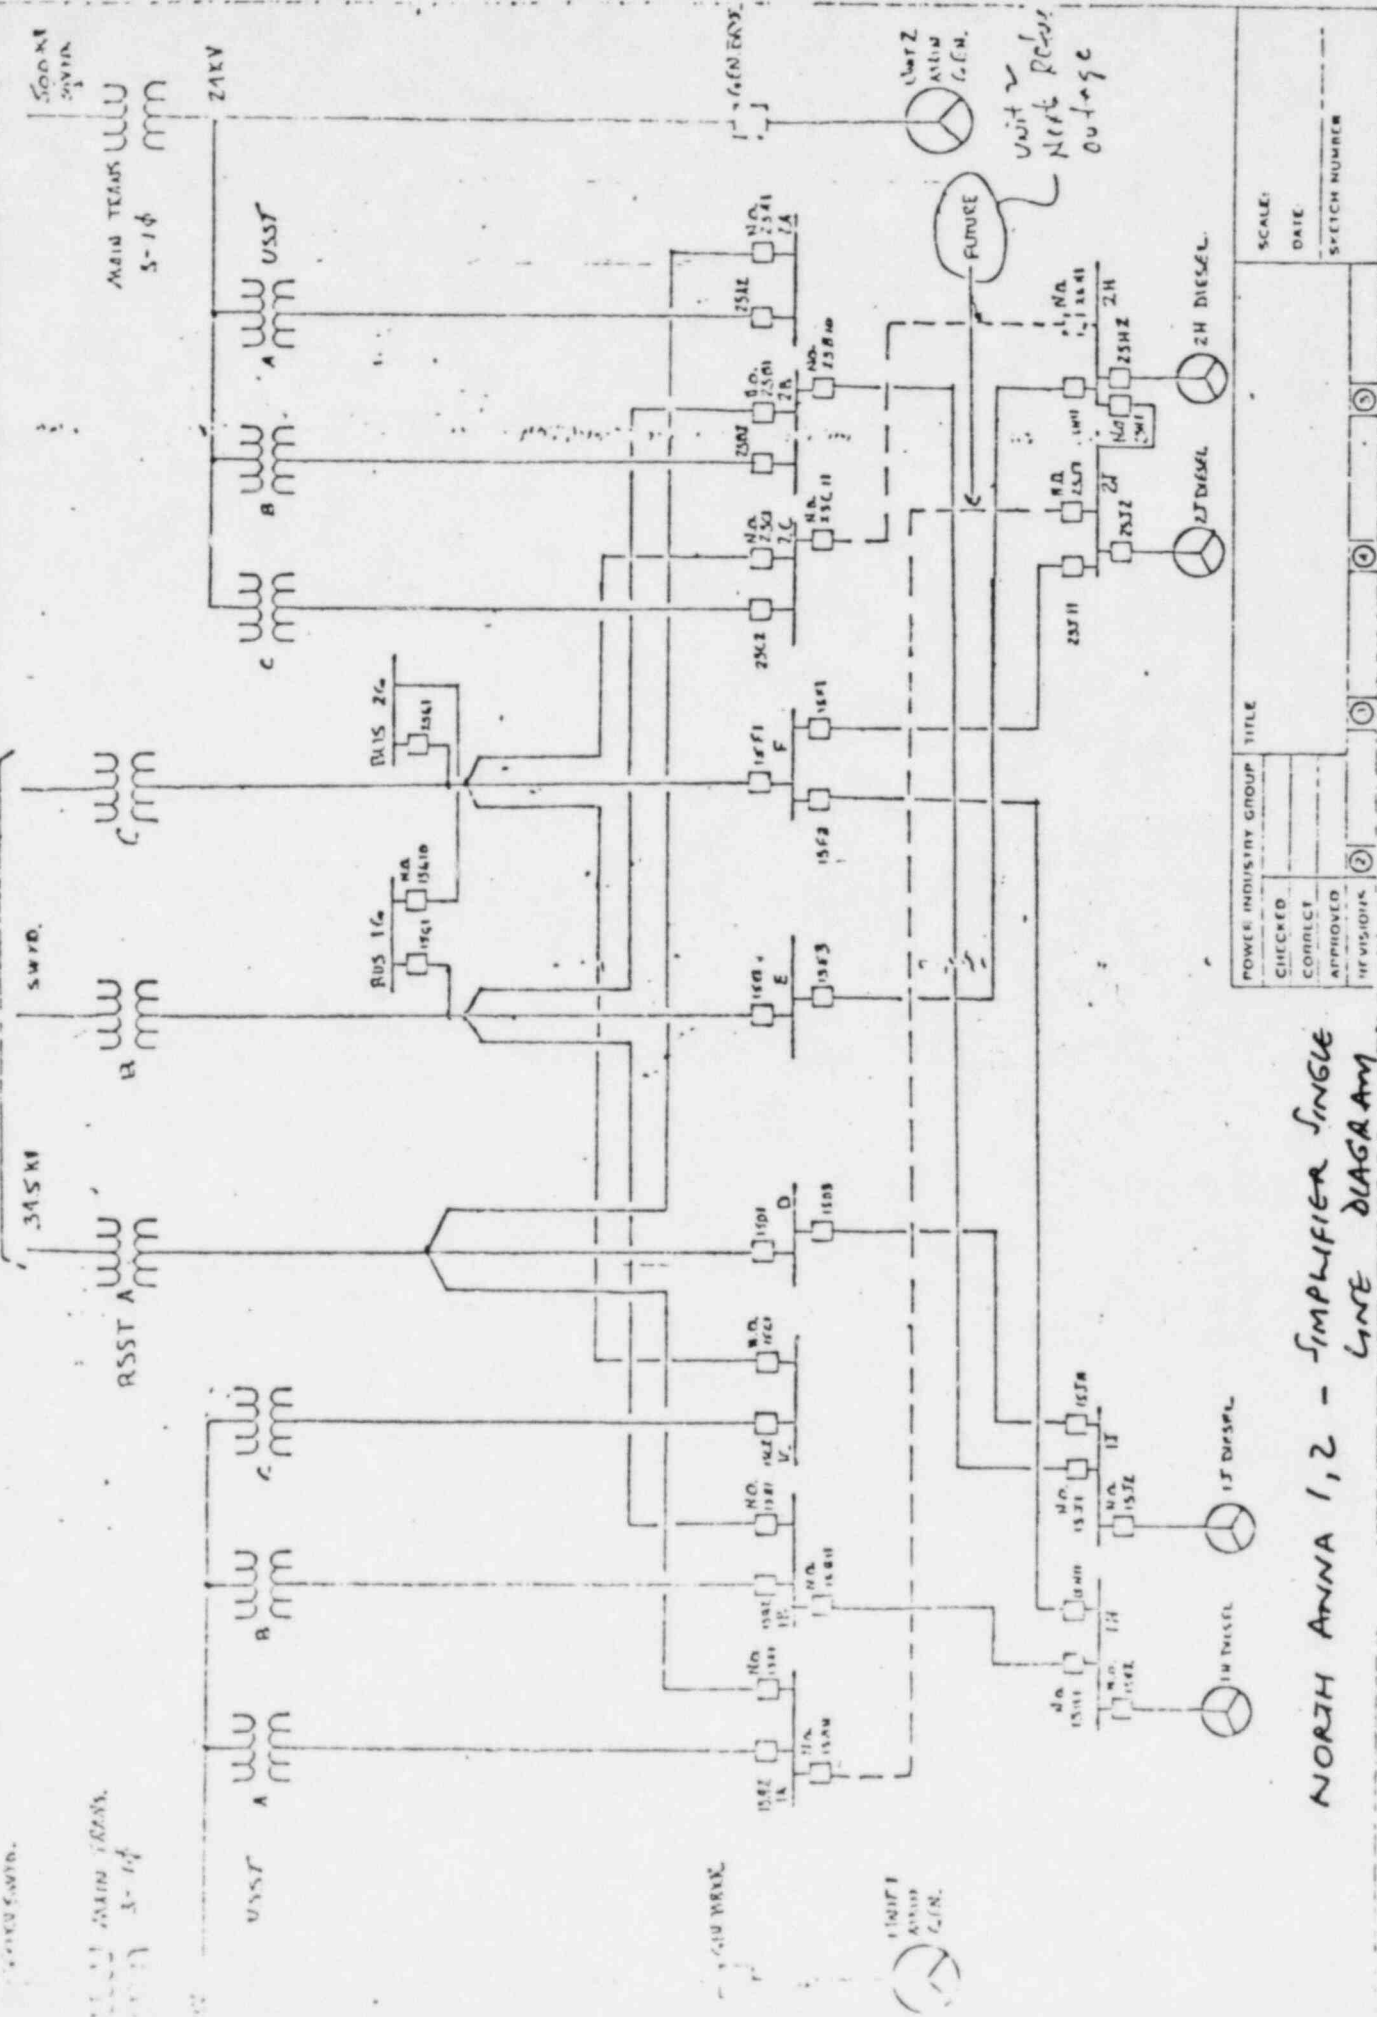
NORTH ANNA 1, 2 - SIMPLIFIER SINGLE LINE DIAGRAM

4. No damage was apparent in the A and C phase transformer sections (again apparently due to the sprinkler systems there).
5. Severe fire damage was seen in the spare transformer bay (which was empty at the time of the event). The spare transformer bay is not fitted with a fire protection system.
6. The fire in the spare bay caused severe damage to the turbine building wall and to overhead aluminium buses of the C Reserve Station Service Transformer (RSST-C). The cables associated with these buses, that were mounted on vertical cable trays on the turbine building wall, were also burnt. (RSST-C provides part of offsite power from the 34.5 KV switchyard to the onsite distribution system - see enclosed single line diagram).
