TRANSIENT ASSESSMENT REPORT

RANCHO SECO REACTOR TRIP

AUGUST 7, 1981

TRANSIENT REPORT NO. 53

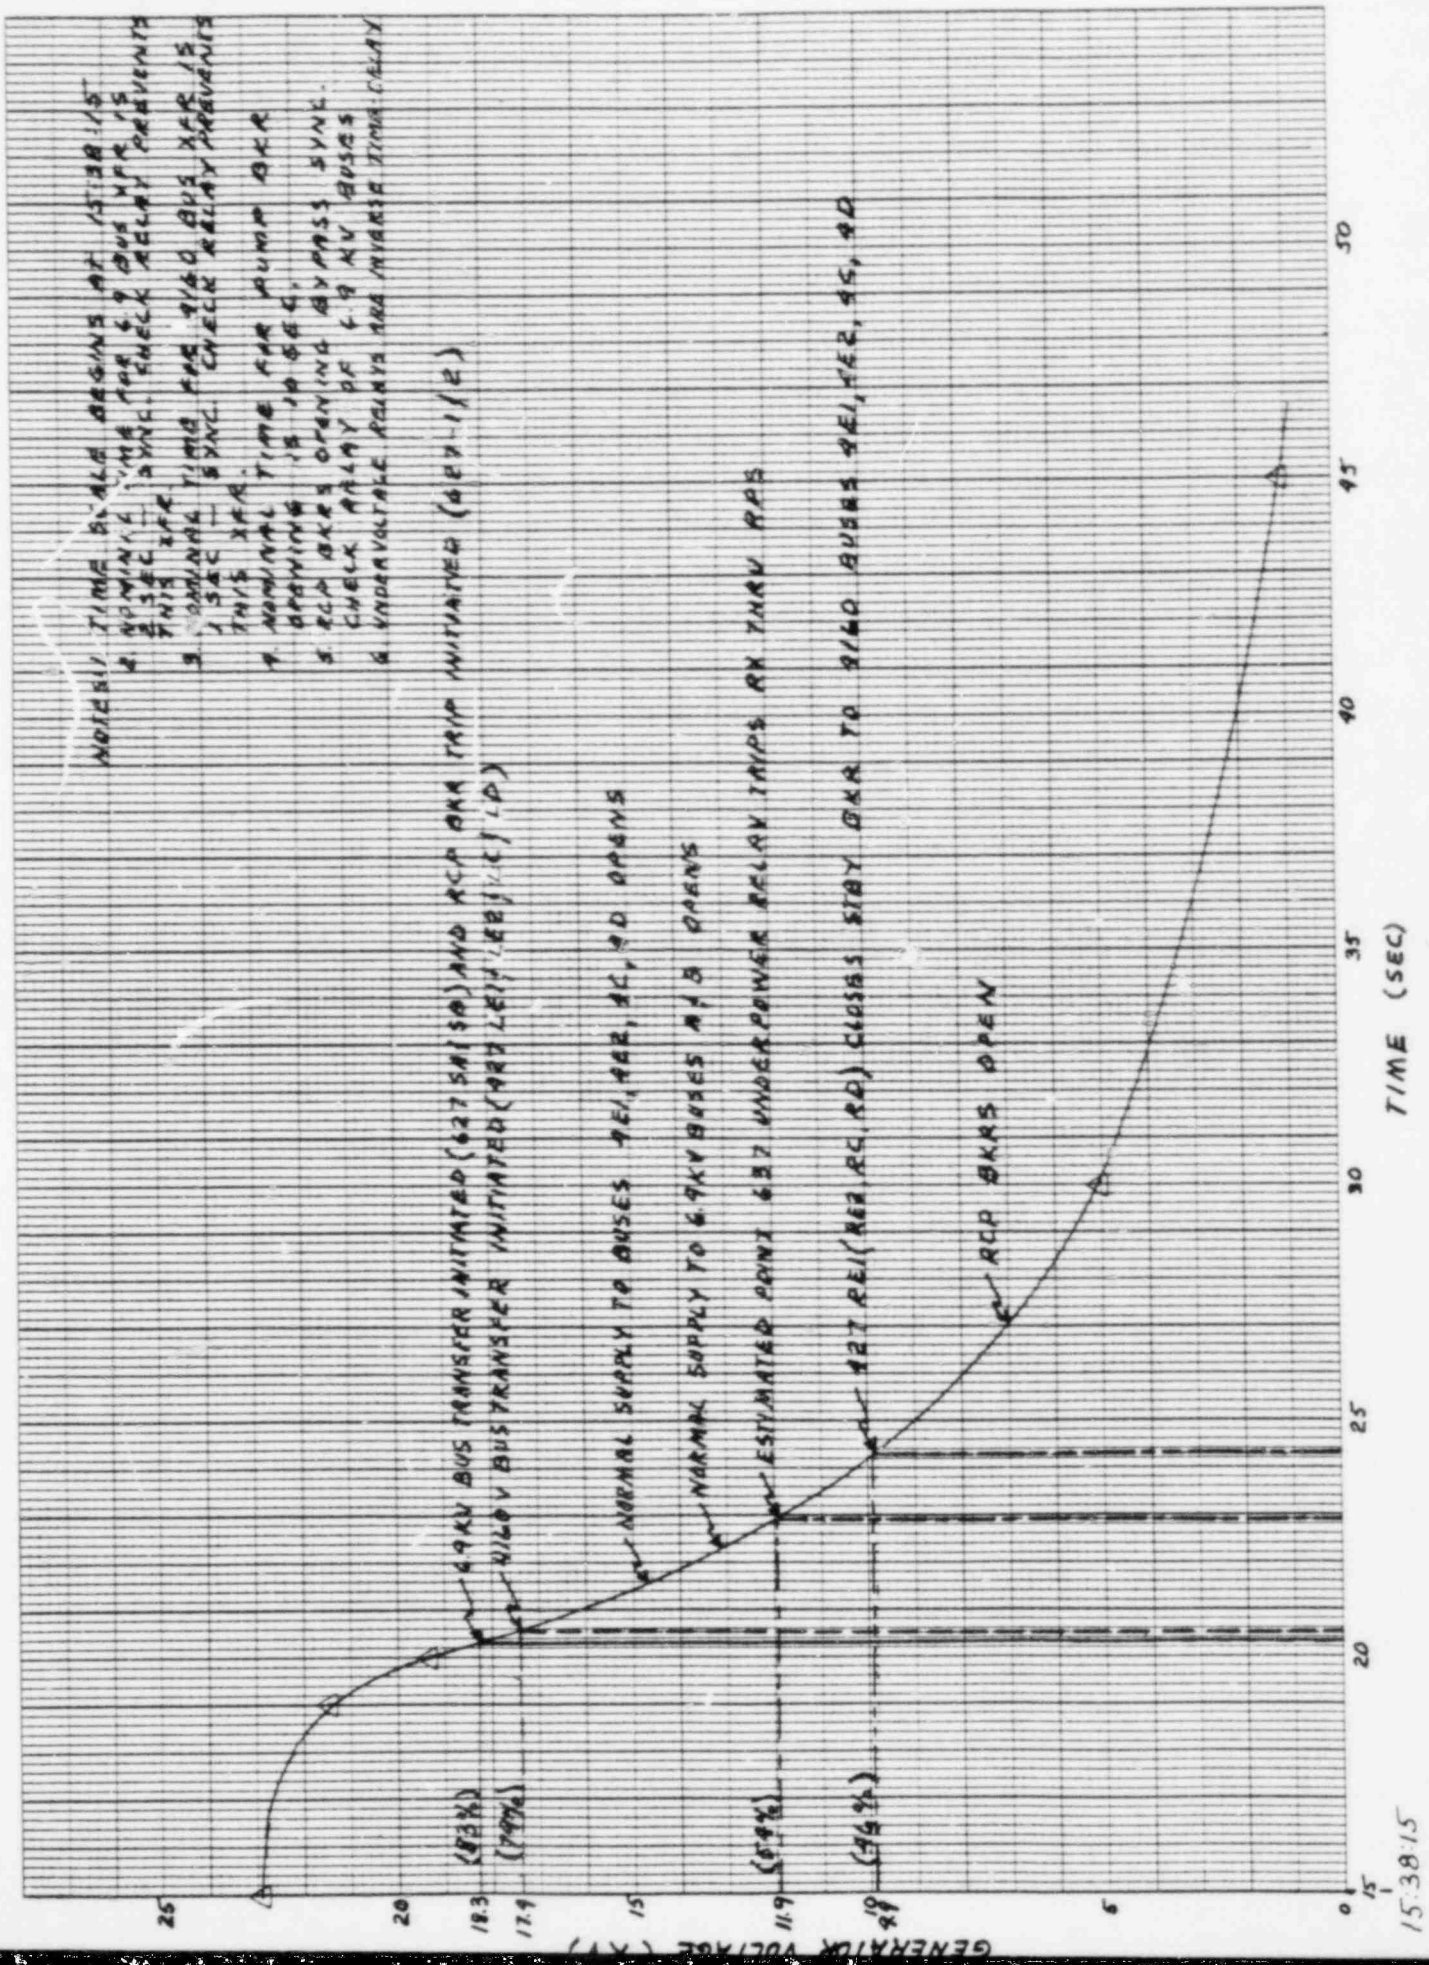
FIGURE 1  
GENERATOR VOLTAGE DECAY VS TIME

The 6900 volt Reactor Coolant Pump Buses S6A and S6B were among the buses subjected to this voltage decay, which is depicted by Figure 1. When voltage on the buses had decayed to approximately 5580V (83% of normal bus voltage), a transfer to

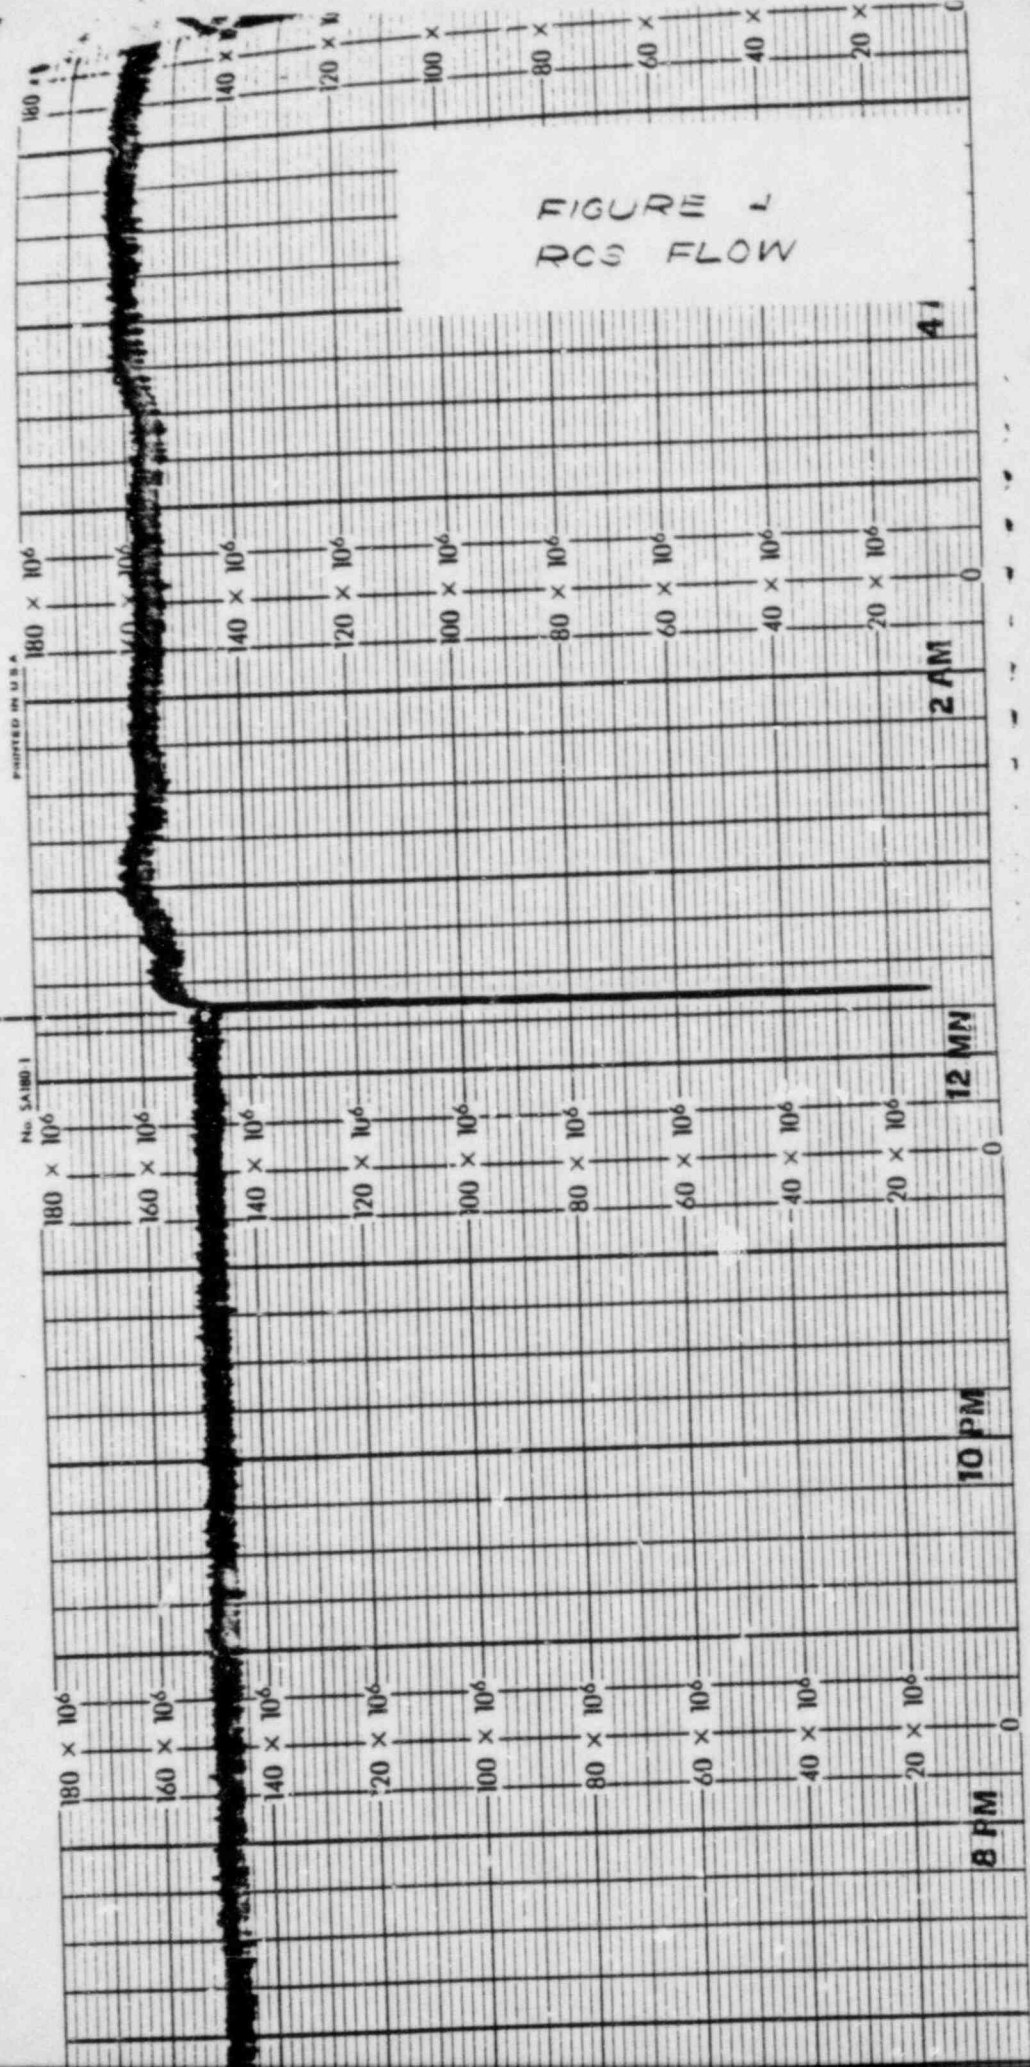
TOTAL RCS FLOW

Immediately following the trip, the Reactor was subjected to a large reduction of RCS coolant flow when all of the RCP's tripped.<sup>7</sup> Total RCS flow, which is shown in Figure 4, decreased from approximately 150 to 12 million pounds per hour. The affect of this reduction upon the reactor coolant temperature difference across the Reactor is shown in Figures 14 through 17.<sup>8</sup>

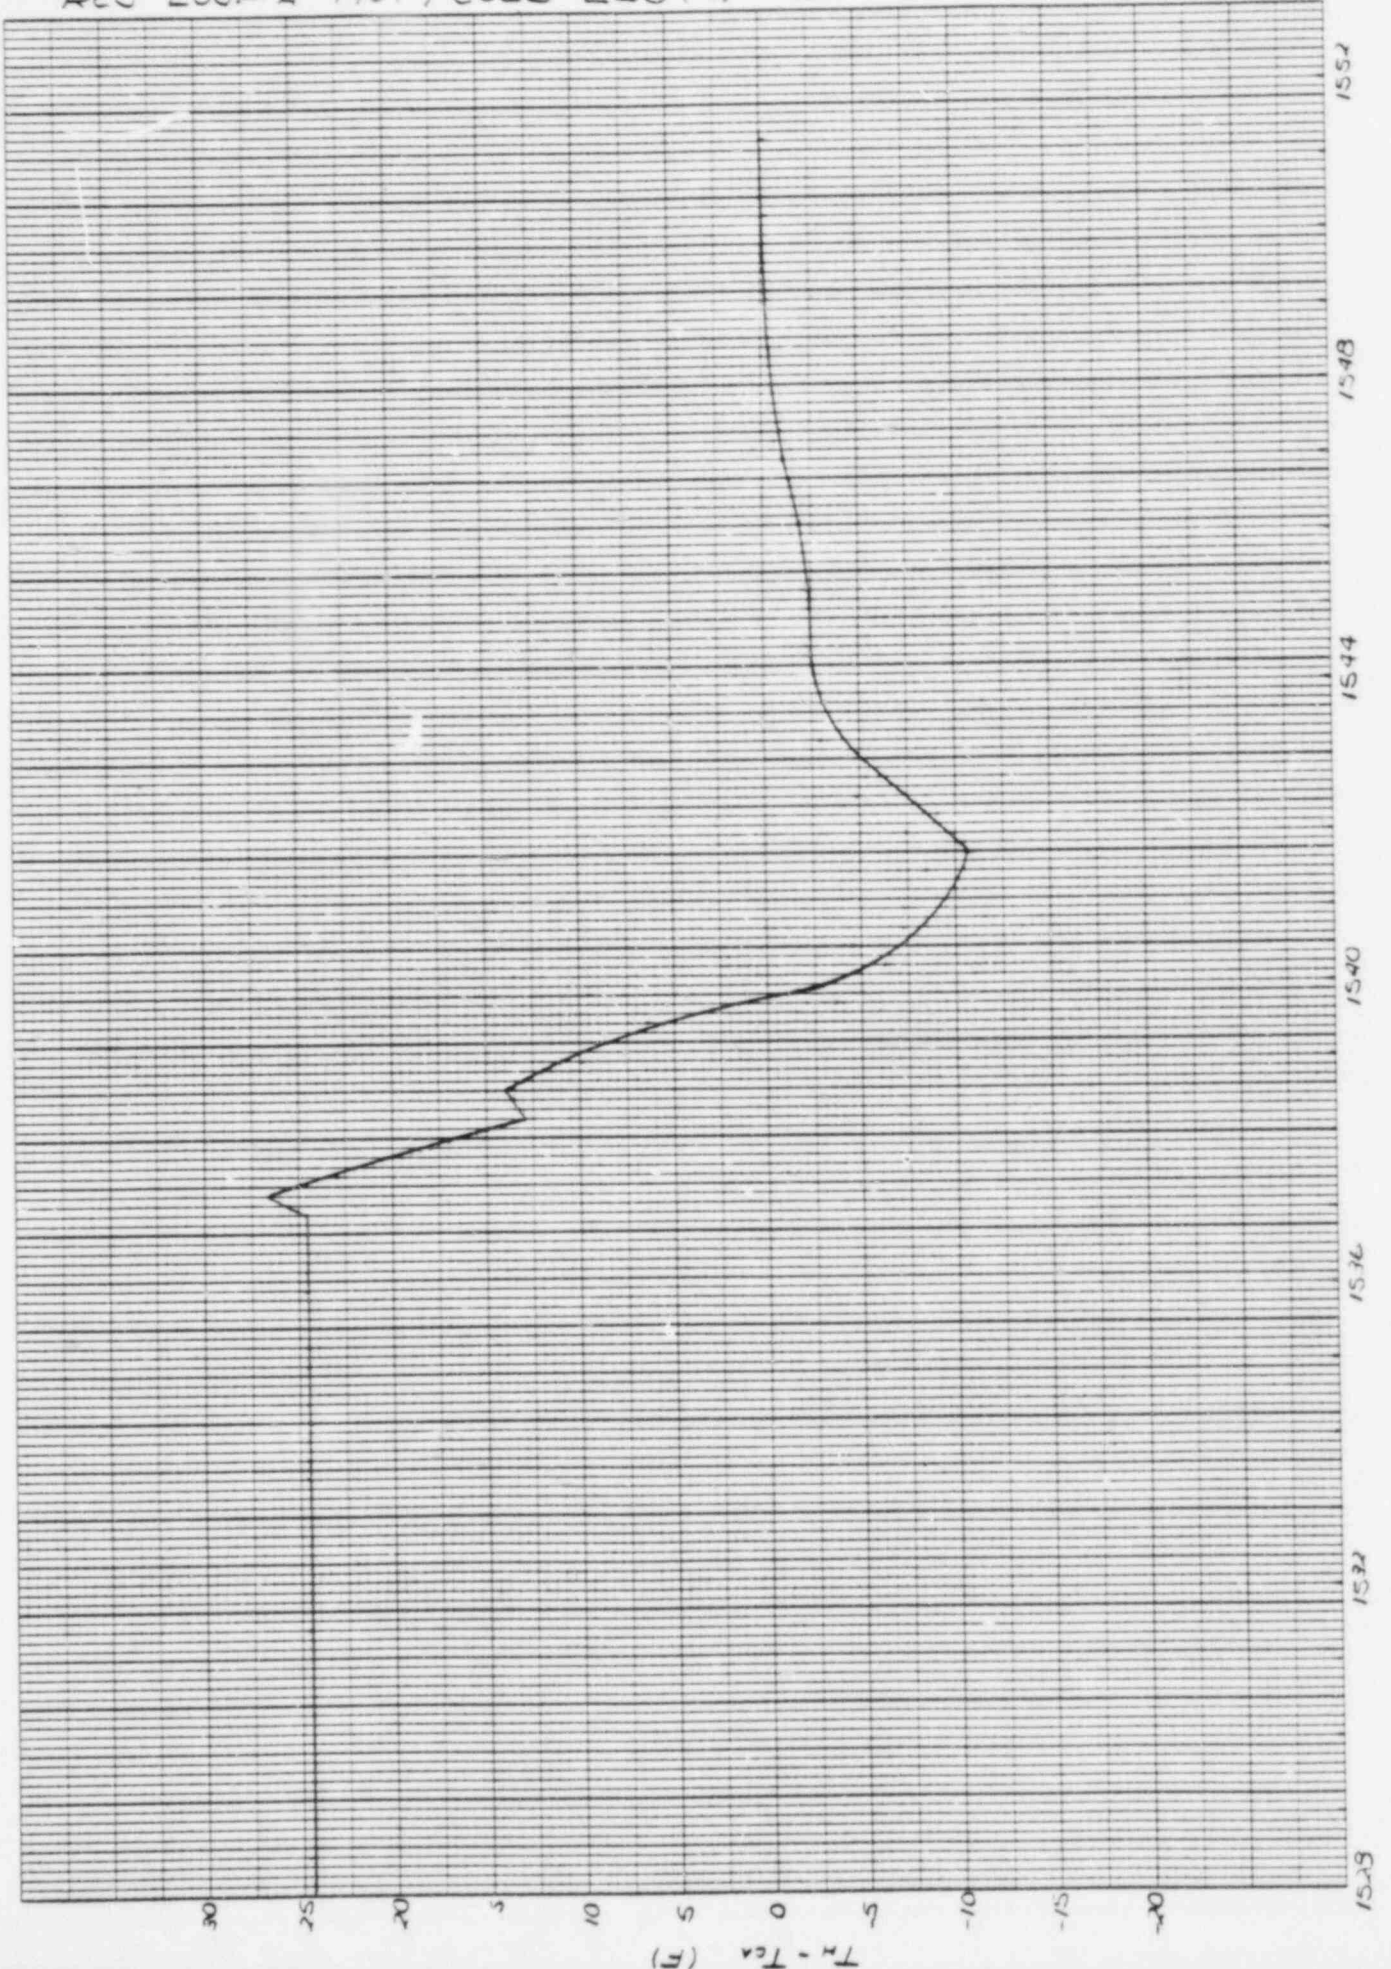
FIGURE 14  
RCS LOOP A HOT/COLD LEG (A) TEMPERATURE DIFFERENCE

8. The curves shown in these figures suggest that RCS cold leg temperatures were greater than the corresponding hot leg temperatures for a short period of time. This is attributed to the computer cold leg temperature data used to plot these curves. The cold leg temperatures listed by the computer represent the calculated average of values measured over the previous minute and, as such, are greater than the actual temperatures. Therefore the curves shown in these figures are approximations of the coolant temperature difference occurring across the Reactor.

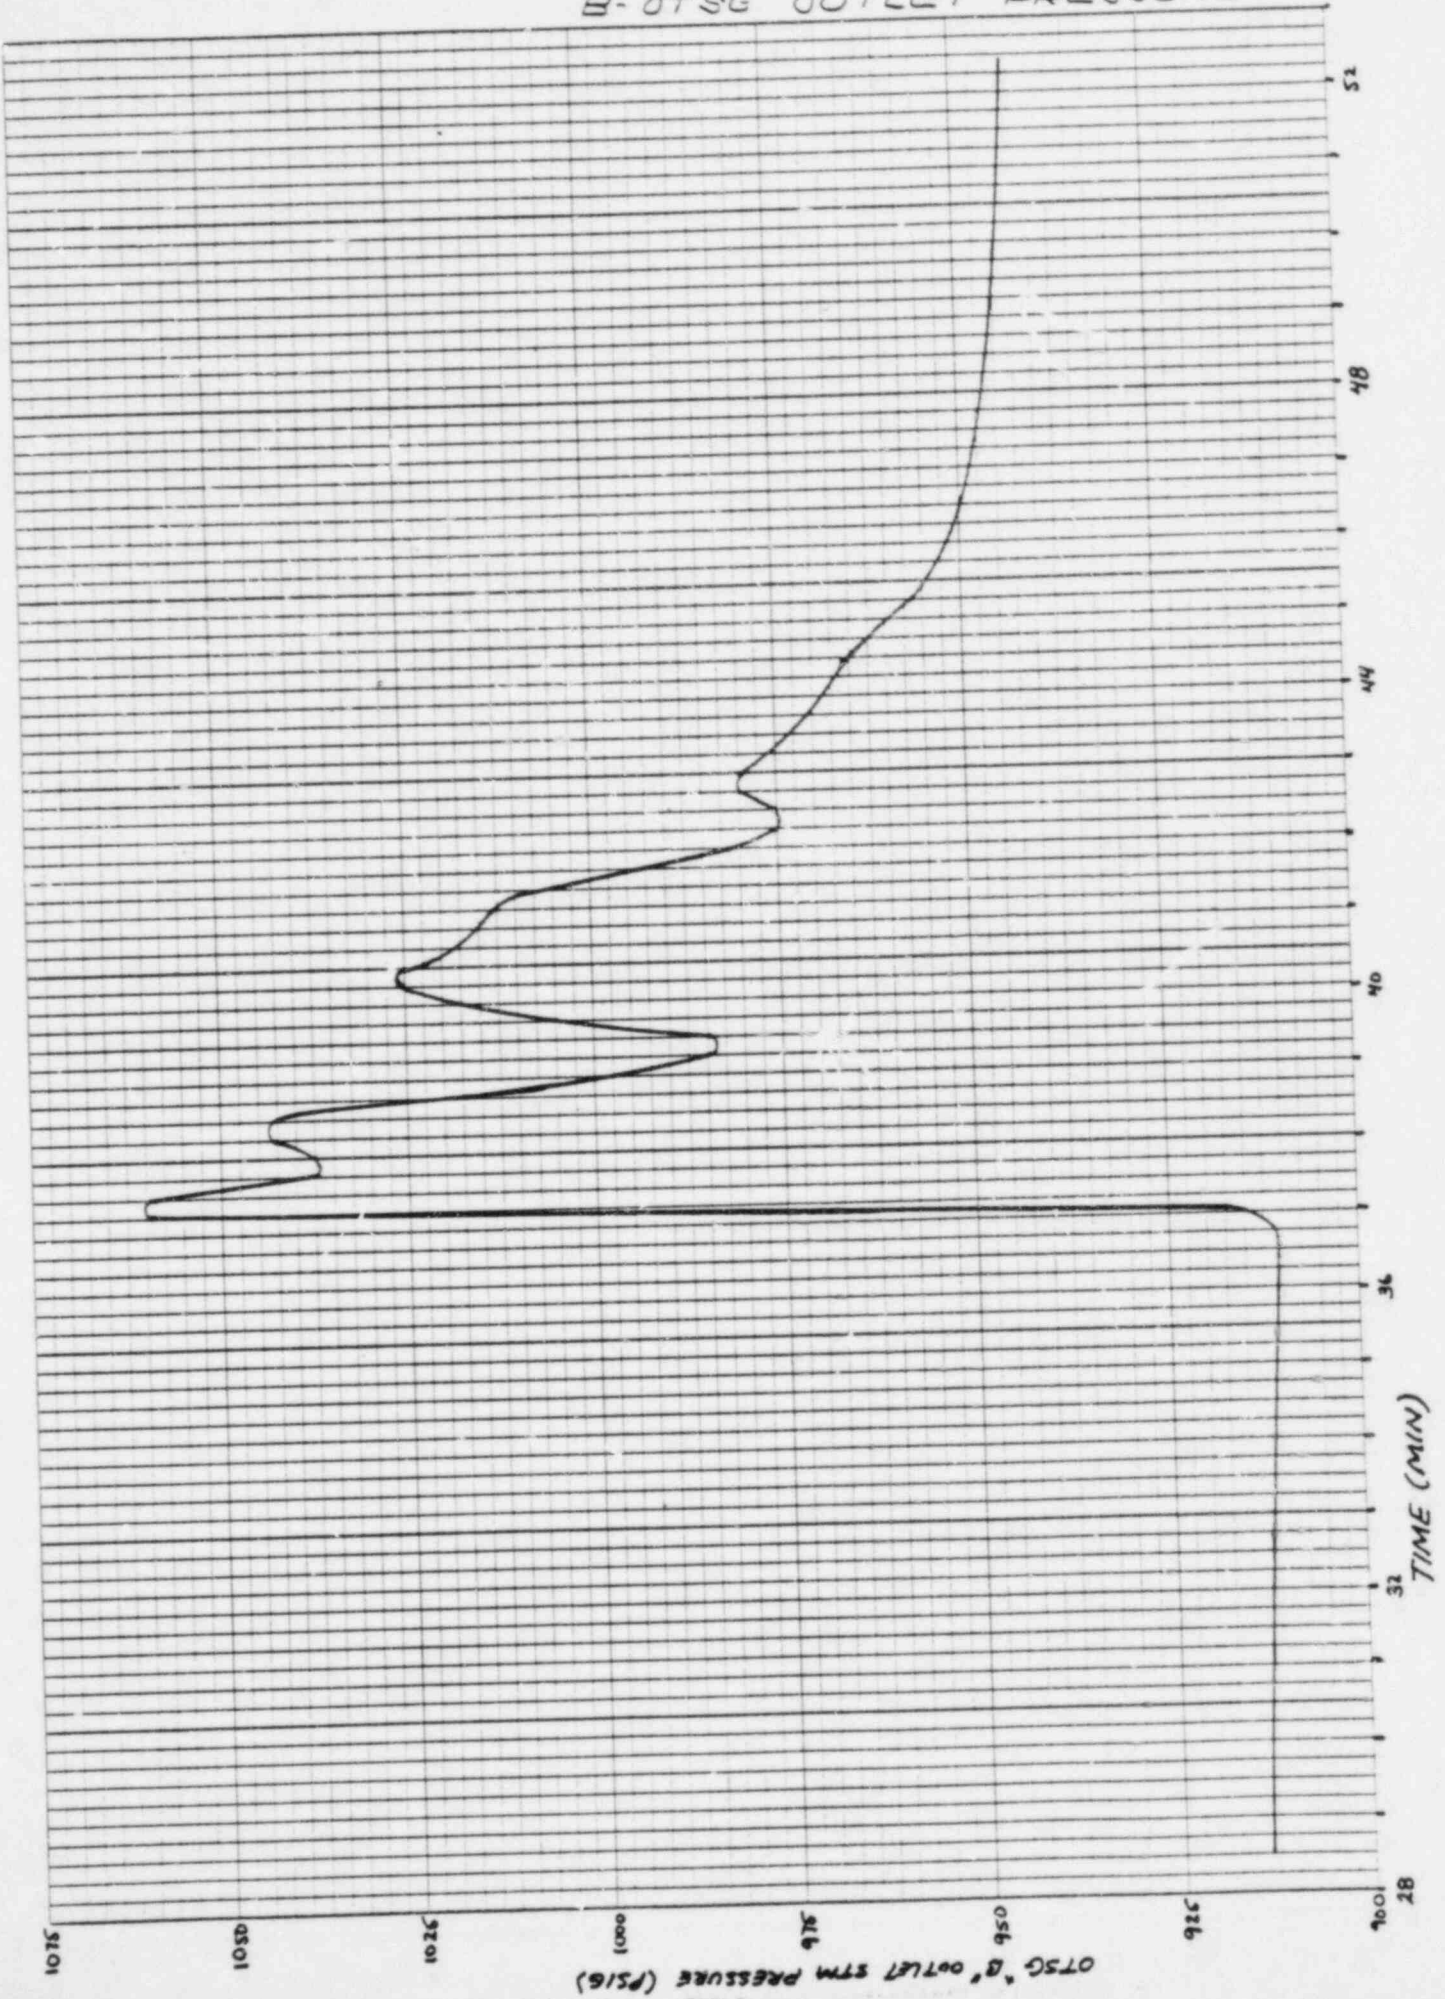
FIGURE 19  
B-OTSG OUTLET PRESSURE

Dissimilar pressure response of the two secondary loops is revealed by a comparison of the OTSG outlet steam pressure charts, Figures 22 and 23. One Turbine Bypass Valve (PV-20563) in the A Loop and one Modulating Atmospheric Dump Valve in the B Loop were out of service. With these valves out of service, pressure relief capabilities of the two loops were different--possibly causing the dissimilar pressure response.

Maximum pressure recorded at the B-OTSG outlet was greater than the 1050 PSIG setpoint for safety relief valves PSV-20544 and PSV-20546, implying that these valves may have operated.
