SUBJECT: Final Report
Limitorque Corporation 10 CFR 21 Evaluation #44
Worm Shaft Clutch #50-501-0012-1

SUBJECT: Final Report
Limitorque Corporation 10 CFR 21 Evaluation #44
Worm Shaft Clutch #60-501-0012-1

SUBJECT: Interim Report
Limitorque Corporation 10 CFR21 Evaluation #44

SUBJECT: Interim Report
Limitorque Corporation 10 CFR21 Evaluation #44
Worm Shaft Clutch #60-501-0012-1

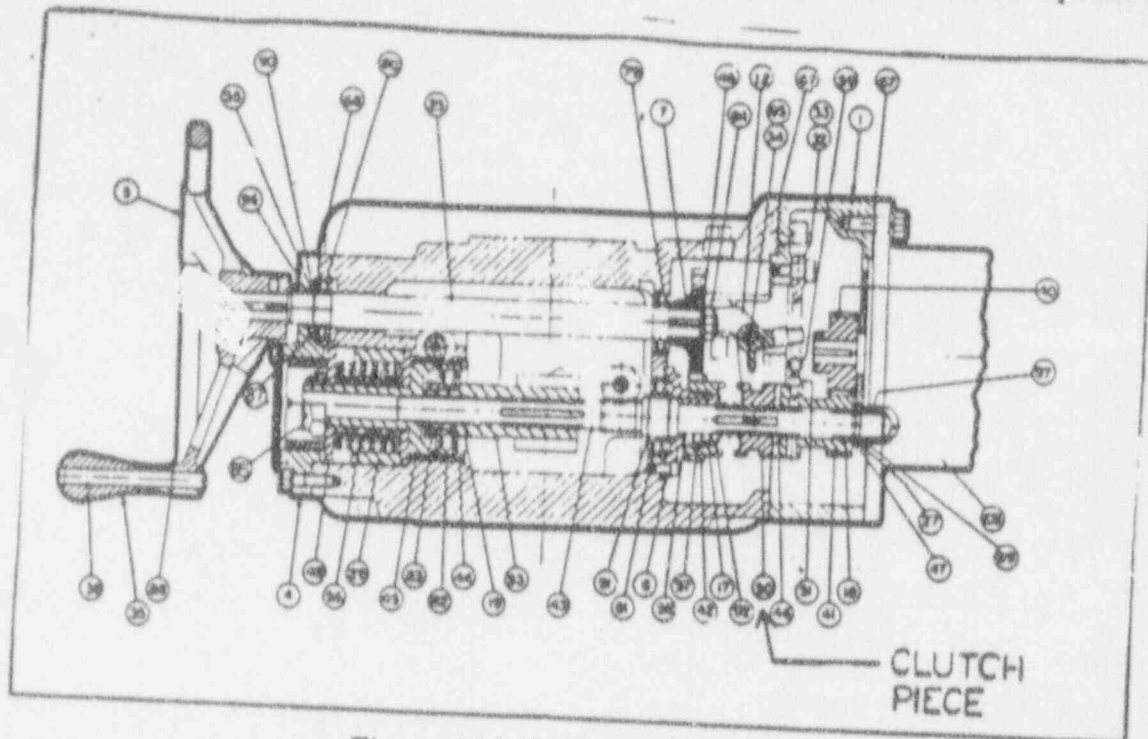
Figure #10--SMB-1 Assembly

A utility discovered a broken worm shaft clutch (part #60-501-0012-1) while performing routine maintenance on an SB-1 actuator. The failure consisted of a separated lug which engages with the motor driven worm shaft gear drive lug. The actuator was still operable since the remaining worm shaft clutch lug was intact.

The worm shaft clutch was installed in an SB-1 actuator (order number 3B5991B, serial number 273065) which was furnished in mid-1978. Limitorque is requesting any additional information regarding similar failures of this component. This data will be evaluated per the requirements of 10CFR21. Please provide the serial number of any actuators that the defective component has been located and whether the component was originally supplied with the actuator. The worm shaft clutch is piece #50 shown in Figure #10--SMB-1 Assembly.
