U.S. NUCLEAR REGULATORY COMMISSION
REGION I

Docket/
Report No. 50-213/94-03

Facility: Haddam Neck Plant

EXECUTIVE SUMMARY
HADDAM NECK PLANT INSPECTION 50-213/94-03

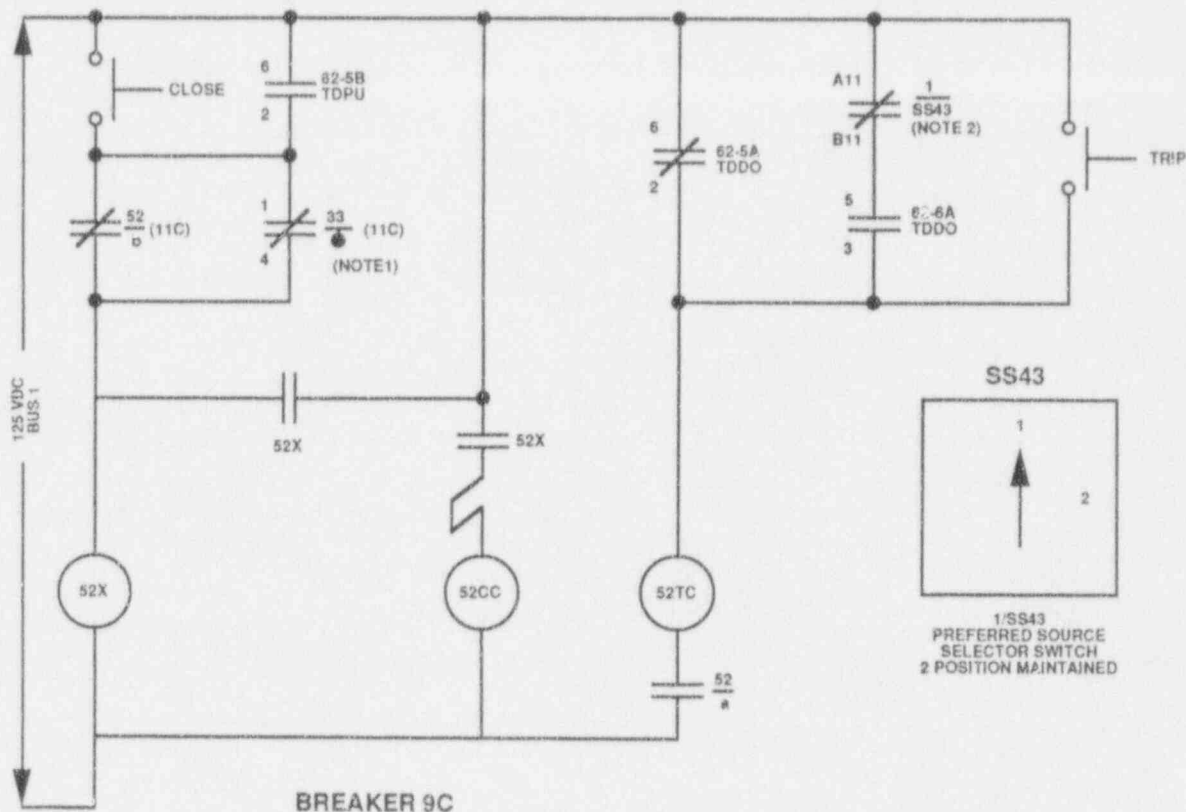
MCC-5 SIMPLIFIED DIAGRAM
FIGURE 1

The inspector reviewed activities in progress throughout this period to test the automatic bus transfer (ABT) for motor control center 5 (MCC-5). The inspection was initiated following the licensee's report that the MCC-5 failed during a test on February 16. The ABT failure during testing was the second such occurrence in nine months. The ABT failures are safety significant since: MCC-5 is not single failure proof; MCC-5 powers redundant plant valves in the emergency core cooling system; and, the proper operation of MCC-5 is essential to mitigate certain design basis accidents.

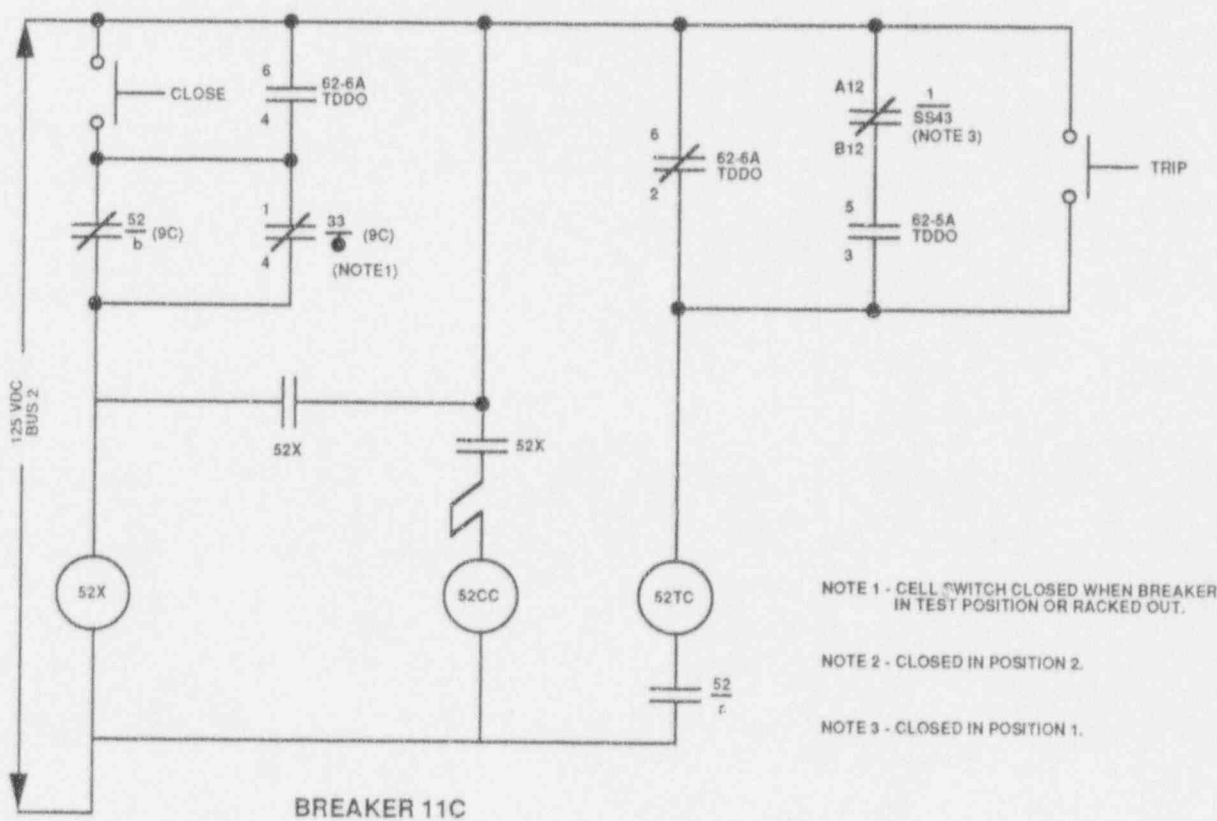
ABT LOGIC DIAGRAM
FIGURE 2

Upon completion of phase 1, plant personnel began procedure step 6.2 to test the scheme in a transfer from Bus 6 to Bus 5. To set up for the phase 2 test, plant personnel placed selector switch SS43 from position 1 to position 2 at 1:40 a.m. This action should have caused breaker 9C to open, and breaker 11C to close. Breaker 9C did open, but breaker 11C did not close as required. MCC-5 deenergized. After consultation with the control room operators, testing was secured and test personnel were directed to reenergize MCC-5 from Bus 5. Test personnel first placed switch SS43 in position 1; but MCC-5 remained deenergized. MCC-5 was reenergized when test personnel manually closed breaker 9C at Bus 5. Test personnel observed the 52X relay in both the 9C and 11C breakers, and noted that both relays were deenergized, the moveable core pieces were in the "down" position, and the relays were ready for a close signal. Further testing was suspended pending the development of a troubleshooting and test plan to investigate the failure in the "as-found" condition. Since the 52 X relays appeared to have operated correctly, the licensee investigation focused on switch SS43 and on a cell switch as the potential cause of the failure.

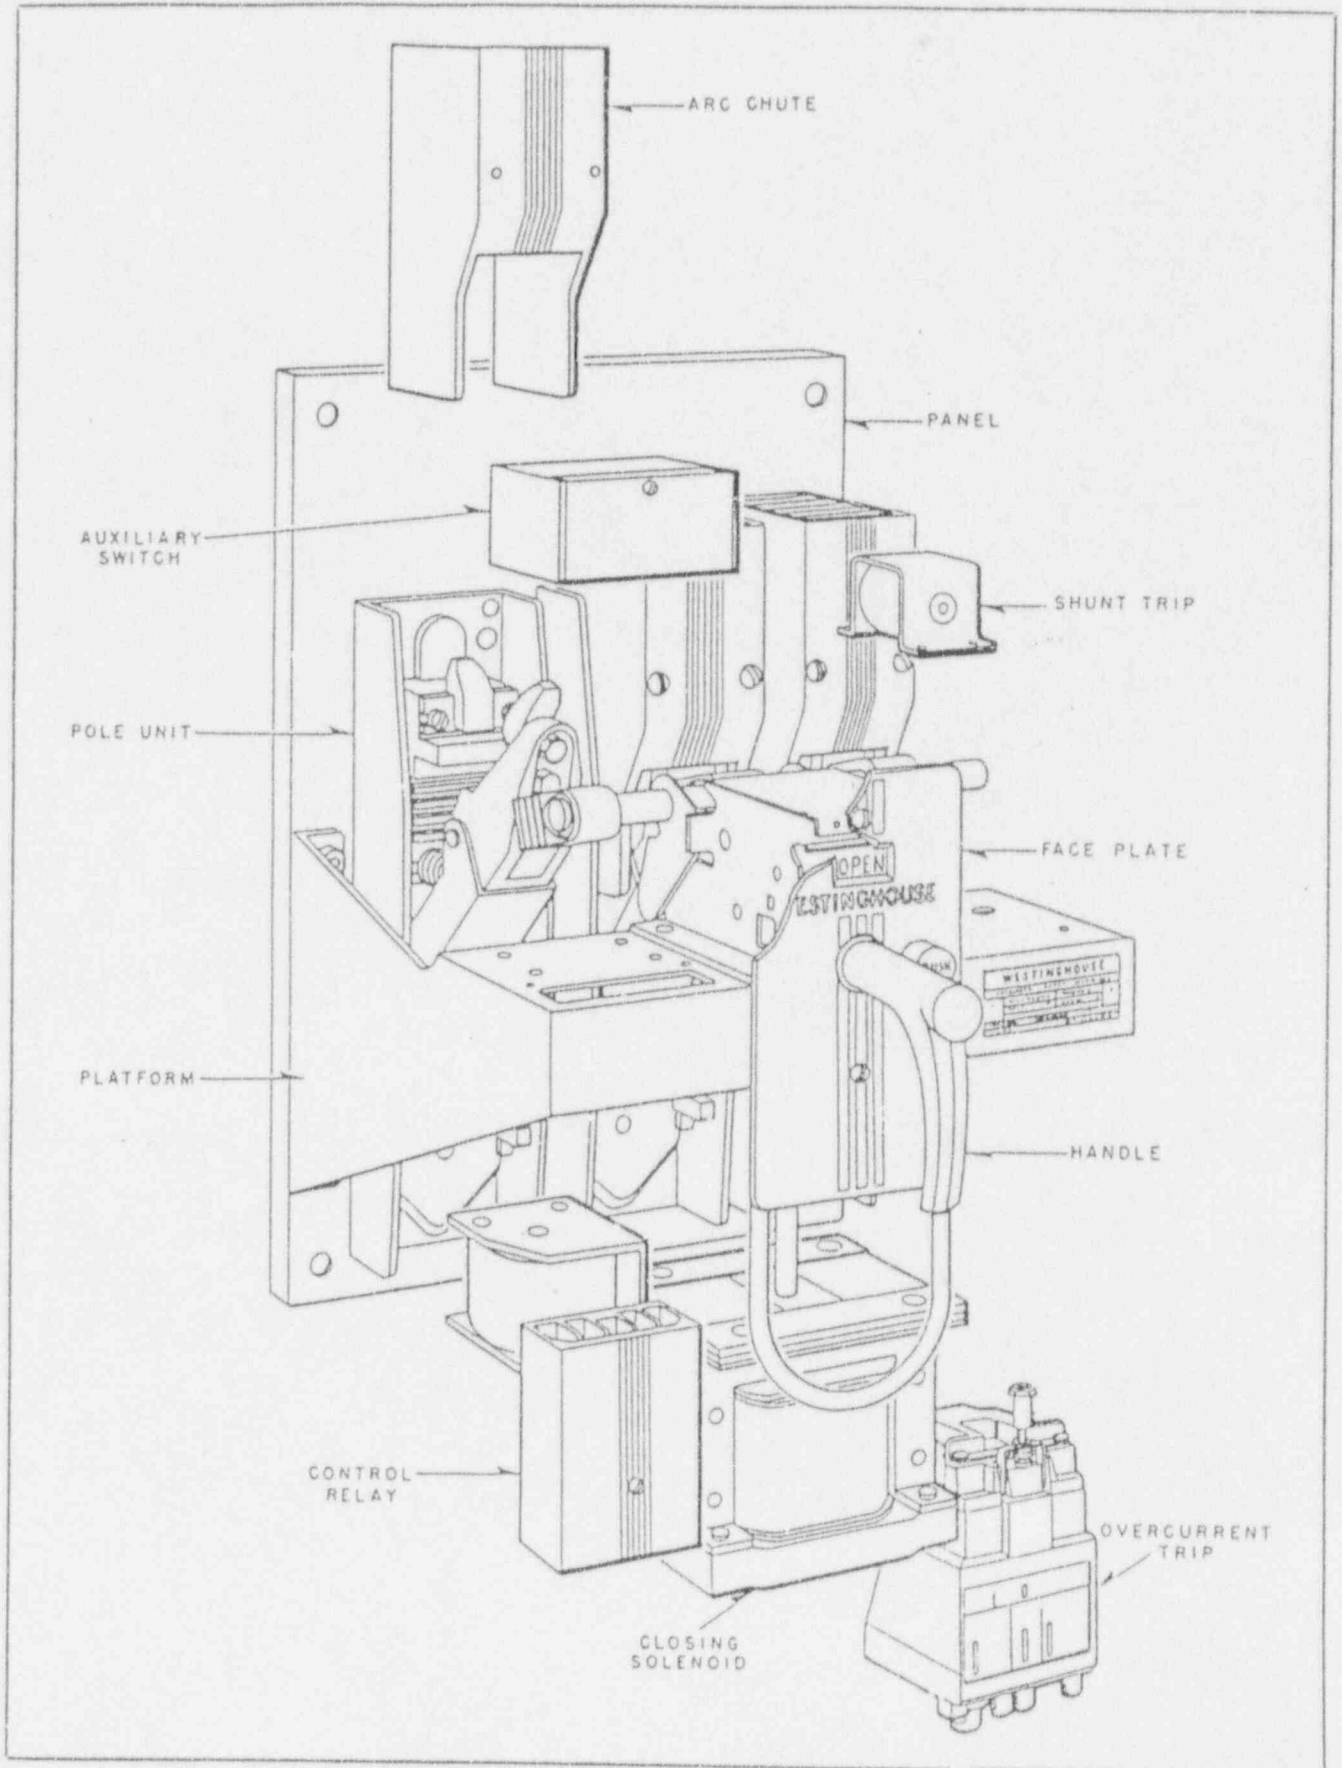
FIGURE 3
VIEW OF DB-25 BREAKER

Since no anomalies were noted in the operation of the ABT, and since breaker 11C was involved in the ABT failures at 1:40 a.m. and 7:44 p.m., the investigation focused on the misoperation of the breaker. Breaker 11C was removed for inspection and a spare breaker (marked 16C) was installed in Bus 6 compartment. The ABT operated properly during subsequent testing on February 16 with the new breaker in Bus 6. Specifically, MCC-5 remained energized when Step 6.1 was performed which caused the ABT to transfer MCC-5 from Bus 5 to Bus 6 and back to Bus 5, in a test sequence starting at 9:00 p.m. At 9:49 p.m., test personnel placed switch SS43 in position 2 to set up for the Bus 6 test. The ABT operated properly at that time. Finally, MCC-5 remained energized when Step 6.2 was performed which caused the ABT to transfer MCC-5 from Bus 6 to Bus 5 and back to Bus 6, in a test sequence starting at 9:50 p.m.

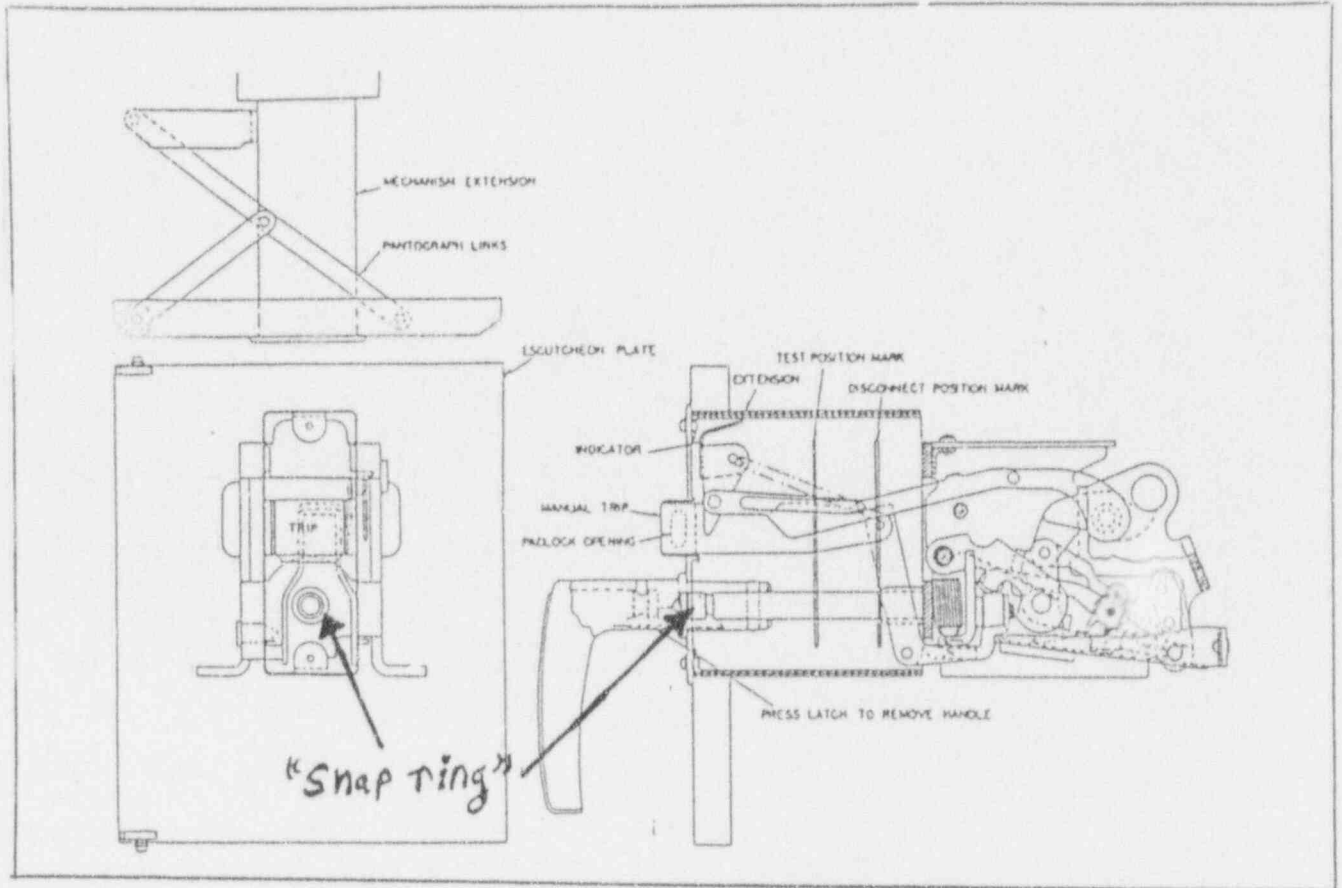
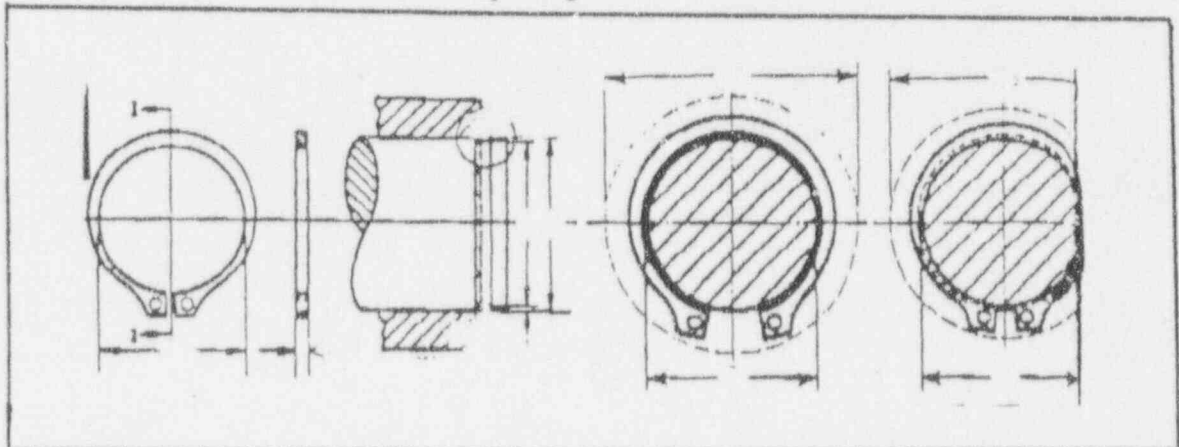
FIGURE 5
DB-25 BREAKER OPERATING MECHANISM

The manual breaker closing linkage interfered with the breaker trip linkage due to the improper position of the snap ring. The licensee was able to demonstrate that a slight rotation of the manual closing linkage tripped the breaker. The licensee then protracted the manual linkage to

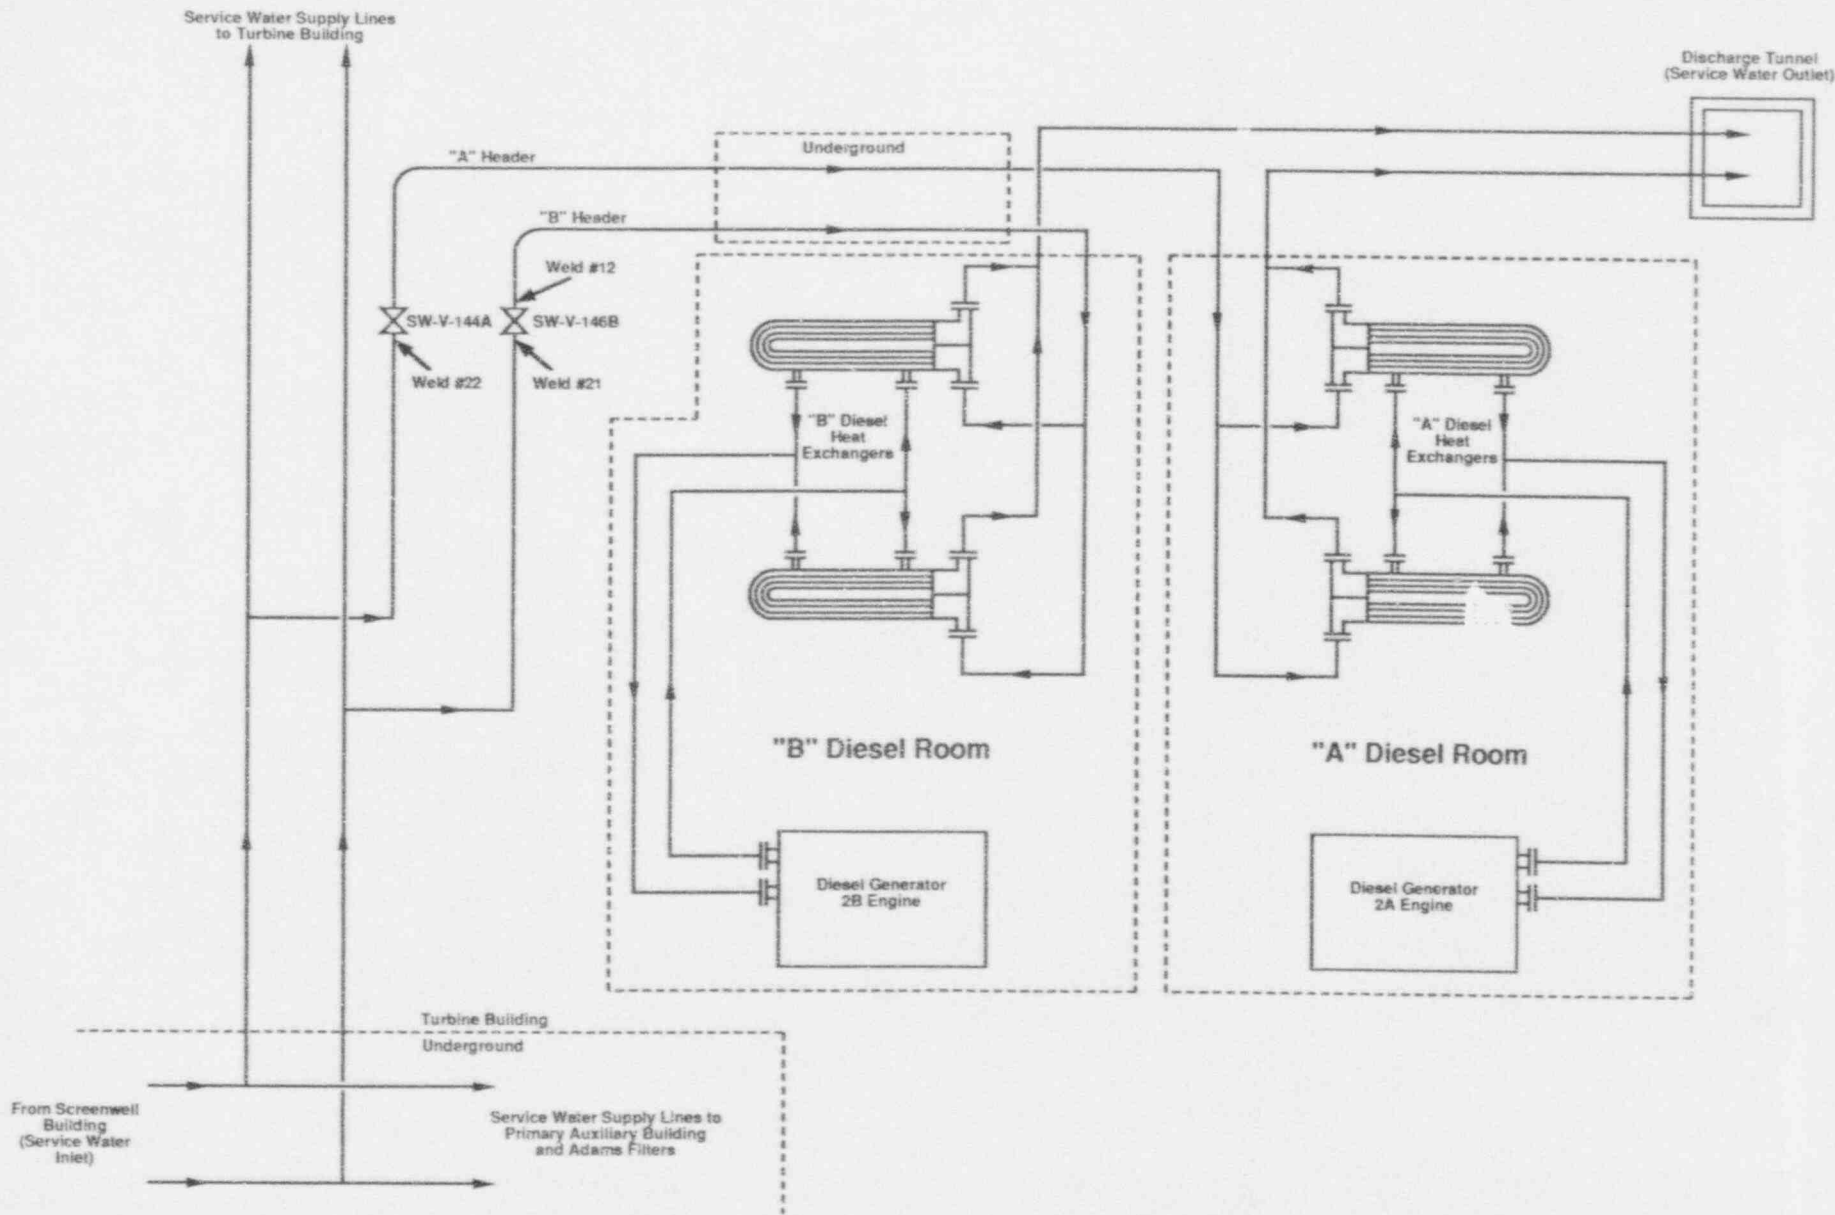
**Service Water to Diesel Generator Heat Exchangers
Figure 6**

With the plant operating at 100% full power on February 12, plant workers prepared two welds in the service water system for ultrasonic (UT) examination. The UT exam was planned to better characterize degradation caused by corrosion in two welds in the service water supply piping to the emergency diesel generators (EDGs). While grinding the crown of weld #22, the weld began to weep through a pin hole sized defect. The leaky weld was on the upstream side of the isolation valve for the 'A' EDG supply header, was not isolable from the main SW header, and thus potentially affected the supply to the 'B' EDG as well. Although the weld still had structural integrity and both supply lines to the diesels were functional, the licensee declared both service water system headers inoperable.

The licensee actions to repair the leaky weld and to address degraded piping in the service water system to are described in Section 3.5 of this report. The degraded conditions will be addressed prior to returning the plant to power operation. The inspector identified no inadequacies in the licensee actions to meet the technical specification requirements. The inspector determined the plant operators performed well in completing the orderly plant shutdown.
